Bureau of Land Management Colorado River Valley Field Office Minerals Inspection Report

General Information	
Date	11/6/2019
Project Name	Rifle Quarry
Operator	Colorado Lien Company
Serial Number	COC-077876
Project Classification	Plan of Operations
Project Location	T4S R92W Sec15, Garfield County
Inspection Purpose	Reclamation site inspection
Time Period Onsite	1 hour
Attendees	Jessica Lopez Pearce, BLM Geologist (report author)

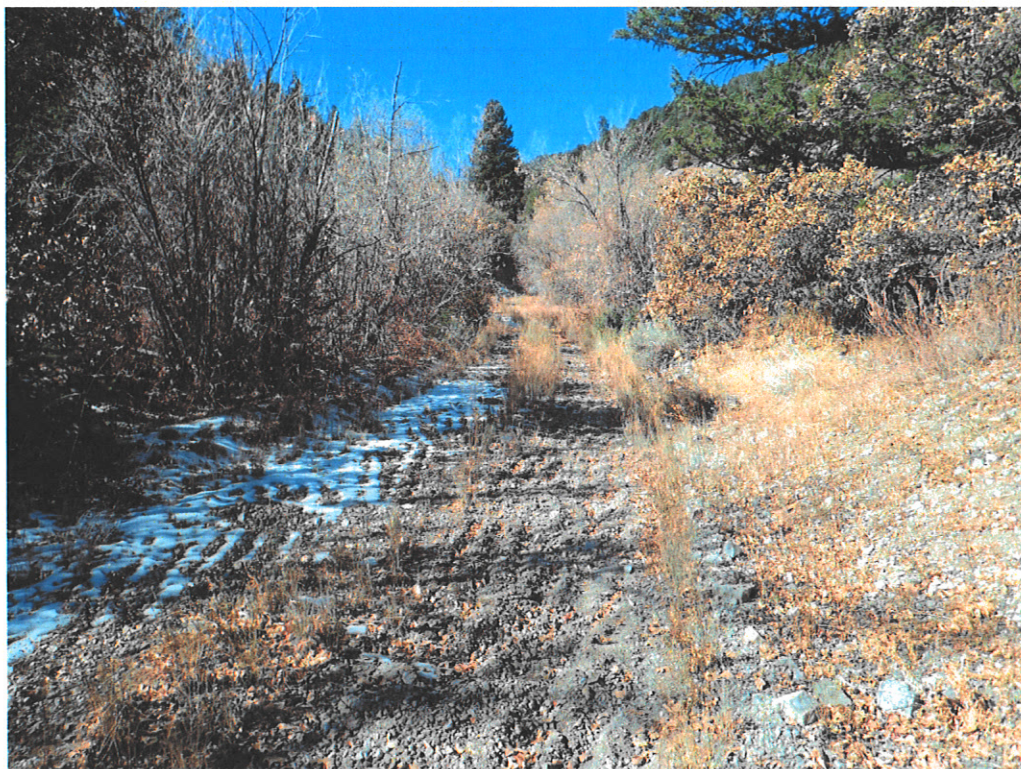
Photo 1: Wheel ruts in the reclaimed access road were recently scarified to promote revegetation.

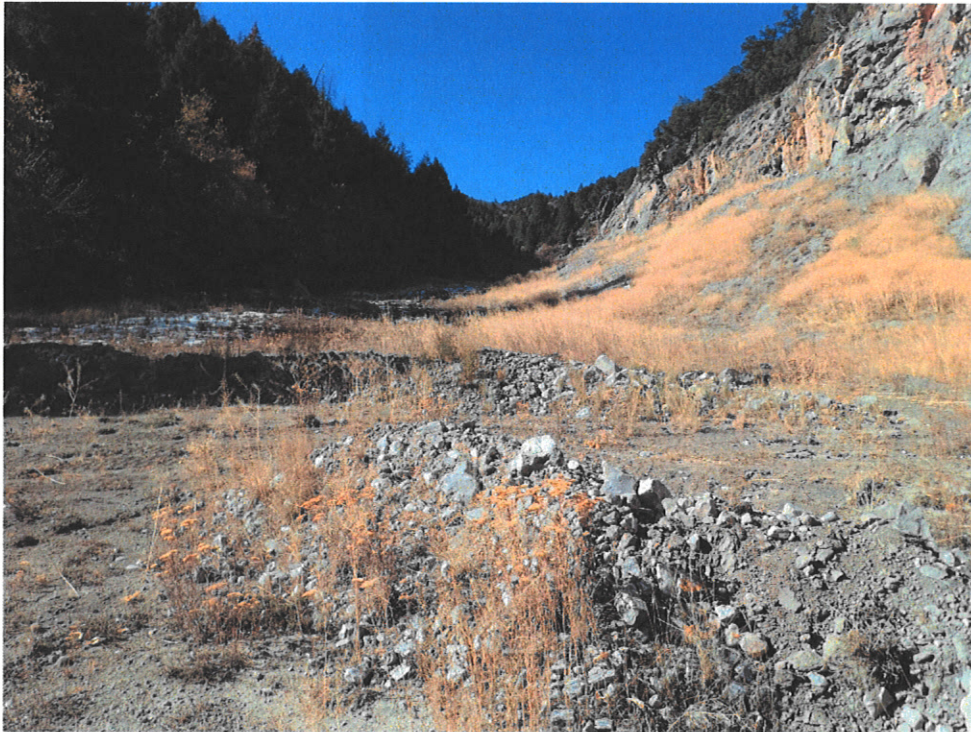
Photo 2: Looking west to the quarry floor. Sediment berms were stabilized and elongated to prevent erosion.

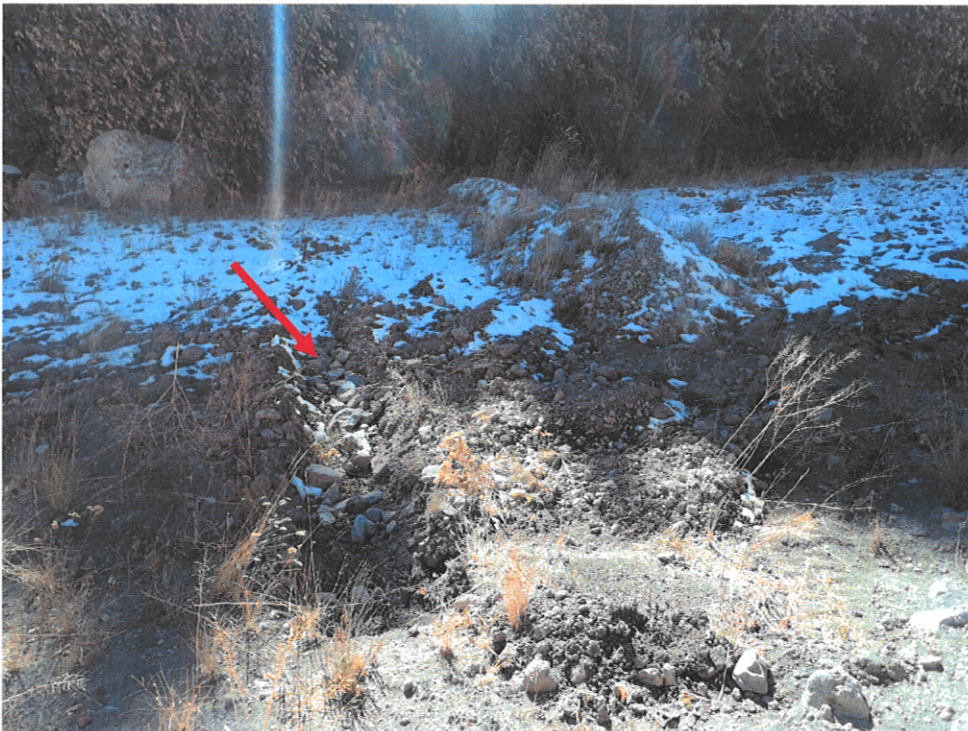
Photo 3: Looking south to the westernmost stormwater BMPs. The new rip-rap lined trench is on the left side of the photo (indicated by red arrow).

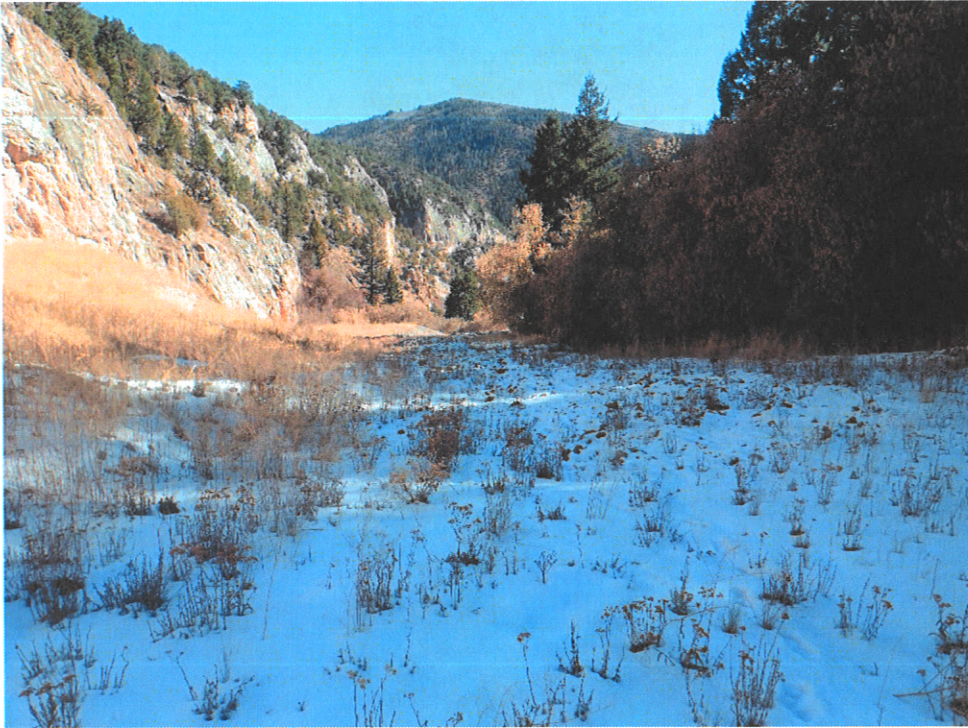
Photo 4. Looking east to the scarified quarry floor under snow.
