REALtime Aquifer Services

Subject: Documentation of Completed Corrective Actions at the Gillette Sand & Gravel Inc. Site
File No.: M-1992-009

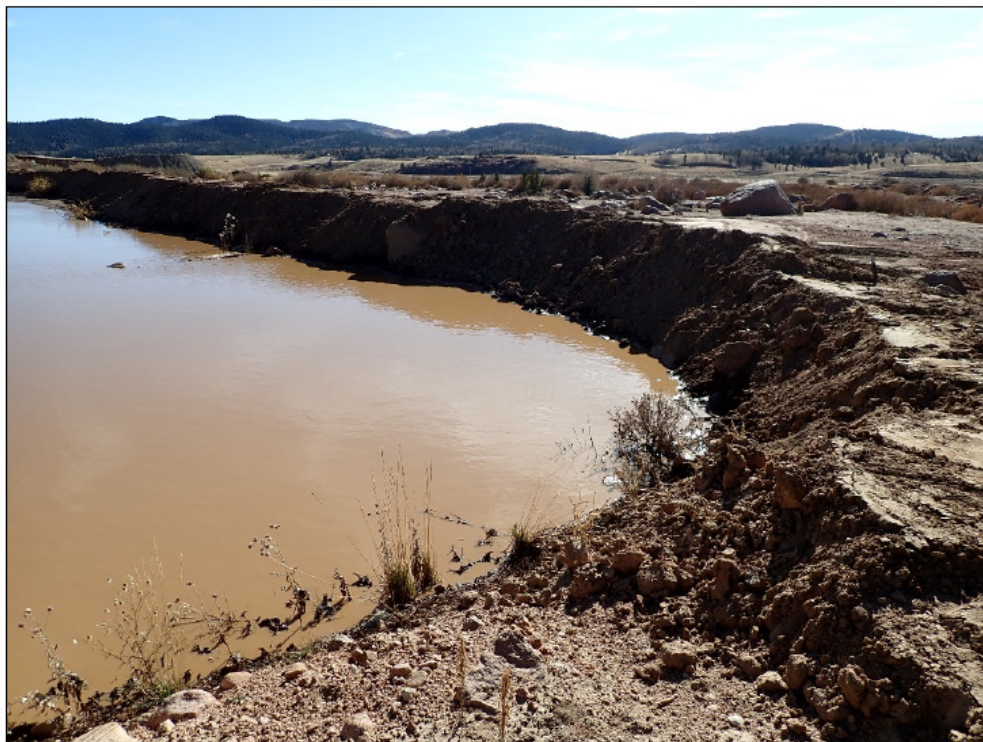
- 1. Inspection Topic Summary: Wash water from the process ponds was released into Beaver Creek and sediment fines from the process ponds have been piled outside of the approved permit boundary.*

Raised embankment in the northwest corner of the northern process pond, looking southeast.

Corrective action was implemented on October 4, 2019, the day following the one-time release. The west berm of the sediment retention pond was significantly enlarged and reinforced, particularly in the part of the pond that had overtopped. The pond freeboard has been increased to reduce the likelihood of future overtopping.

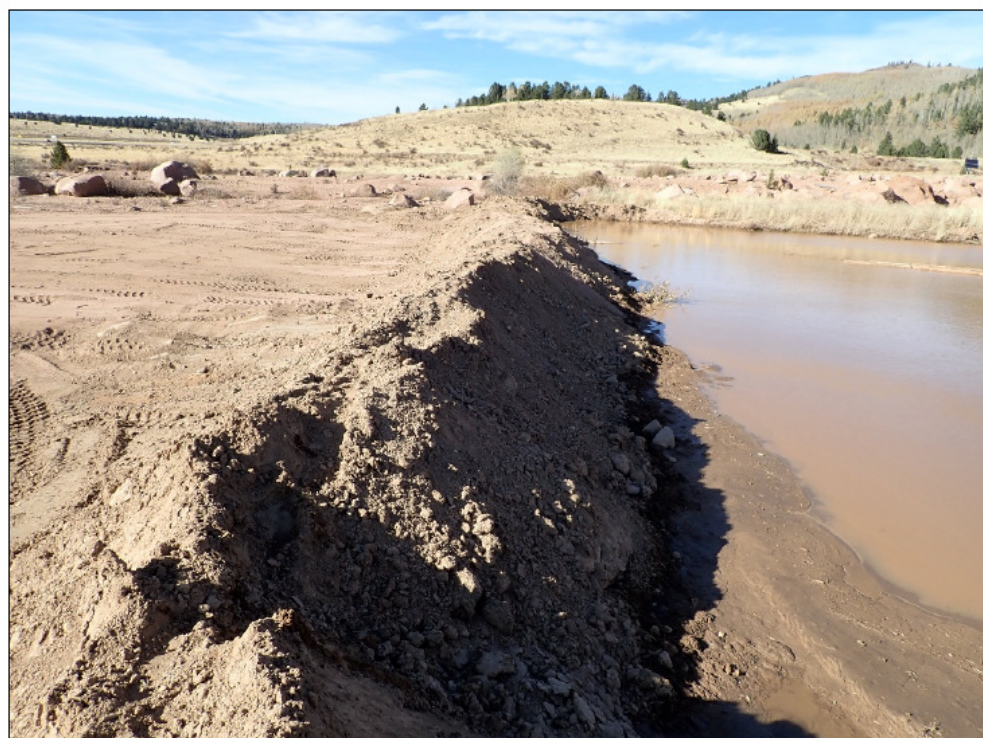
Raised embankment along the western side of the northern process pond, looking north.

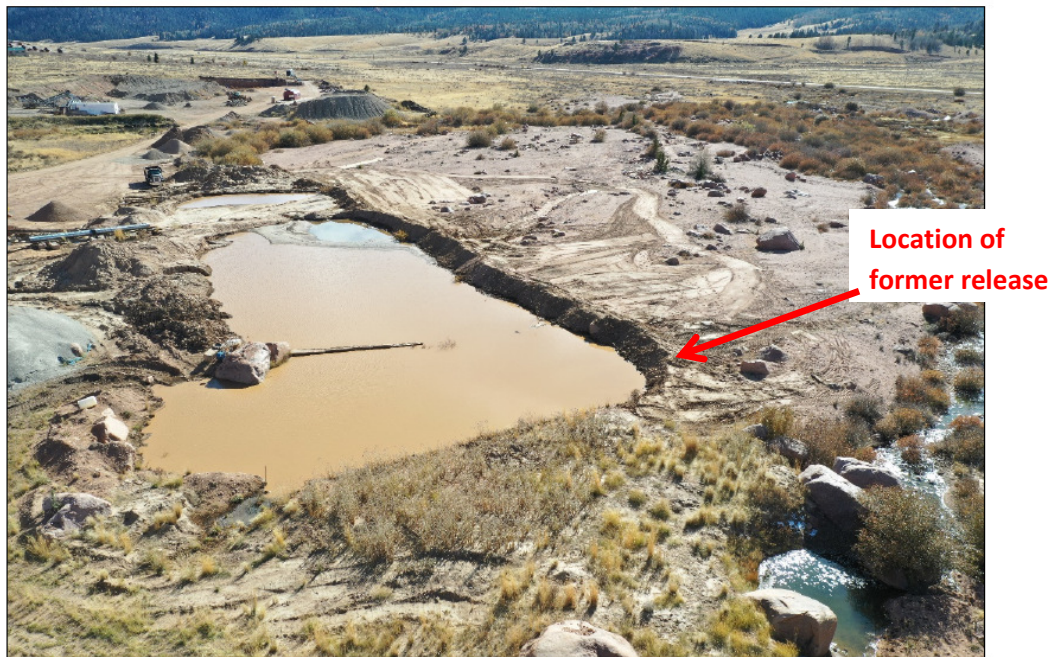
Aerial overview of the process ponds looking southwest.

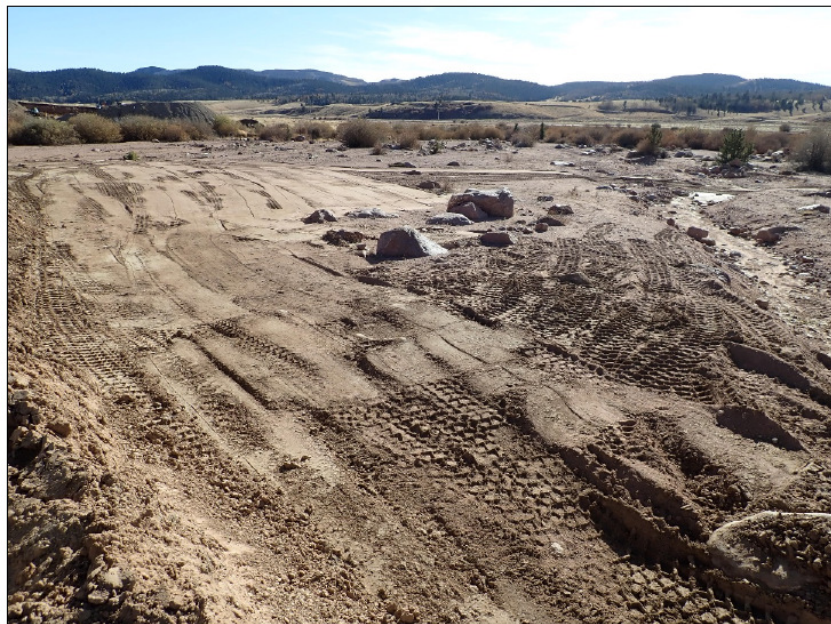
2. *Failure to protect areas outside of the affected land from slides or damages occurring during the mining operation and reclamation.*

Graded off-site disturbance area to the west of the permit boundary, looking southwest.

Sediment that had been released beyond the western permit boundary was graded back onto the Site and the off-permit area was regraded to approximately pre-release conditions.

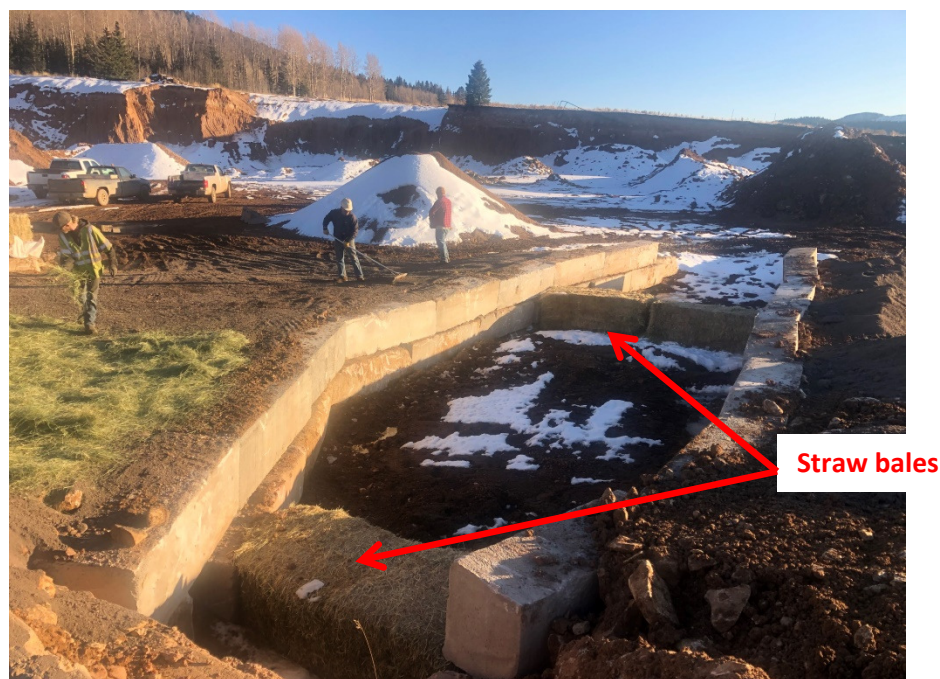
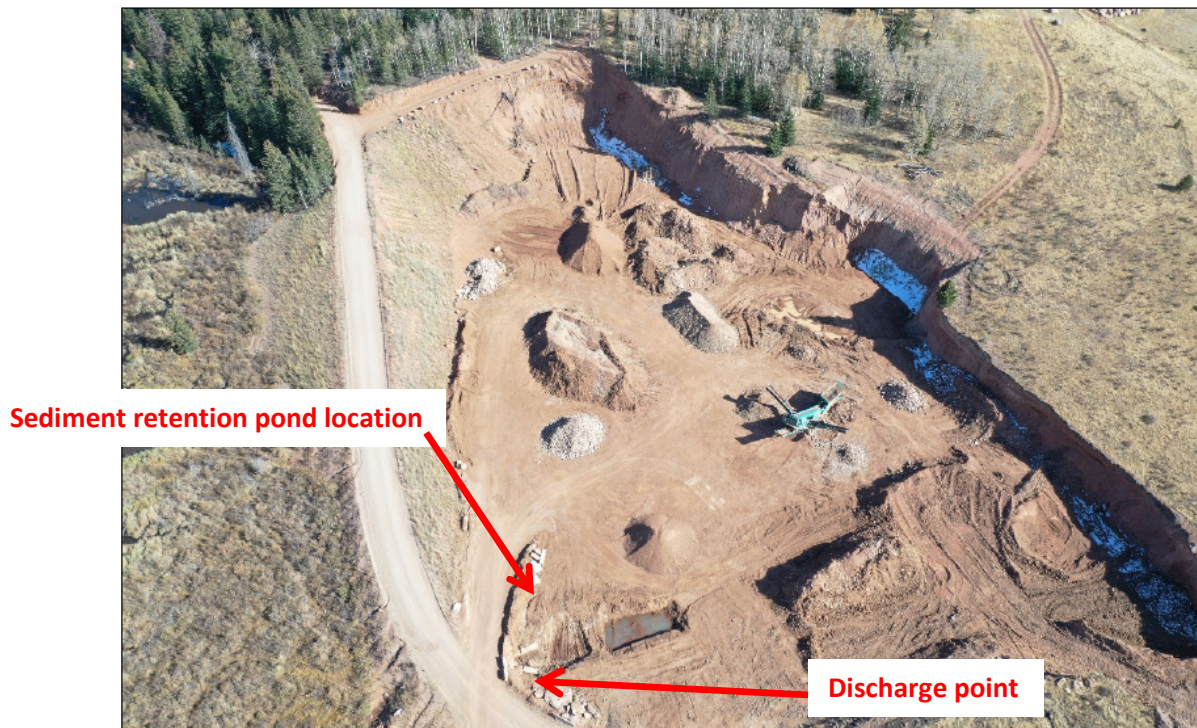
4. *Inspection Topic: The drainage from the Southern Pit reports to a culvert under the private access road and into the Wetlands Area.*

Excavation and construction of a sediment retention pond has been completed. The two-stage, 5-foot deep retention pond is designed to control the release of sediment into the wetlands area using a concrete outlet structure with large straw bales located between stages and at the outfall of the second stage pond check dam to act as sediment filters. The pond perimeter and outlet are defined by concrete blocks as shown.

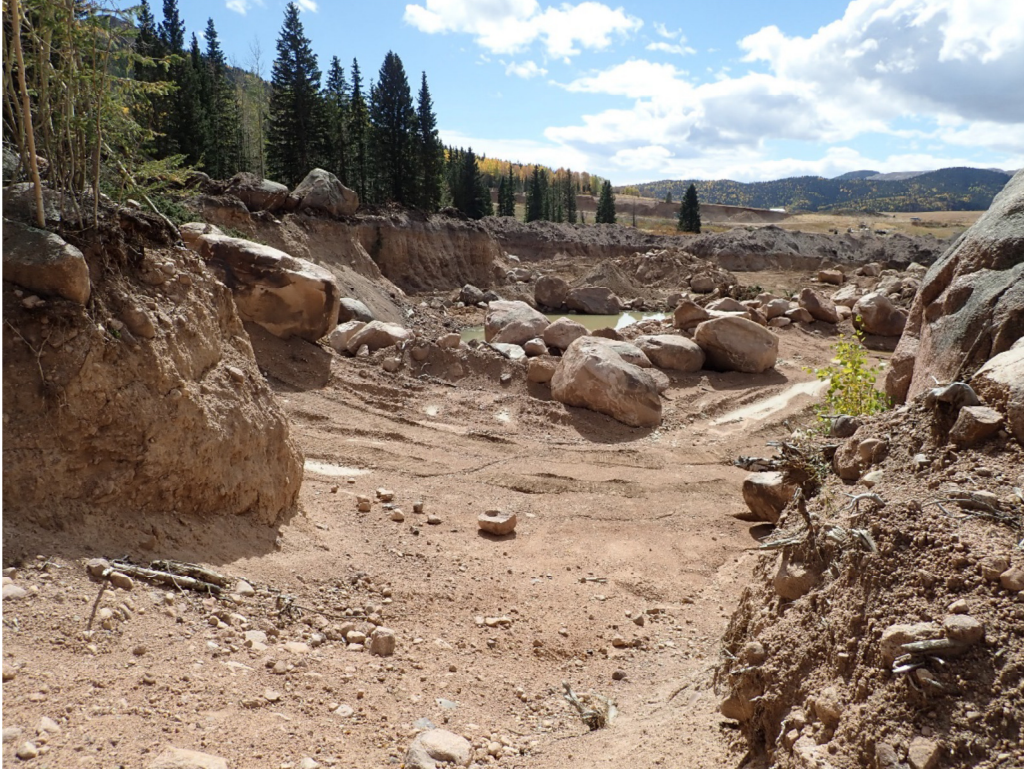
3. *Inspection Topic: Groundwater has been exposed in the Northern Pit. The Division has no evidence that the operator has a valid well permit, substitute water supply plan, or approved water augmentation plan for the exposed groundwater at the site.*

Northern pit area with groundwater exposure in the background, taken October 4, 2019 by Mr. Russell of the Colorado Division of Reclamation Mining and Safety, before corrective action.

Mr. Pyles has backfilled the area in question with approximately two feet of fine sediment from the sediment retention pond. This will effectively isolate the shallow groundwater system from the surface.

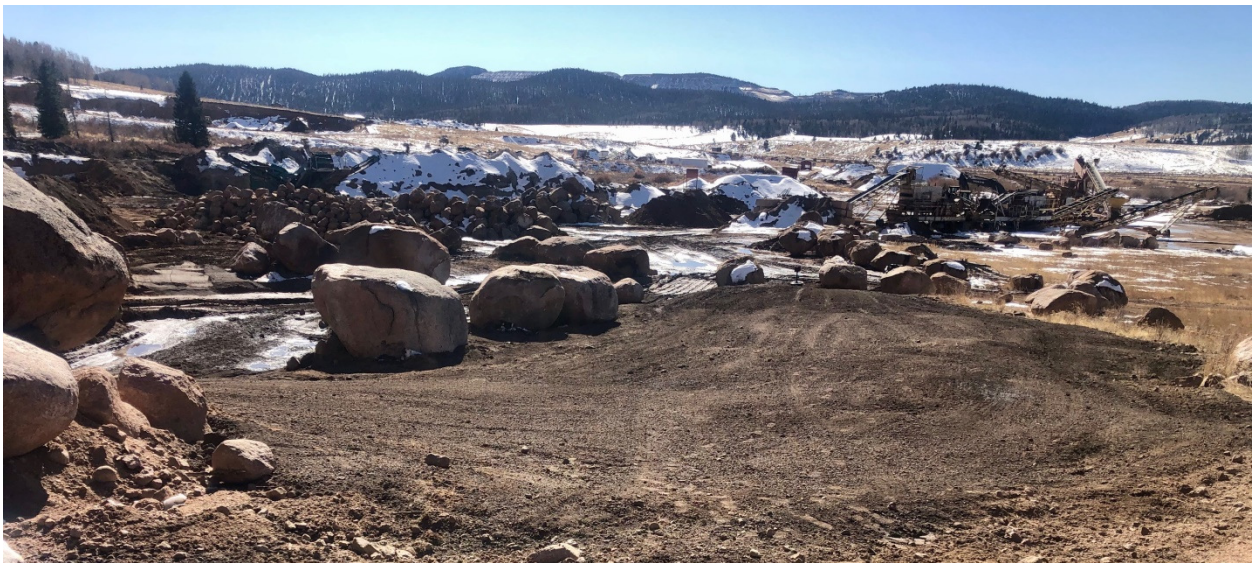
This photograph, taken November 11, 2019, is of the same previously-mined, 0.75 acre area. The corrective action has been completed to cover and isolate the groundwater surface with a minimum of two feet of fine soil. The area was then graded. Topsoil was applied and the area has been seeded.

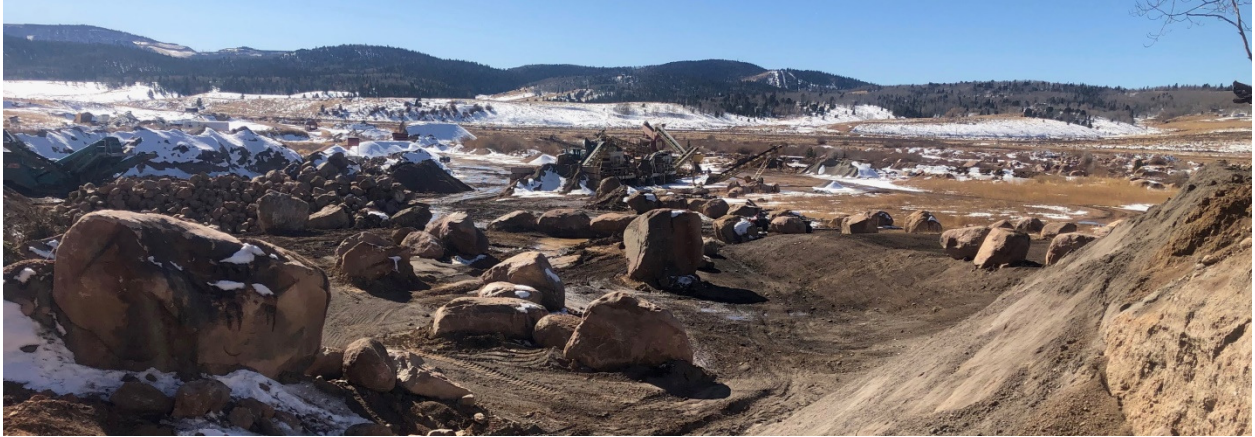
This photograph was also taken on November 11, 2019 and shows the same, reclaimed area as above, but from a slightly different perspective.

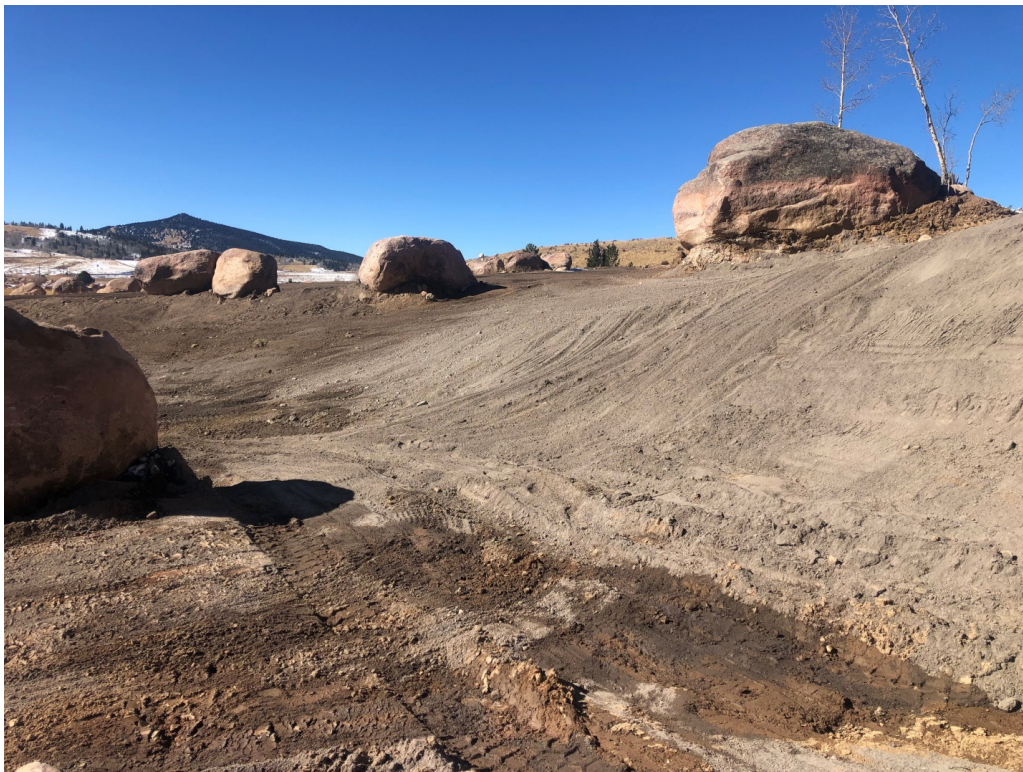
This is the same corrective action area, taken November 11, 2019, looking northwest.

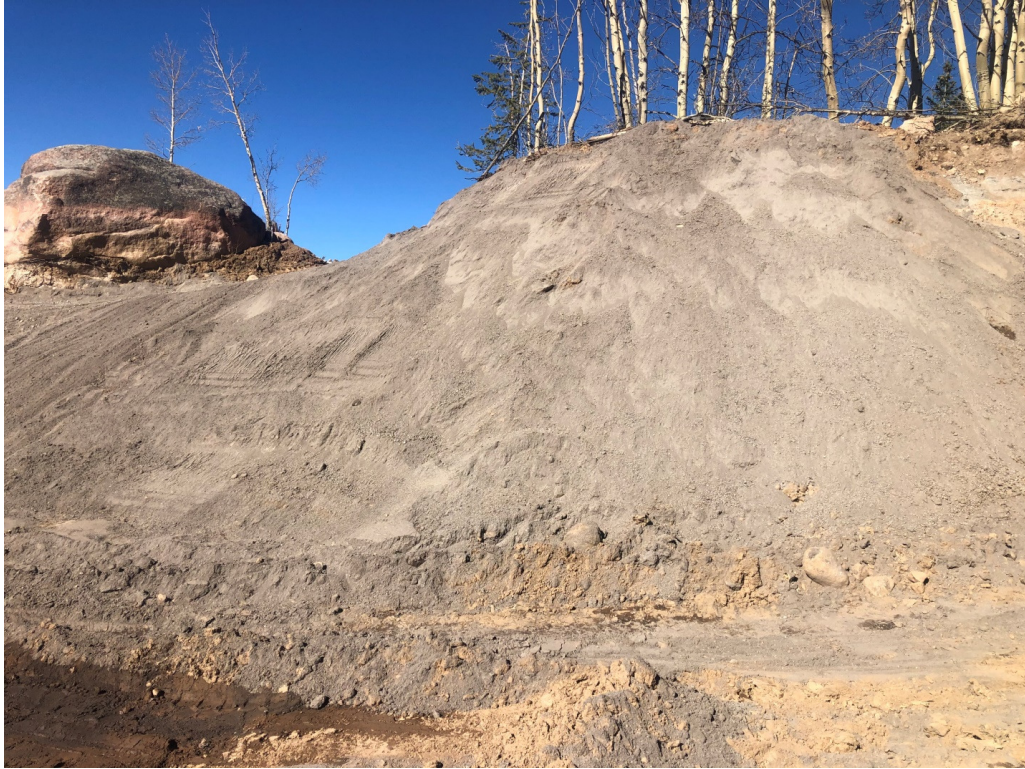
Reclaimed hillside above the corrective action area, taken November 11, 2019, looking north-northwest.

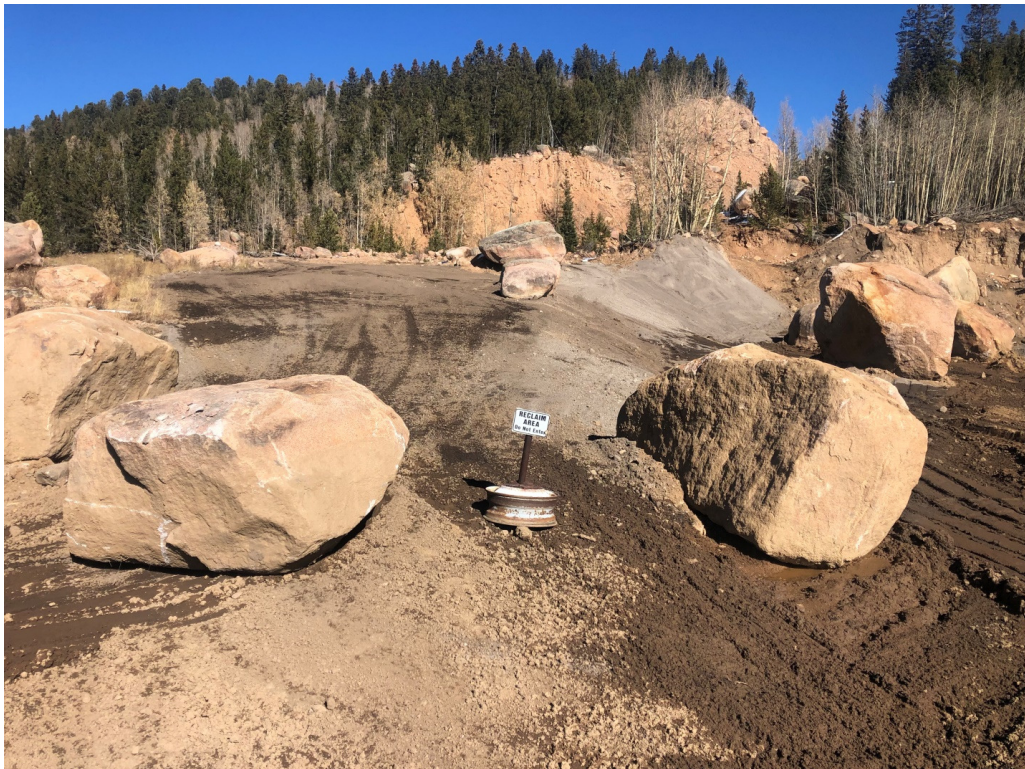
Reclaimed corrective action area, taken November 11, 2019, looking north-northeast.

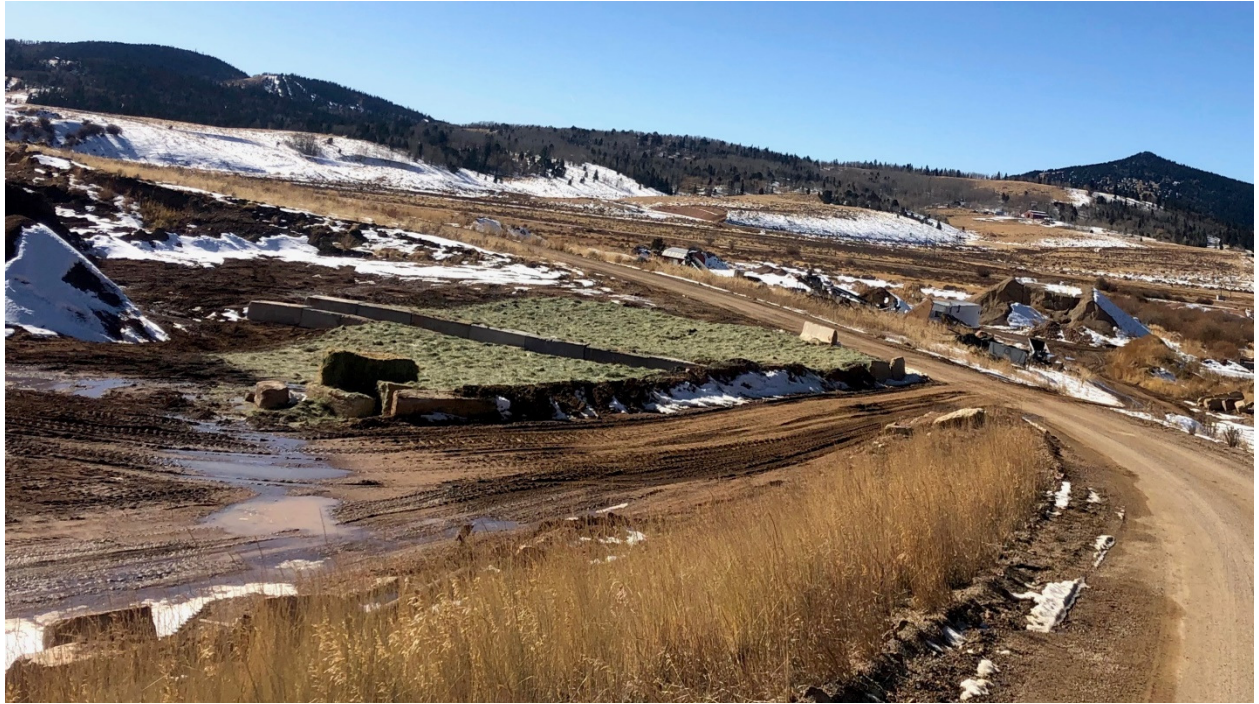
Looking south across the corrective action area.
