**MINERALS PROGRAM INSPECTION REPORT**  
**PHONE: (303) 866-3567**

<b>MINE NAME:</b> Masters Pit #2	<b>MINE/PROSPECTING ID#:</b> M-2010-037	<b>MINERAL:</b> Clay (general), grave	<b>COUNTY:</b> Washington
<b>INSPECTION TYPE:</b> Monitoring	<b>INSPECTOR(S):</b> Brock Bowles	<b>INSP. DATE:</b> October 16, 2019	<b>INSP. TIME:</b> 10:30
<b>OPERATOR:</b> Elva Masters	<b>OPERATOR REPRESENTATIVE:</b> Elva Masters	<b>TYPE OF OPERATION:</b> 112c - Construction Regular Operation	
<b>REASON FOR INSPECTION:</b> Normal I&E Program	<b>BOND CALCULATION TYPE:</b> Complete Bond	<b>BOND AMOUNT:</b> \$15,500.00	
<b>DATE OF COMPLAINT:</b> NA	<b>POST INSP. CONTACTS:</b> None	<b>JOINT INSP. AGENCY:</b> None	
<b>WEATHER:</b> Cloudy	<b>INSPECTOR'S SIGNATURE:</b>

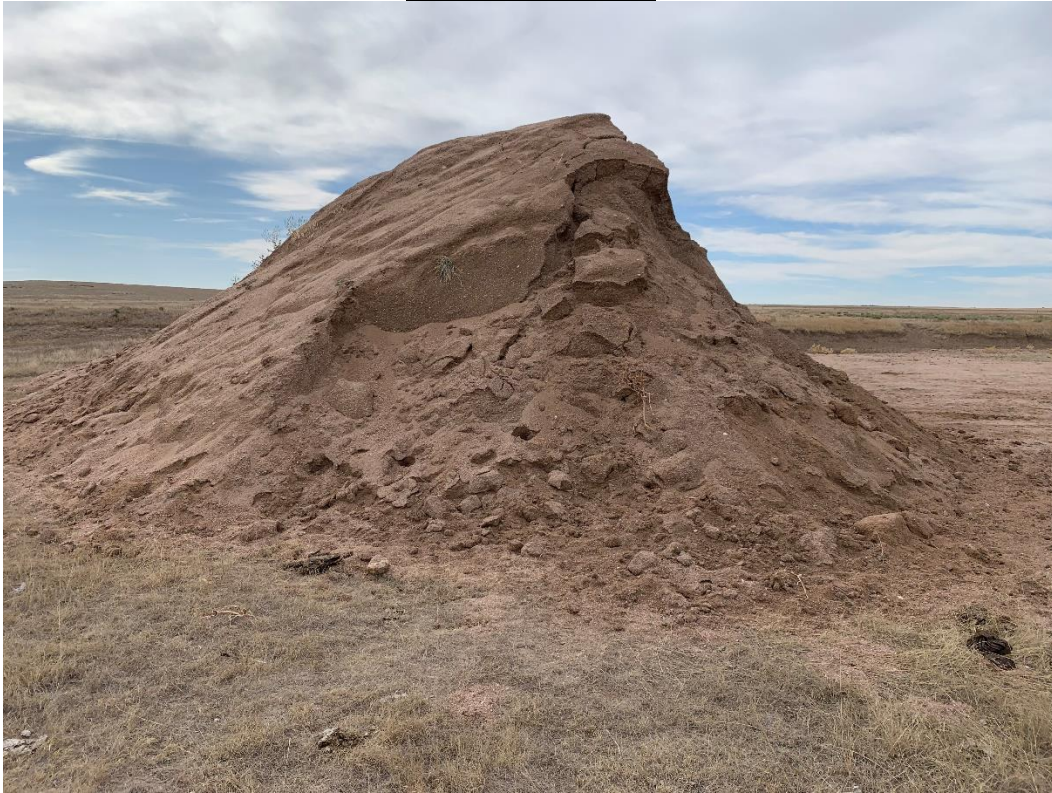
The mine plan consists of 8 areas within the permit boundary that will be mined. Currently, all the mining operations are in Area 1 and the area is marked with t-posts. Sand and gravel was pushed into a pile on the north side of the creek bed. No mining activity was happening at the time of the inspection and no equipment was on site.

Gravel stockpile on north side of creek bed

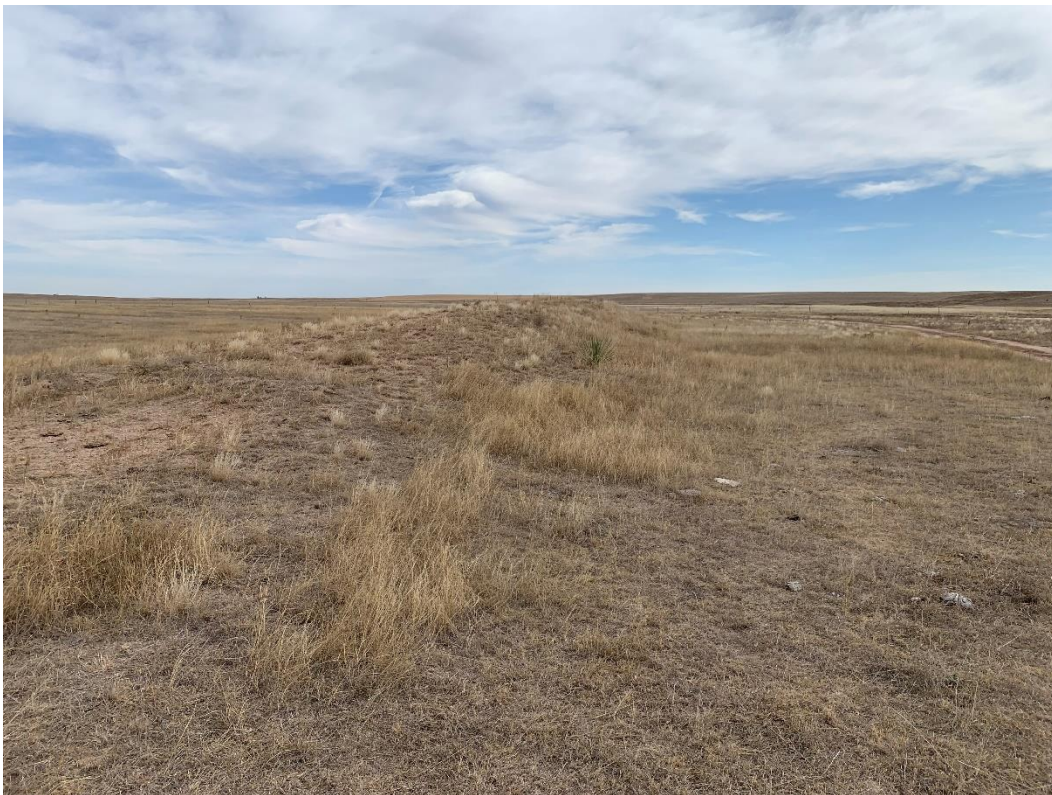
The topsoil stockpile was located uphill of the pit operations. It was well vegetated and appeared to be stable. No noxious weeds were noted.

Topsoil stock pile located north of mine workings area.

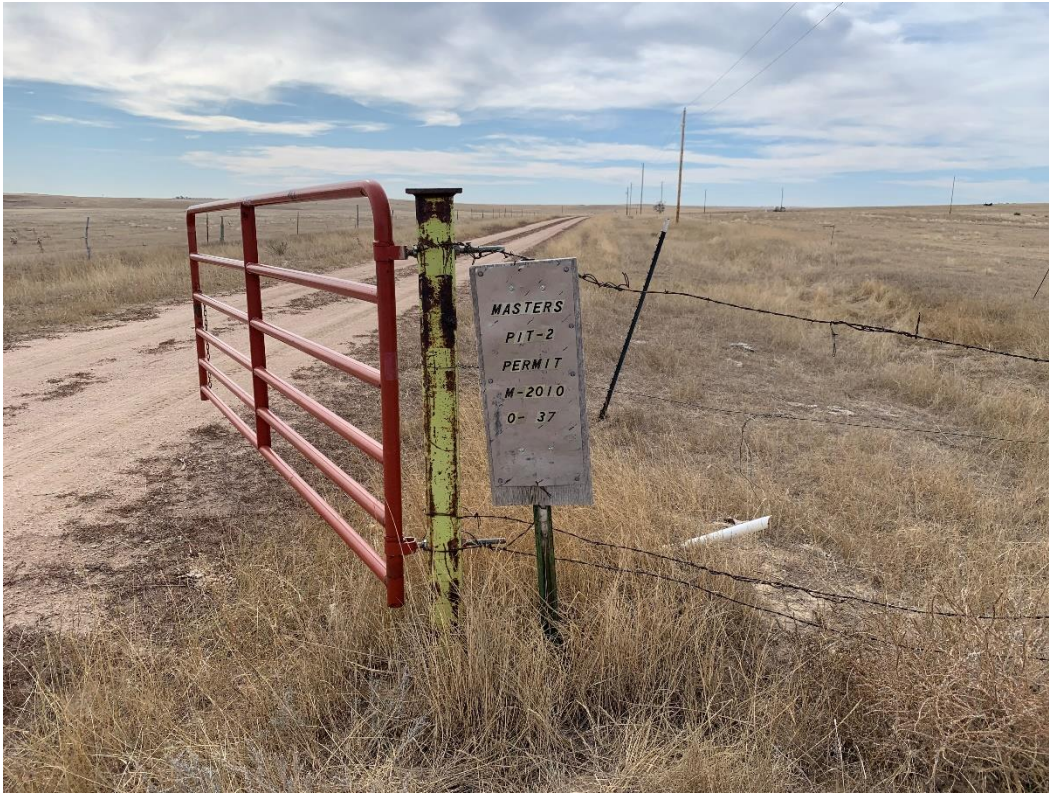
The mine entrance sign was in place at the entrance gate.

Mine entrance sign
