MINERALS PROGRAM INSPECTION REPORT

MINE NAME: Seifert Pit	MINE/PROSPECTING ID#: M-1985-040	MINERAL: Sand and gravel	COUNTY: Custer
INSPECTION TYPE: Monitoring	INSPECTOR(S): Timothy Cazier	INSP. DATE: June 19, 2019	INSP. TIME: 07:45
OPERATOR: Seifert Construction dba Seifert Enterprises, I	OPERATOR REPRESENTATIVE: Kent Beach	TYPE OF OPERATION: 112c - Construction Regular Operation

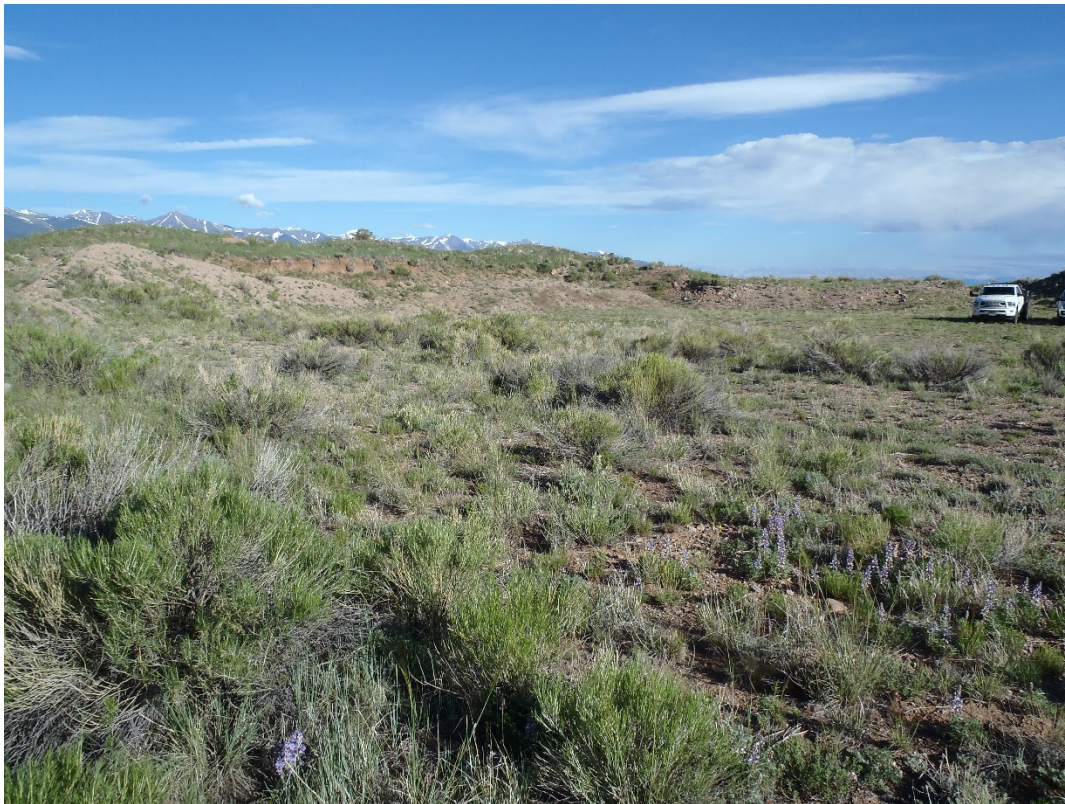
Gen. Compliance with Mine Plan: The pit operation appeared to be in compliance with the approved mine plan. However, the access road was constructed in a significantly different location than presented in the original permit application (see enclosed **Post-Inspection Map**). A review of Google Earth historical imagery suggests the present access is the only one ever used for the site. **This access road discrepancy is cited as Problem No. 2 on page 1 of this report.** The maximum allowed disturbed area is 17.34 acres. This number is derived from the original permit application for 37.34 acres with 20 acres of undisturbed area removed from the south end of the original permit area through the approval of TR-01 in 1986. Google Earth was used to measure the disturbed area (based on 2017 imagery), which was estimated to be approximately 4.2 acres in the pit area plus 1.8 acres of access road (based on 0.6 miles of ~25-ft wide road), for a total of 7.0 acres (see enclosed **Post-Inspection Affected Area Map**). The length of highwall was estimated to be 150 and approximately eight feet in height, appearing stable (see **Photo 1**).

Photo 1. West end of pit floor and highwall (looking north).

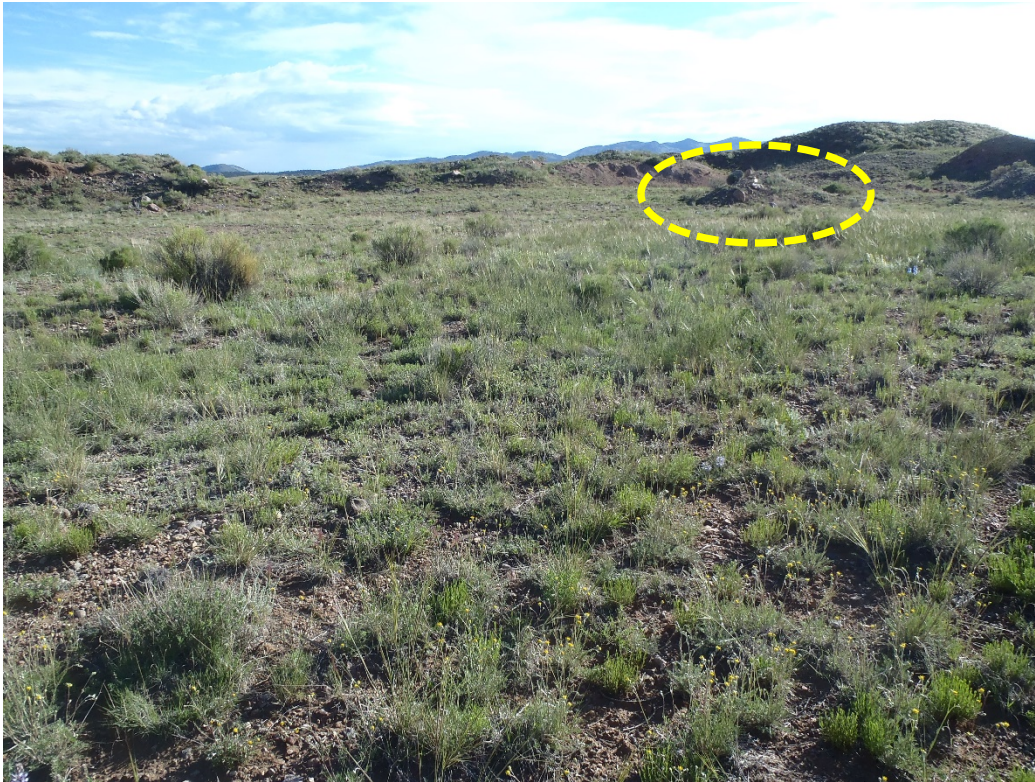
Processing Waste: A small stockpile of oversized rock, too big for the crusher, was observed on the pit floor (see **Photo 2**).

Revegetation: With the exception of the highwalls, the pit was observed to be generally well vegetated, mostly due to natural volunteers (see **Photos 2** and **4**). No noxious weeds were observed. Mr. Beach explained they have a weed control specialist visit the site annually in the June/July time frame.

Photo 2. Pit floor, highwall on left, oversize rock stockpile circled (looking NE).

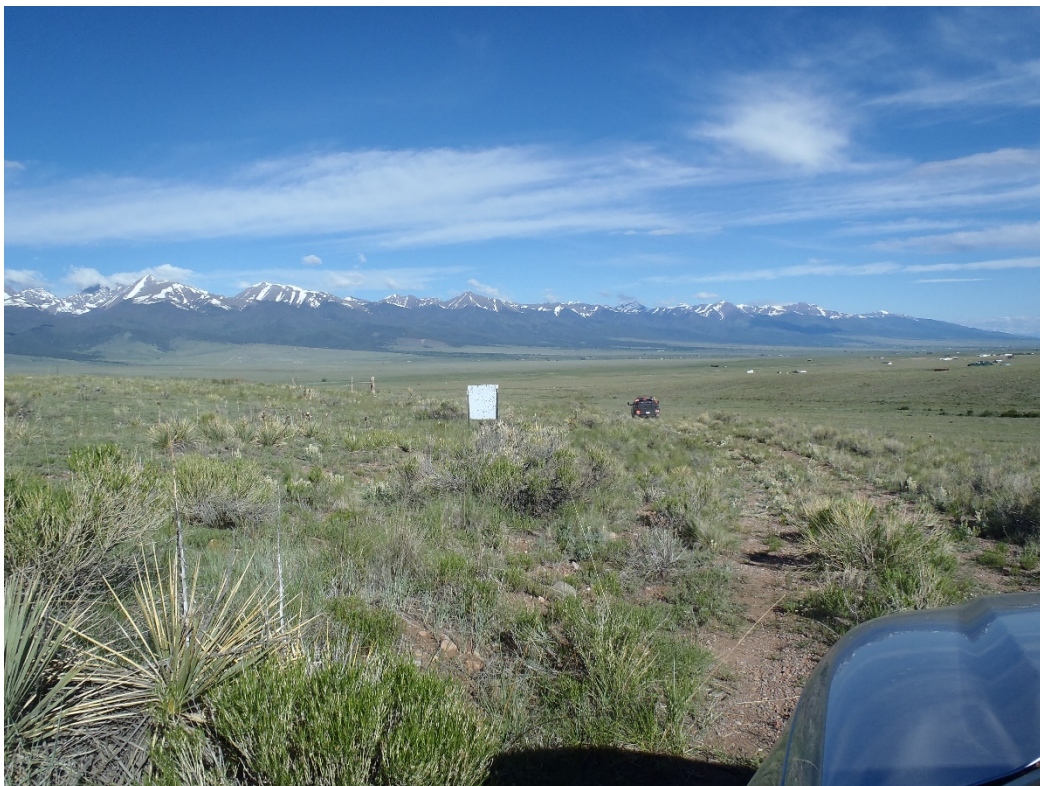
Roads: Haul and access roads did not appear to be a source of sediment that could be tracked offsite as the

road was fairly well vegetated (see **Photo 3**).

Photo 3. Access road – fairly well vegetated (looking NW from behind permit sign).

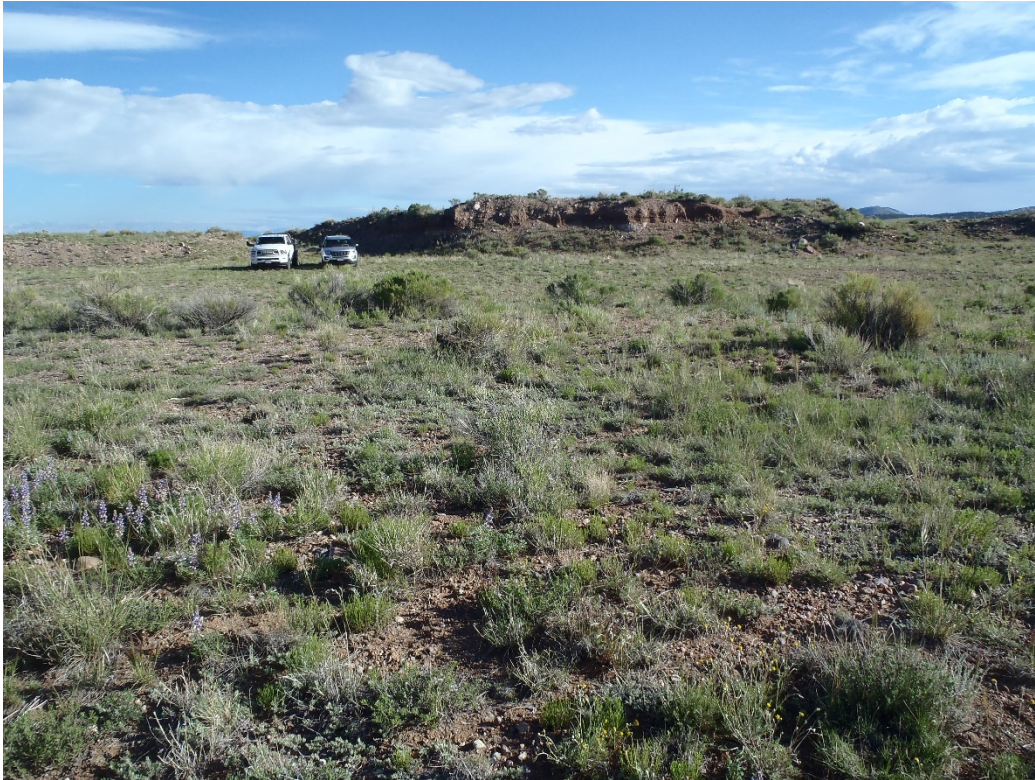
Photo 4. Pit floor – mostly vegetated (looking north).

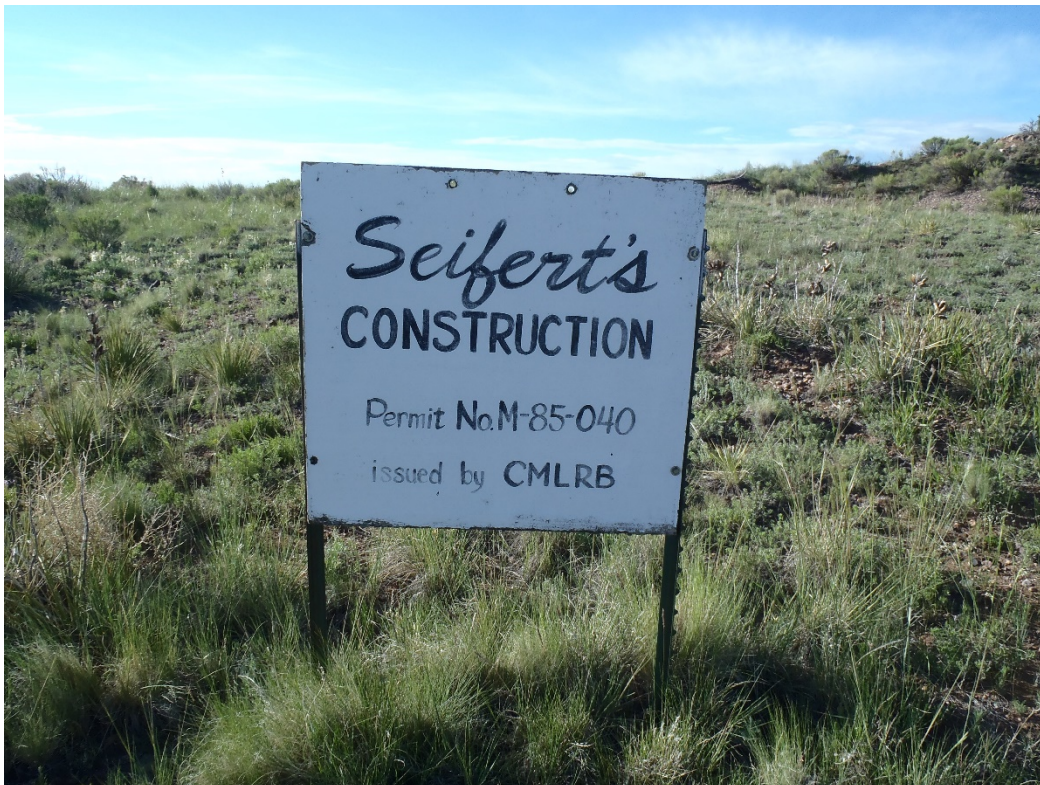
Signs and Markers: The permit sign was properly posted (see **Photo 5**) and T-post boundary markers were observed to delineate the permit boundary (see **Photos 6** and **7**).

Photo 5. Permit sign near pit entrance.

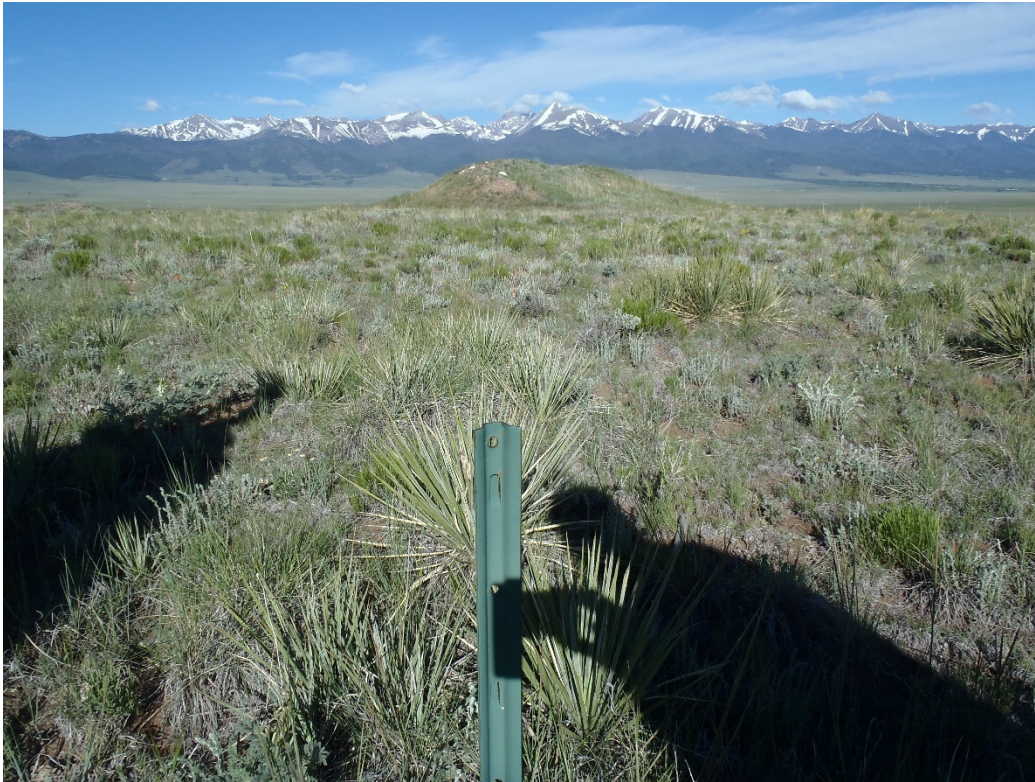
Photo 6. Typical T-post boundary marker (east side, looking west).

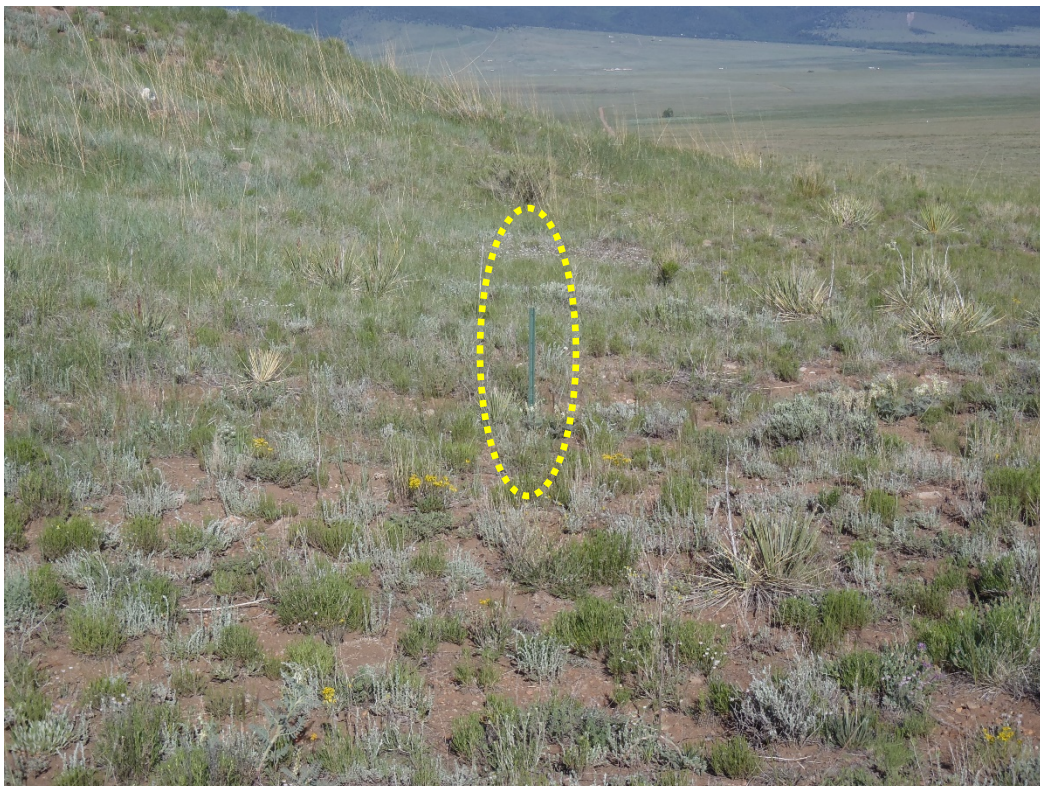
Photo 7. Typical T-post boundary marker.

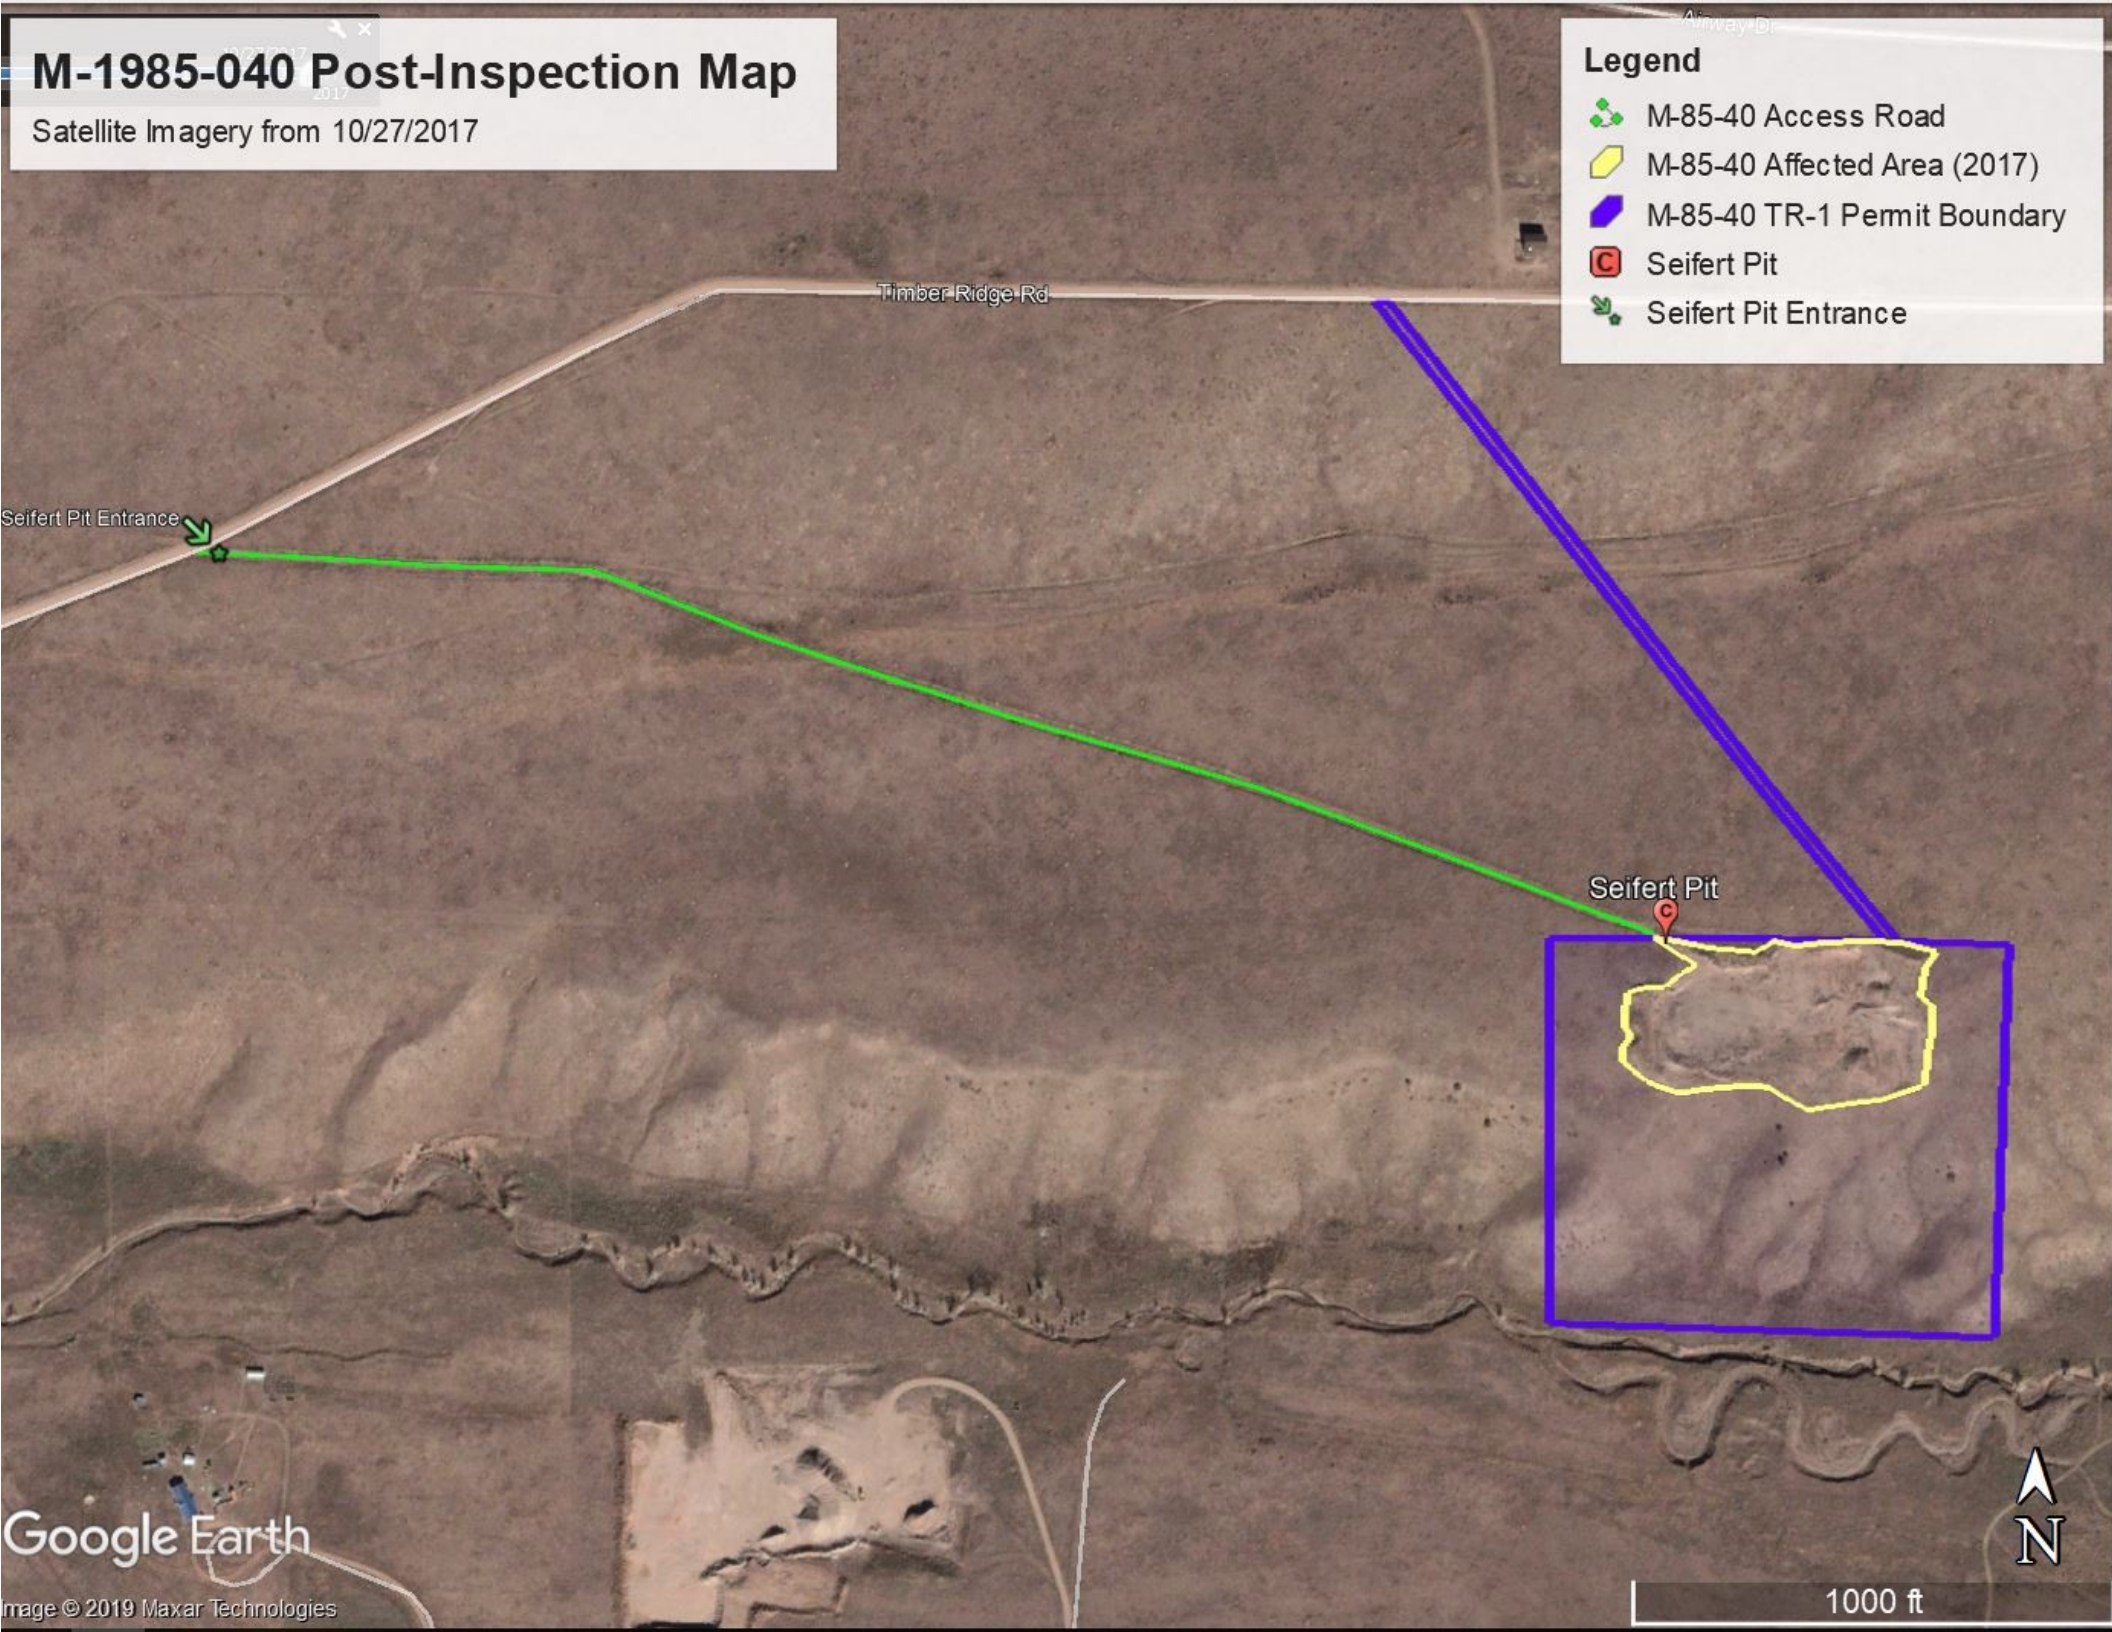
M-1985-040 Post-Inspection Map

PROBLEM/POSSIBLE VIOLATION: Problem No. 2: The access road was constructed in a significantly different location than presented in the original permit application.

CORRECTIVE ACTIONS: Submit a technical revision (along with the required \$216 fee) with a revised map and legal description to clarifying the location of the existing access road and permit area.
