MINERALS PROGRAM INSPECTION REPORT
PHONE: (303) 866-3567

MINE NAME: Uncompahgre Pit	MINE/PROSPECTING ID#: M-2013-007	MINERAL: Gravel and sand	COUNTY: Montrose
INSPECTION TYPE: Monitoring	INSPECTOR(S): Stephanie Mitchell	INSP. DATE: November 6, 2019	INSP. TIME: 10:15
OPERATOR: Lazy K-Bar Land & Cattle Company, LLLP	OPERATOR REPRESENTATIVE: Zane Luttrell and Kyle Avery	TYPE OF OPERATION: 112c - Construction Regular Operation	
REASON FOR INSPECTION: Normal I&E Program	BOND CALCULATION TYPE: Complete Bond	BOND AMOUNT: \$99,409.04	
DATE OF COMPLAINT: NA	POST INSP. CONTACTS: None	JOINT INSP. AGENCY: None	
WEATHER: Clear	INSPECTOR'S SIGNATURE:

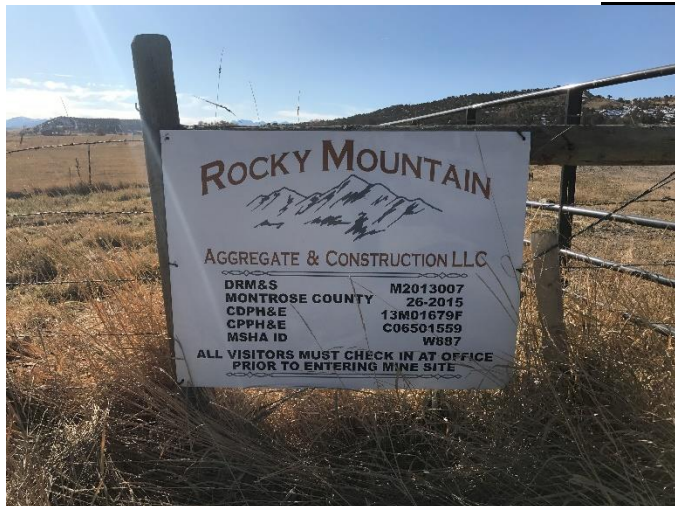
Mine ID Sign

Topsoil has been stripped from the plant area and stockpiled on the west side of the Phase 1 area. The plant area has been graded flat. A stockpile of pit run is located on the east side of the plant area. Adequate mine identification signage was noted at the entrance to the site.

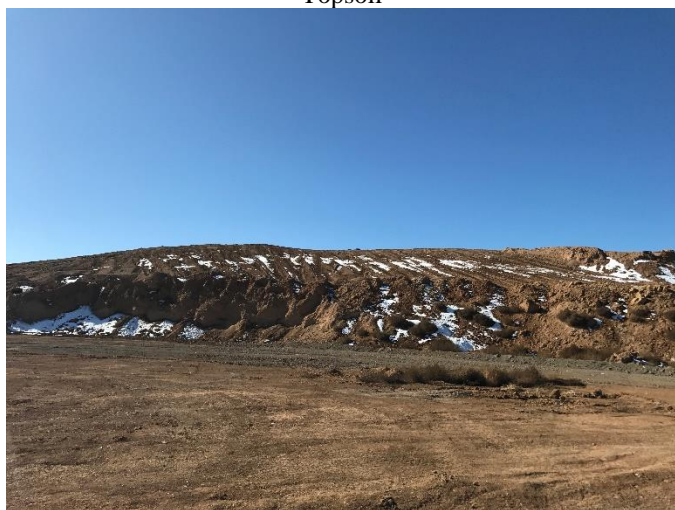
Topsoil/Overburden

Mining is moving to the east and north after phase 2 is completed. Large topsoil and overburden are stable. There are no weeds on site.

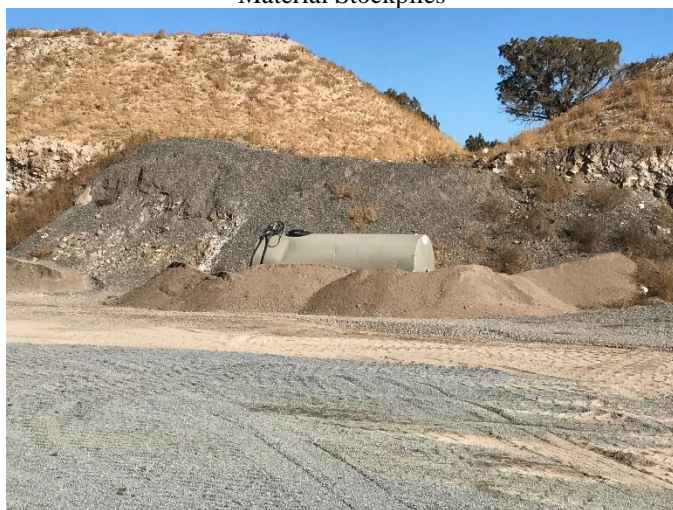
Fuel Storage

The shop and office area construction are both complete. The bench area has been built up and the shop building has been constructed. The slopes around the bench perimeter appeared stable. No problems were noted. Fuel is being stored with secondary containment in the bench area and in the pit area.
