MINERALS PROGRAM INSPECTION REPORT
PHONE: (303) 866-3567

MINE NAME: Henderson Mine	MINE/PROSPECTING ID#: M-1977-342	MINERAL: Molybdenum	COUNTY: Clear Creek, Grand
INSPECTION TYPE: Monitoring	INSPECTOR(S): Peter Hays	INSP. DATE: November 1, 2019	INSP. TIME: 09:00
OPERATOR: Climax Molybdenum Company	OPERATOR REPRESENTATIVE: Aaron Hilshorst	TYPE OF OPERATION: 112d-3 - Designated Mining Operation	
REASON FOR INSPECTION: Normal I&E Program	BOND CALCULATION TYPE: None	BOND AMOUNT: \$37,993,785.00	
DATE OF COMPLAINT: NA	POST INSP. CONTACTS: None	JOINT INSP. AGENCY: None	
WEATHER: Clear	INSPECTOR'S SIGNATURE:

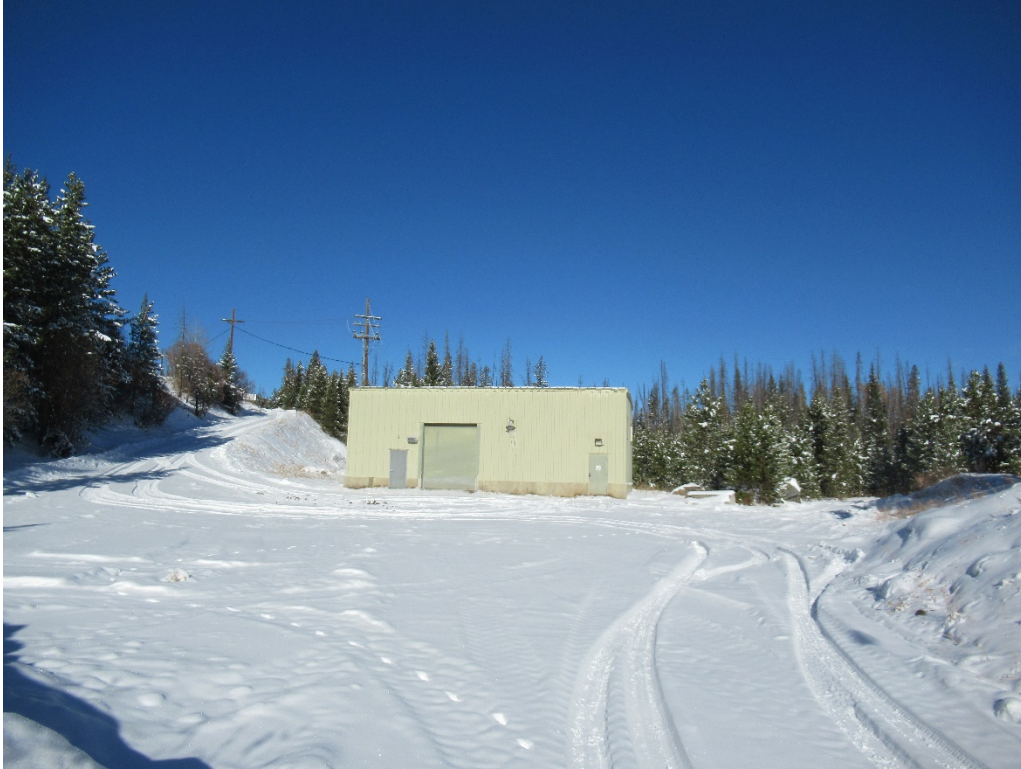
Surface water sampling locations WFR-20 and WFR-40 were discussed but could not be observed due to the amount of snow on the access roads to the locations. The East Branch Reservoir and Mill Process Water Storage Tanks (Mill EPF 1.1 and 1.2) were discussed and the Williams Fork Pump station, intake diversion structure and surface water sampling point WFR-003 was observed during the inspection.

View of the Williams Fork pump station

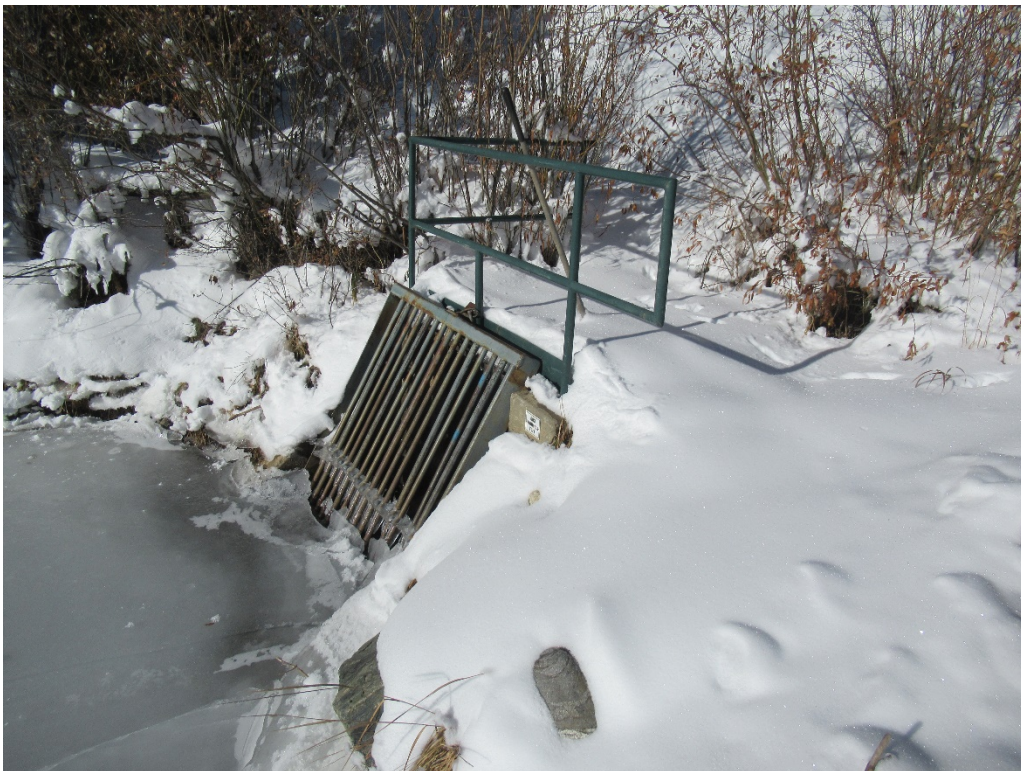
View of the William Fork diversion structure and sampling location WFR-003

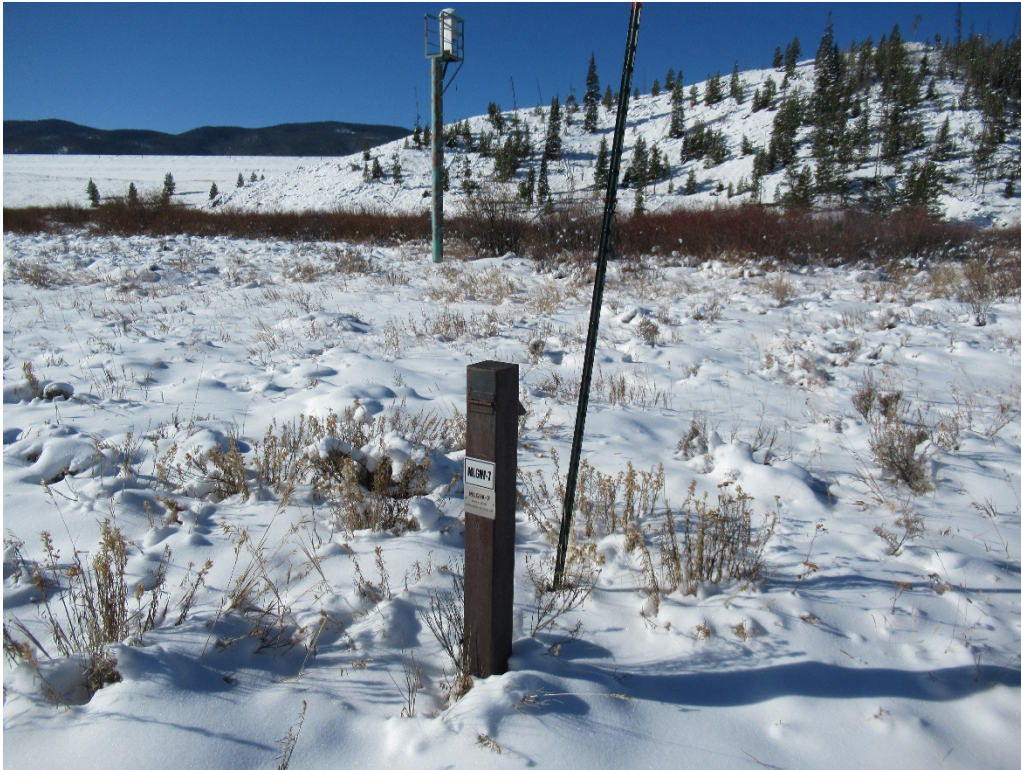
The focus of this inspection was to discuss and observe the groundwater and surface water compliance facilities and locations at the Mill. The point of compliance (POC) groundwater wells MLGW-7 and MLGW-15 were observed and discussed during the inspection. Compliance well MLGW-ACR was not accessible due to a locked gate at the entrance of the ranch property. The Operator reported the previous problem with iron-reducing bacteria in the well was resolved with the treatment of the well.

View of MLGW-7

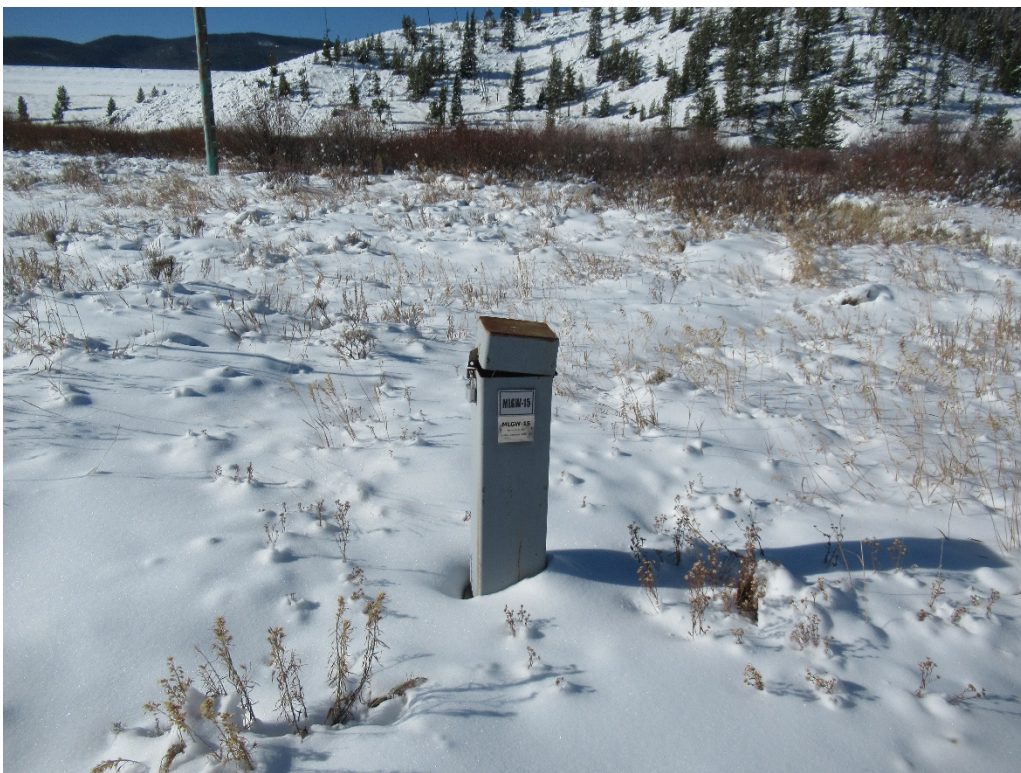
View of MLGW-15

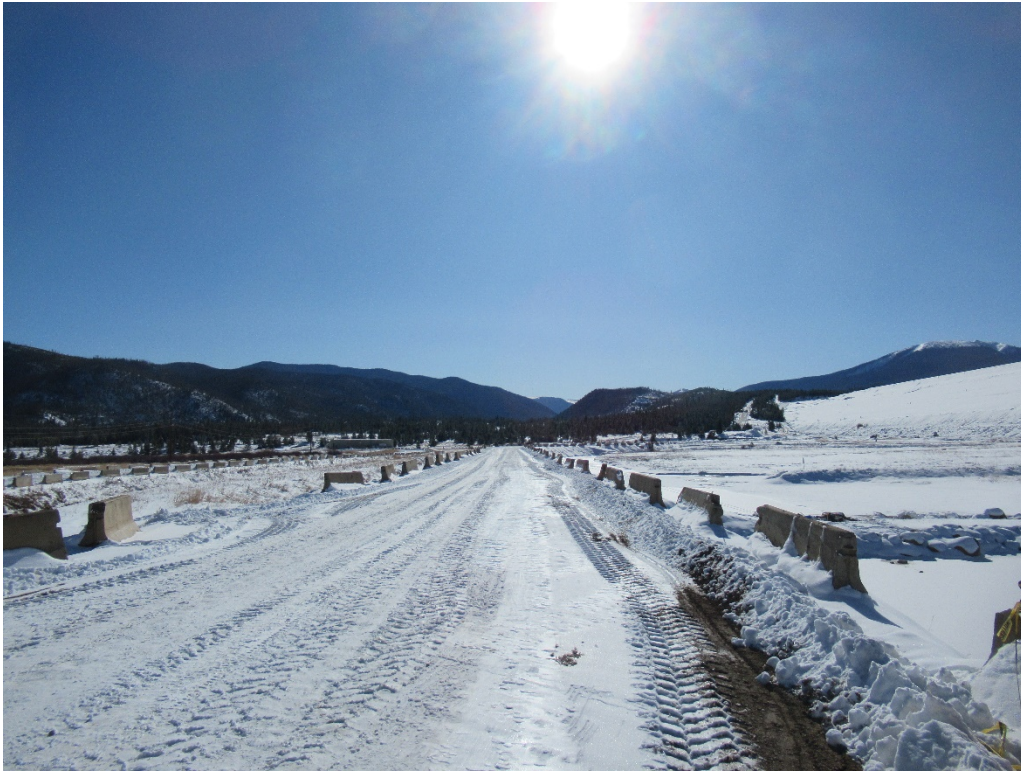
The 1-Dam Seep Water Collection and Return System Improvements project approved under TR-30 by the Division on November 1, 2018 is complete. The road was observed as part of the inspection of the seep water collection inspection. The Operator reported the final survey for the as-built drawings was scheduled to be completed soon.

View of completed 1-Dam seep road raise project looking south from north canal junction

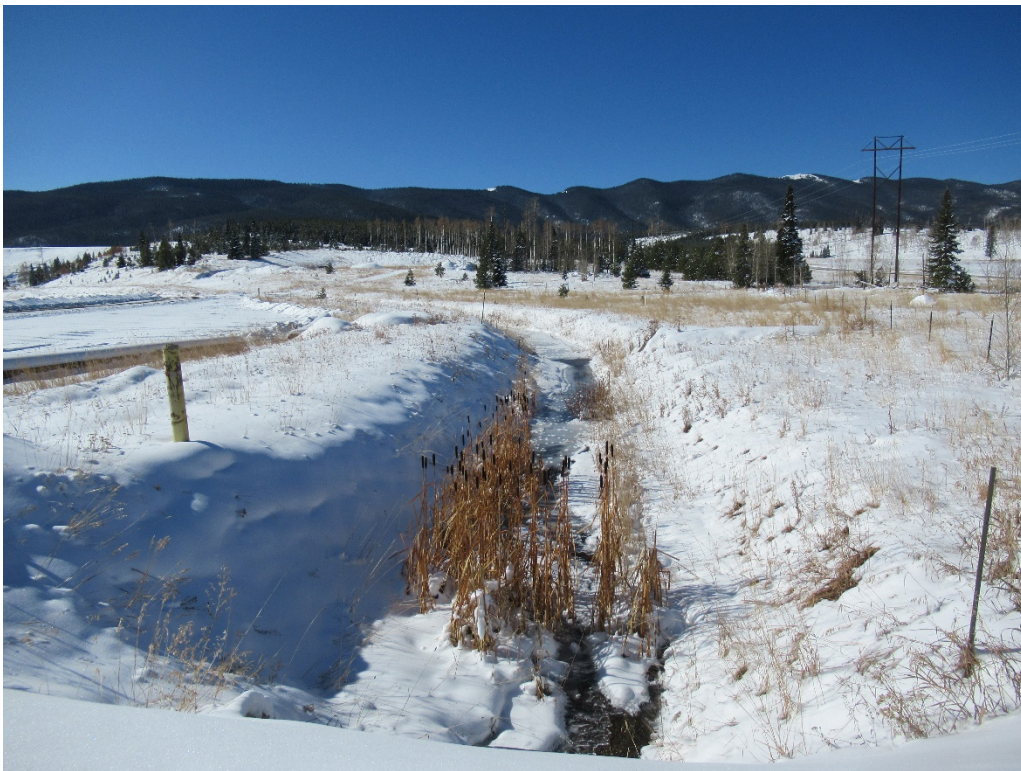
The ultimate canal which is included as part of EPF-3.1 was observed from the access road from north to south. The water surface was ice covered but the canal appeared to be operating as designed.

View of the Ultimate Canal
