MINERALS PROGRAM INSPECTION REPORT
PHONE: (303) 866-3567

MINE NAME: Climax Mine	MINE/PROSPECTING ID#: M-1977-493	MINERAL: Molybdenum	COUNTY: Summit
INSPECTION TYPE: Monitoring	INSPECTOR(S): Dustin Czapla	INSP. DATE: November 13, 2019	INSP. TIME: 11:00
OPERATOR: Climax Molybdenum Company	OPERATOR REPRESENTATIVE: Diana Kelts	TYPE OF OPERATION: 112d-3 - Designated Mining Operation	
REASON FOR INSPECTION: Normal I&E Program	BOND CALCULATION TYPE: None	BOND AMOUNT: \$91,011,850.00	
DATE OF COMPLAINT: NA	POST INSP. CONTACTS: None	JOINT INSP. AGENCY: None	
WEATHER: Clear	INSPECTOR'S SIGNATURE:

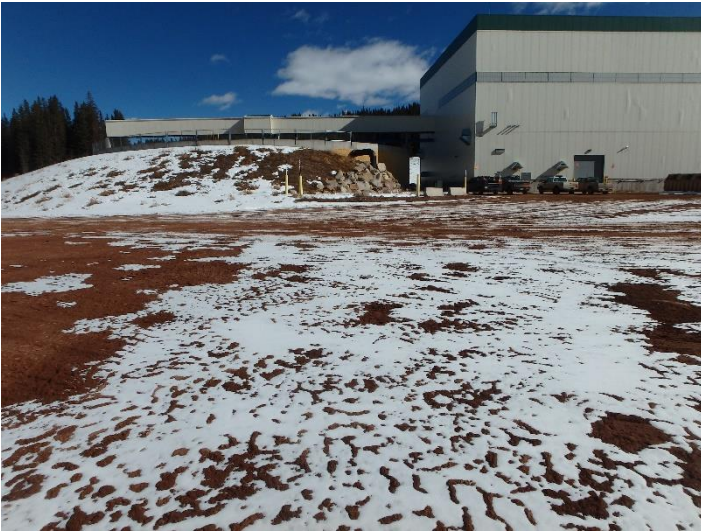
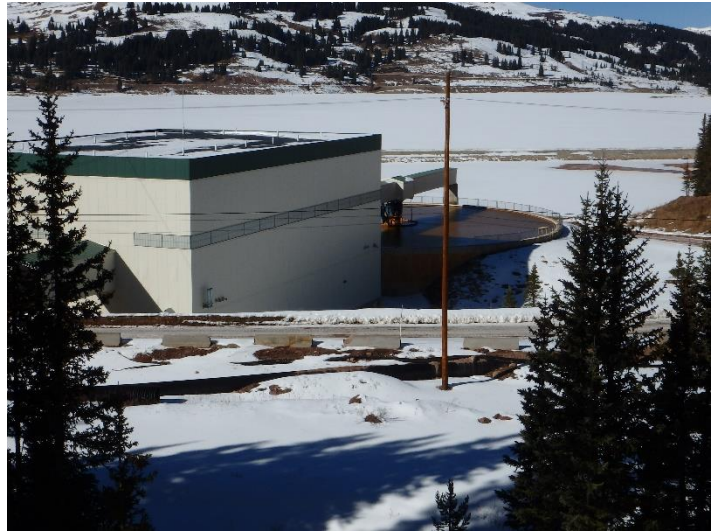
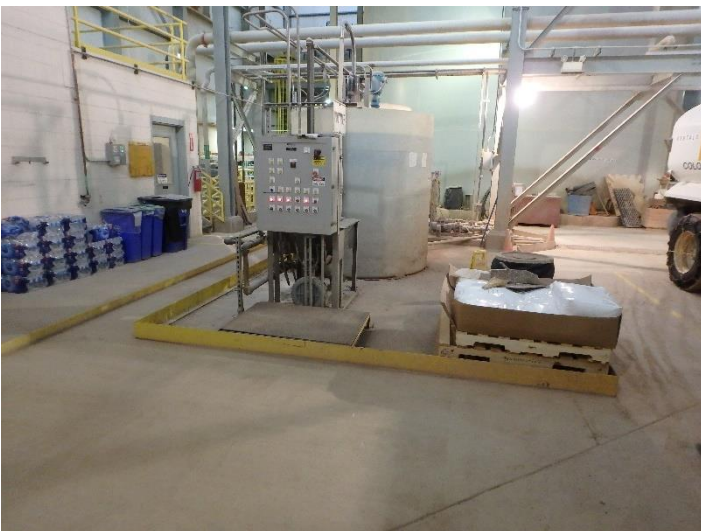
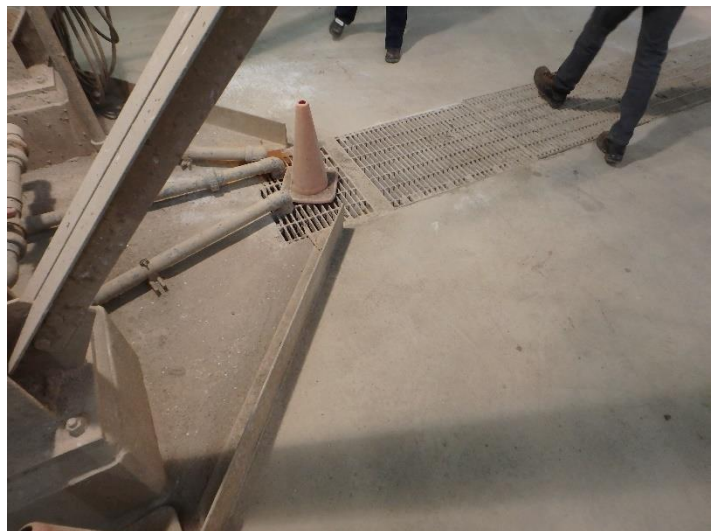
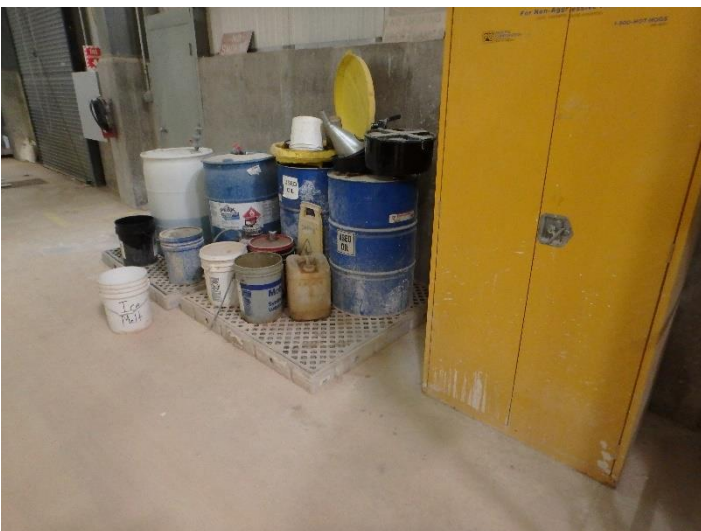
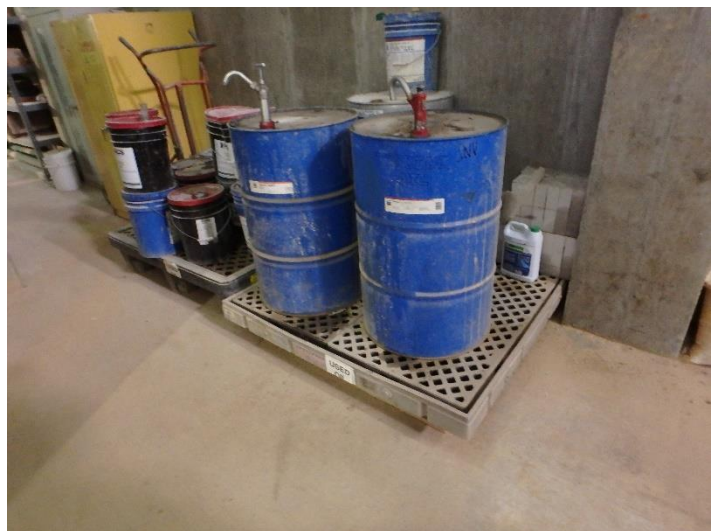
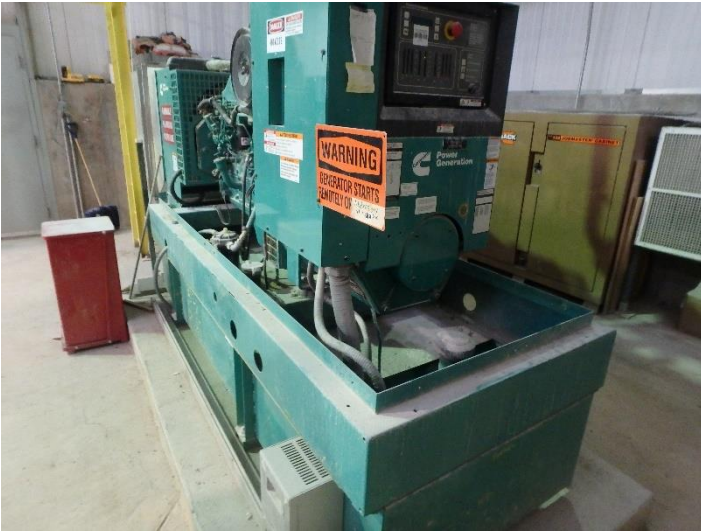
Sludge Densification Plant

The SDP is located on the east side of Tenmile Pond. The SDP provides first stage metals treatment for a significant portion of the mines affected waters and creates sludge for deposition in tailings storage facilities. When possible, water is recycled through Robinson Lake for use in the mill facility. The plant has been constructed with adequate secondary containment, in the form of concrete sumps, to contain spills that could occur within the plant. Spills were not noted during this inspection. Operation of the SDP is automated and emergency generators are in place in case of power outages. Reagents utilized in the SDP include lime and flocculant. All chemicals and reagents observed in the SDP area were properly stored with adequate secondary containment protections. Containers were clearly labeled. The SDP Lime Station was locked. The SDP facility appeared well kept and maintained.

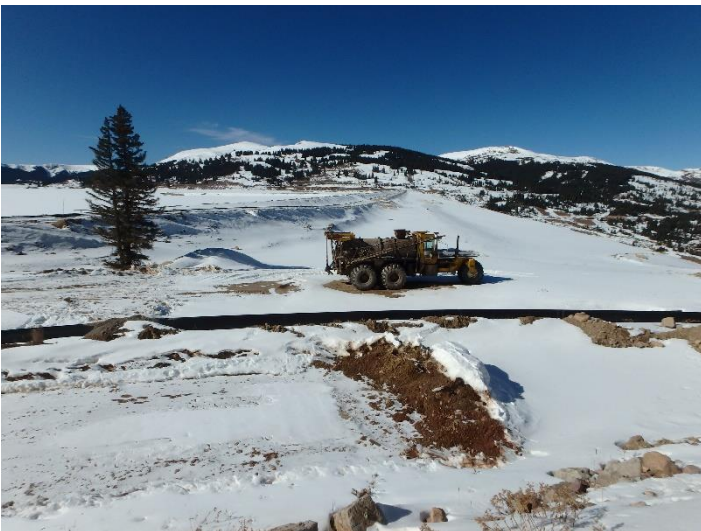
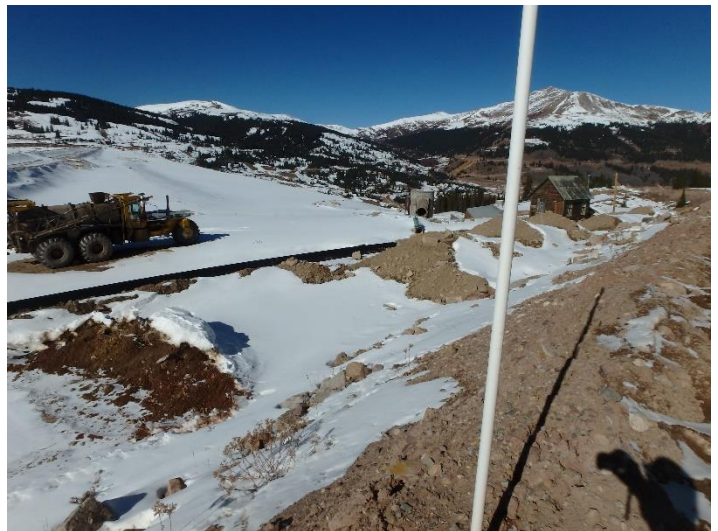
Tenmile TSF and 3 Dam were observed. No unusual conditions were noted.

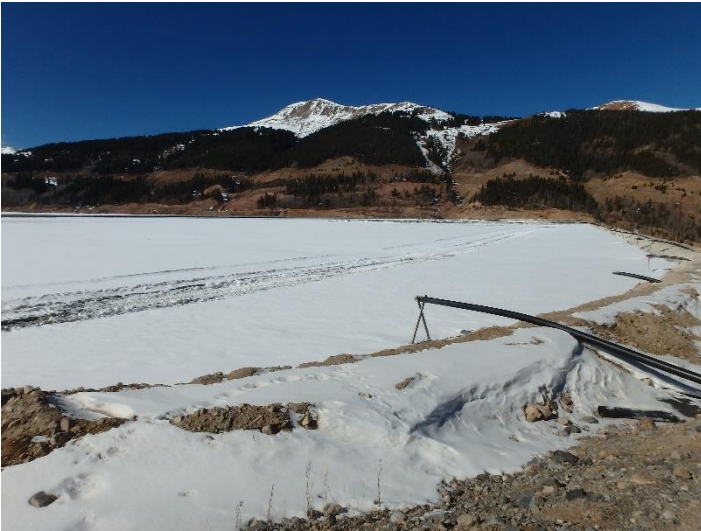
Mayflower TSF-5 Dam

Mayflower TSF and 5 Dam were observed. No unusual conditions were noted. The mill was not running and tailings deposition was not occurring during this inspection.

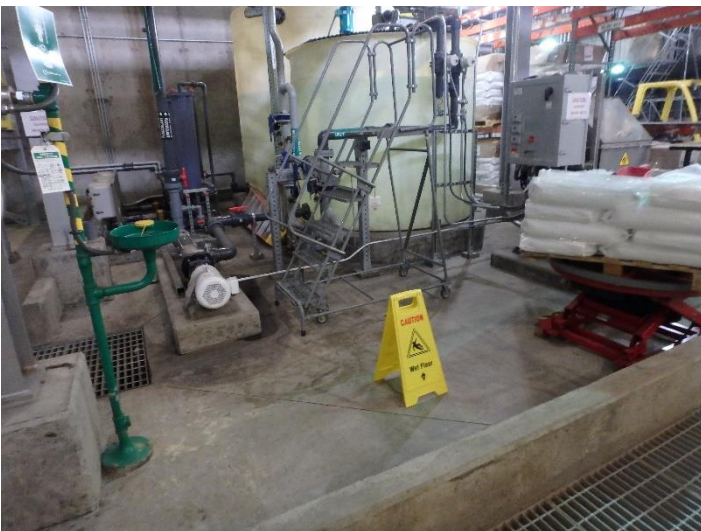
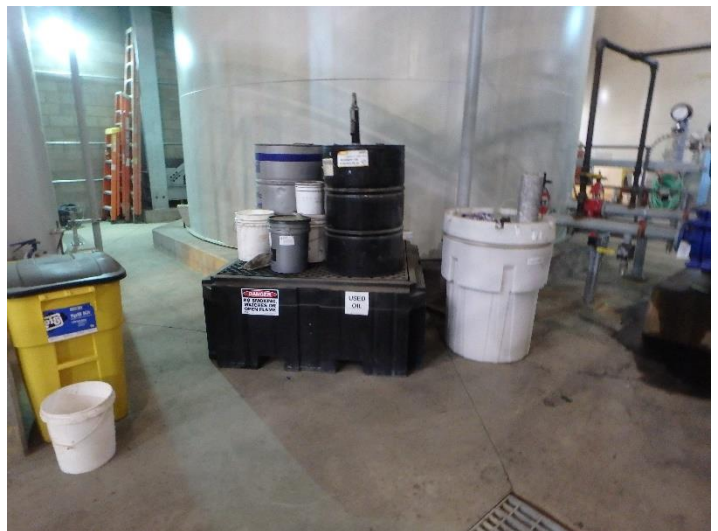
Property Discharge Water Treatment Plant

The PDWTP is located below 5 Dam and is intended to remove second stage metals, such as manganese, iron, copper and zinc, prior to discharging excess water into Tenmile Creek. It provides final treatment before affected water leaves the property. The plant has been constructed with adequate secondary containment, in the form of concrete sumps, to contain spills that could occur within the plant. Spills were not noted within the PDWTP during this inspection. There is an "Events Pond", constructed of concrete, downstream to the west of the PDWTP. The "Events Pond" is constructed with a five million gallon capacity intended to temporarily store any water not meeting discharge requirements. Any water reaching the "Events Pond" can be recycled back to the head of the PDWTP. The "Events Pond" was empty during this inspection. Operation of the PDWTP is automated, but also manned around the clock. Emergency generators are in place in case of power outages. Reagents utilized in the PDWTP include lime, flocculant and sulfuric acid. All chemicals and reagents observed in the PDWTP area were properly stored with adequate secondary containment protections. Containers were clearly labeled. The sulfuric acid is stored in an isolated room in a phenolic lined carbon steel tank, located within an epoxy coated concrete containment area, which is isolated from the rest of the plants containment area. The sulfuric acid truck unloading area has adequate secondary containment in the form of a concrete sump. The PDWTP facility appears very well kept and maintained.
