**MINERALS PROGRAM INSPECTION REPORT**  
**PHONE: (303) 866-3567**

<b>MINE NAME:</b> Burton Pit	<b>MINE/PROSPECTING ID#:</b> M-1987-013	<b>MINERAL:</b> Sand and gravel	<b>COUNTY:</b> Rio Grande
<b>INSPECTION TYPE:</b> Monitoring	<b>INSPECTOR(S):</b> Stephanie Mitchell	<b>INSP. DATE:</b> November 7, 2019	<b>INSP. TIME:</b> 09:00
<b>OPERATOR:</b> Southway Construction Company, Inc.	<b>OPERATOR REPRESENTATIVE:</b> Loretta Martinez	<b>TYPE OF OPERATION:</b> 112c - Construction Regular Operation	
<b>REASON FOR INSPECTION:</b> Citizen Complaint	<b>BOND CALCULATION TYPE:</b> Complete Bond	<b>BOND AMOUNT:</b> \$42,184.00	
<b>DATE OF COMPLAINT:</b> NA	<b>POST INSP. CONTACTS:</b> None	<b>JOINT INSP. AGENCY:</b> None	
<b>WEATHER:</b> Clear	<b>INSPECTOR'S SIGNATURE:</b>

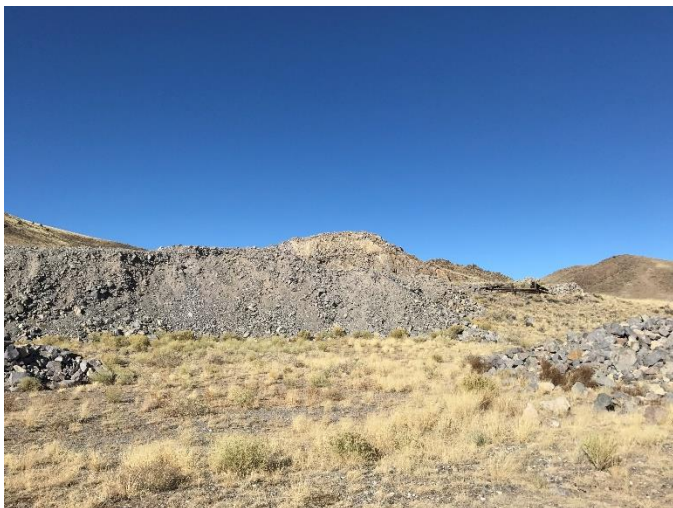
**PROBLEM/POSSIBLE VIOLATION:** Problem: Land has been affected outside of the approved permit boundary. This is a possible violation at this time pursuant to: 1.) C.R.S. 34-32.5-109(1) for failure to first obtain from the board or office a reclamation permit prior to engaging in a new operation. AND/OR 2.) C.R.S. 34-32.5-116(4)(i) for failure to protect areas outside of the affected land from slides or damages occurring during the mining operation. 2.) C.R.S. 34-32.5-116(4)(i) for failure to protect areas outside of the affected land from slides or damages occurring during the mining operation.

This is a 112c mining operation with a 13.44 permit acres. Mining is moving in a northeasterly direction and is following the approved mining plan. A highwall was about 20' high. Corner markers and fences delineated the permit area. At this time there is a material stockpile that is lying on the outside of the southern boundary of the permit area. Right now this is a possible violation. It is recommended that the Operator move the pile back in the permit area onto the Burton's land that is within the permit area but not move it off site. For this reason, there is another problem with the permit at this time which is lack of maintaining legal right of entry with Bob and Suzanne Burton. The lease expired 2.5 years ago. The material stockpile is one the southern portion of the permit area- the land that the Burton's own. This is a civil matter between the two parties and not a matter that the Division is going to take issue upon at this time. There are two landowners: Rio Grande Canal Water Users and the Burtons. The Burtons have expressed submitting their own 110c application that will overlay the existing permit that will encompass their land only. With that, once the permit gains approval, the existing permit that Southway has permitted will shrink down to less acres than 13.44 acres. The Division will require a new permit boundary map at that time and a survey to determine the new boundary.

Stockpile outside of permit boundary (arrow)

**CORRECTIVE ACTIONS:** Move the material stockpile that is sitting just over the southern boundary onto the Burtons property. Please take photos of the moved pile and send to the Division.

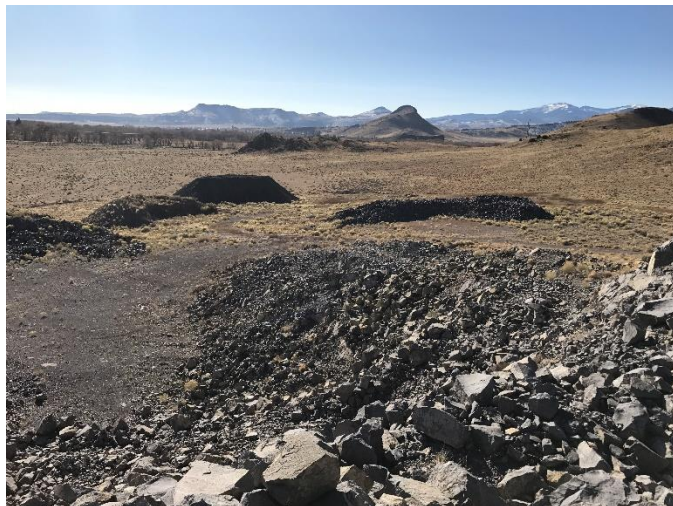
Highwall
