MINERALS PROGRAM INSPECTION REPORT
PHONE: (303) 866-3567

MINE NAME: Luke the Duke Gravel Pit	MINE/PROSPECTING ID#: M-2013-036	MINERAL: Gravel	COUNTY: La Plata
INSPECTION TYPE: Monitoring	INSPECTOR(S): Lucas West	INSP. DATE: November 12, 2019	INSP. TIME: 07:30
OPERATOR: Luke The Duke, LLC	OPERATOR REPRESENTATIVE: John Avery	TYPE OF OPERATION: 110c - Construction Limited Impact	
REASON FOR INSPECTION: Normal I&E Program	BOND CALCULATION TYPE: Complete Bond	BOND AMOUNT: \$14,631.48	
DATE OF COMPLAINT: NA	POST INSP. CONTACTS: None	JOINT INSP. AGENCY: None	
WEATHER: Clear	INSPECTOR'S SIGNATURE:

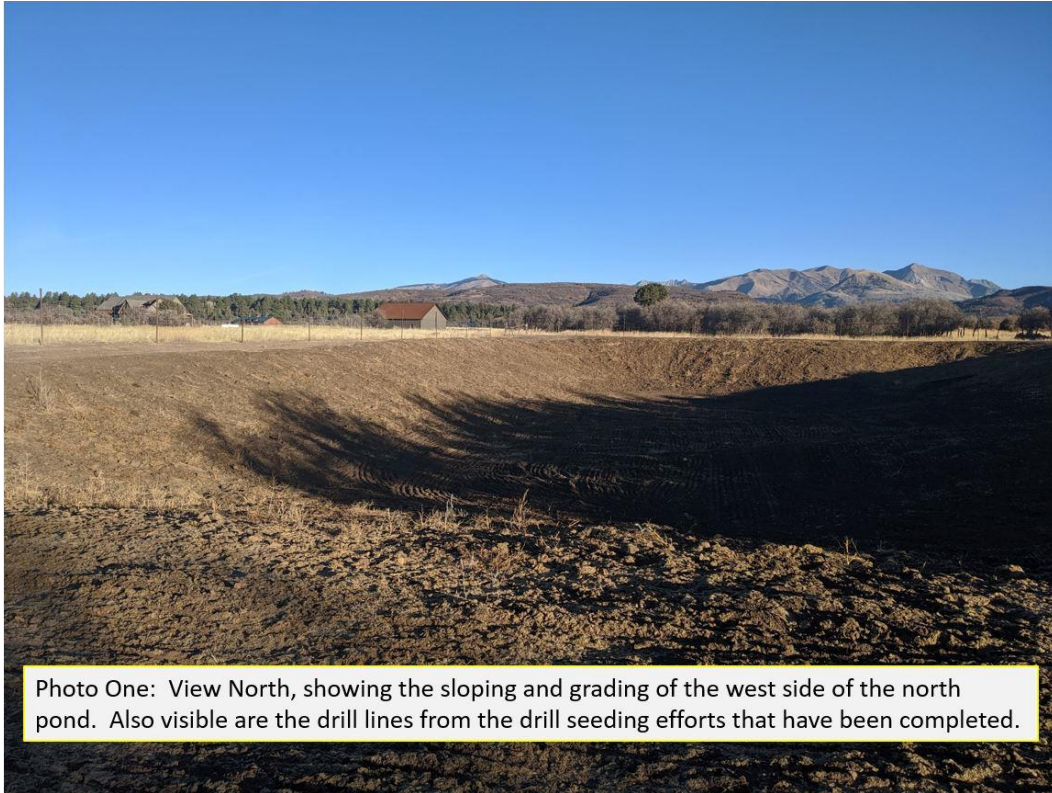
Photo One: View North, showing the sloping and grading of the west side of the north pond. Also visible are the drill lines from the drill seeding efforts that have been completed.

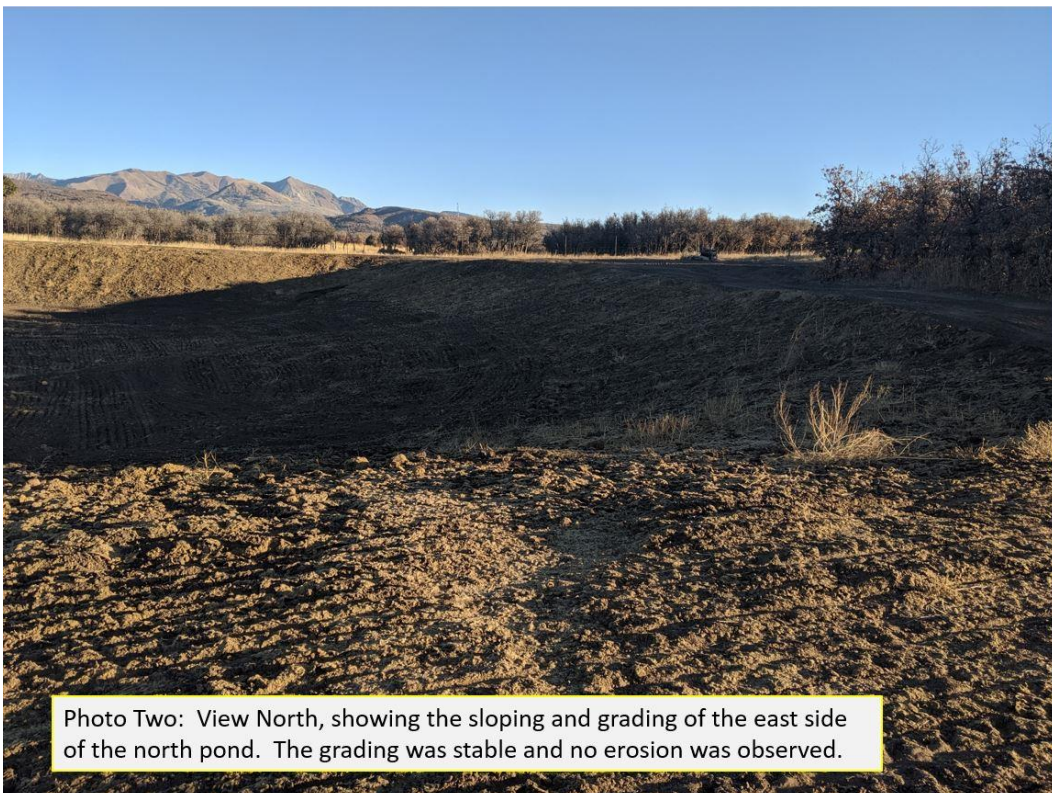
Photo Two: View North, showing the sloping and grading of the east side of the north pond. The grading was stable and no erosion was observed.

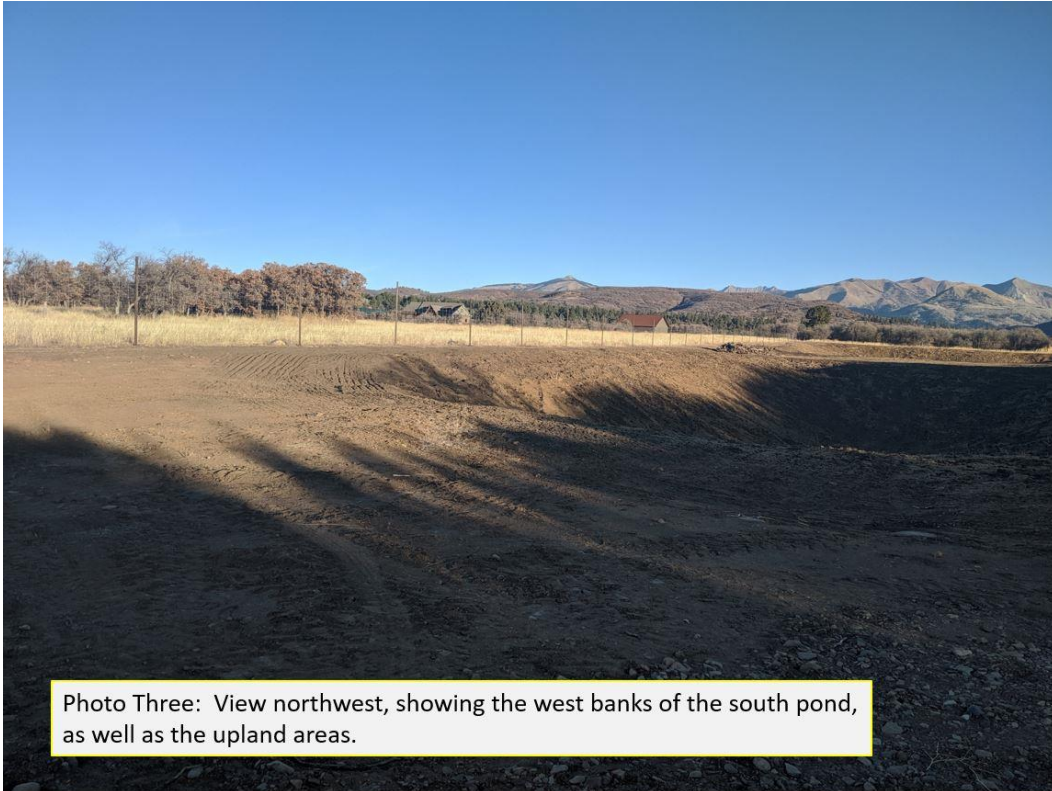
Photo Three: View northwest, showing the west banks of the south pond, as well as the upland areas.

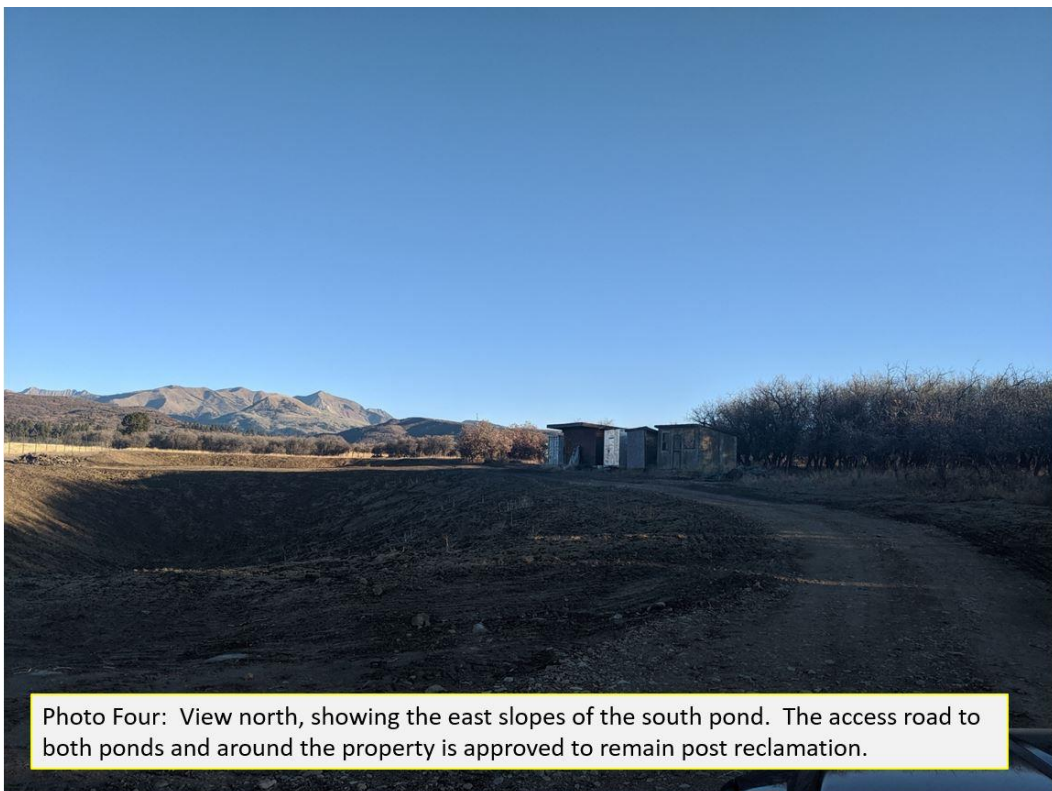
Photo Four: View north, showing the east slopes of the south pond. The access road to both ponds and around the property is approved to remain post reclamation.
