MINERALS PROGRAM INSPECTION REPORT
PHONE: (303) 866-3567

| MINE NAME: Corkle Construction Pit #2 | MINE/PROSPECTING ID#: M-2011-033 | MINERAL: Reclamation only | COUNTY: Jackson |
| INSPECTION TYPE: Surety Release Inspection | INSPECTOR(S): Peter Hays | INSP. DATE: November 5, 2019 | INSP. TIME: 11:30 |

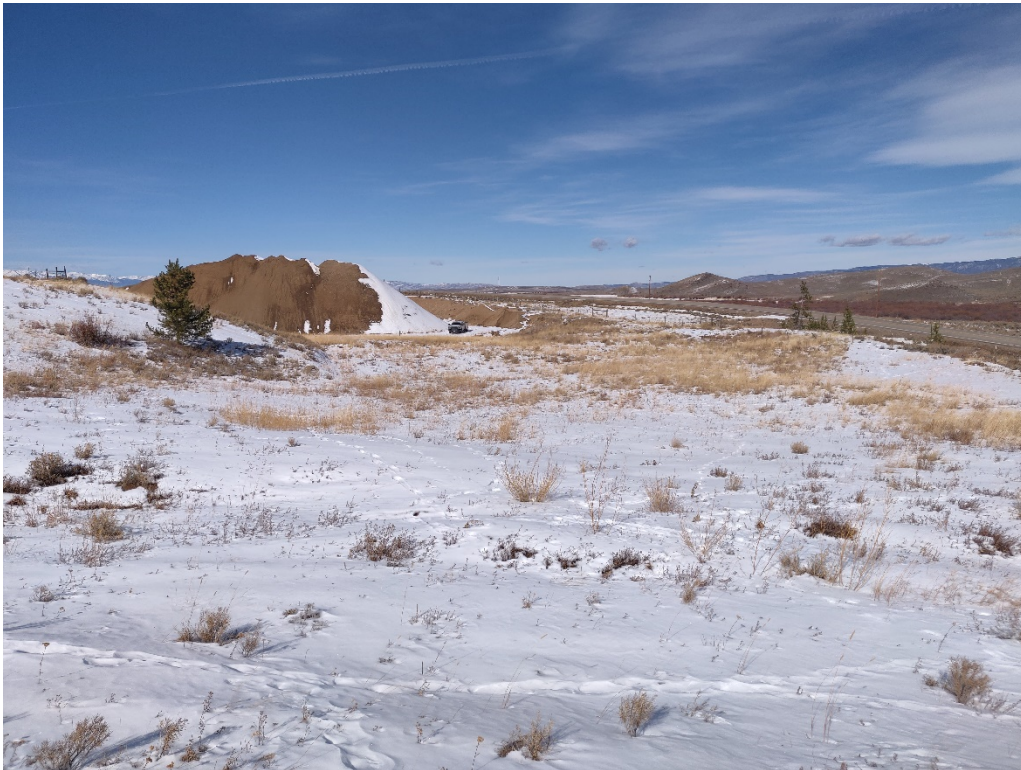
View of the site from the southeast side looking northwest

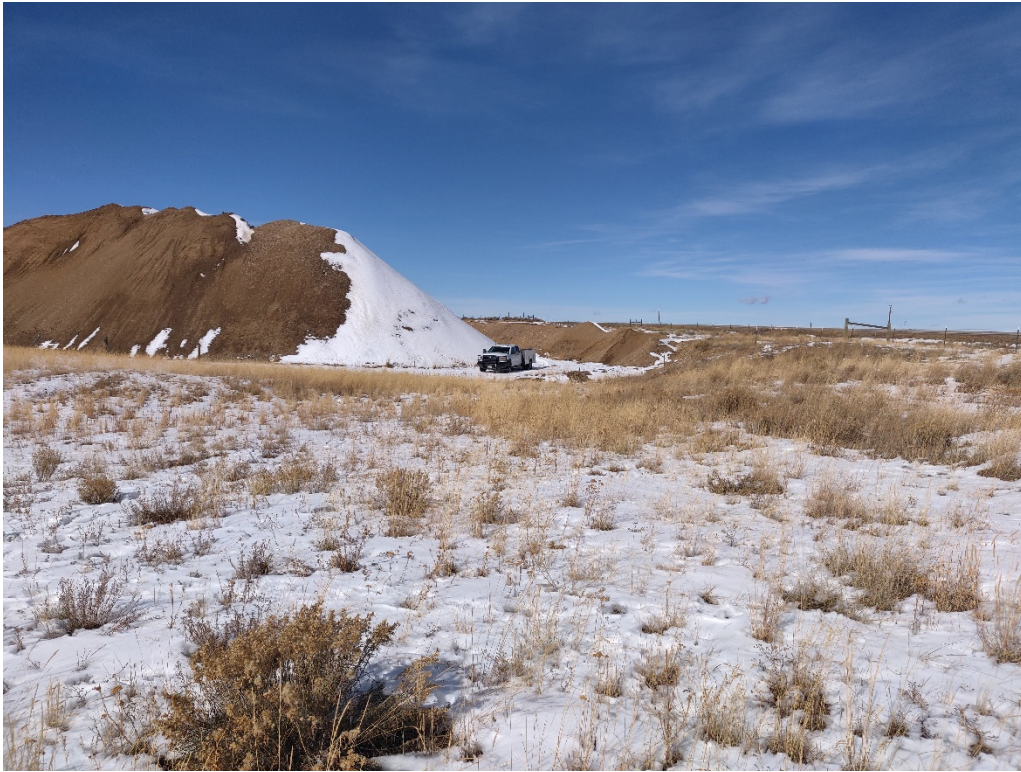
View of the northwest corner of the site

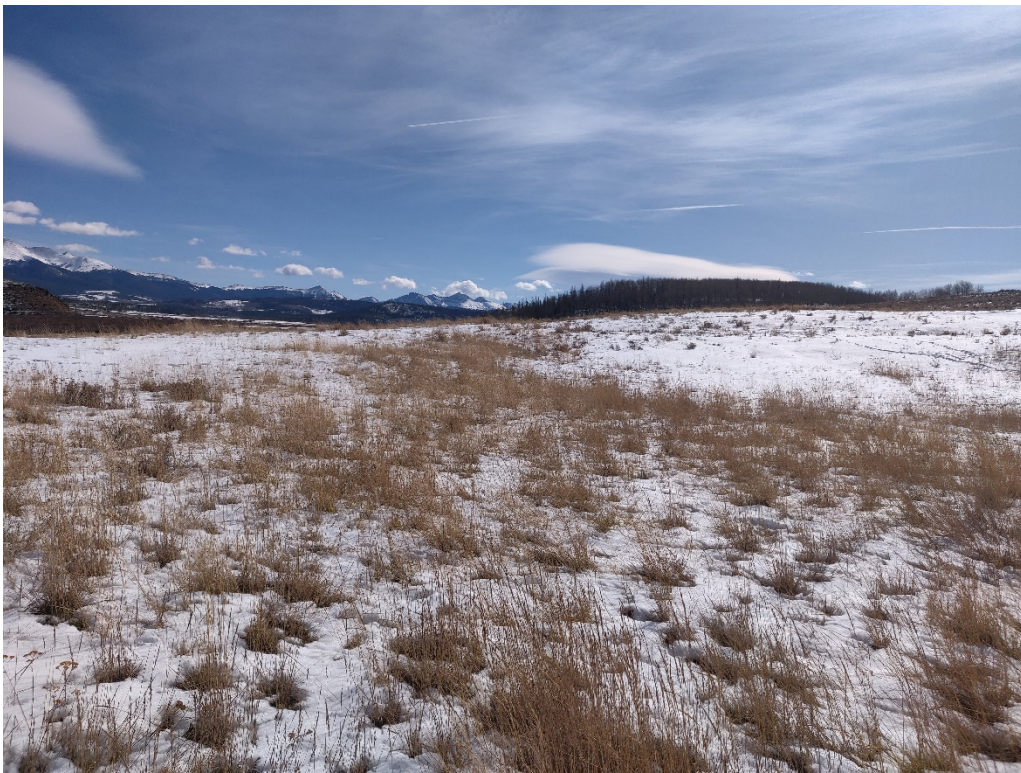
View of the north portion of the site from the entrance gate looking southeast

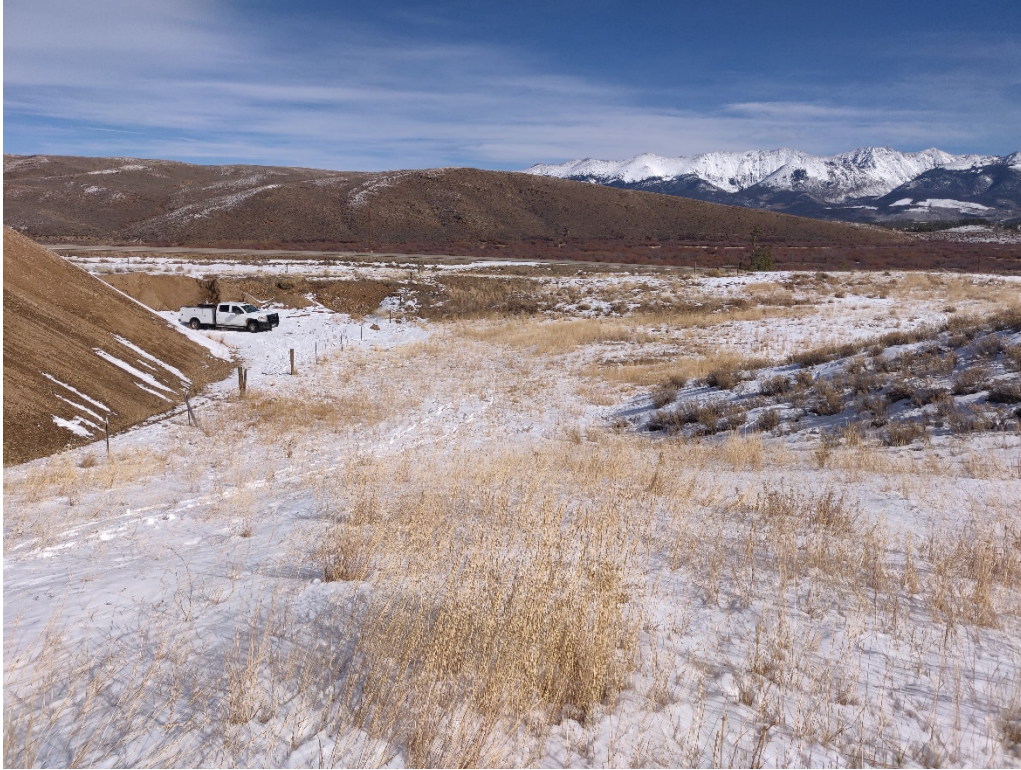
The previous release request (SL-01) was denied by the Division based on the presence of two (2) erosion areas, lack of well-established vegetation in portions of the site and presence of noxious weeds.

View looking down the slope where erosion feature were observed during the 2016 inspection

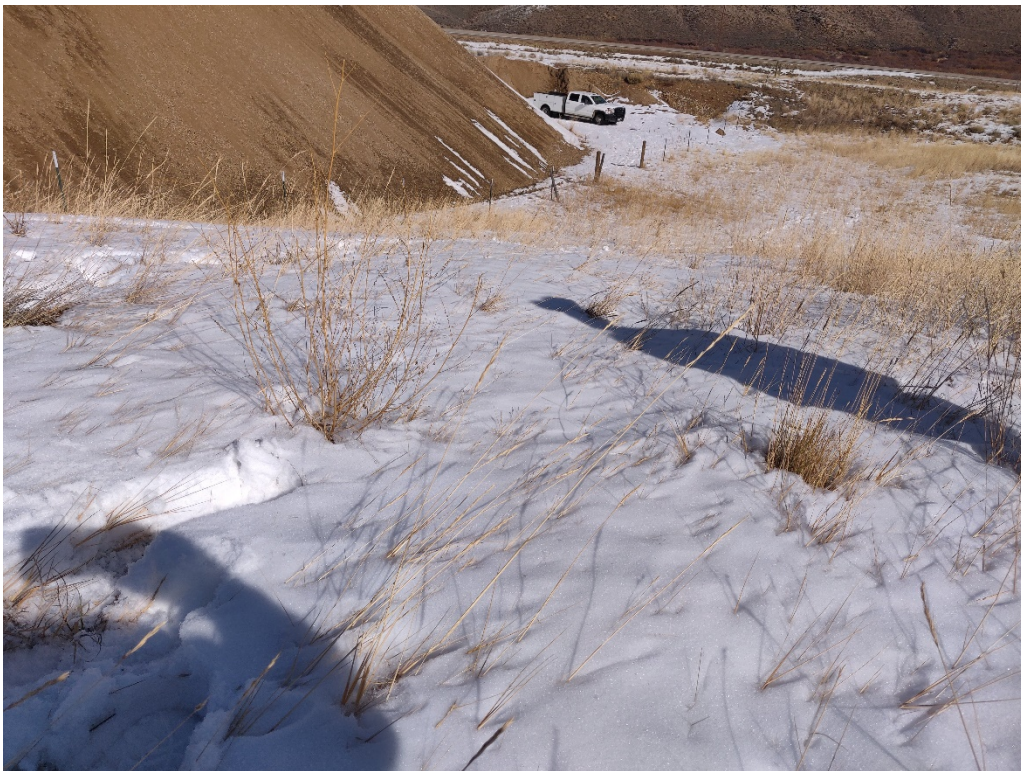
During this inspection, the vegetative coverage was difficult to observe due to snow cover. The ground was covered in approximately 4 inches of snow. Patches of grass, primarily blue bunch wheatgrass, were observed above the snow cover and appeared well-established. The Division scraped several areas of snow to observe the underlying ground conditions. The areas contained a mixture of bare ground, sparse vegetation and dormant grasses bent over by the snow. The northeast end of the site lacked vegetation above the snow and therefore could not be adequately evaluated by the Division. An aster species of perennial plant was observed on the pit floor. The plant was identified by the Division following the inspection. The presence of the plant indicates the site vegetation is unstable, but trending in the right direction for release approval by the Division. The previously identified erosion areas could not be evaluated for stability due to snow cover. Two (2) Canada thistle plants were observed during the inspection, which was the noxious weed species observed during the 2016 inspection. The plants appeared to have been chemically treated and controlled by the Operator.

View of typical snow coverage at the site

The Division will issue a weather delay notice pursuant to Rule 4.17.2(2) and plan to inspect the site in the Spring of 2020, tentatively scheduled for June 2, 2020, to evaluate the site without snow cover and while the grasses are actively growing. The Operator reported the site was reseeded in early October to increase the vegetative cover.
