MINERALS PROGRAM INSPECTION REPORT
PHONE: (303) 866-3567

MINE NAME: Neglected Mine	MINE/PROSPECTING ID#: M-1981-165	MINERAL: Gold	COUNTY: La Plata
INSPECTION TYPE: Monitoring	INSPECTOR(S): Lucas West	INSP. DATE: November 12, 2019	INSP. TIME: 14:20
OPERATOR: Mine Development Inc	OPERATOR REPRESENTATIVE: Harold Luzar	TYPE OF OPERATION: 110(2) - Hard Rock Limited Impact	
REASON FOR INSPECTION: Normal I&E Program	BOND CALCULATION TYPE: Complete Bond	BOND AMOUNT: \$23,221.00	
DATE OF COMPLAINT: NA	POST INSP. CONTACTS: None	JOINT INSP. AGENCY: None	
WEATHER: Clear	INSPECTOR'S SIGNATURE:

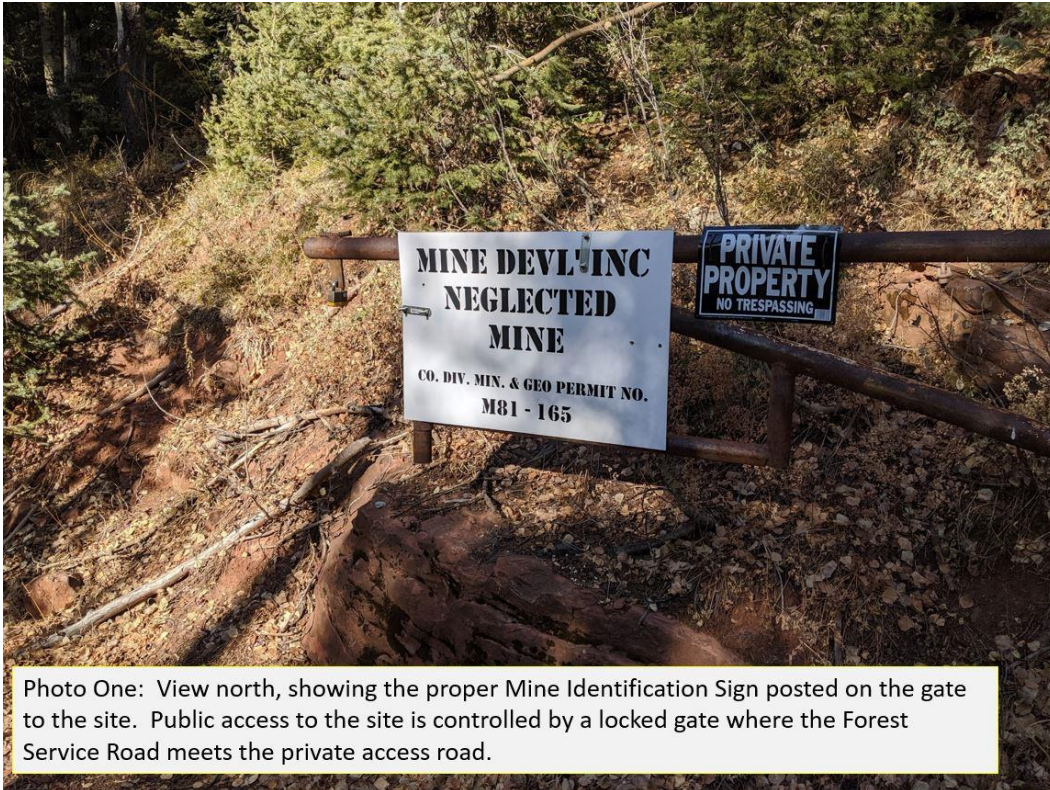
As seen in Photos One, proper mine identification signage was observed. The permit boundaries were also clearly marked. The site is currently winterized with minimal activity taking place over the past mining season. The portal was sealed with a locked steel door and small temporary berm pushed up to its base, shown in Photo Two. The portal was not draining water during the inspection. The secondary egress/ vent shaft was observed to be in good condition. The storage yard was in good condition, and well vegetated. Equipment stored includes a box truck, lumber, scrap iron and an explosives magazine. The Explosives magazine is secure and appears to be in good condition. The Operator confirms it is empty and prior to the commencement of mining activities next season he will change the locks to allow for access and use. The magazine can be seen in Photo Three. The mill building, which is built on a concrete pad with proper drainage structures to contain any processed water generated during operations was observed and was in good condition. The interior of the Mill building was not inspected at this time. The mill building can be seen in Photo Four. All other surface structures and facilities were inspected. The lined pond was in good condition, as seen in Photo Five. The area above the water line showed no signs of tearing or compromising of any kind. The pond level is lowered by the assisted evaporation process and is low enough to support the addition of any contributions from precipitation events.

Photo One: View north, showing the proper Mine Identification Sign posted on the gate to the site. Public access to the site is controlled by a locked gate where the Forest Service Road meets the private access road.

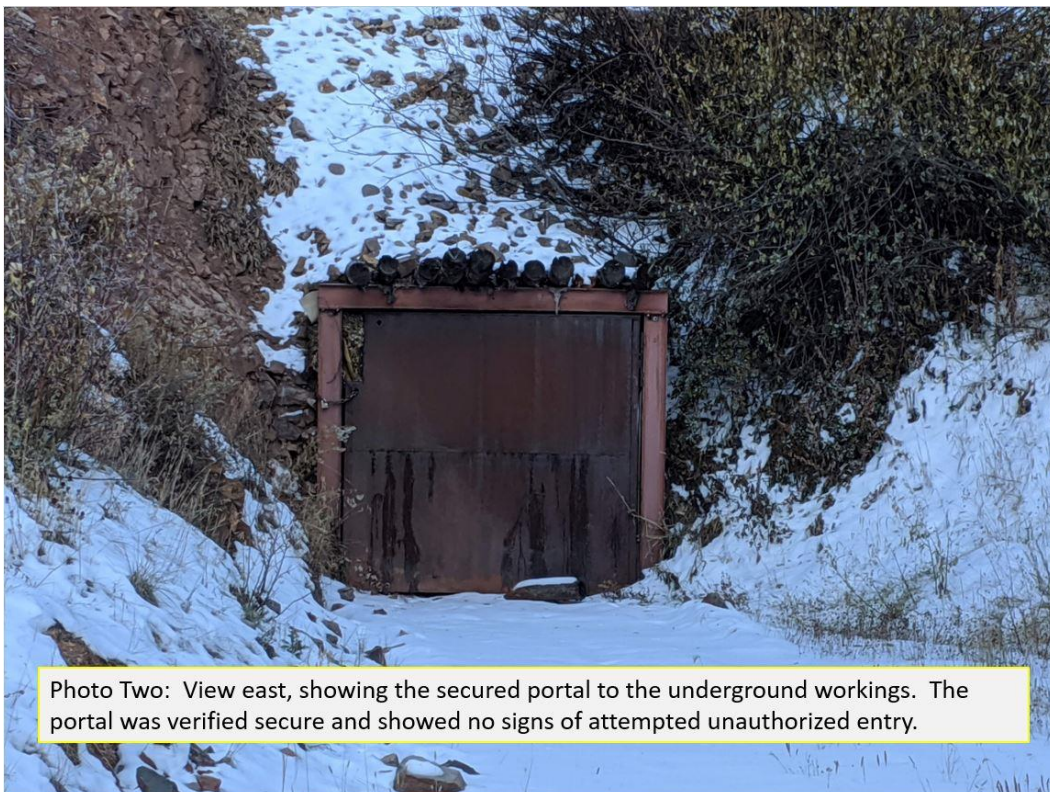
Photo Two: View east, showing the secured portal to the underground workings. The portal was verified secure and showed no signs of attempted unauthorized entry.

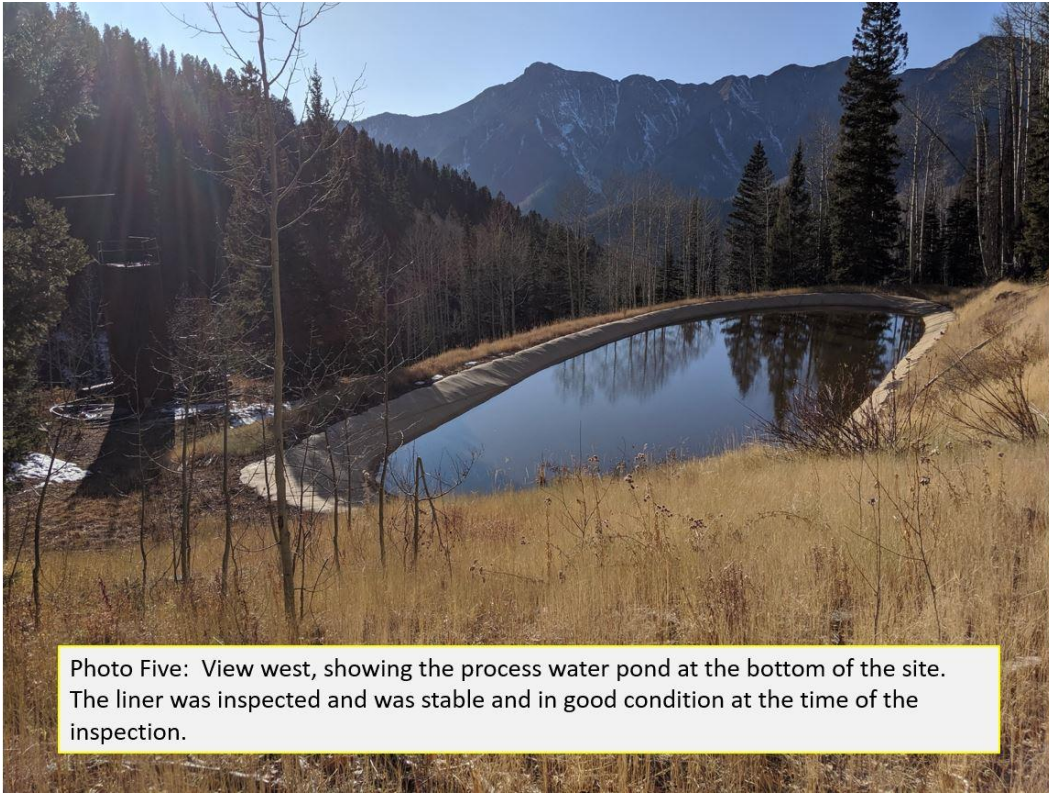
Photo Five: View west, showing the process water pond at the bottom of the site. The liner was inspected and was stable and in good condition at the time of the inspection.
