MINERALS PROGRAM INSPECTION REPORT
PHONE: (303) 866-3567

MINE NAME: Pueblo East Pit	MINE/PROSPECTING ID#: M-1906-015	MINERAL: Sand and gravel	COUNTY: Pueblo
INSPECTION TYPE: Monitoring	INSPECTOR(S): Patrick Hennberg	INSP. DATE: October 17, 2019	INSP. TIME: 1000
OPERATOR: Continental Materials Corporation	OPERATOR REPRESENTATIVE: Bruce Humphries	TYPE OF OPERATION: 112c - Construction Regular Operation	
REASON FOR INSPECTION: <input type="checkbox"/> Normal <input type="checkbox"/> Program		BOND CALCULATION TYPE: Complete Bond	
DATE OF COMPLAINT: <input type="checkbox"/> A		BOND AMOUNT: \$2,200.00	
WEATHER: Clear		JOINT INSP. AGENCY: None	
INSPECTOR'S SIGNATURE:

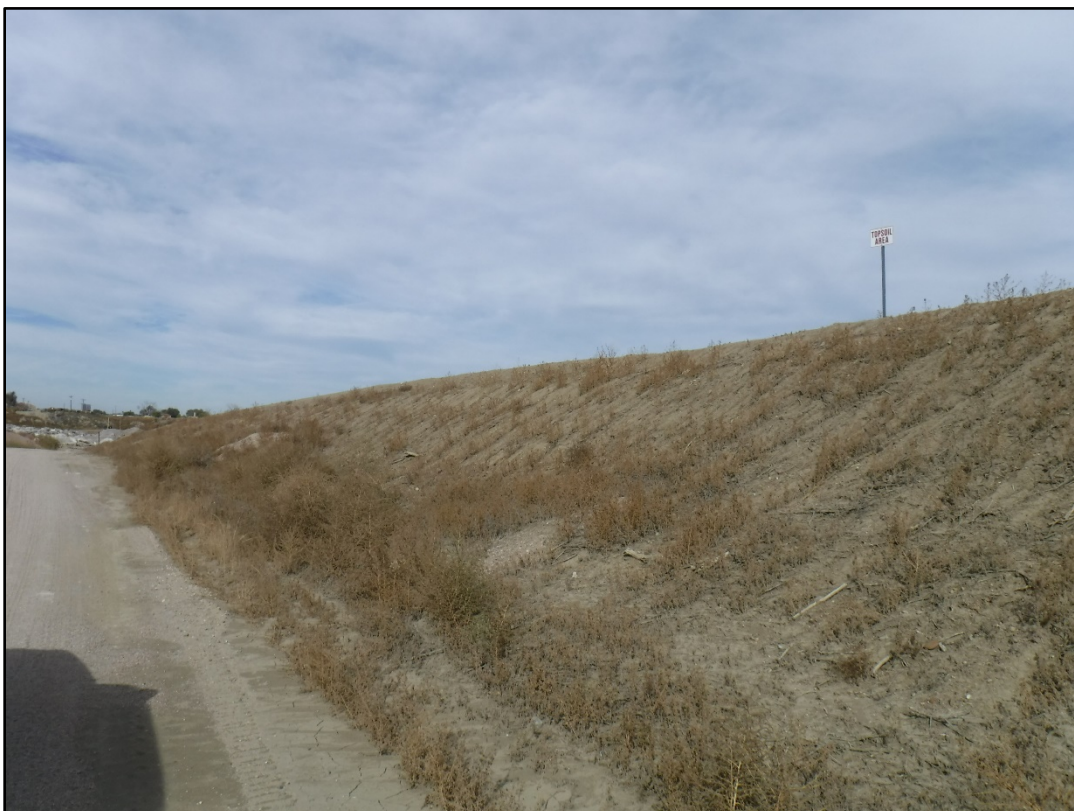
Photo 2: Topsoil stockpile located on the northern boundary of Phase 1

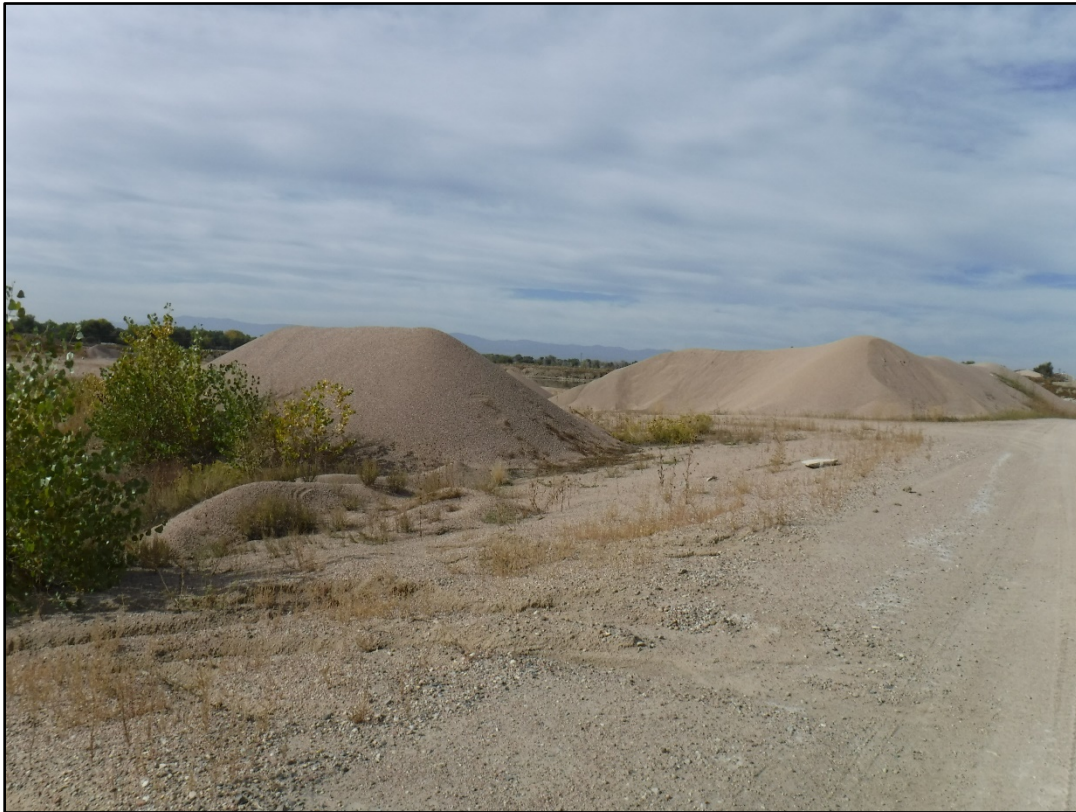
Photo 3: Product stockpiles still being sold, located within Phase 1

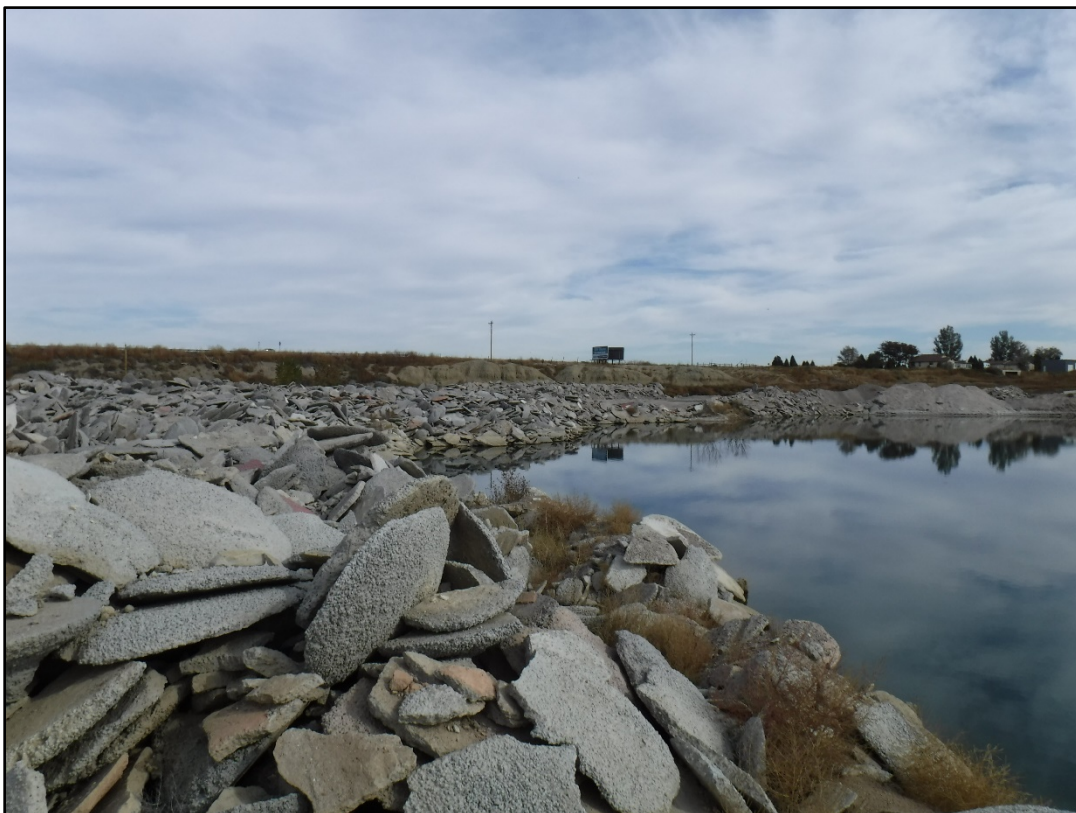
Currently, Phase 1 has a few material stockpiles that are being sold. In 2017 Technical Revision 4 (TR-04) was approved and allowed for the importation of inert fill to be used as backfill. Currently cement truck cleanout material is being used as backfill. As shown in Figure 1 there is approximately 65 acres of exposed groundwater that requires backfilling. The actual depth of the exposed groundwater is not known at this time. According to the reclamation plan approved in Amendment 4 (AM-04) it is assumed that 26 feet of backfill material will be required to get approximately 2 to 3 feet above the groundwater elevation. The slopes of the pit will be graded to 3:1 or flatter. The floor of the basin will be graded to slope to the southeastern corner where an outfall structure will be located to discharge to the river. The post-mining land use for Phase 1 is to be wildlife habitat. Topsoil will be spread 6 to 12 inches on the side slopes. The floor will be left barren for a period of two years to allow for invasion of desired vegetation. If the desired vegetation fails to establish then cottonwood trees and willows will be planted. There are two sediment clean out ponds, totaling about 9 acres, will have to be backfilled above groundwater. At this time it does not appear that there is sufficient backfill and topsoil remaining onsite to complete reclamation, therefore material will have to be imported. The Operator is currently searching for potential sources of backfill.

Photo 4: Inert fill material being dumped along the northern shores of the Phase 1 Pond

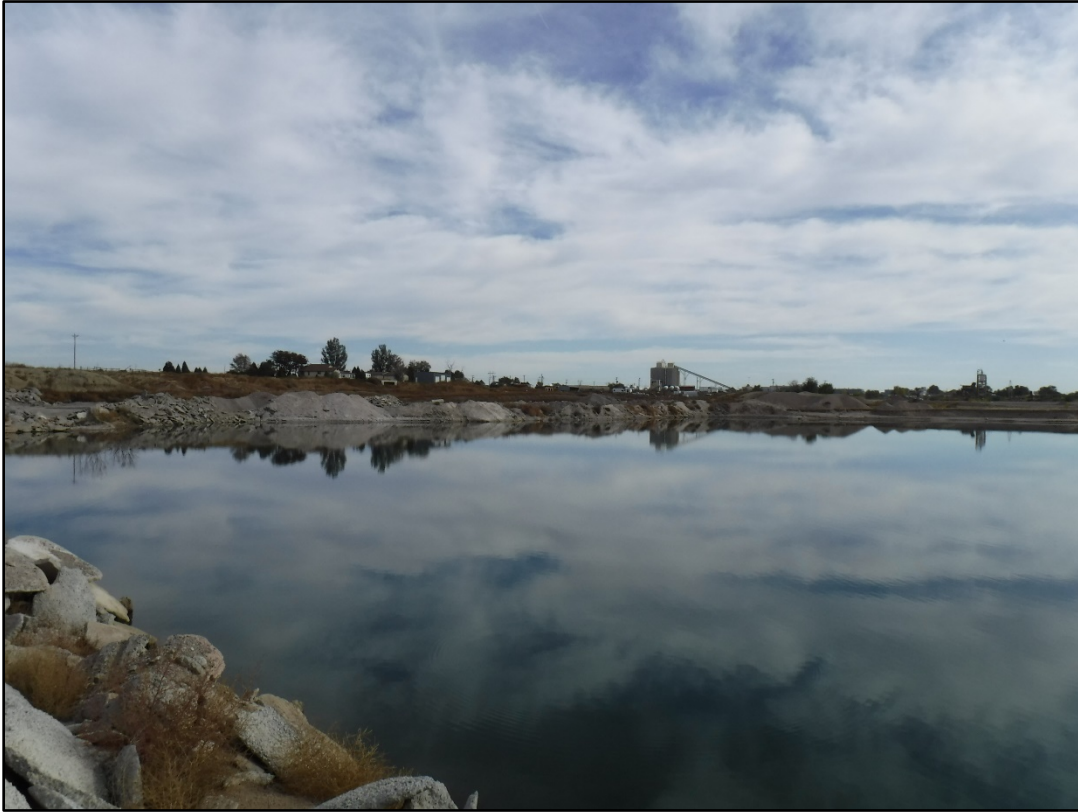
Photo 5: Looking east across the northern half of Phase 1 pond

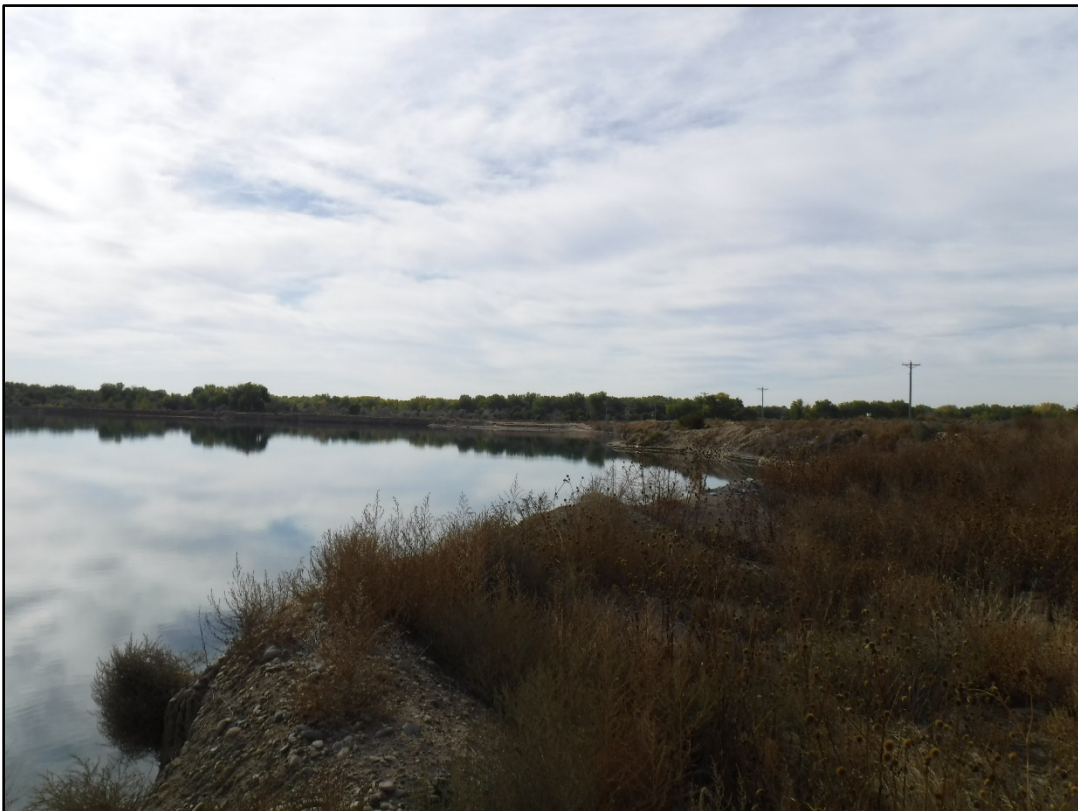
Photo 6: Looking south along the western boundary of Phase 1 pond

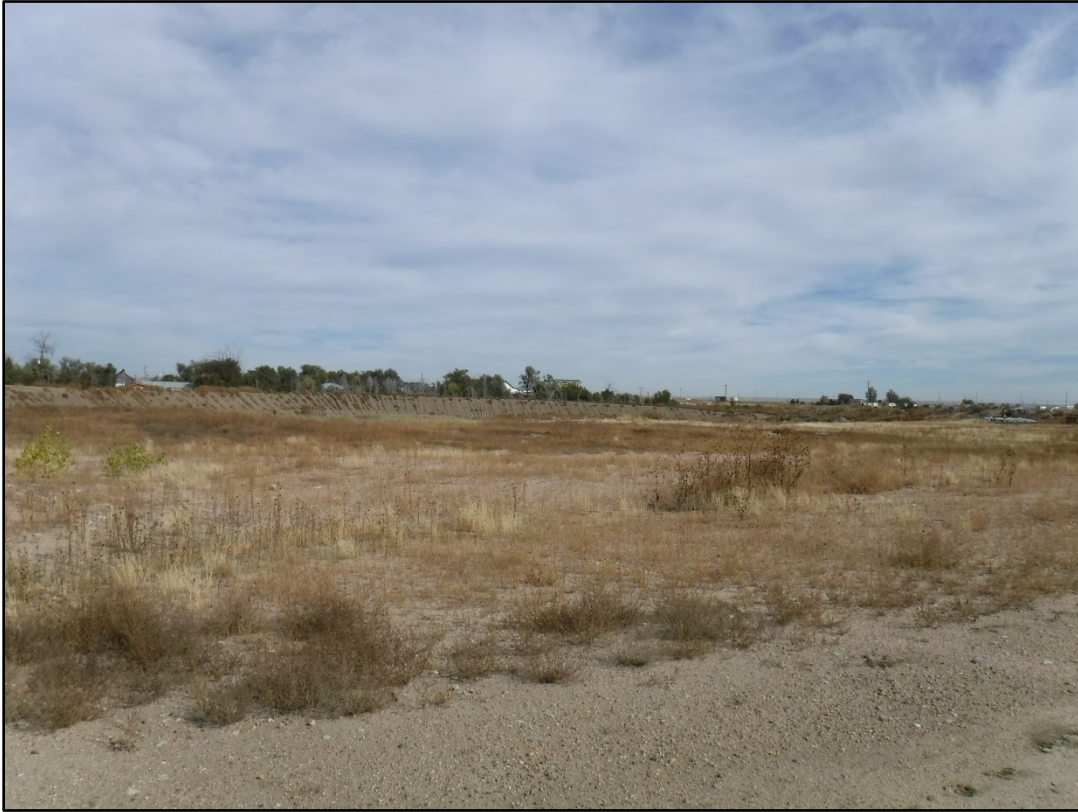
Photo 7: Topsoil stockpile along the northern perimeter of the mining and processing area in Phase 2

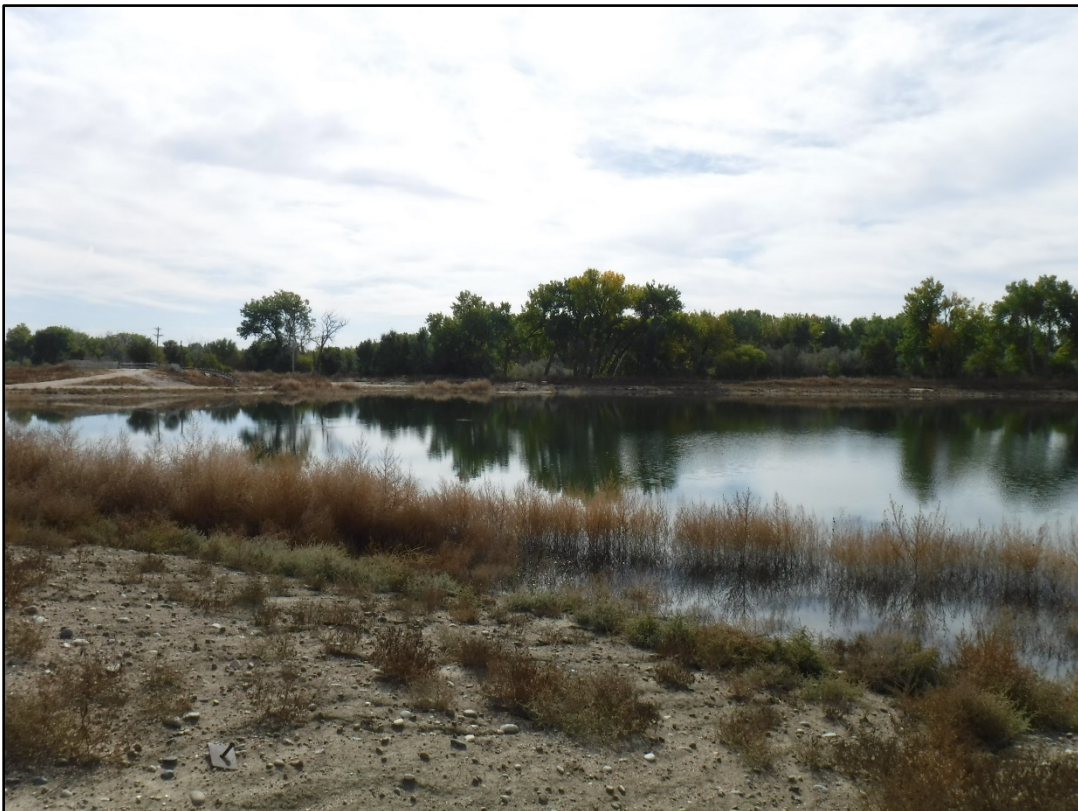
Photo 8: Looking southeast across the Phase 2 lined pond

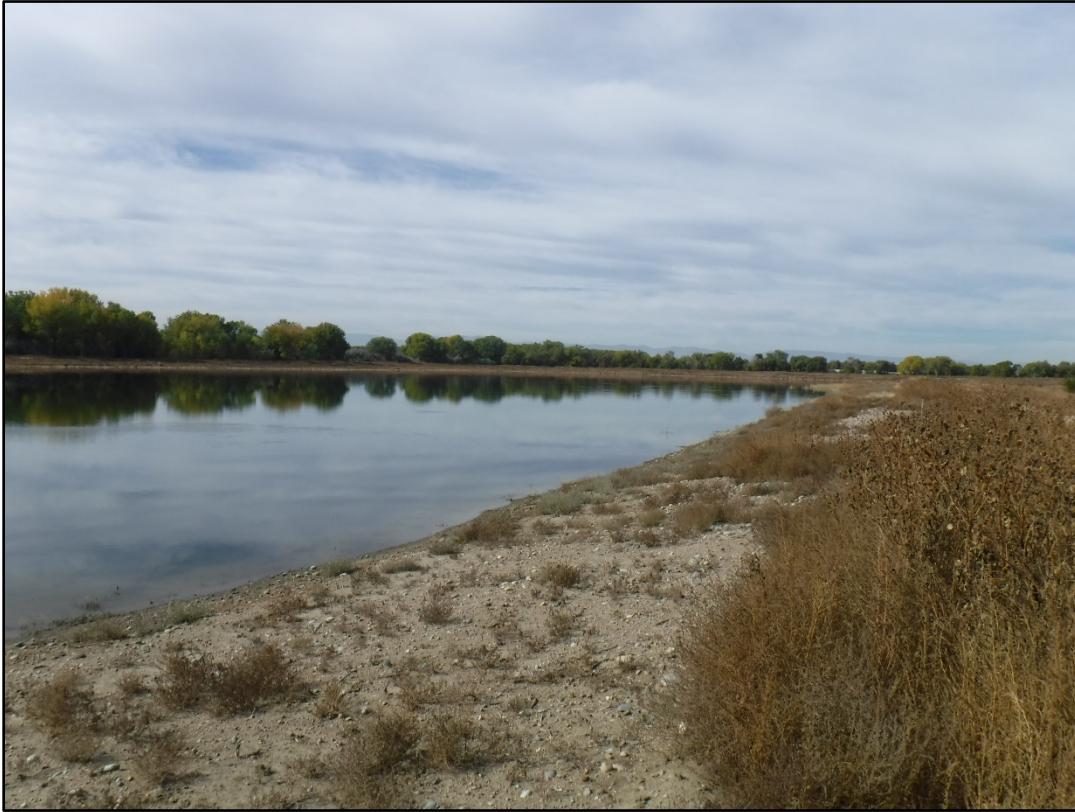
Photo 9: Looking southwest across the Phase 2 lined pond

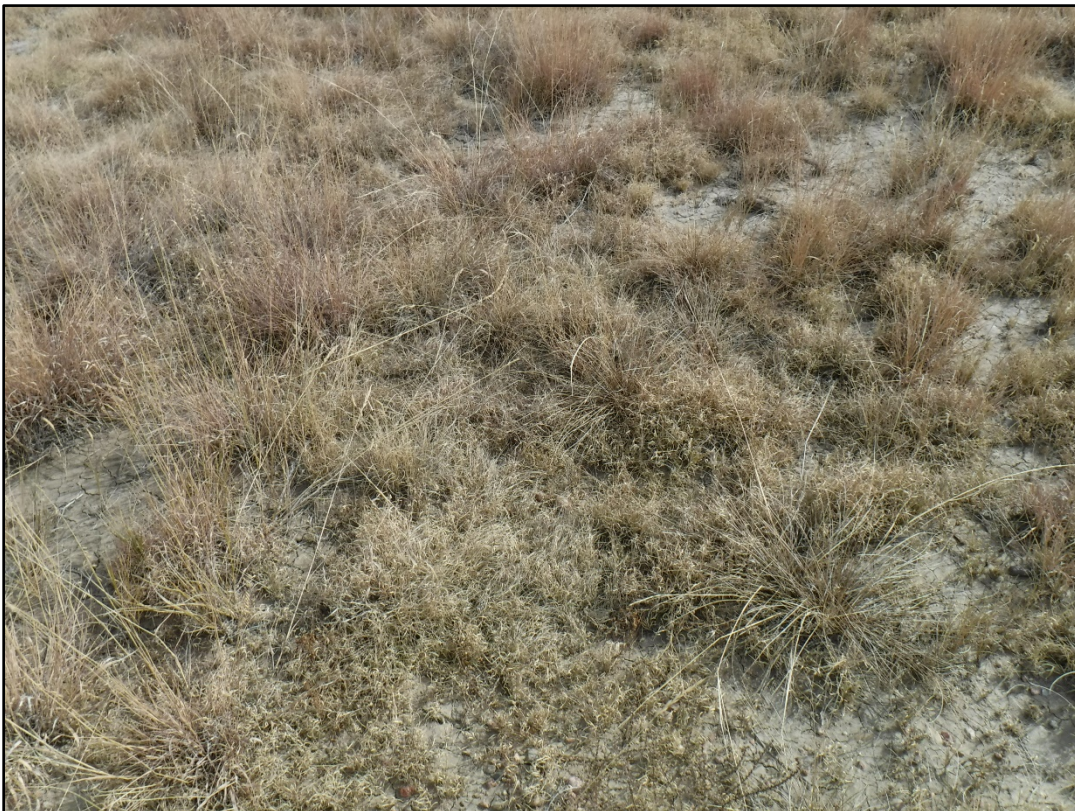
Photo 10: Vegetation established on the 6 acre topsoil overburden stockpile area in Phase 2

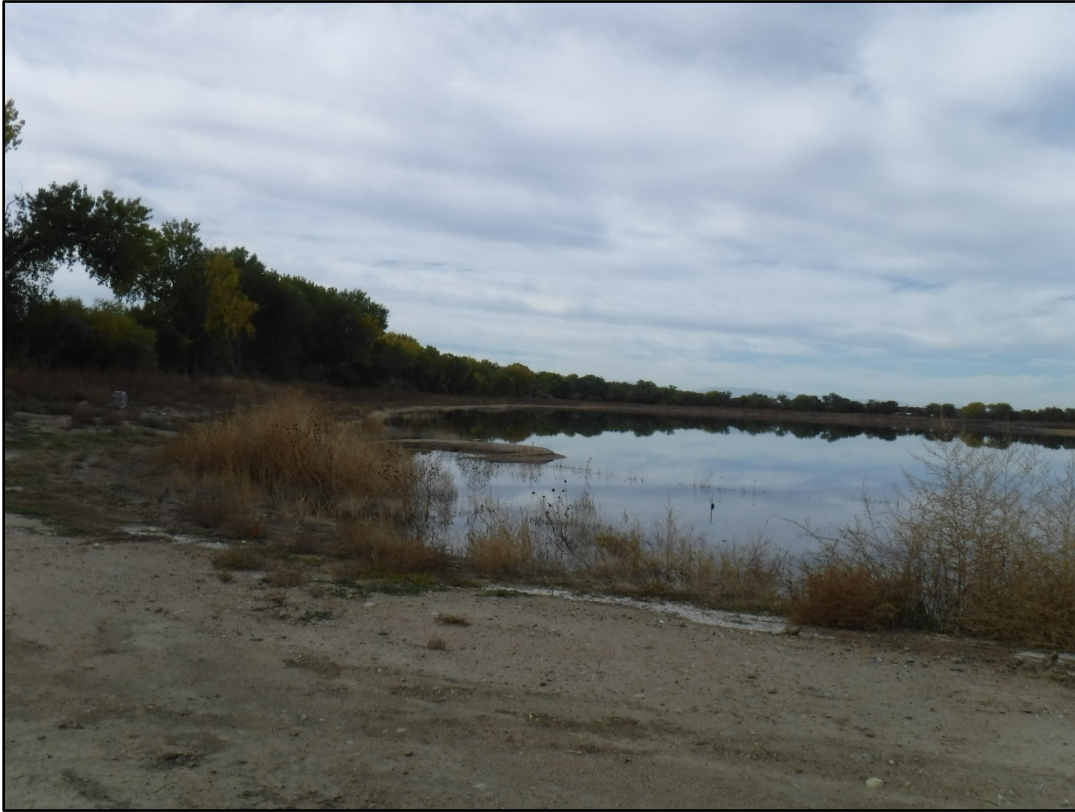
Photo 11: Looking west across the southern edge of the Phase 2 pond

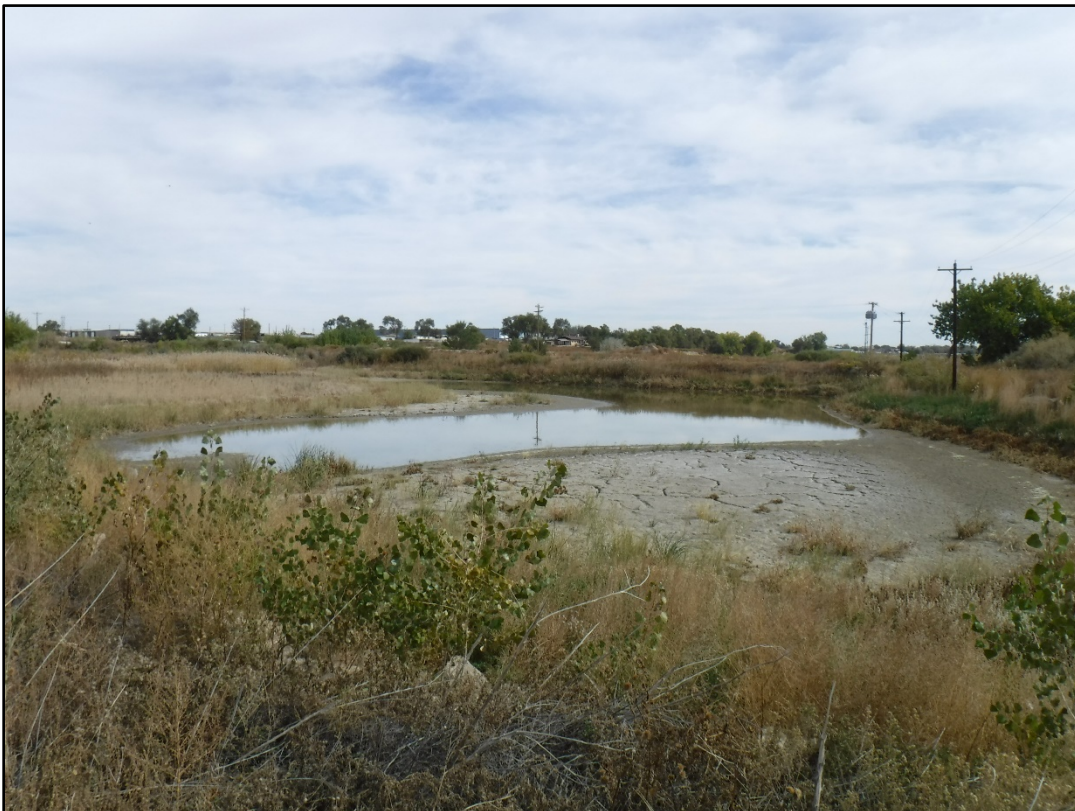
Photo 12: The western most sediment clean out pond

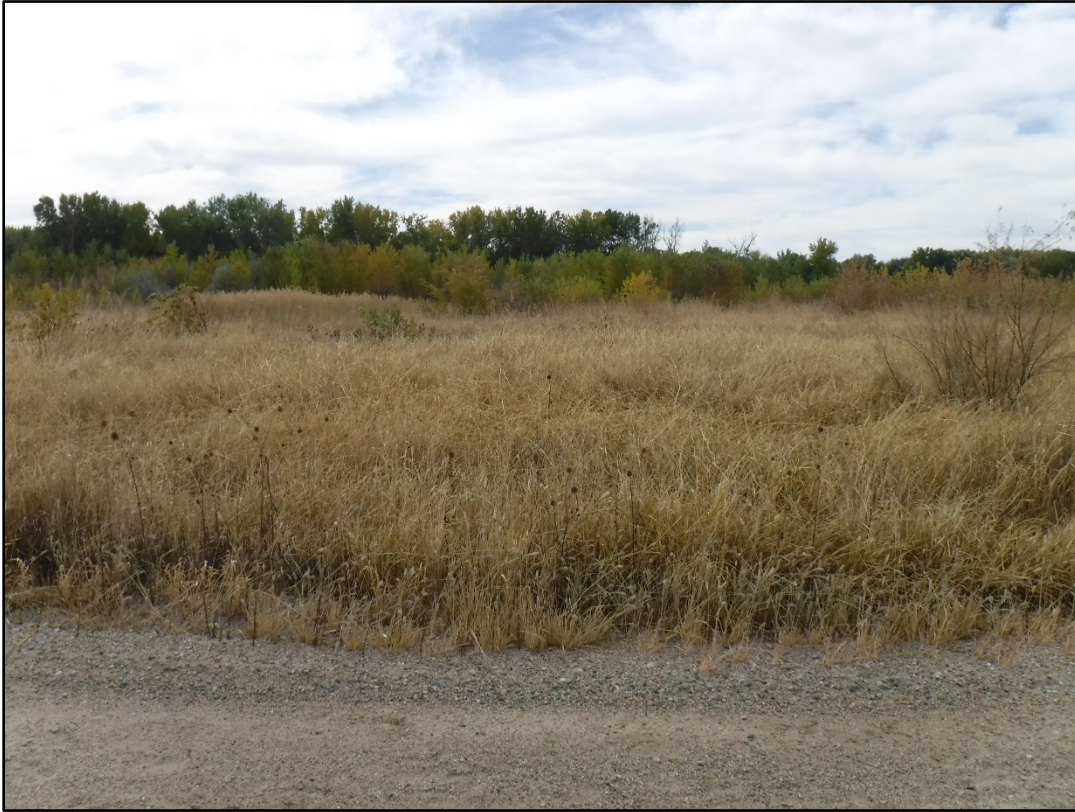
Photo 13: Vegetation conditions on the south side of haul road Phase 7

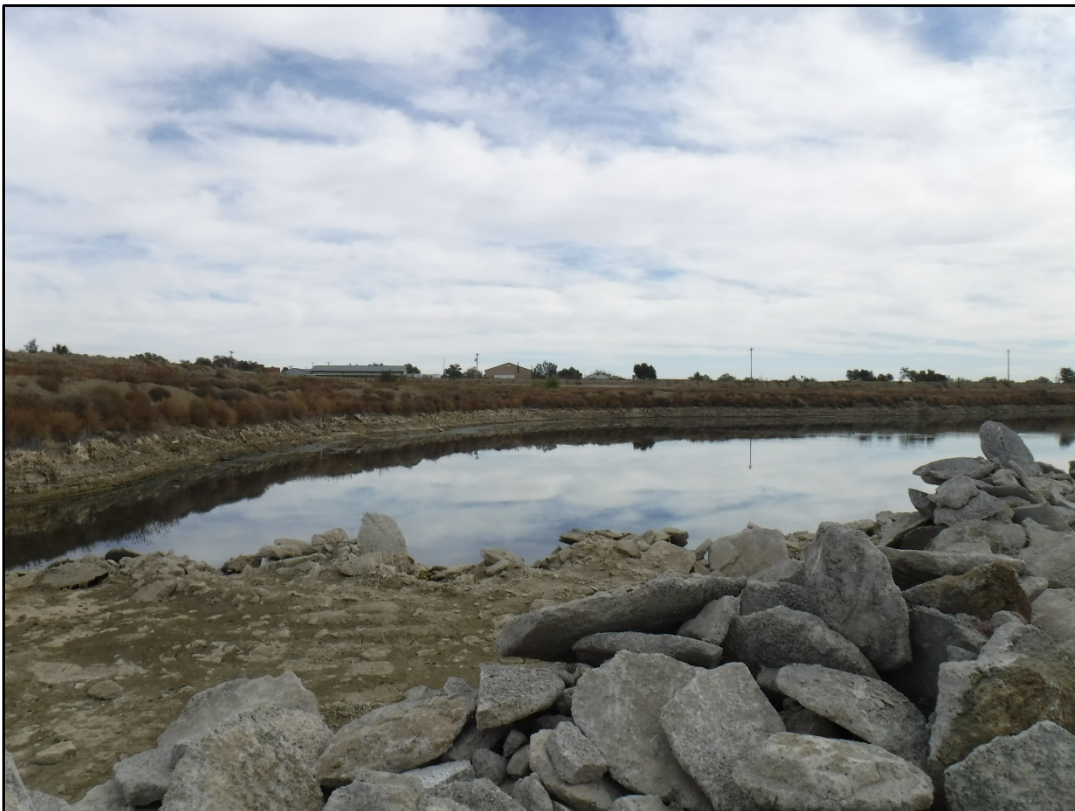
Currently there is approximately 6.3 acres of exposed groundwater in Phase 7. The side slopes around the exposed groundwater ranges from 3H:1V to near vertical. The depth of the water is unknown but according to AM-04 the depth of water could reach 26 feet or more. There are a couple of topsoil and overburden stockpiles that are located north and northeast portions of the phase. It is unknown at this time the volume contained within these piles. The perimeter slopes along the northern boundary varies from 3H:1V to vertical in some areas. These slopes are to be graded to 3H:1V per AM-04. During the inspection the Operator's representative noted that the floor of the phase may show small areas of ponding during high groundwater levels. The approved reclamation plan calls for backfilling to be a minimum of 2 feet above groundwater. Native vegetation is volunteering across the southern areas near the river.

Photo 14: North end of exposed groundwater Phase 7

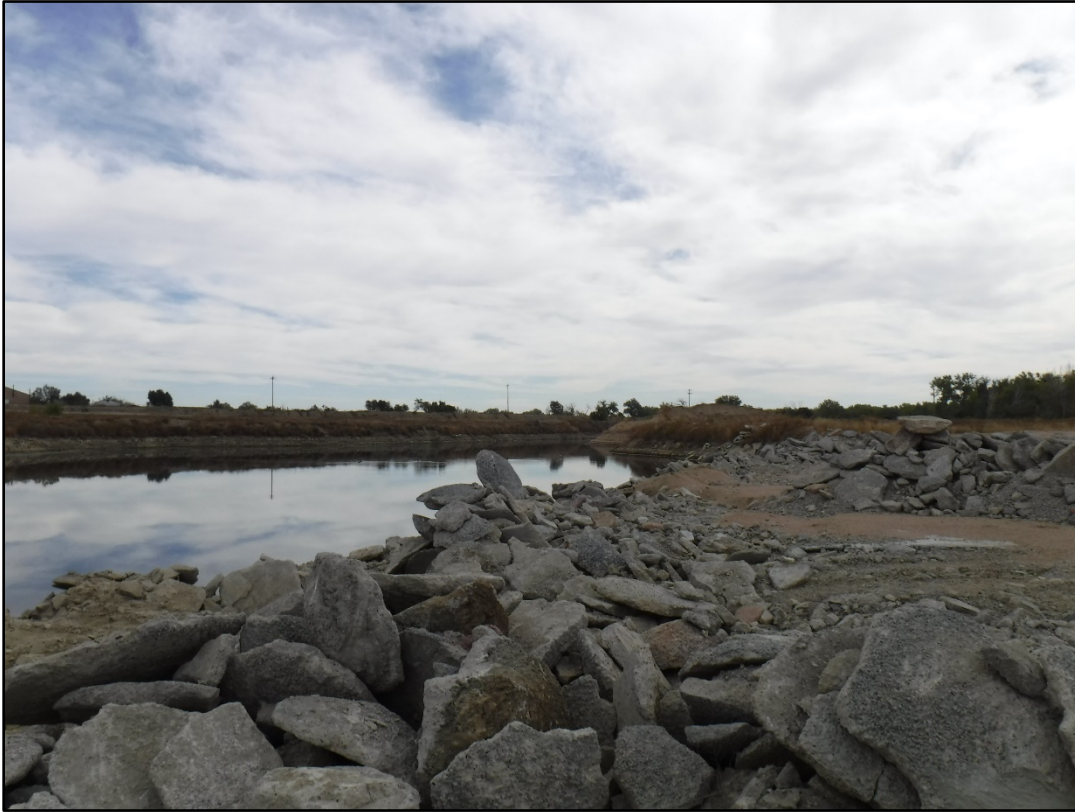
Photo 15: Looking southeast across exposed groundwater pond Phase 7

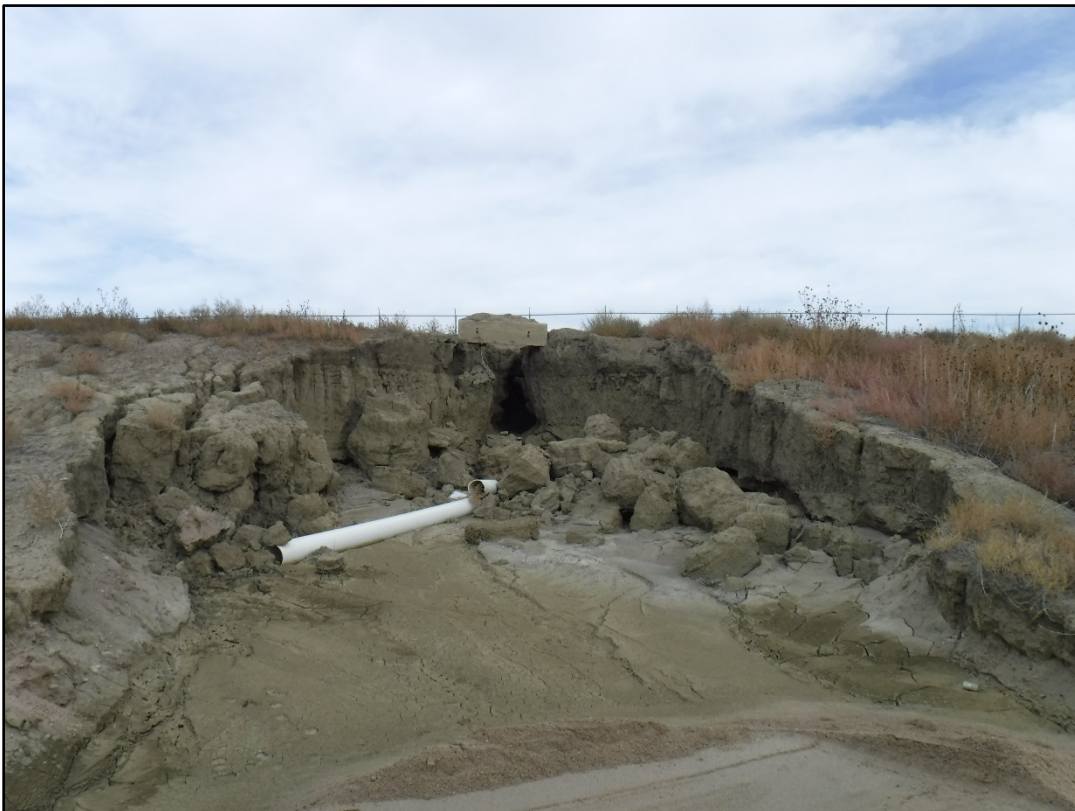
Along the northern boundary there is a culvert that drains an industrial area to the north. The culvert has blown out several times and created a large erosion rill. The rill is approximately 10 feet deep and varies in width from 8 to 15 feet wide. It is unclear who owns and is responsible for the culvert. However, this issue has to be addressed for the long term reclamation of the site.

Photo 16: Drainage erosion from adjacent property coming onsite

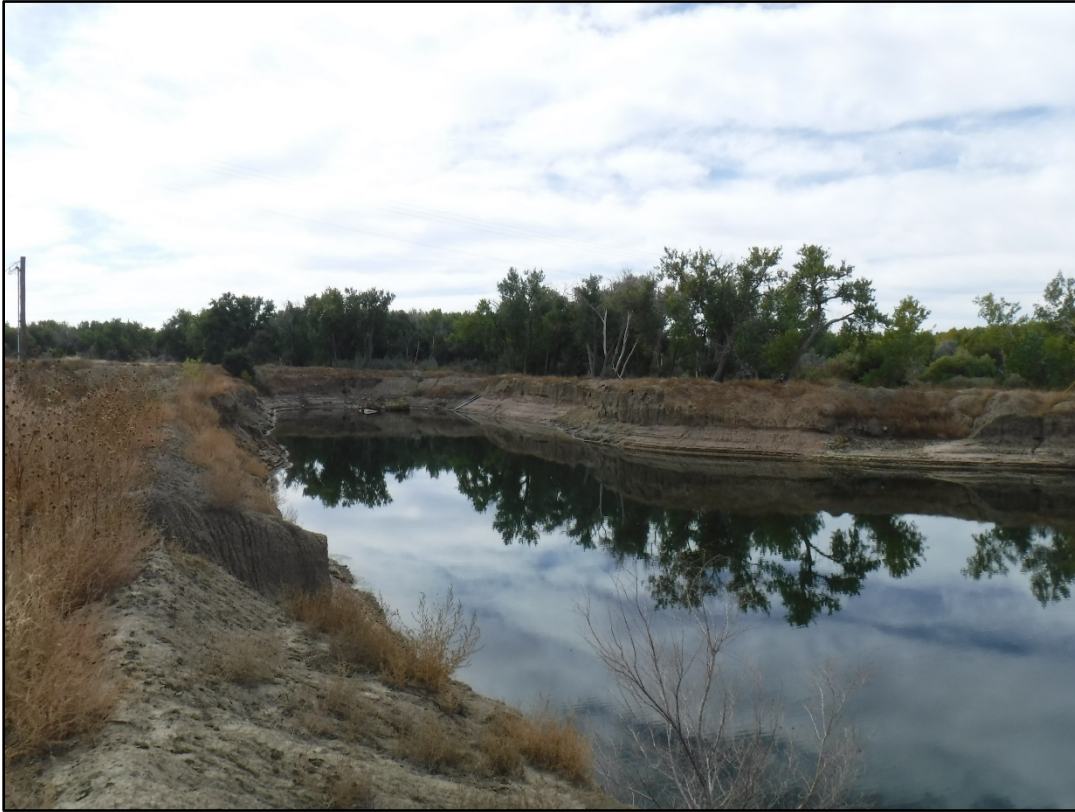
Photo 17: South end of Phase 7, note near vertical pond banks

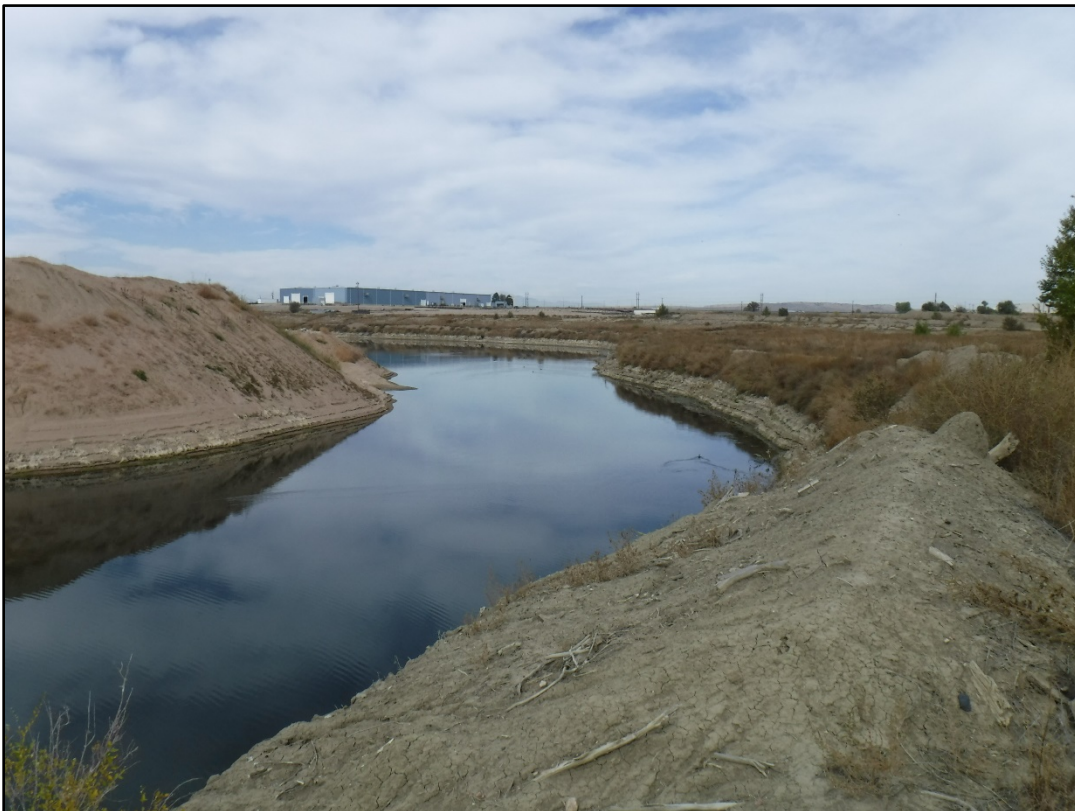
Photo 18: Looking north from near the south end of the Phase 7 pond
