Greg Lewicki And Associates, PLLC

RE: Pride of America Mine, Colorado Stone Quarries, M-1999-058, October 2019 Diesel Spill Incident Report and Mitigation and Remediation Plan; Minerals Program Inspection Report, October 24, 2019; Follow-up Notice Requirements

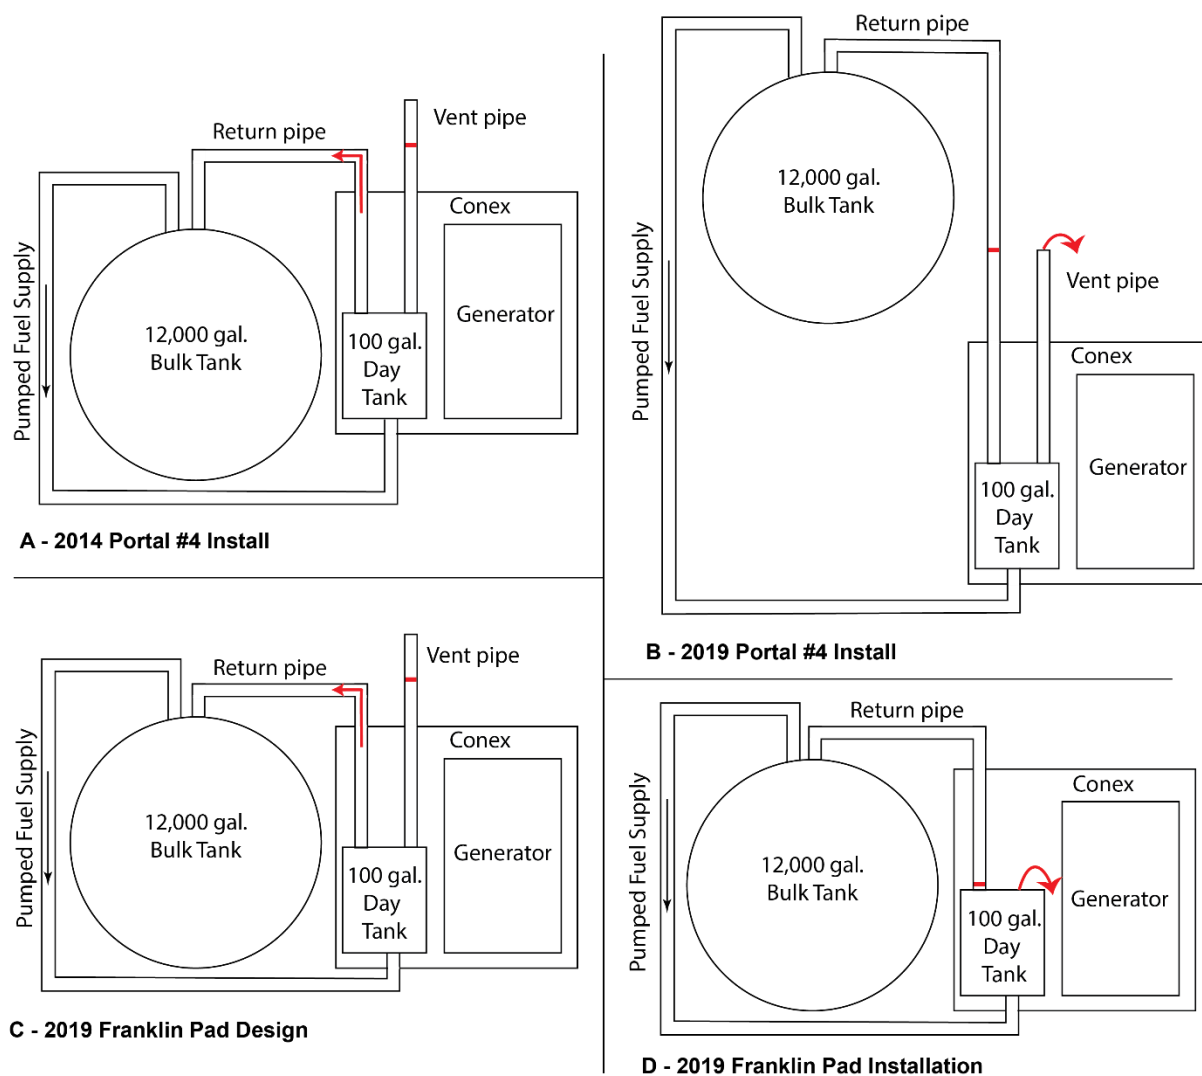
In April 2019, the primary power genset required a rebuild due to failure of one of the C27 engines. The other generator was also rebuilt at the same time. Permitted temporary power was brought onsite to relieve the primary power unit and allow the mine to continue to operate. The two C27s were ready for recommissioning in mid-July. Temporary power was decommissioned on July 14th and the rebuilt prime power genset was brought back online on July 17th. The rebuilt genset was installed outside Portal #4 and is depicted in Figure 1B.

Red lines and arrows denote fuel levels (lines) and pathways (arrows).

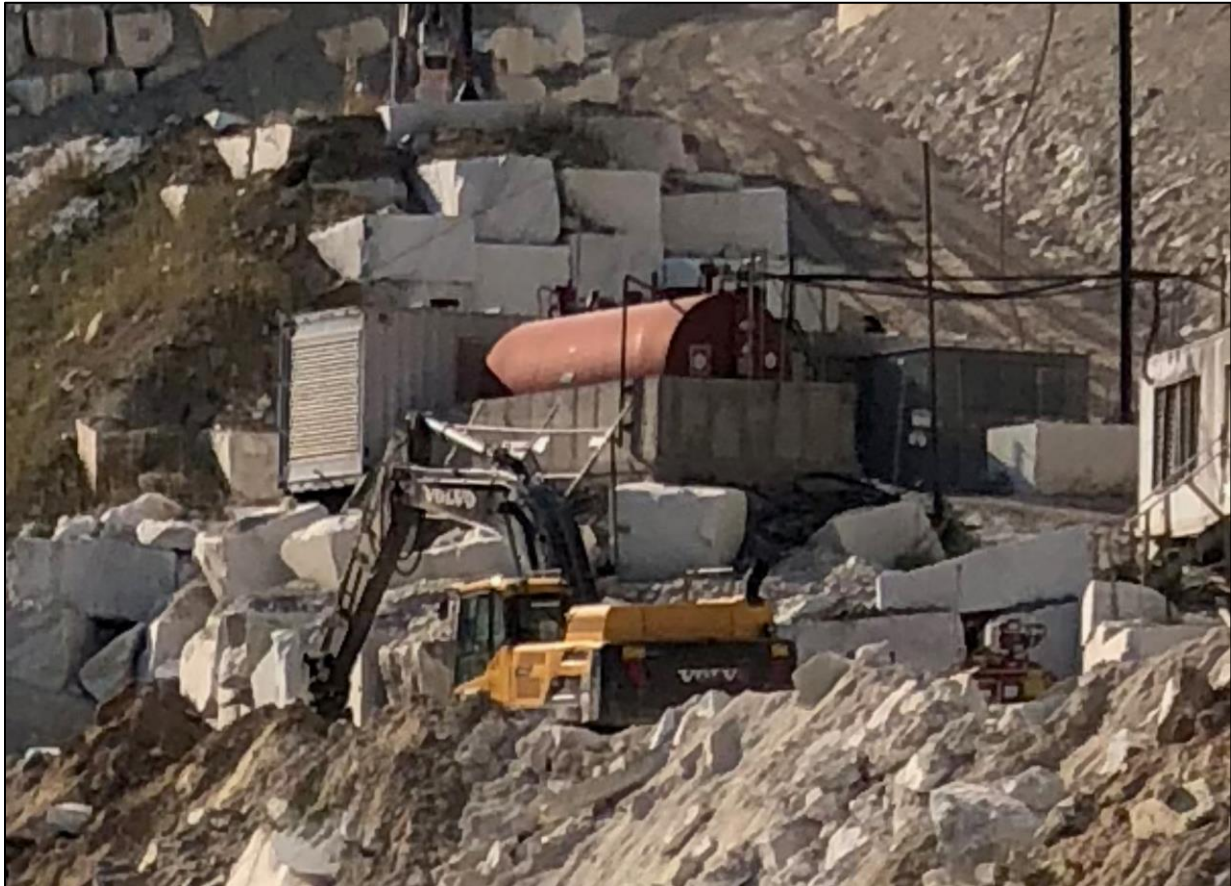
Figure 2. Original installation of the prime power genset and bulk tank. Lines running to the right serviced the previous overnight generator. Photo captured August 16, 2018; view to the south.

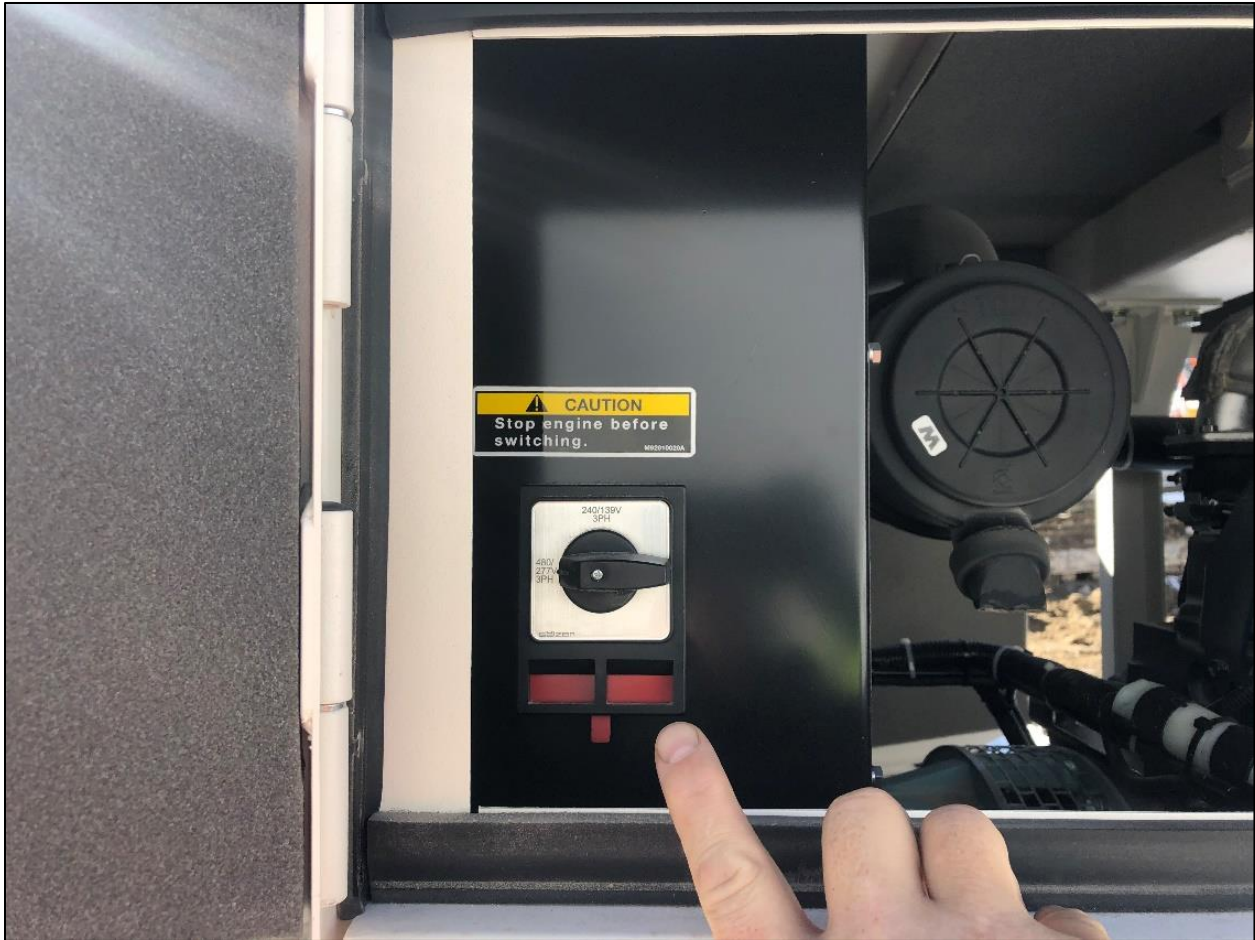
On Friday, October 11, 2019, for unknown reasons, the power switch on the overnight genset was switched from the 480V position to the 240V position (Figure 3). The Eaton transfer system and the Caterpillar transfer switch on the day tank requires a single phase from a 480V supply to operate. The lower voltage (240V) may have caused or contributed to the system not functioning correctly, and as a result, the day tank filled to over capacity during the night. Due to the fact that the vent pipe had not been reinstalled and had been replaced by a pressure release cap on the top of the day tank, diesel flowed out of the pressure release cap and spilled into the generator trailer and ultimately onto the road fill beneath it (Figure 1D and Figure 4).

Figure 3. Photo captured Thursday, October 31, 2019 of the 480V to 240V switch within the overnight generator. Access to the switch was not limited.

The switch from 480V to 240V caused a condition where the float control, valves, and pump malfunctioned. The malfunction allowed the day tank to overfill and continue overfilling. As required by a root-cause analysis, a number of questions are raised by this failure point:

As previously noted, access to the switch was not restricted. Additional protection could be provided by limiting access to the 240V to 480V switch panel (Figure 3). On cursory inspection, the panel did not provide access to typical maintenance points of the machinery. Upon restart of the primary power generation, consideration should be given to locking the voltage panel.

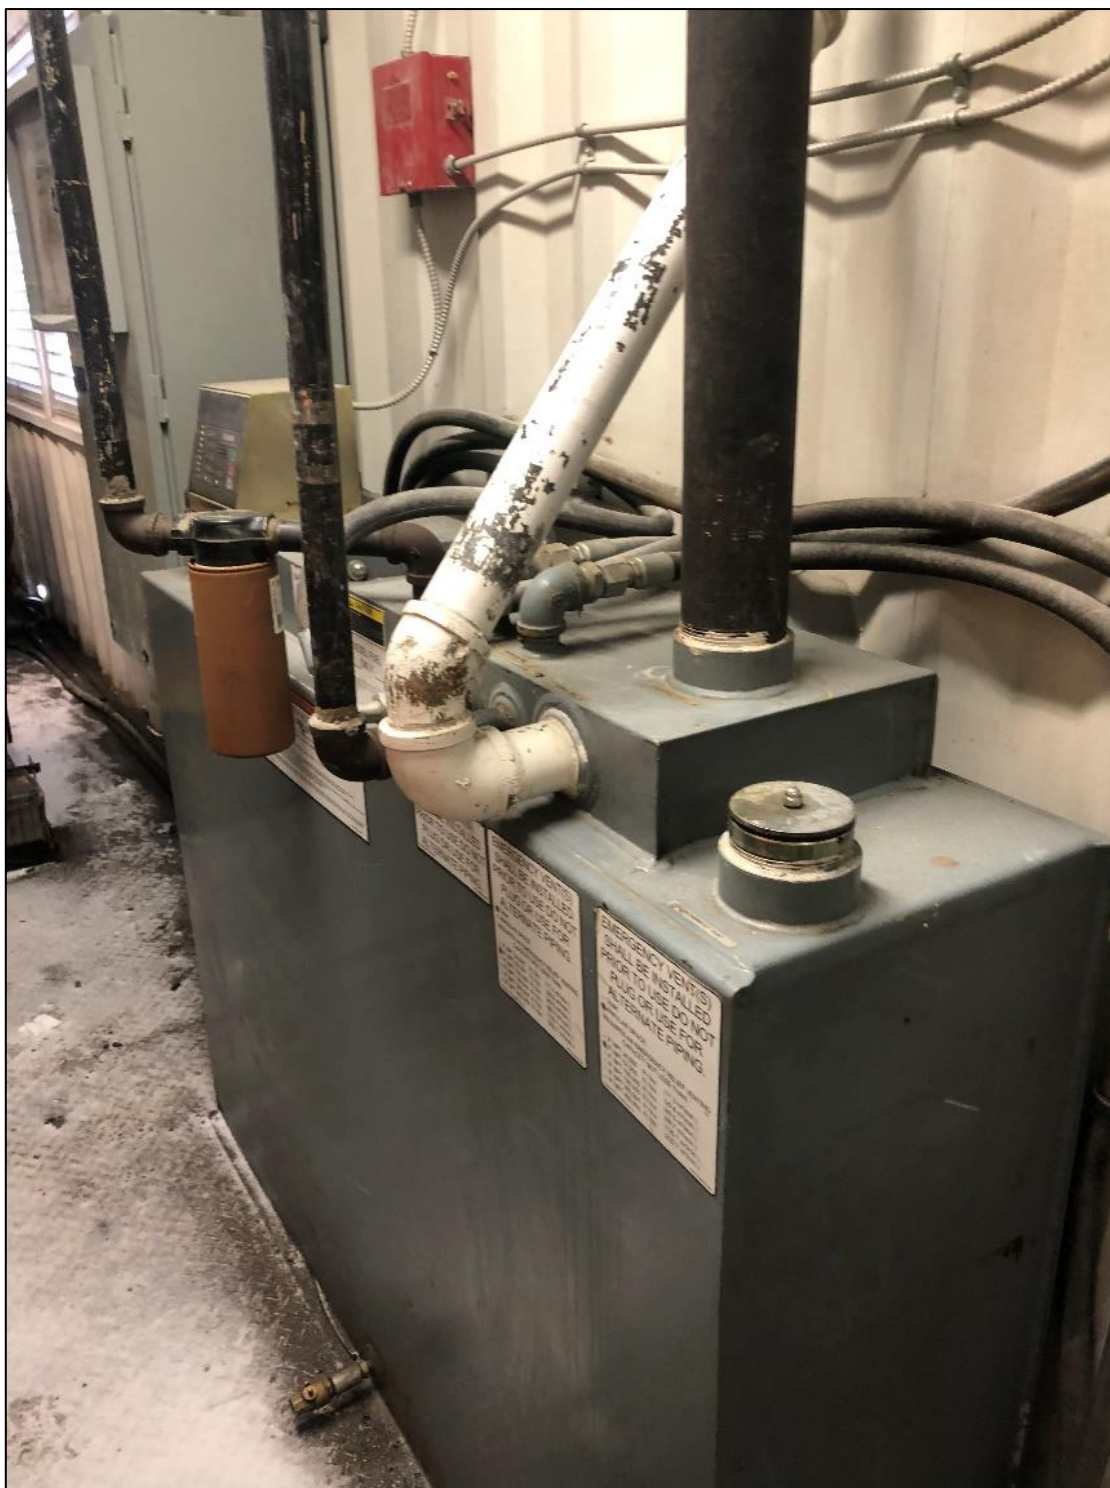
Figure 4. 100 gallon dyed diesel day tank within the generator Conex. The large diameter black pipe in the foreground is the vent pipe that, if installed properly with the top of the pipe at a height higher than the ‘elbow’ of the return flow line, would ensure return overflow was directed to the 12,000 gallon diesel tank via the return piping. The vent pipe had not been reinstalled at the time of the spill. Photo captured Monday, October 21, 2019.

The second physical factor contributing to the spill was that the vent pipe was not reinstalled on the day tank following the relocation of the generators on July 17th, 2019 (Figure 3). Instead, a vent pressure cap was installed directly on top of the day tank in the previous location for the vent pipe. The fuel system was then operated in a test mode to trouble shoot and solve any fuel transfer issues. As a result, the vent cap was more than 10 feet lower than what was required to mitigate an overfill condition event (Figure 1). The vent pipe was reinstalled and extended to provide spill protection on October 16th.

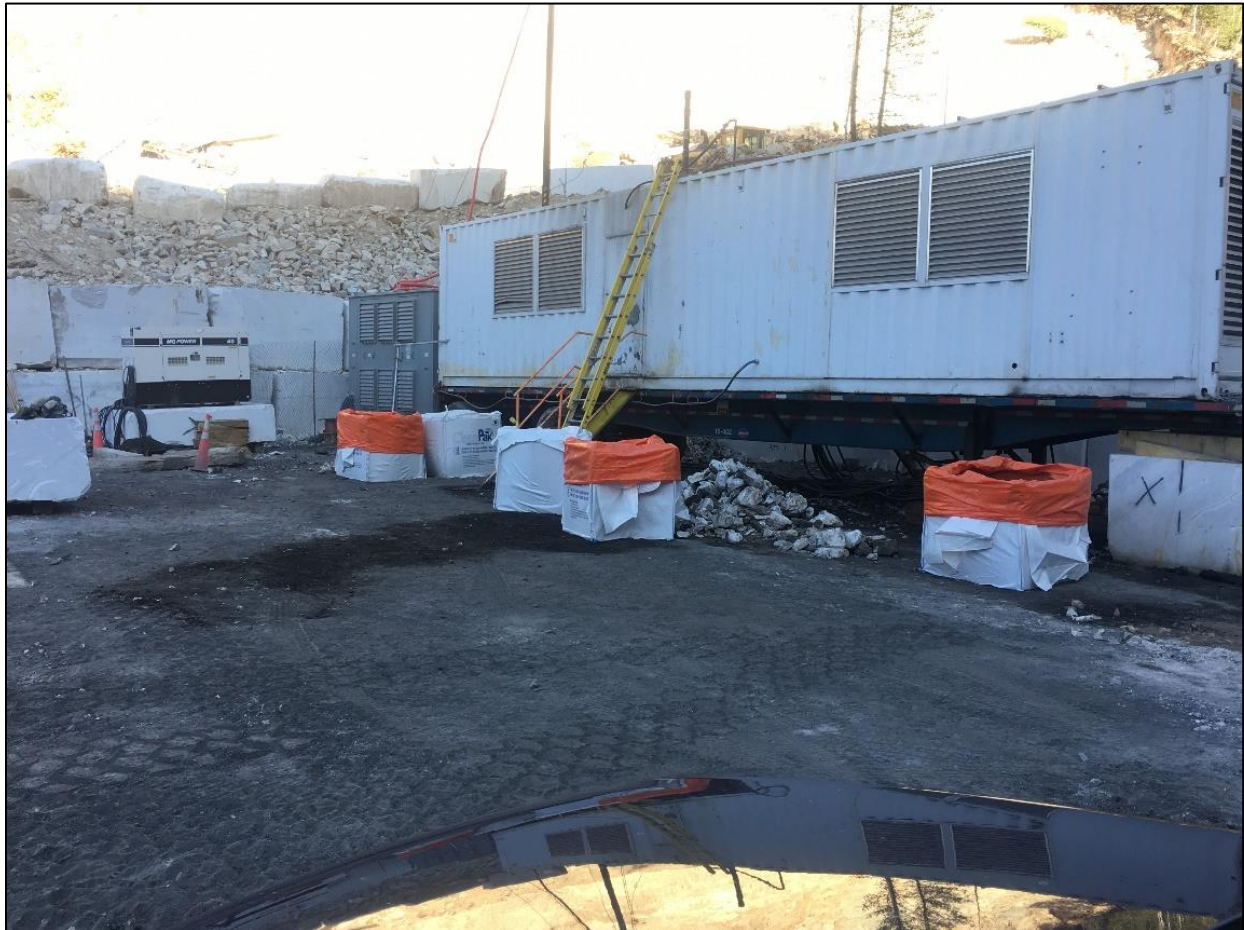
On the morning of Saturday, October 12, 2019, diesel sheen was first smelled and discovered immediately west of the generator trailer within the road alignment (Figure 5). Recent rains and typical morning dew wet the area and did not allow for full characterization of the surface spill stain. Furthermore, the fuel area footprint is dark in color and soil staining was unobservable. At the time, the spill was assumed to be minor.

Figure 5. View of diesel spill near the generator Conex and Clean Pak totes filled with contaminated soils. Photo captured Wednesday, October 16, 2019; view to the east-southeast.

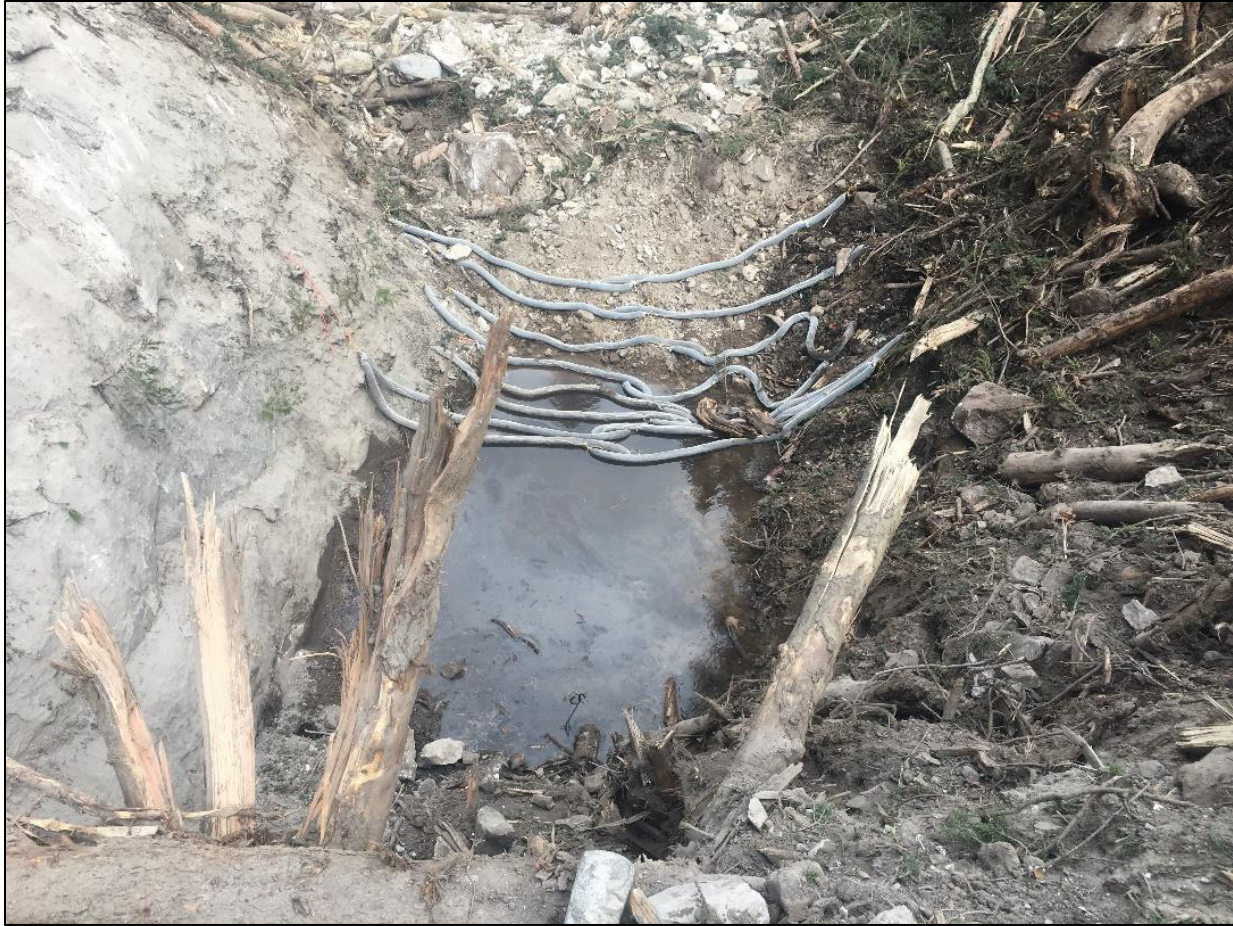
Figure 6. Image of sheen on the sump. Photo captured Wednesday, October 16, 2019; view to the northeast.

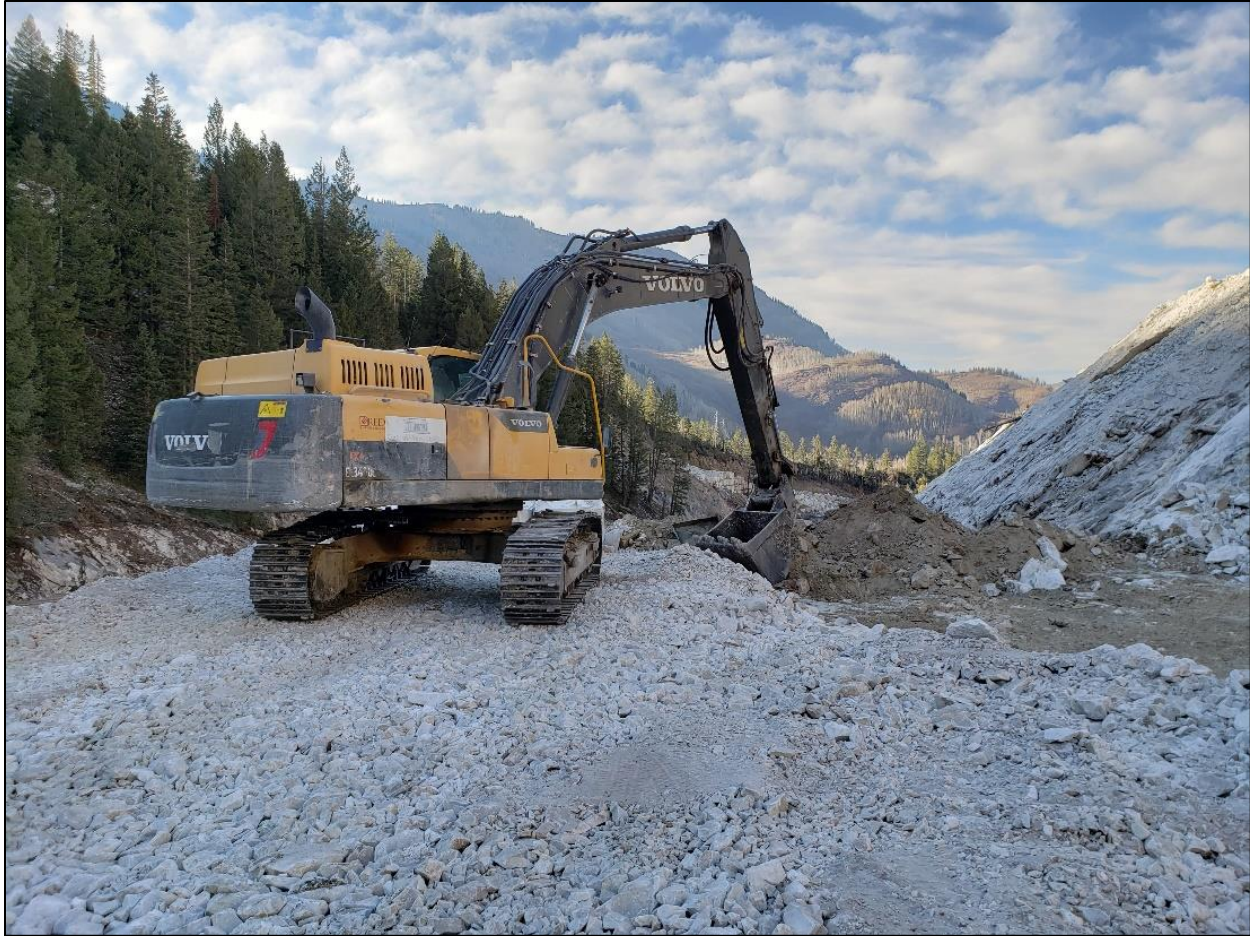
On Thursday, October 17th, an inspection hole was dug near the Franklin quarry surface opening along the marble outcrop (Figure 8). The hole was dug to the maximum depth the excavator could reach and was along the sloped marble bedrock surface. Placement was determined to visualize if dyed diesel was flowing along the fill to bedrock contact on the east side of the fill material. Excavation to the bedrock contact on the west side would have been near impossible due to constraints from blasted material and due to the dip of bedding. No stained soils or other evidence of diesel was observed during this digging exercise. CSQ operators began preparing clean-up activities at the sump.

Figure 8. View of excavation along the west side of the Franklin ridge to characterize spill depth and contamination. Photo captured October 17, 2019; view to the north-northwest.

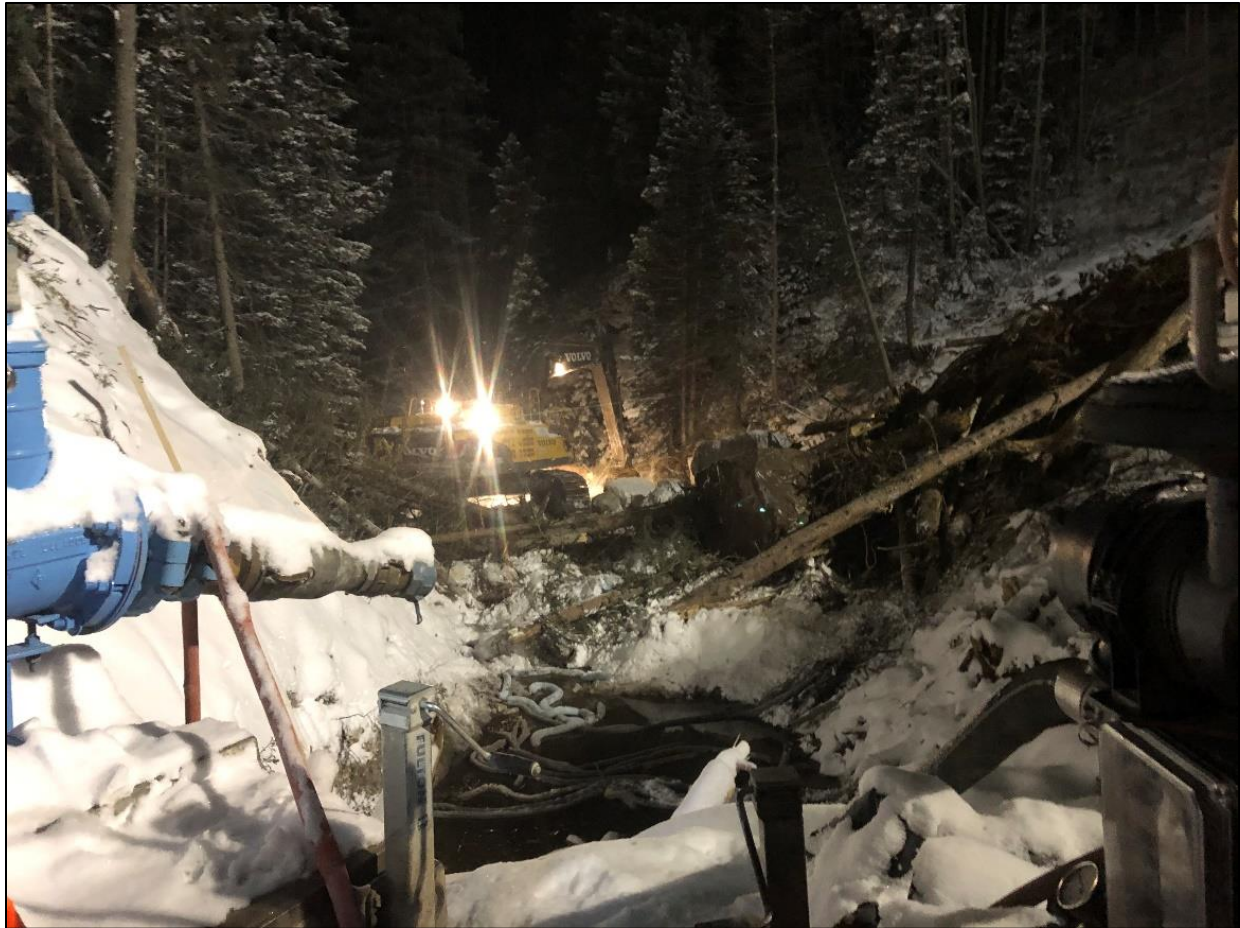
Figure 16. Emergency night work to fortify and build up the berm along the northern edge of the sump. Photo captured from the pump pad on October 29, 2019; view to the northeast.

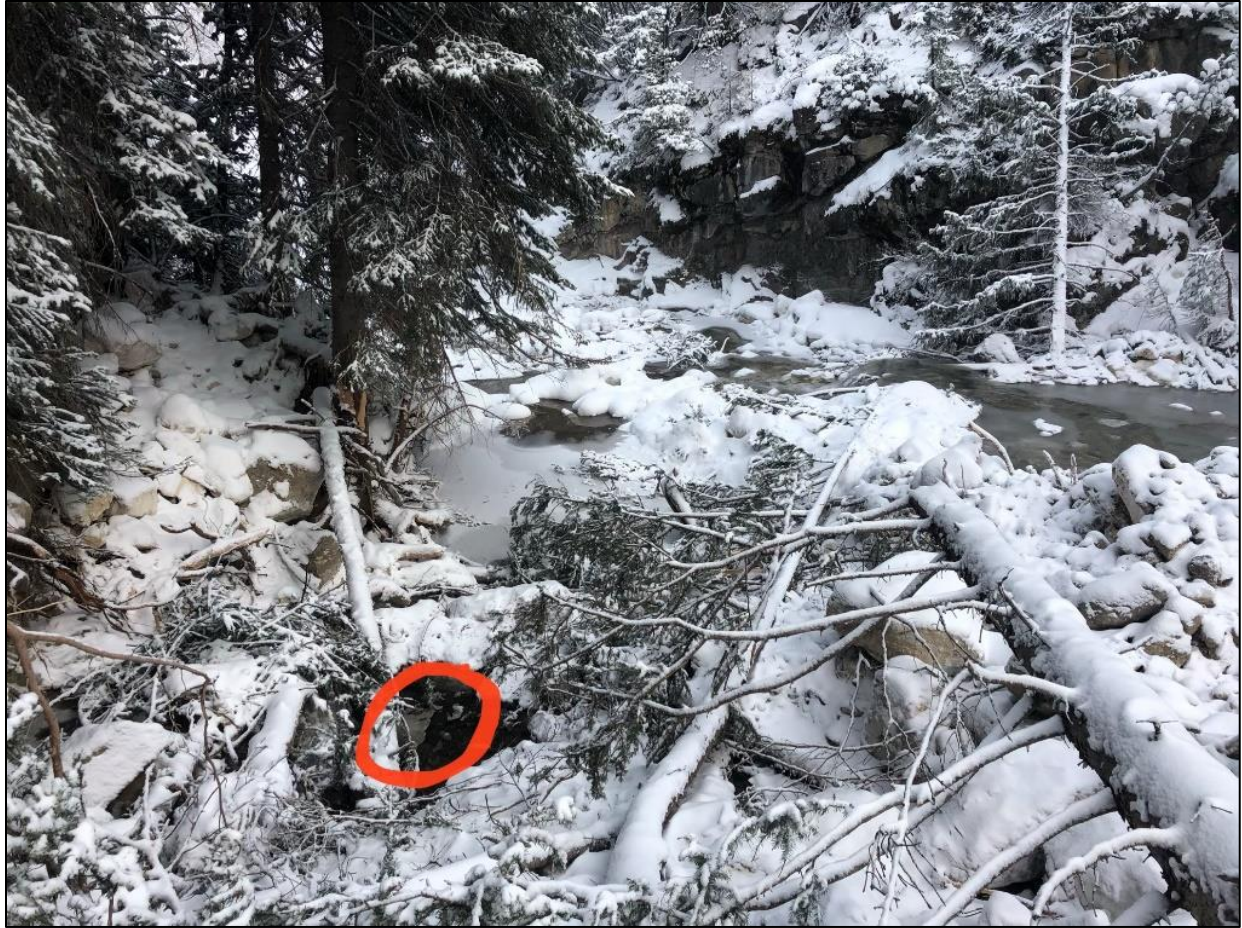
Figure 17. Location of strong diesel odor and visible sheen within ponds that outlet into Yule Creek. Photo captured October 30, 2019; view to the north.

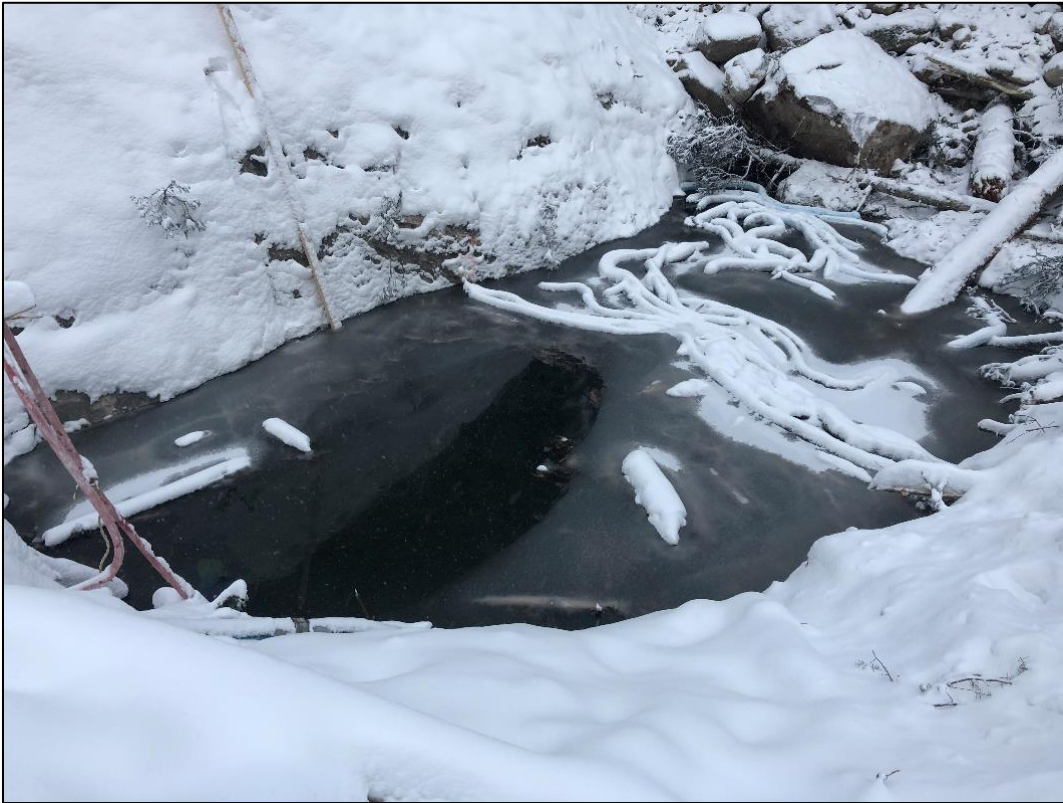
Figure 18. View of the sump at its elevated height of 6 feet following the termination of full-time pumping. Diesel laden surface water was captured within the berm while clean water was allowed to infiltrate through the lower levels of the berm. Photo captured October 30, 2019; view to the north.

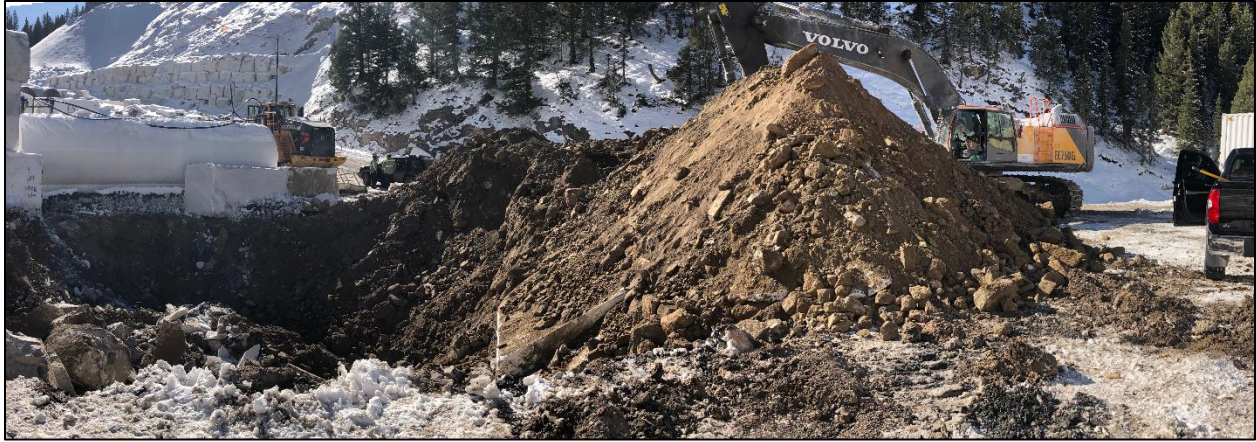
Figure 21. Contaminated soil stockpile to be removed pending approval from South Canyon landfill. Photo taken November 1, 2019; panoramic view to the west and south-southwest.

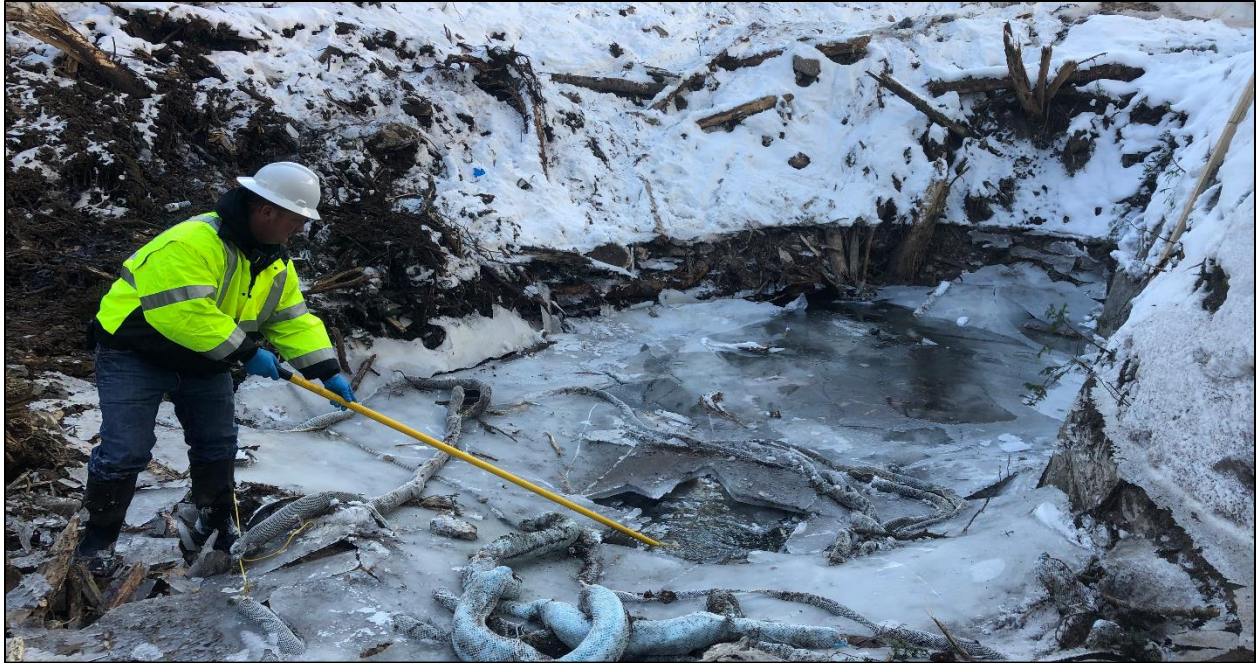
Figure 22. Water sampling the sump at post pumping levels of around 3 feet; notice the cracked ice at the height of the sump at its previous 6 foot level. Photo captured November 1, 2019; view to the west-southwest.

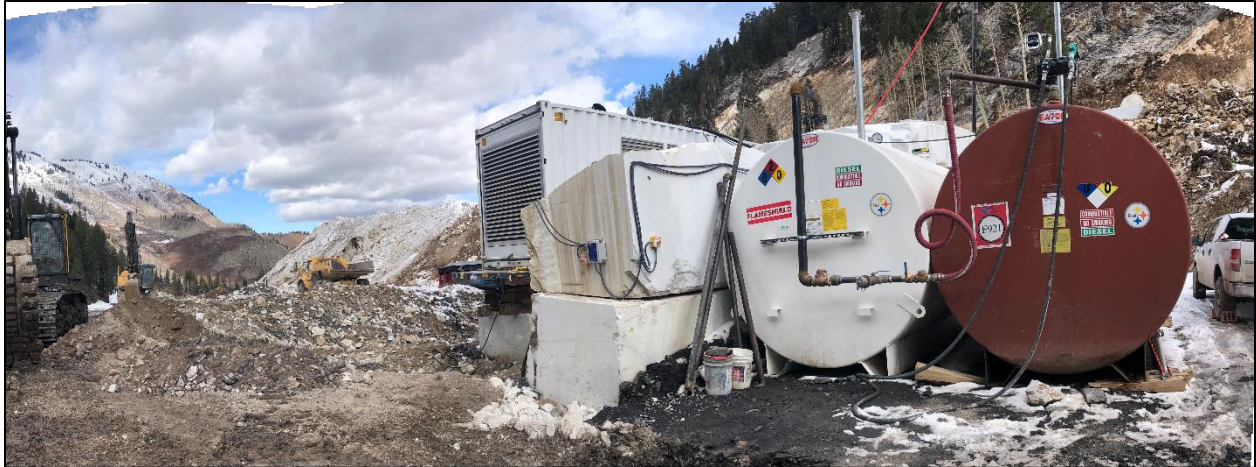
While all the tanks in issue are either double walled or within a metal secondary containment structure, certain transfer points were not (Figure 25). Also, as noted above, the primary vent pipe had not been reinstalled at the time of the spill. Although the top of the now reinstalled vent pipe is at an elevation higher than the ‘elbow’ of the return piping, the transfer points – the return piping system – still needed secondary containment. CSQ, based on advice from of GLA and later direction from DRMS, installed a liner beneath the entire fueling and generator area.

Figure 25. Panoramic photo of the fuel tanks adjacent to the generator Conex. The red tank is used to fuel heavy equipment while the white 12,000 gallon tank feeds the 100 gallon day tank within the generator Conex. While both tanks are double walled, none of the transfer points for either tank or the equipment in the generator Conex are in secondary containment. Photo captured October 23, 2019; view to the north and northeast.

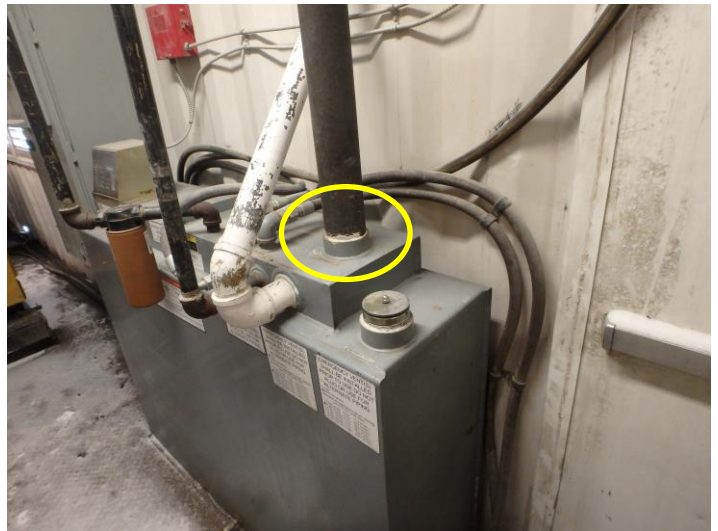
Figure 4: Fuel tank with pump located inside generator unit. Vent was initially installed without the extension pipe causing the system to fail
