RE: State Pit; DRMS File No. M-1990-112; Inaccurate Annual Reports

MINERALS PROGRAM INSPECTION REPORT

MINE NAME: State Pit	MINE/PROSPECTING ID#: M-1990-112	MINERAL: Gravel	COUNTY: Pueblo
INSPECTION TYPE: Monitoring	INSPECTOR(S): Elliott R. Russell	INSP. DATE: February 28, 2018	INSP. TIME: 09:00
OPERATOR: Fremont Paving & Redi-Mix, Inc.	OPERATOR REPRESENTATIVE: Jodi Schrieber	TYPE OF OPERATION: 112c - Construction Regular Operation

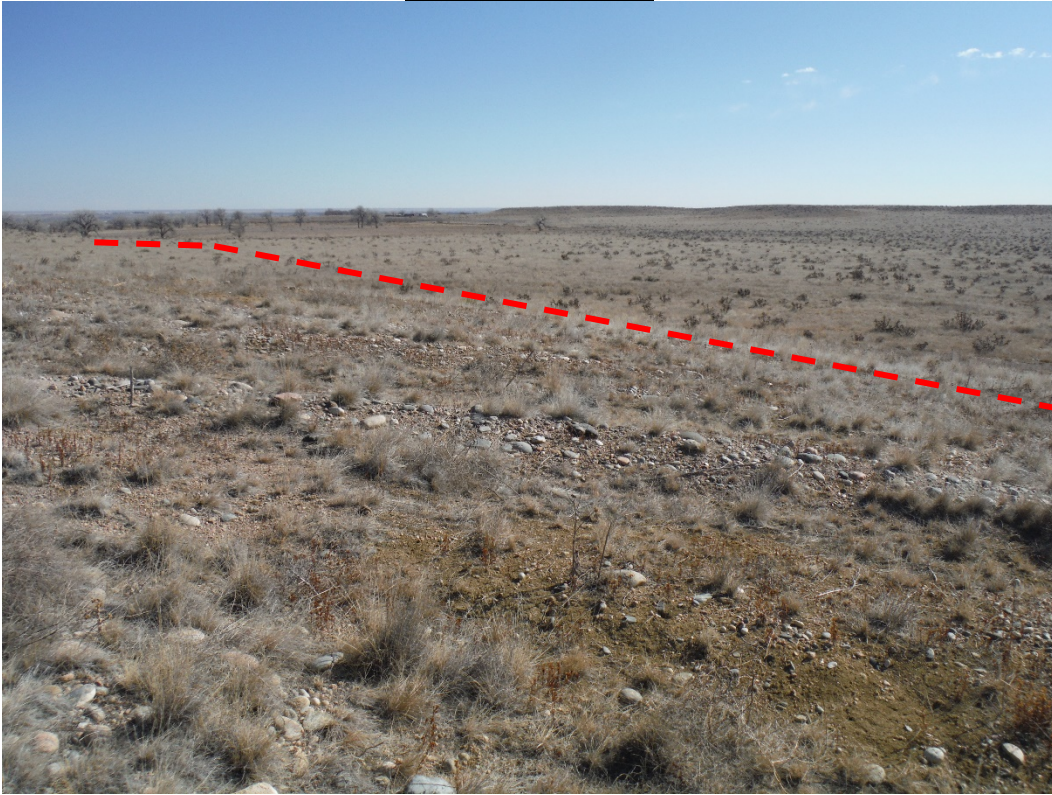
- B. Mining outside of the boundary: Ms. Kern indicated the northeast portion of the disturbance could be outside of the boundary. The northern portion of the permit was mined by previous Operators until roughly 2004. This area is in final reclamation and the Operator has stated no further mining will re-disturb this area as the operation is now advancing to the south. The Division inspected the northeast area of the permit and observed no evidence of disturbance beyond the affected lands boundary (**Photos 1 & 2**). Additionally, the Division acquired GPS data of the affected area boundary and compared that to a Google Earth aerial image to confirm all mining disturbances have remained within the affected area boundary.

Photo 1. Reclaimed disturbance in northeast portion of the site near the affected lands boundary (approximately delineated by red-dashed line); looking northeast.

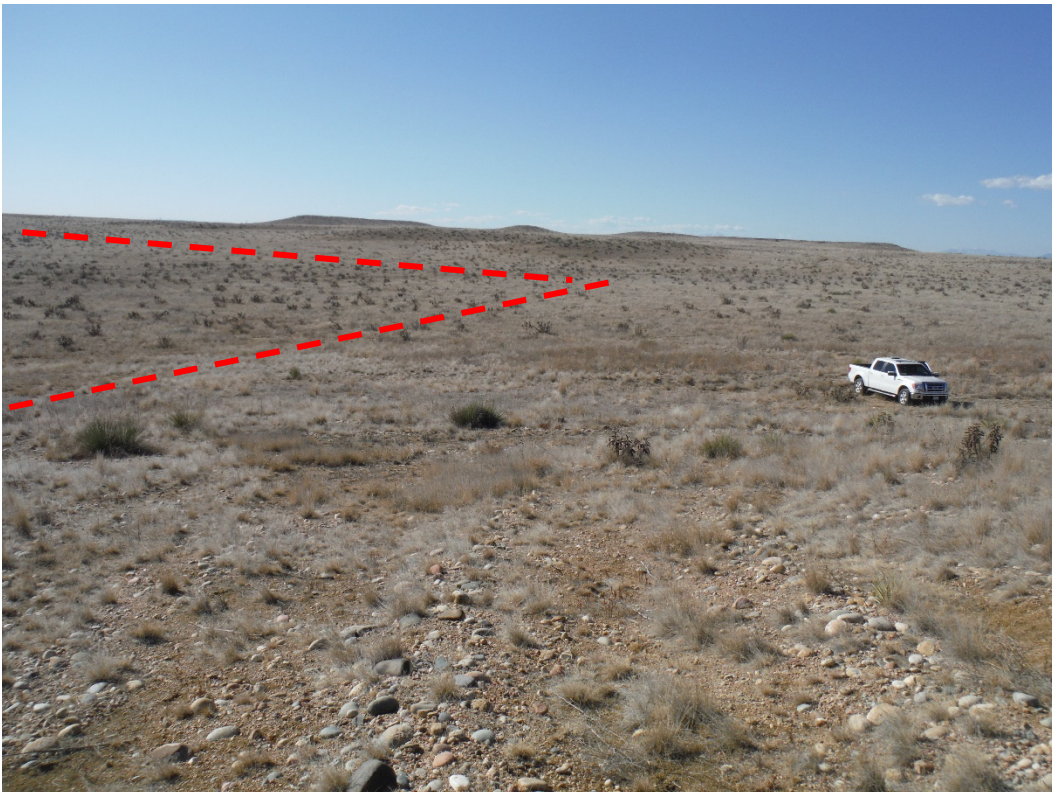
Photo 2. Reclaimed disturbance in northeast portion of the site near the affected lands boundary (approximately delineated by red-dashed line); looking southwest.

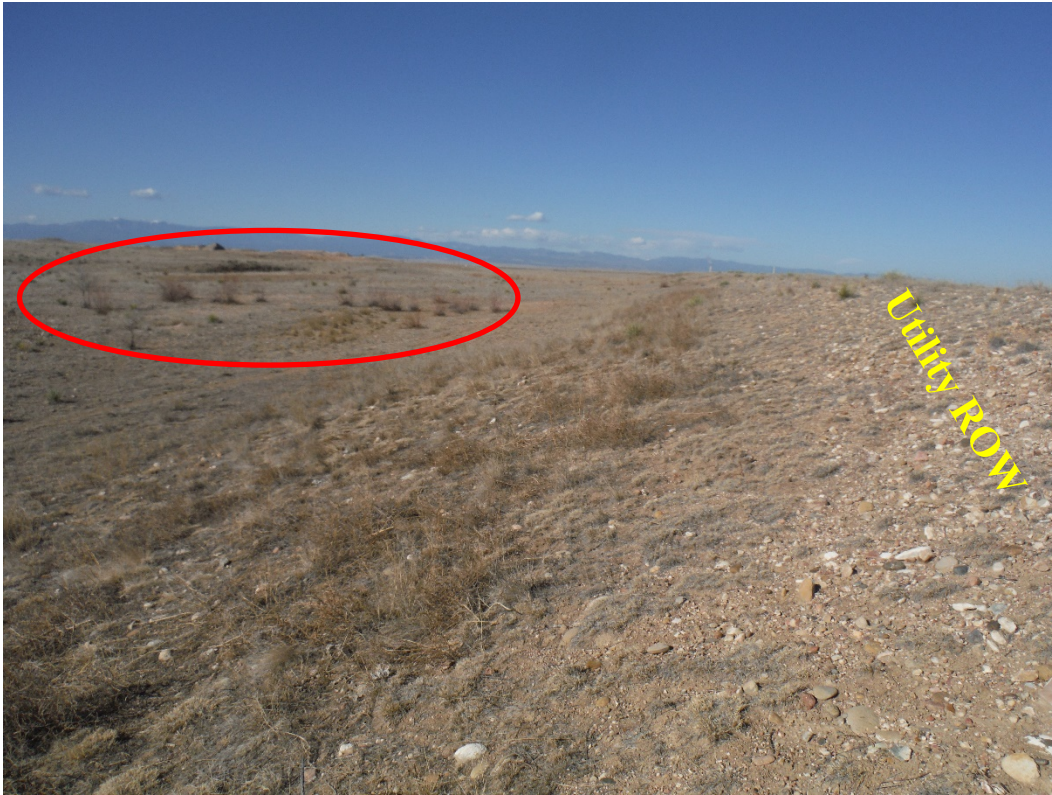
- C. Slopes near a gas utility line: The northern portion of the permit is bisected by a gas utility line. The 1990 permit application includes information regarding the established slopes leading away from the gas line. The gas utility structure owner asked the Operator to stay 50 feet away from the gas line and have a maximum gradient of 1.5H:1V. The Operator felt this was too steep to revegetate and committed to replacing the excavations near the pipeline with a slope not steeper than 3H:1V on the south facing side and not steeper than 2.5H:1V on the north facing slope. A 2013 structure agreement, executed between the Operator and gas utility structure owner, states that no mining is to occur within 50 feet of the gas line and a minimum of 4H:1V slope will be maintained as a back-slope to the existing right of way (ROW) easement "from this time forward of the current operations." The Division observed the side slopes away from the gas utility line ROW during the inspection (**Photos 3 - 6**). Based on the revegetation and time since the mining operation was near the gas line (before 2004), these slopes have not been re-disturbed since the 2013 agreement. These slopes appear stable and well vegetated and appropriately graded. The Division recommends the Operator contact the utility company to verify and document there are no issues with the slopes prior to submitting any future release requests of these areas.

Photo 3. Portion of the southern slope along gas utility line, tamarisk circled in red; looking west.

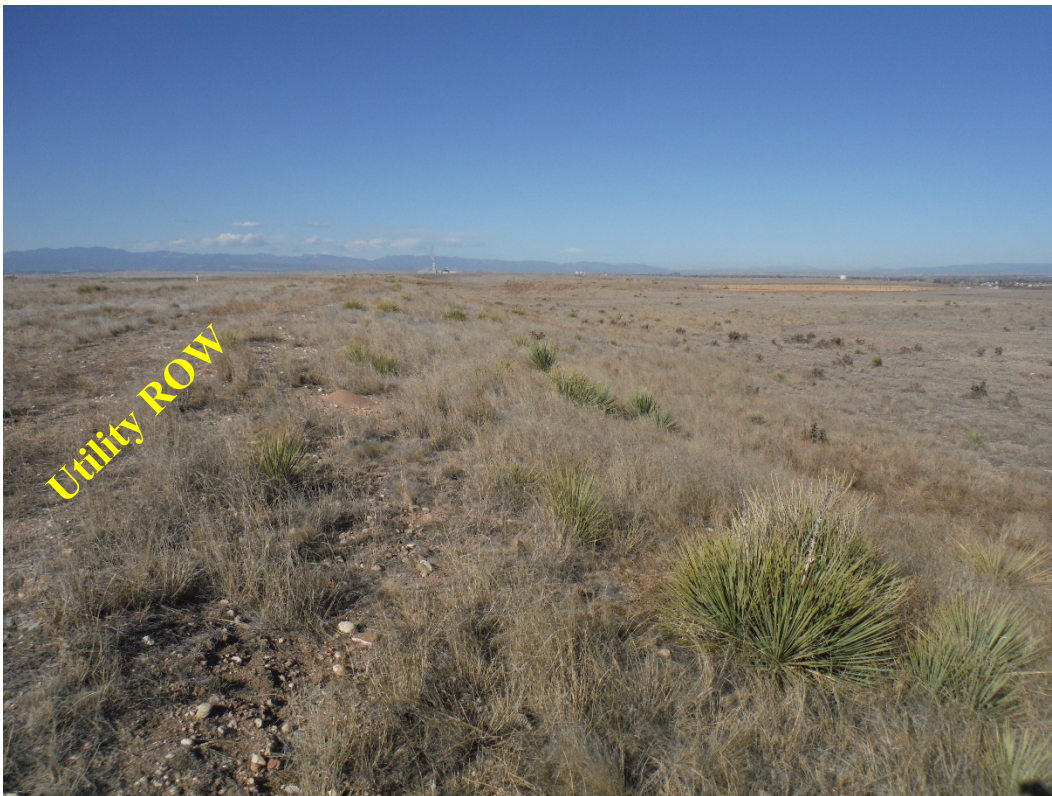
Photo 4. Portion of the northern slope along gas utility line; looking west.

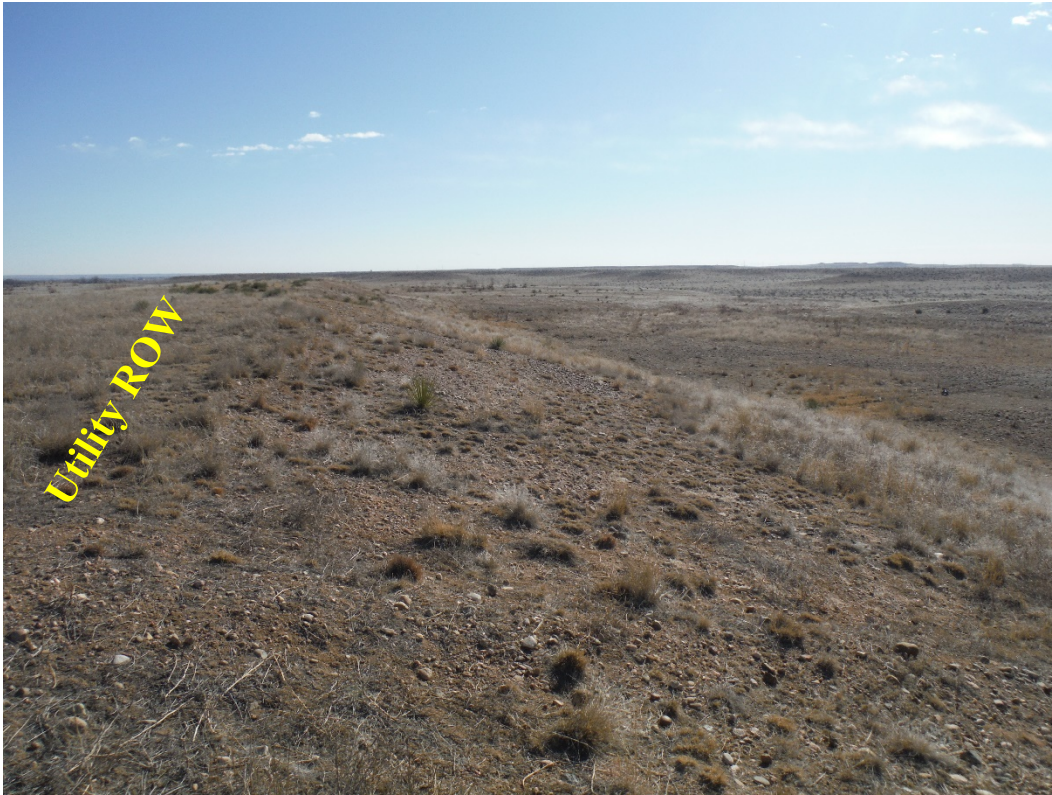
Photo 5. Portion of the southern slope along gas utility line; looking west.

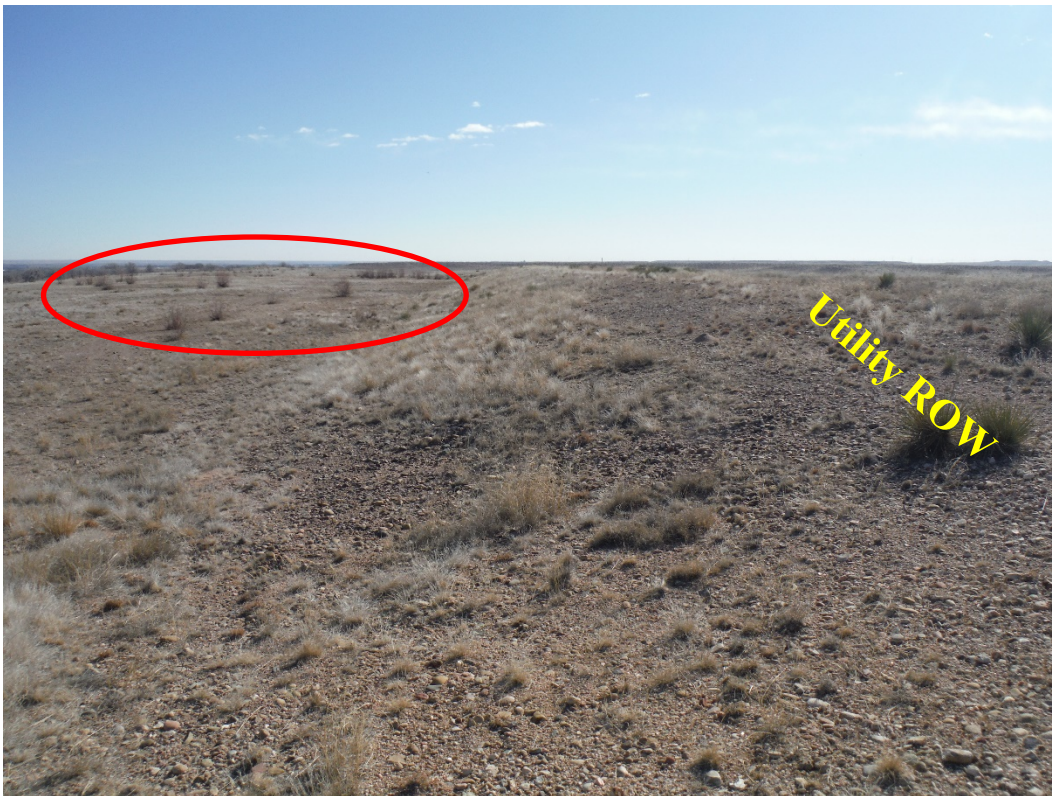
Photo 6. Portion of the northern slope along gas utility line, tamarisk circled in red; looking east.

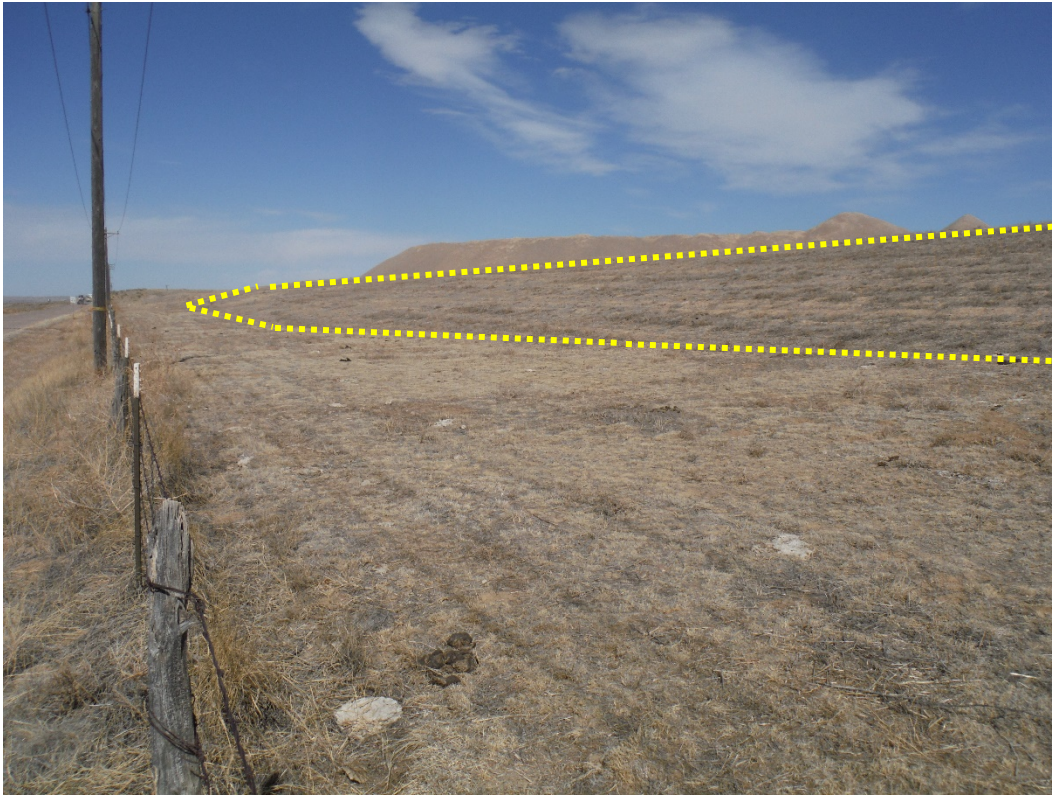
- D. Use of topsoil to build berms: The Operator has mined, backfilled, and started to reclaim portions of the affected lands along the western and southern sides of the active mining area (**Photos 7 & 8**). The Division believes these backfilled areas are the referenced berms in the complaint. The Operator stated these areas were backfilled with overburden, topsoiled, seeded, and mulched in accordance with the approved Reclamation Plan. These areas help contain storm water on the active mining and processing areas from leaving the site. It appears these also serve as a slight visual barrier of the processing area from 36th Lane. The outward slopes of this backfilled area have been seeded and mulched, but have yet to be established with vegetation.

Photo 7. Backfilled and seeded area (circled in dotted yellow) along western portion of the site; looking northeast.

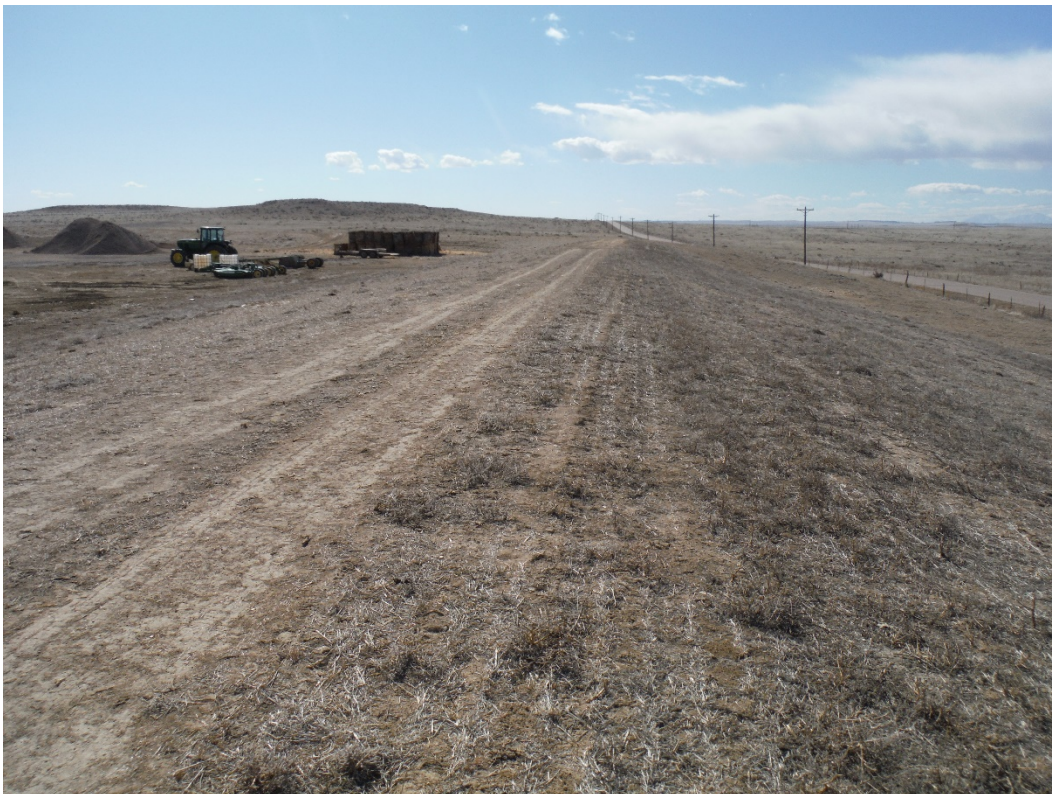
Photo 8. Backfilled and seeded area along western portion of the site; looking south from on top of the backfilled and seeded area.

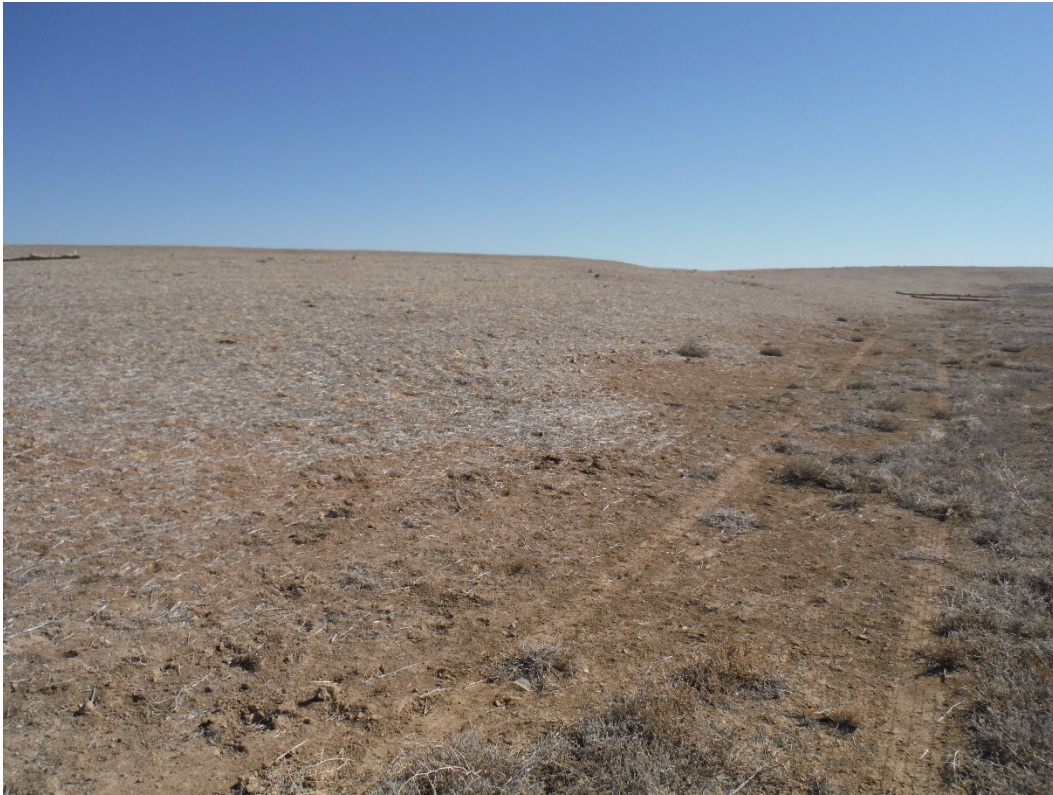
- E. Storm water controls: The approved permit references storm water would be controlled by utilizing low berms between the edge of the disturbance and undisturbed lands, however, also states the land is relatively flat and a NPDES permit is not applicable to the operation as no discharge will occur. Additionally, the

permit states contour furrows and rough grading would control erosion during reclamation. The compliant and subsequent emails from Ms. Kern describe and show storm water leaving the site near the southwest portion of the active disturbance. The outward slopes of the backfilled areas (referenced in Issue D above) directly report to undisturbed lands and a small drainage, within the permit boundary, which travels to the west under 36th Lane via a culvert (**Photos 9 & 10**). The Operator had recently installed new erosion control wattles on various portions of this outward slope as well as across the drainage. There was also an older wattle across the drainage near the permit boundary. The Operator stated a discharge permit from the Colorado Department of Public Health and Environment (CDPHE) has been obtained for the operation. The Division has determined the original permit's storm water and erosion control discussion and the methods being implemented on-site do not appear adequate. The Division recommends establishing more appropriate storm water controls on these un-vegetated outward facing slopes as they currently exhibit the potential for erosion and sedimentation. Such controls could include contour ditches and berms, silt fencing, more wattles, or other Best Management Practices (BMPs). This issue has been cited as Compliance Problem #1 on page two of this report. The Operator is required to submit a Technical Revision to the permit to address improved erosion control BMPs and an updated Exhibit M regarding the discharge permit in accordance with C.R.S. 34-32.5-116(4)(j) and Rules 3.1.5(3), 6.4.7(2)(c), and 6.4.13.

Photo 9. Backfilled and seeded area in need of improved erosion control BMPs; looking east.

CORRECTIVE ACTIONS: The operator shall submit a Technical Revision, with the required \$216 revision fee, to update and clarify the current plan to control erosion and sedimentation.

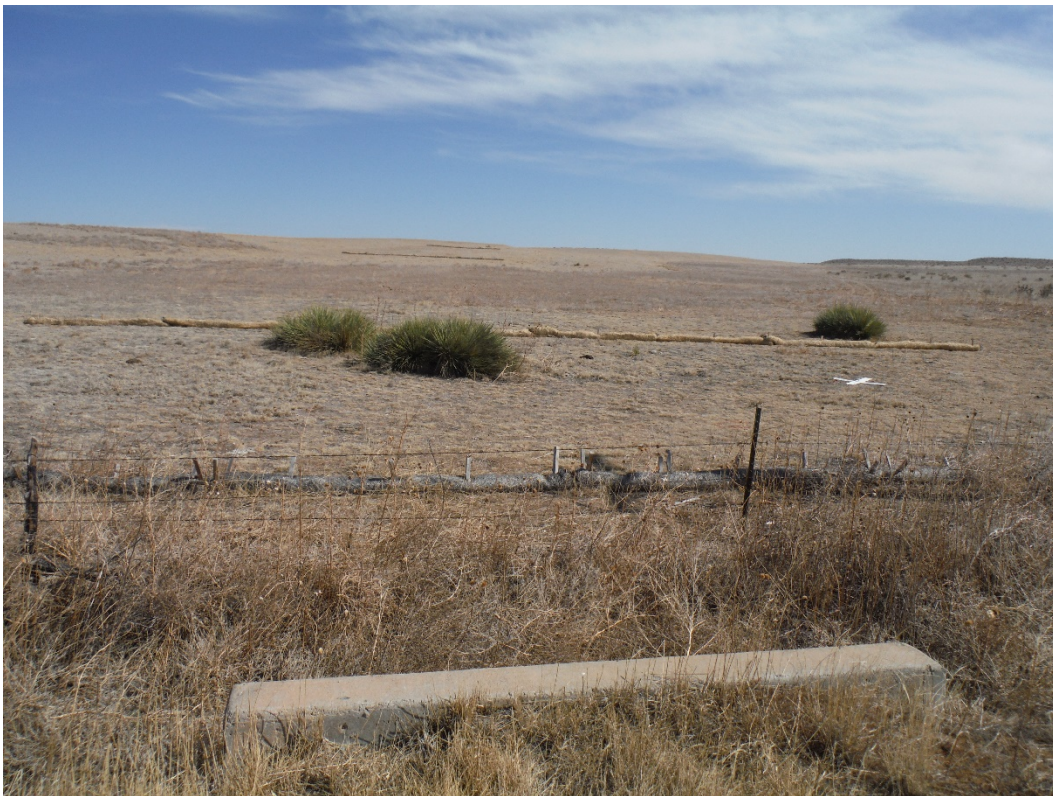
Photo 10. Drainage located to the south of the backfilled and seeded areas, 36th Lane culvert headwall in foreground; looking east.

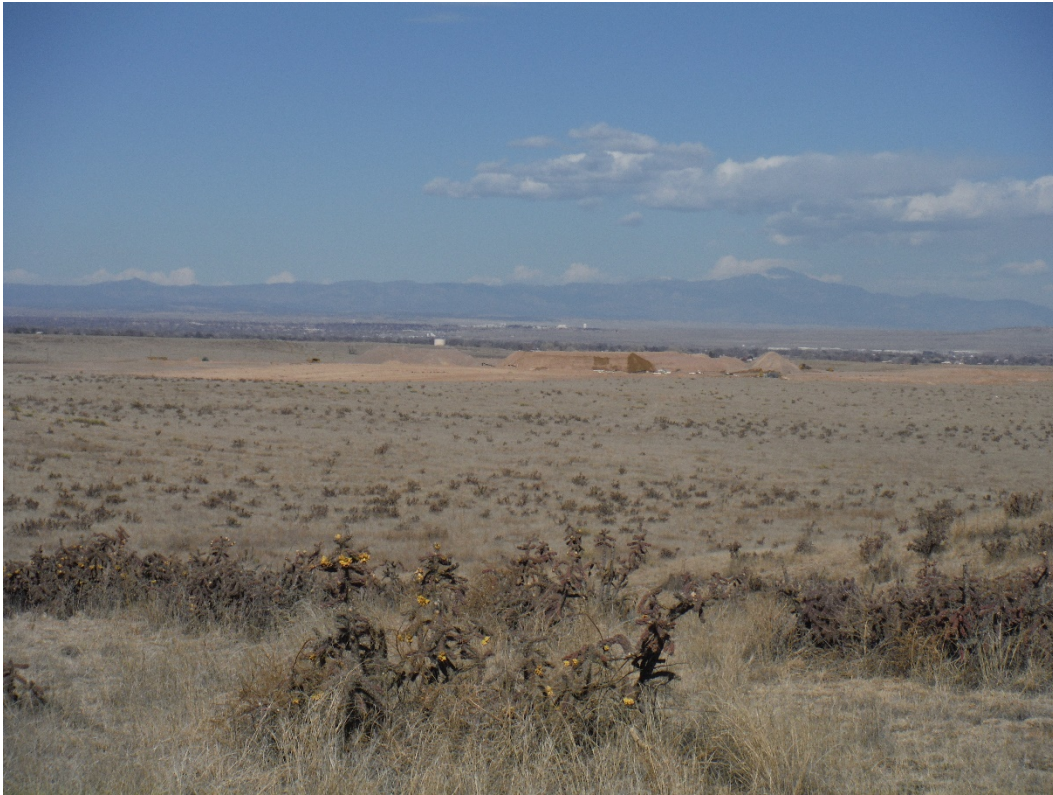
General Compliance with Mine Plan: The operation extracts gravel from eroded river terraces and processes the material with a mobile crushing and screening plant (**Photos 11 & 12**). The Operator states the operation is currently removing approximately 3-12 feet of overburden and mining approximately 15 feet of gravel. The active mining highwall is currently located along the east portion of the pit (**Photo 13**). Various product stockpiles are located around and to the west of the processing plant (**Photo 14**).

Photo 11. Active operation overview; looking northwest from the southern portion of the permit.

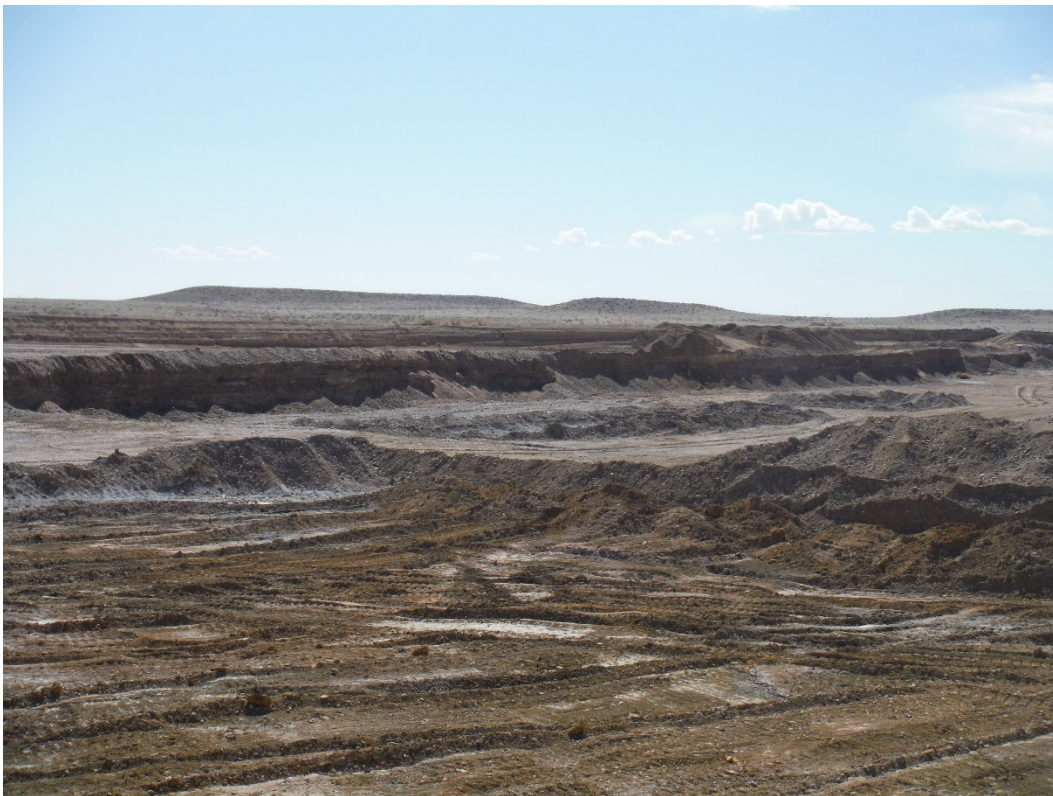
Photo 12. Active mining face along east side of the pit; looking southeast.

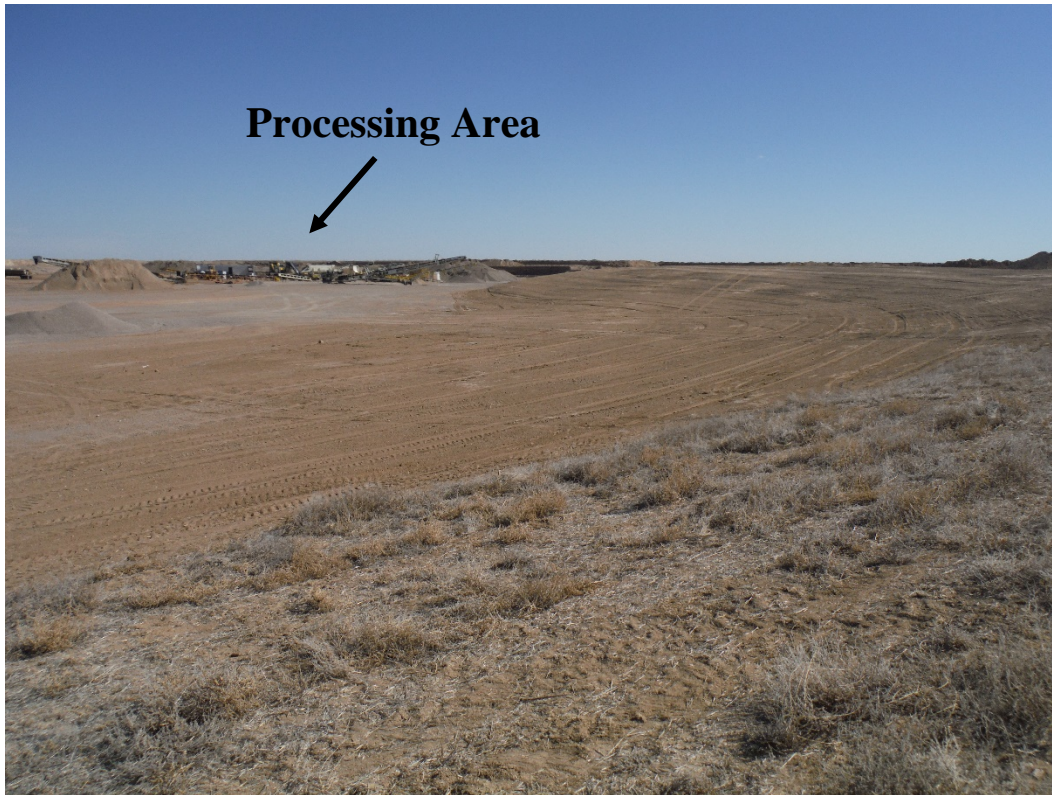
Photo 13. Inward facing slope of the backfilled area south of the active mining and processing areas; looking northeast.

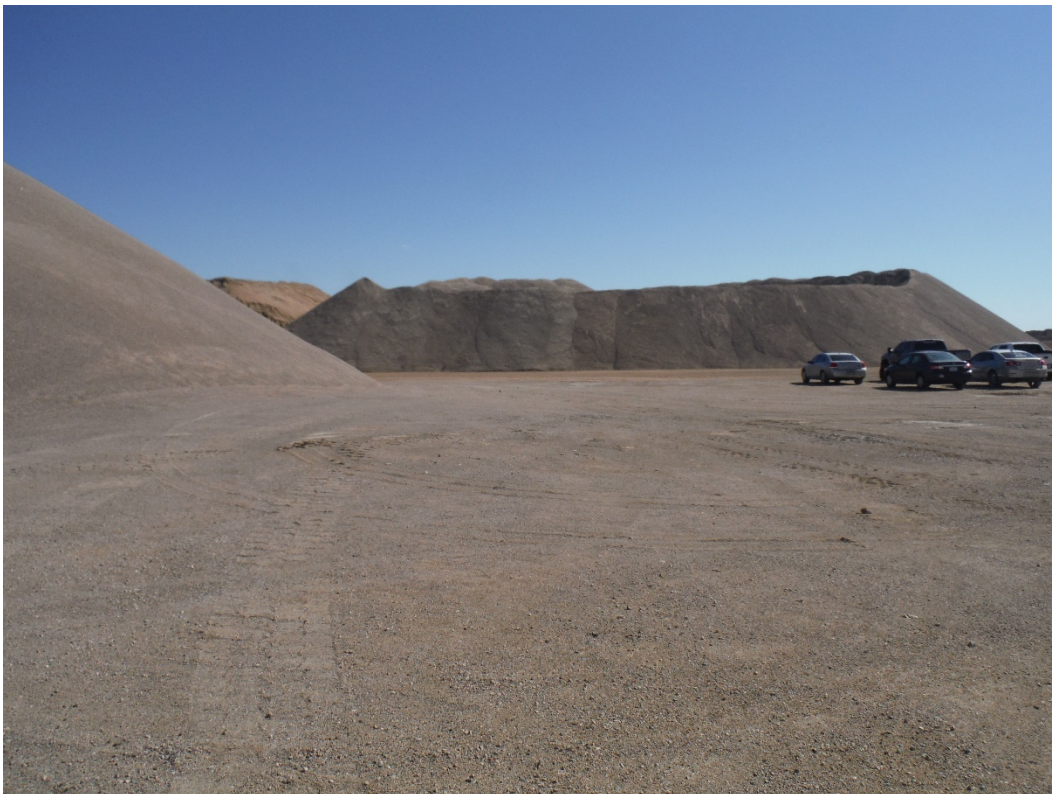
Photo 14. Various product stockpiles located west of the active pit and processing area; looking east.

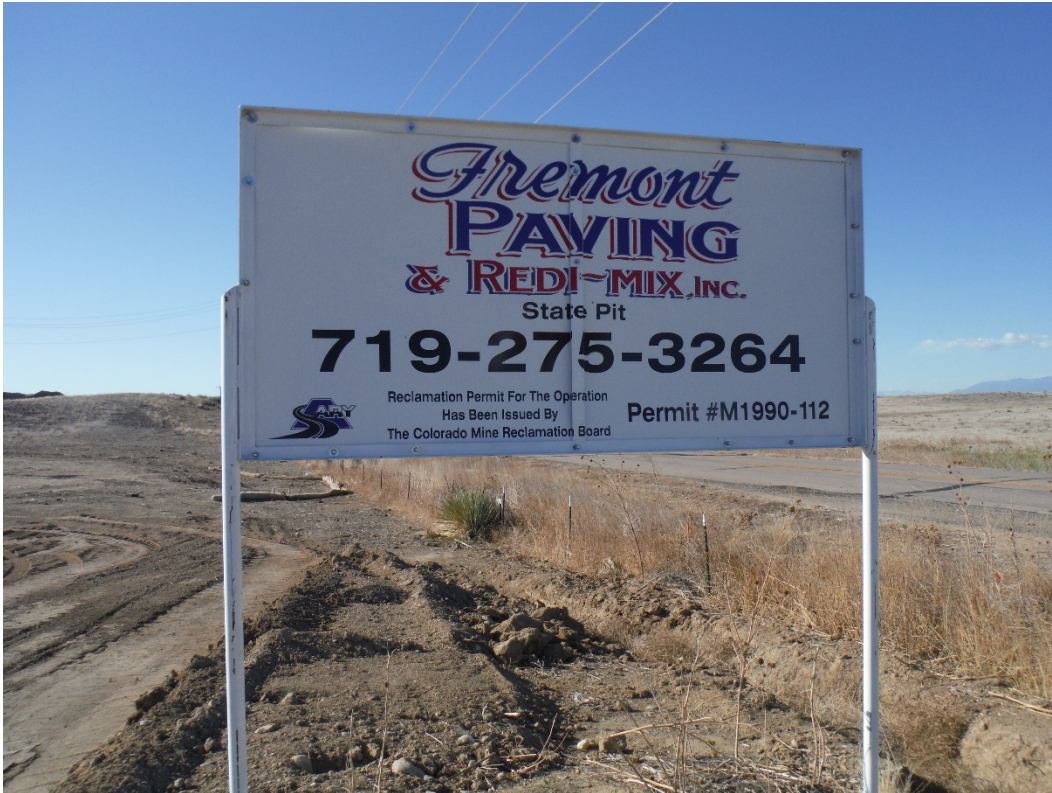
Signs and Markers: The mine identification sign was posted at the entrance of the mine site along the east side of 36th Lane (**Photo 15**). The Affected lands boundary was recently survey by the Operator and was delineated with tall PVC pipes painted with florescent green (**Photo 16**). The GPS location of these markers were recorded with a Trimble Juno 3b unit. The attached *DRMS 2-28-18 Inspection Map M1990112* delineates the GPS location of these boundary markers. The Operator stated that the original hand-drawn Mine Plan and Reclamation Plan Maps contain various errors and inaccuracies based on the total affected and permit acreages. The Division suggests the Operator submit updated Mine and Reclamation Plan Maps, in accordance with Rules 6.4.3 and 6.4.6, as a Technical Revision to the permit.

Photo 15. Permit identification sign posted at the entrance to the site along 36th Lane; looking south.

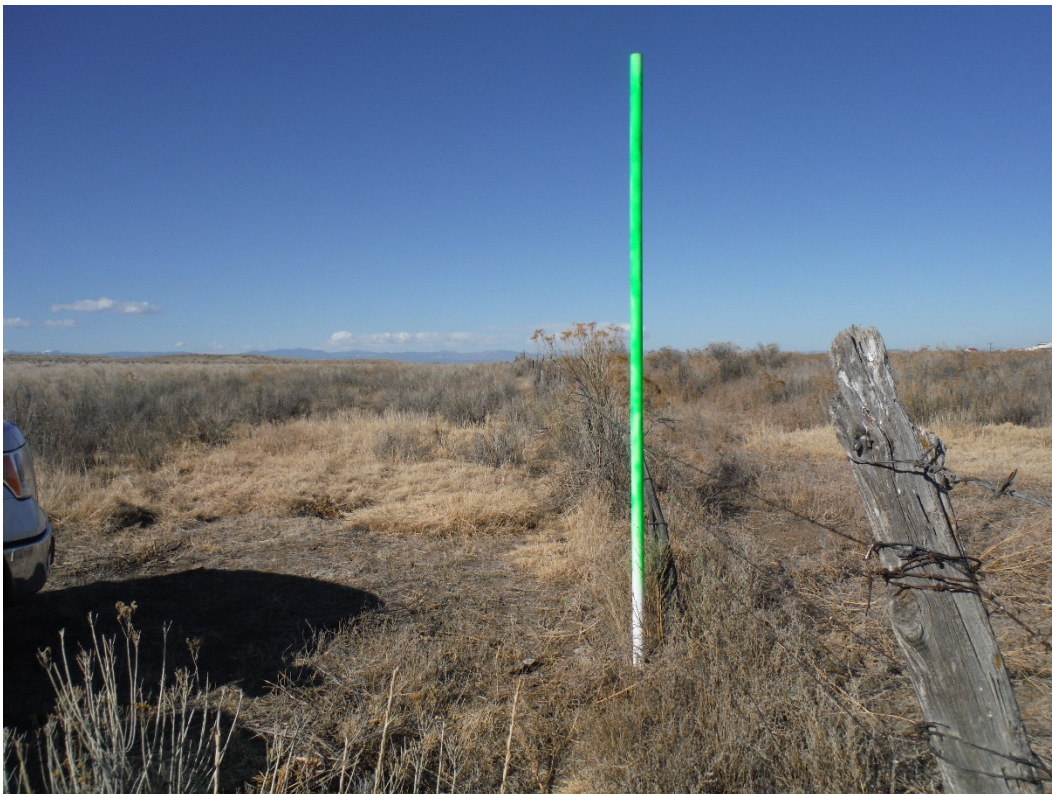
Photo 16. Sample photo of the affected area boundary markers; looking west.

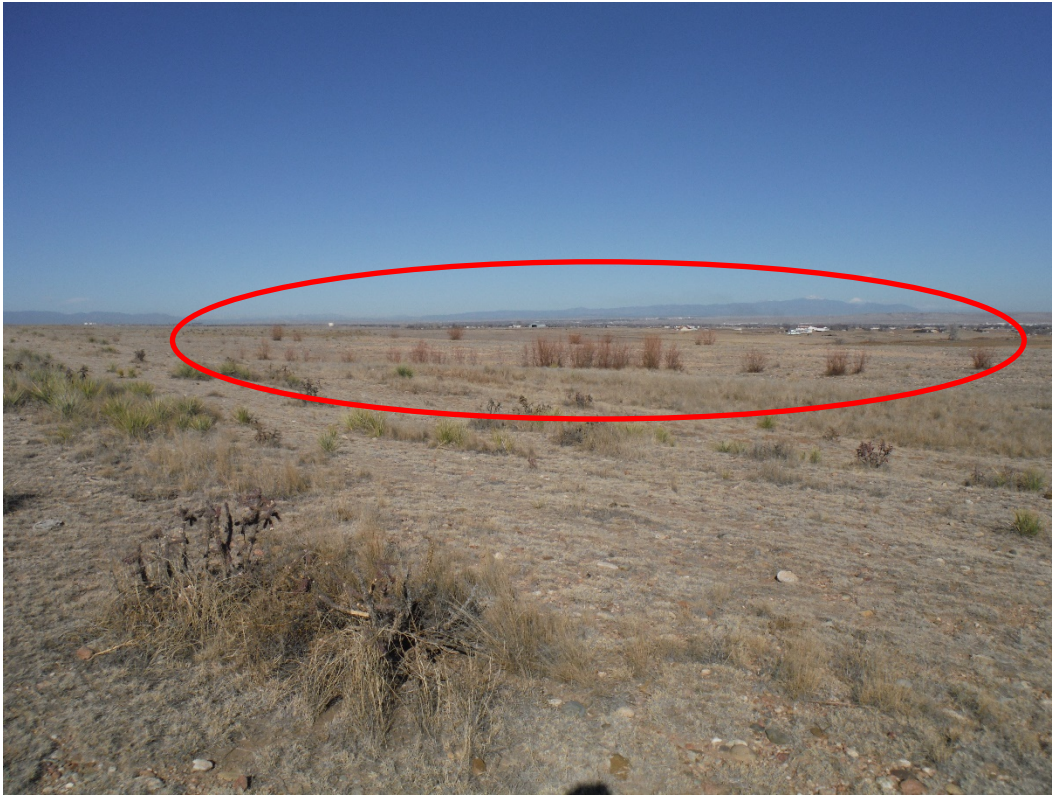
COMPLIANCE PROBLEM #3: Tamarisk (salt cedar) trees are present within or have volunteered into the permit area and are becoming established. This is a problem for failure to employ weed control methods for a state listed noxious weed species within the permitted area, and to reduce the spread of weeds to nearby areas as required by Rule 3.1.10(6). Additional details regarding this compliance problem are provided in this inspection report.

Revegetation: As discussed above, the northern portion of the site, approximately 122 acres has been mined and is in final reclamation. The southern half of this area (approximately 56 acres) has yet establish appropriate vegetative cover and may need to be re-seeded. The northern half of this area (approximately 66 acres) has vegetation established. This 66-acre area is located from the northern edge of the mining disturbance to the toe of the southern gas utility line slope as well as a section on the south side of the utility line in the northeast portion of the mining disturbance. This area could be eligible for release through an Acreage Reduction request, however, Tamarisk is starting to establish on the reclaimed lands (**Photos 3, 6, & 17**). Tamarisk is a noxious weed List B species which will need to be controlled. The current permit does not contain a weed control and management plan in accordance with Rule 3.1.10(6). This issue has been cited as Compliance Problem #3 on page two of this report. The Operator is required to submit a Technical Revision to the permit to address the control and management of Tamarisk. The Weed Control Plan shall provide the control methods, a schedule for when control measures will be applied, and a post-treatment monitoring plan. The Division recommends you contact the Pueblo County Weed Manager for assistance with this plan. The 12th edition of the Noxious Weeds of Colorado handbook by the Colorado Weed Management Association lists Bill Alt at 719-586-9768 and balt7302@gmail.com as the Pueblo County Weed Manager. Please note, a Technical Revision to the Weed Control Plan will be required if the Operator intends to modify this plan in the future to include new treatment methods and time tables for other noxious weed species. The Division recommends the Operator develop specific management plans for several common noxious weed species that occur in the area of the State Pit and submit those with the required Weed Control Plan, as this will avoid having to submit future Technical Revision(s) for any new species. The Pueblo County Weed Manager should be able to assist you in determining which noxious weed species are likely to occur within the area of the State Pit and provide you with the management plans for those species.

Photo 17. Tamarisk infestation (circled in red) in northern portion of the site; looking northwest.

CORRECTIVE ACTIONS: The operator shall develop a weed control and management plan in accordance with Rule 3.1.10(6). This plan should be developed in consultation with the county extension agency, or weed control district office and should include specific control measures to be applied, a schedule for when control measures will be applied and a post-treatment monitoring plan. This weed control plan shall be submitted to the Division as a Technical Revision to the permit with the appropriate Technical Revision fee of \$216.00 by the corrective action date.
