**RE: Colowyo Coal Mine  
Permit No. C-1981-019  
Fill Monitoring Certifications  
Fourth Quarter 2019**

### South Taylor Fill Inspection Certification

**INSPECTION REPORT ~ SOUTH TAYLOR FILL**  
(Including Both the East Taylor and West Taylor Fill Segments)

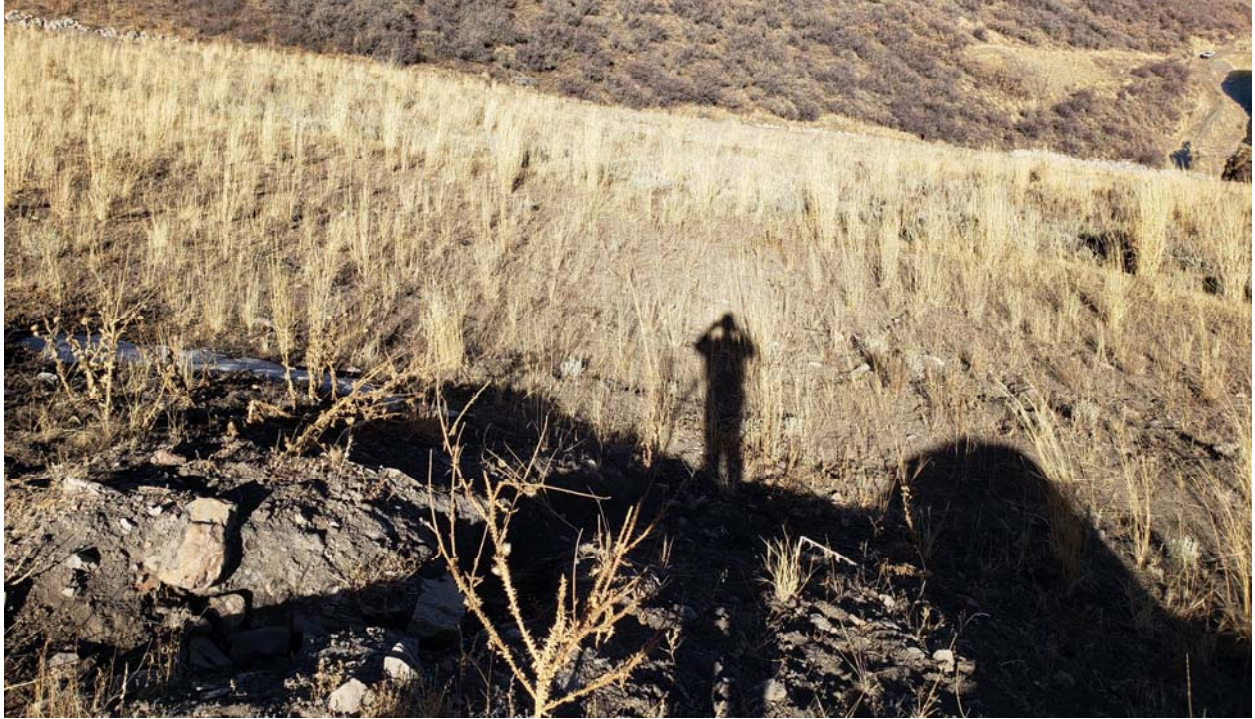
11-19-19 - West Taylor fill looking northwest from monitoring well location

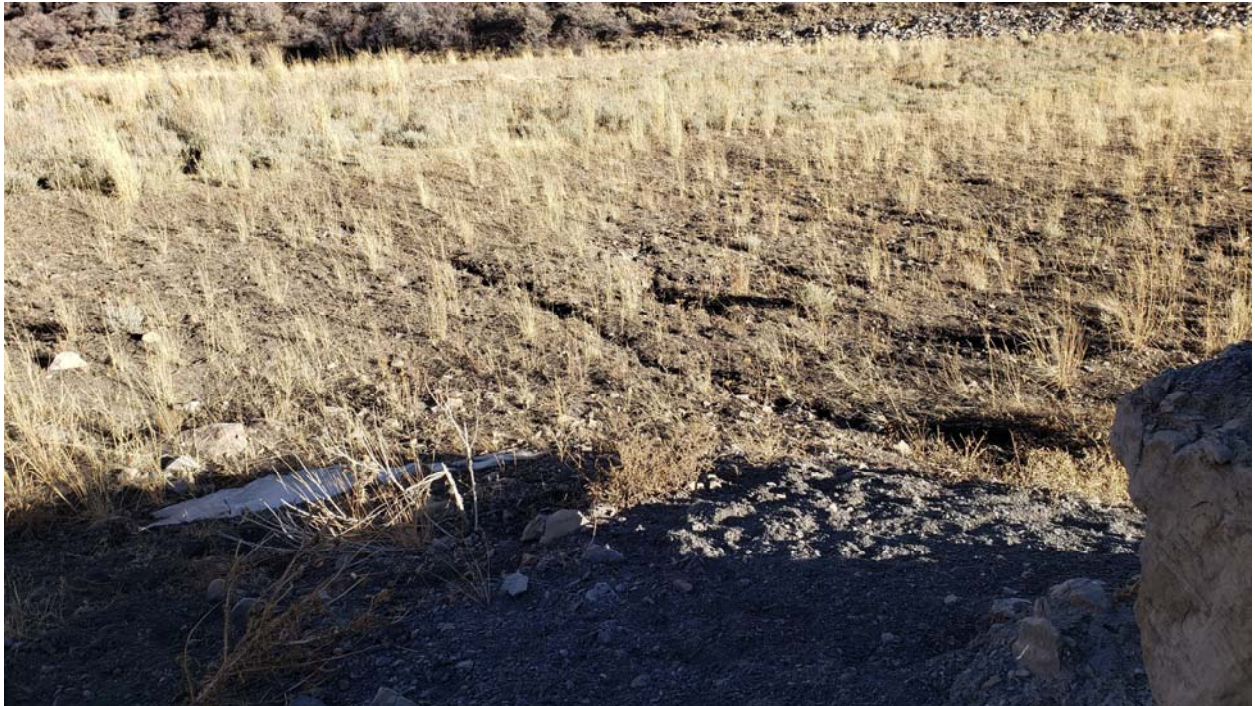
11-19-19 - West Taylor fill looking northeast from monitoring well location

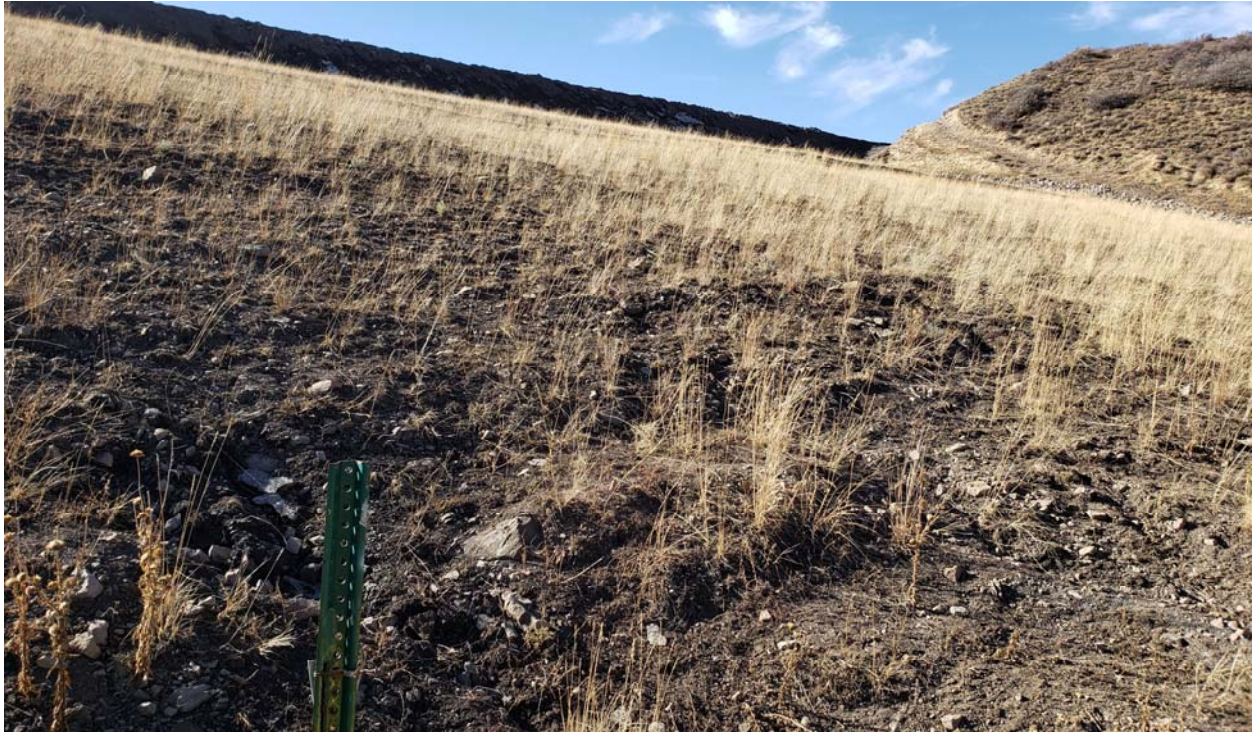
11-19-19 - West Taylor Fill West Flank from monitoring well location

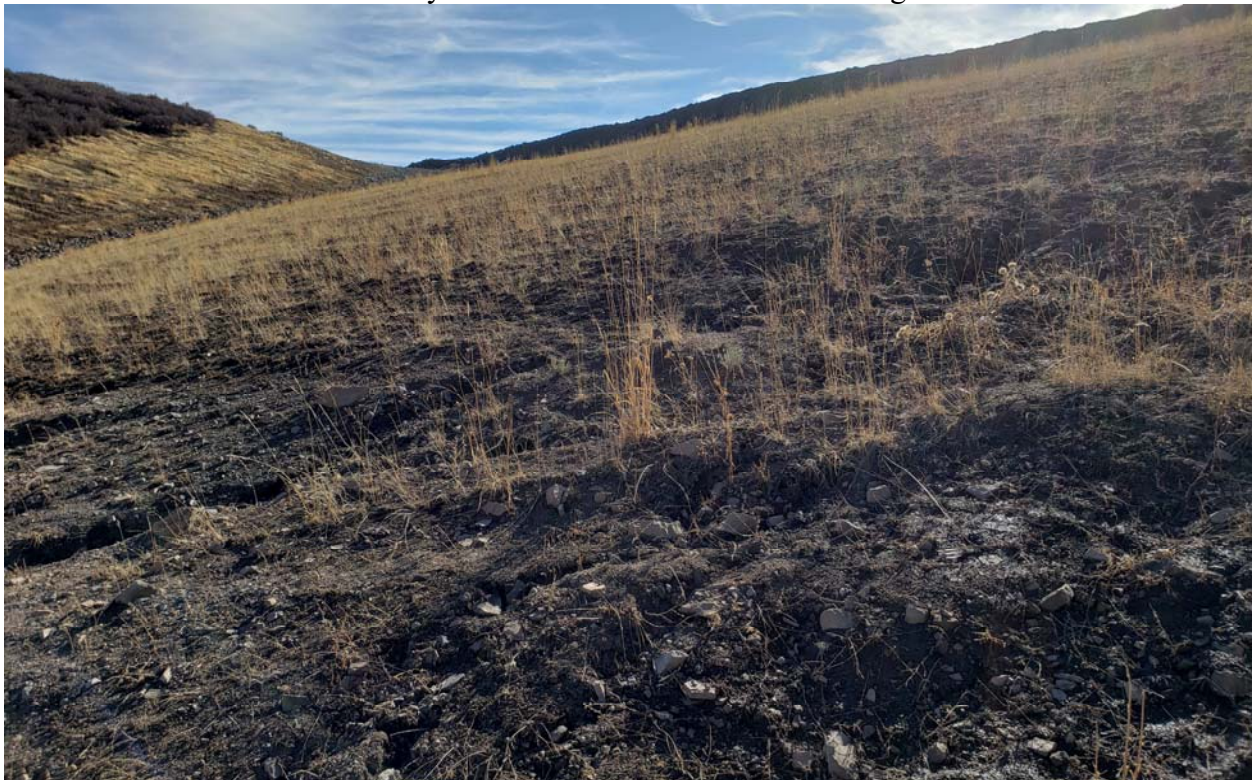
11-19-19 - West Taylor Fill East Flank from monitoring well location

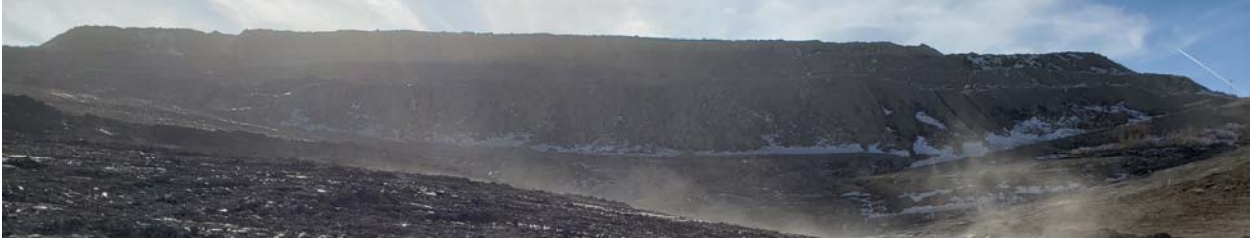
**East Taylor Fill with C-C' Underdrain Area:** No activity other than rock crusher operations have taken place within the East Taylor fill during this quarter. Reclamation activity has been ongoing this quarter below the East Taylor fill. The toe of the fill is being trimmed at angle of repose on the west end and buttressed slightly on the east end. All water is directed away from the fill and into the West Pit.

No structural weakness, signs of instability, or other hazards were noted at the time of inspection.

11-19-19 - East Taylor Fill looking south from the West Pit reclaimed area
