**MINERALS PROGRAM INSPECTION REPORT**  
**PHONE: (303) 866-3567**

<b>MINE NAME:</b> Silver Cliff Pit	<b>MINE/PROSPECTING ID#:</b> M-2011-015	<b>MINERAL:</b> Borrow material for	<b>COUNTY:</b> Custer
<b>INSPECTION TYPE:</b> Monitoring	<b>INSPECTOR(S):</b> Timothy Cazier	<b>INSP. DATE:</b> June 19, 2019	<b>INSP. TIME:</b> 12:15
<b>OPERATOR:</b> Seifert Enterprises, LLC	<b>OPERATOR REPRESENTATIVE:</b> Kent Beach	<b>TYPE OF OPERATION:</b> 112c - Construction Regular Operation	
<b>REASON FOR INSPECTION:</b> Normal I&E Program	<b>BOND CALCULATION TYPE:</b> Partial Bond	<b>BOND AMOUNT:</b> \$130,243.60	
<b>DATE OF COMPLAINT:</b> NA	<b>POST INSP. CONTACTS:</b> None	<b>JOINT INSP. AGENCY:</b> None	
<b>WEATHER:</b> Cloudy	<b>INSPECTOR'S SIGNATURE:</b>

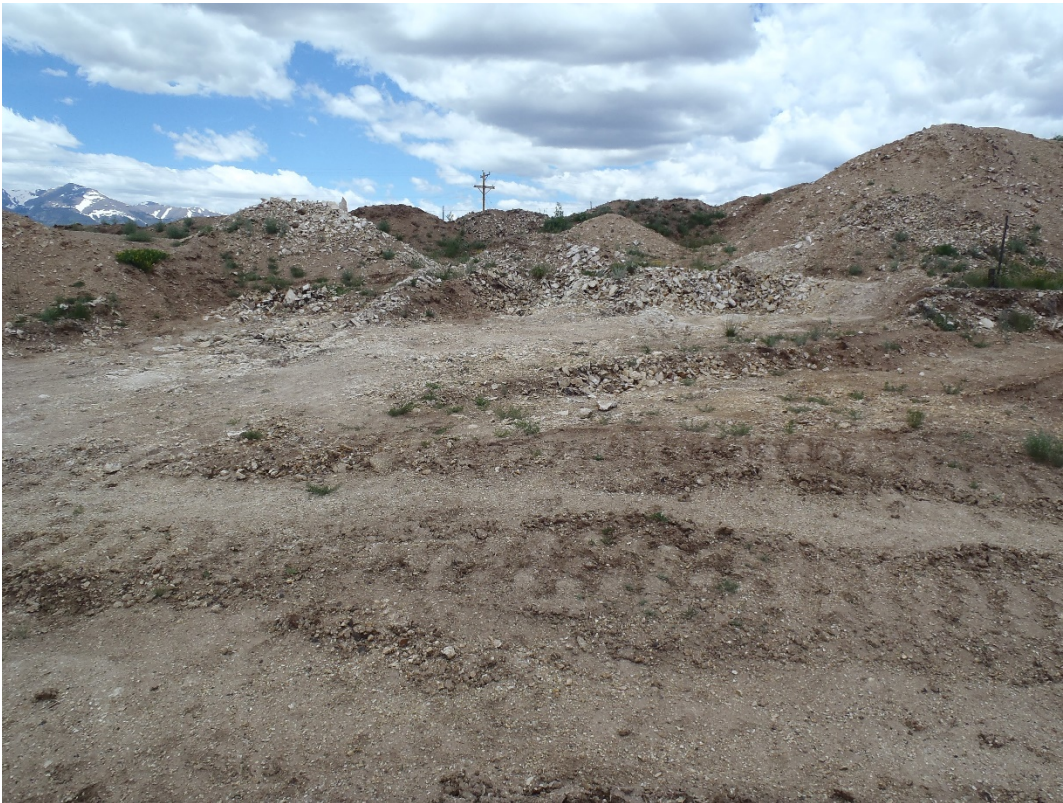
Excess Spoil and Dev. Waste: Overburden piles were observed (see **Photo 1**).

Photo 1. Overburden stockpiles (looking north from pit).

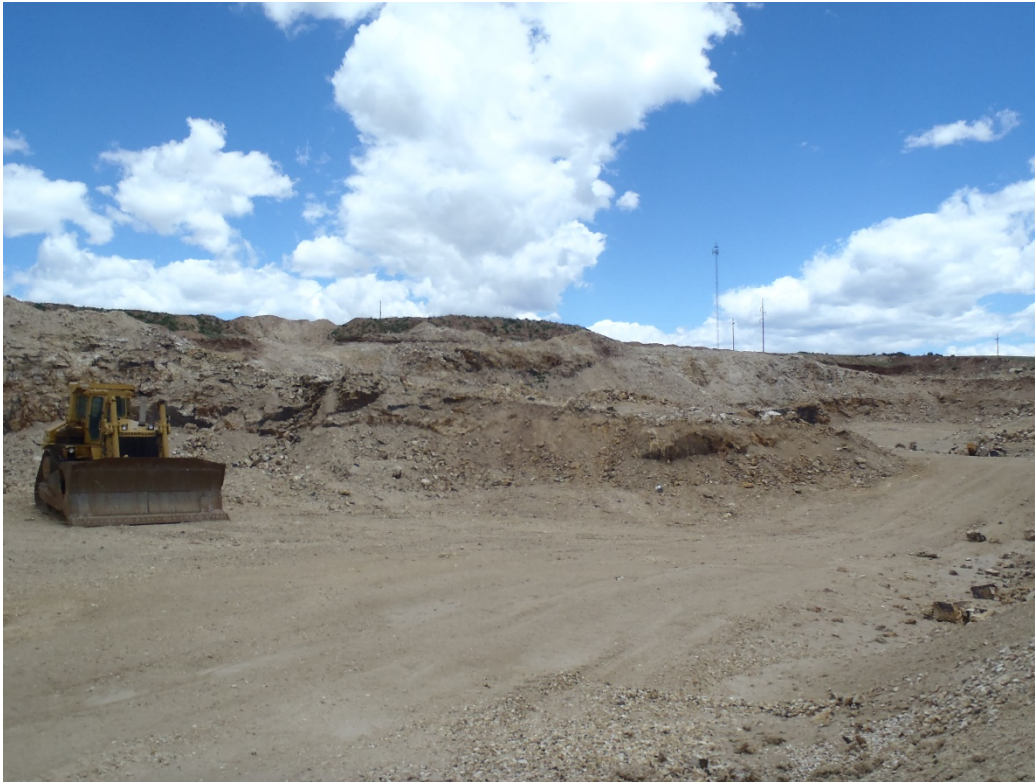
Gen. Compliance with Mine Plan: The operation appeared to be in compliance with the approved mine plan. The maximum allowed disturbed area is 37 acres (based on Exhibit L of the original application). Google Earth was used to measure the disturbed area, which was estimated to be approximately 7.5 acres, based on 2016 imagery. Highwalls were benched at an estimated 12 feet (see **Photo 2**).

Photo 2. Benched highwalls (looking NE from west side of pit).

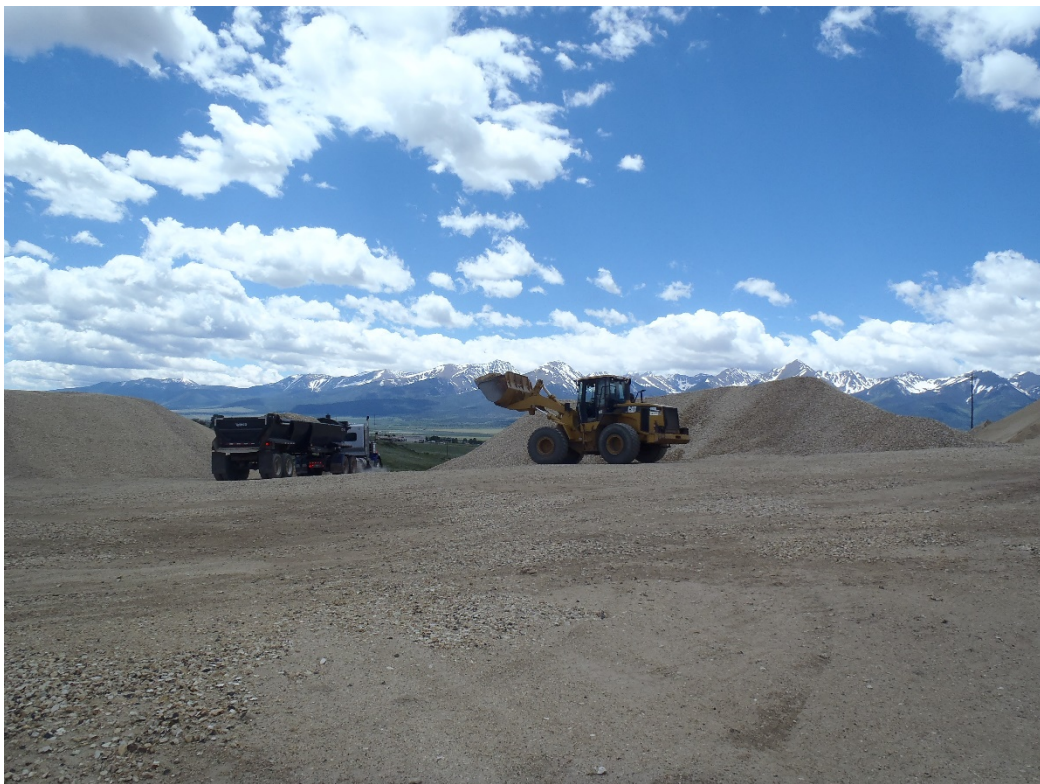
Support Facilities On-site: A loader, several trucks and a dozer were observed on site (see **Photo 3**). Several large product stockpiles were also observed.

Photo 3. Loader fill one of several haul trucks observed (looking SW).

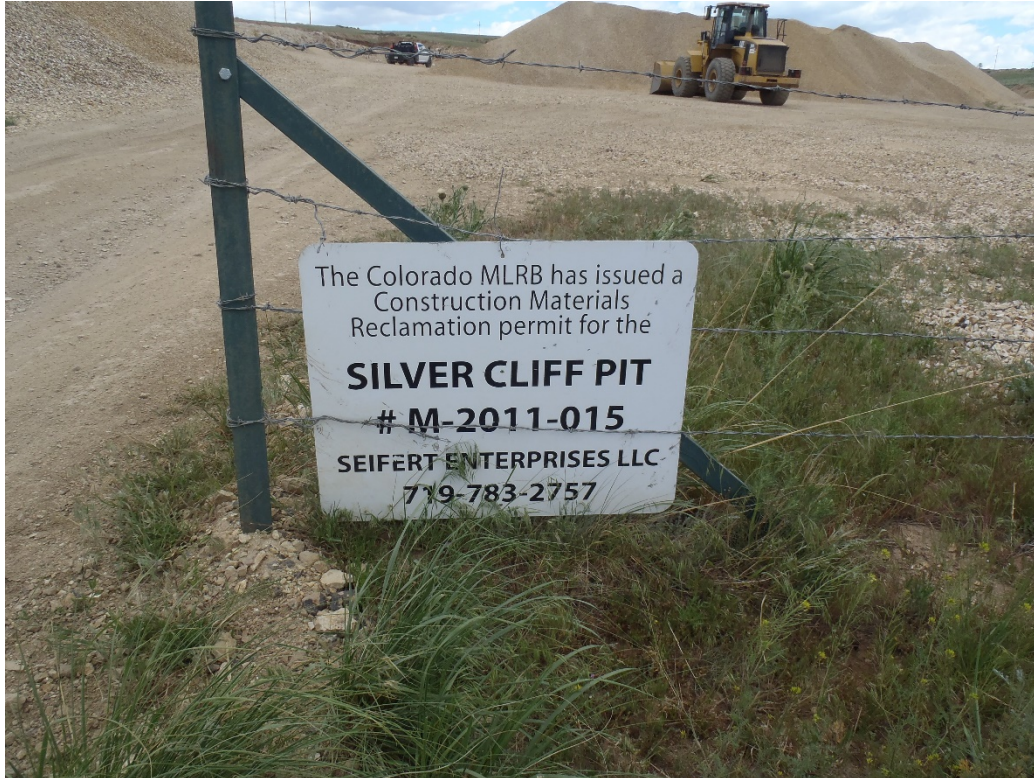
Signs and Markers: The permit sign was properly posted (see **Photo 4**) and the affected area boundary was fenced with four-strand barbed wire (see **Photos 5 and 6**).

Photo 4. Permit sign (at entrance).

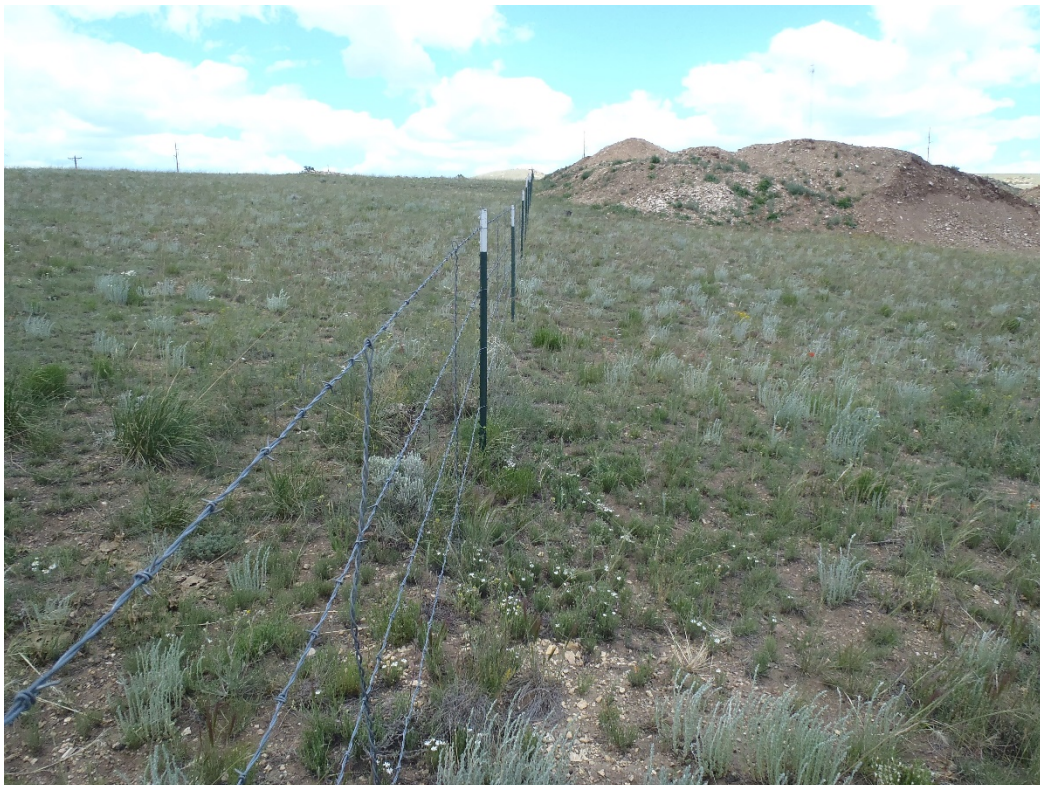
Photo 5. Affected area boundary fence (north side, looking NE).

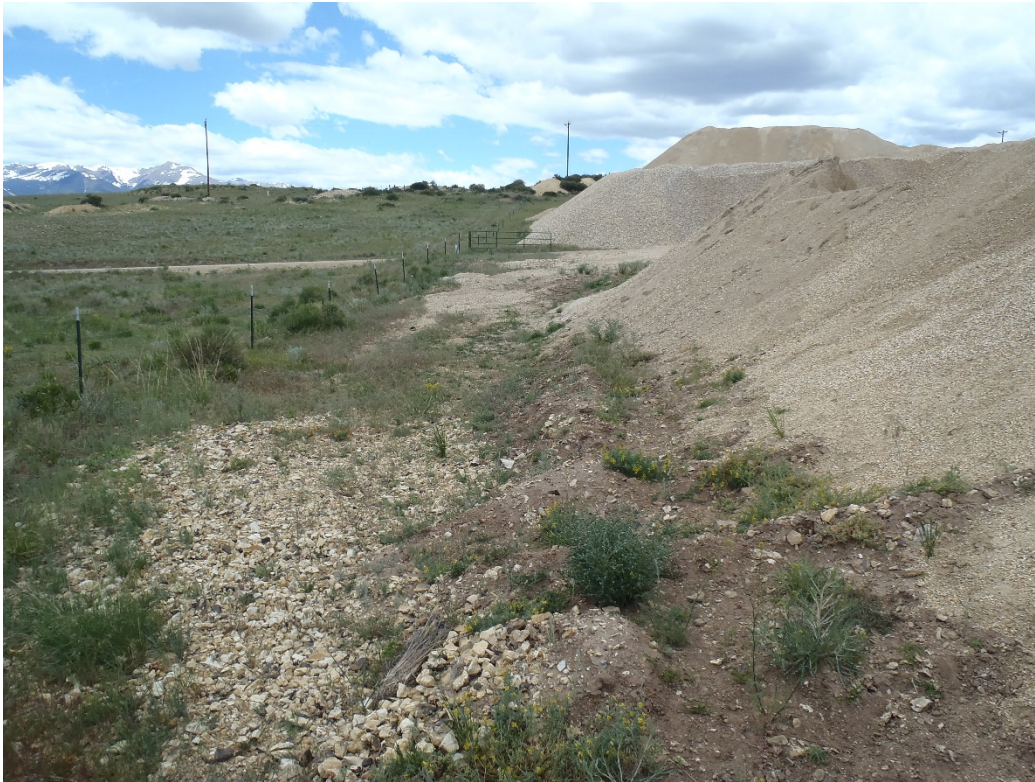
Photo 6. Affected area boundary fence (south side, looking WNW, product stockpiles on right).

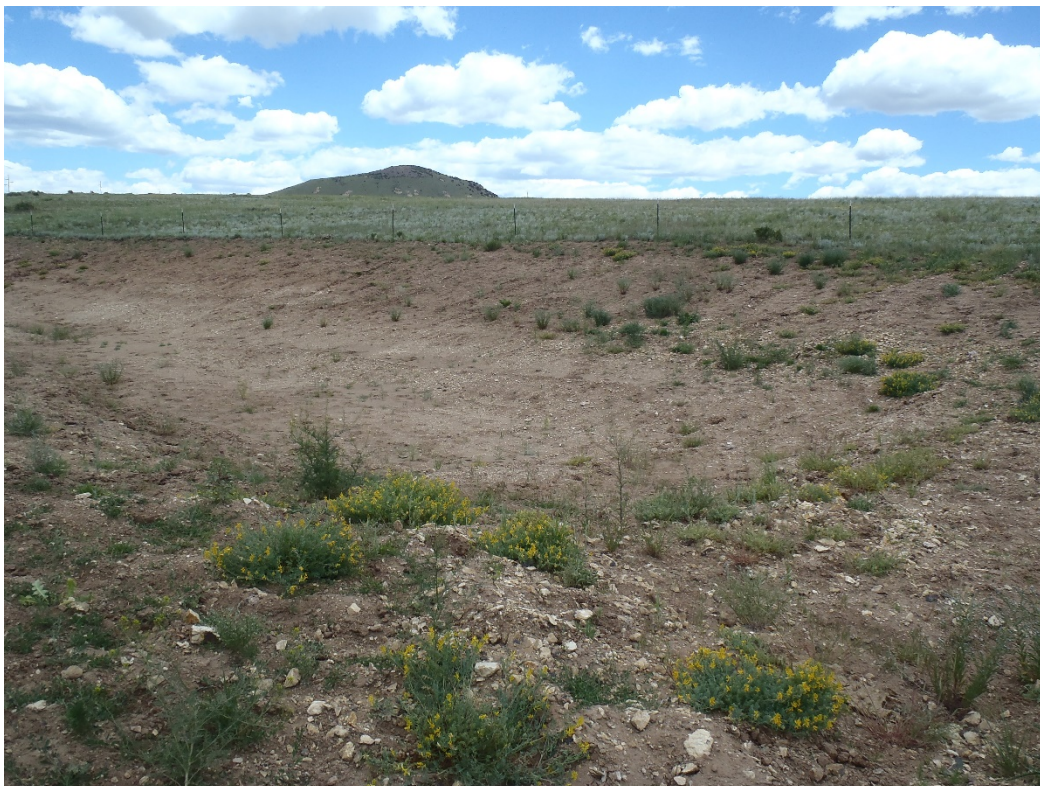
Storm Water MGT Plan: No oil or fuel spills observed. The stormwater/sediment pond on the south corner did not appear to need maintenance (see **Photo 7**).

Photo 7. Stormwater/sediment pond on the south corner (looking east).
