**MINERALS PROGRAM INSPECTION REPORT**  
**PHONE: (303) 866-3567**

<b>MINE NAME:</b> V.F. Smith Pit #5	<b>MINE/PROSPECTING ID#:</b> M-1981-309	<b>MINERAL:</b> Sand and gravel	<b>COUNTY:</b> Washington
<b>INSPECTION TYPE:</b> Monitoring	<b>INSPECTOR(S):</b> Brock Bowles	<b>INSP. DATE:</b> October 16, 2019	<b>INSP. TIME:</b> 11:30
<b>OPERATOR:</b> Mason King	<b>OPERATOR REPRESENTATIVE:</b> Mason King	<b>TYPE OF OPERATION:</b> 110c - Construction Limited Impact	
<b>REASON FOR INSPECTION:</b> Normal I&E Program	<b>BOND CALCULATION TYPE:</b> Complete Bond	<b>BOND AMOUNT:</b> \$7,849.00	
<b>DATE OF COMPLAINT:</b> NA	<b>POST INSP. CONTACTS:</b> None	<b>JOINT INSP. AGENCY:</b> None	
<b>WEATHER:</b> Clear	<b>INSPECTOR'S SIGNATURE:</b>

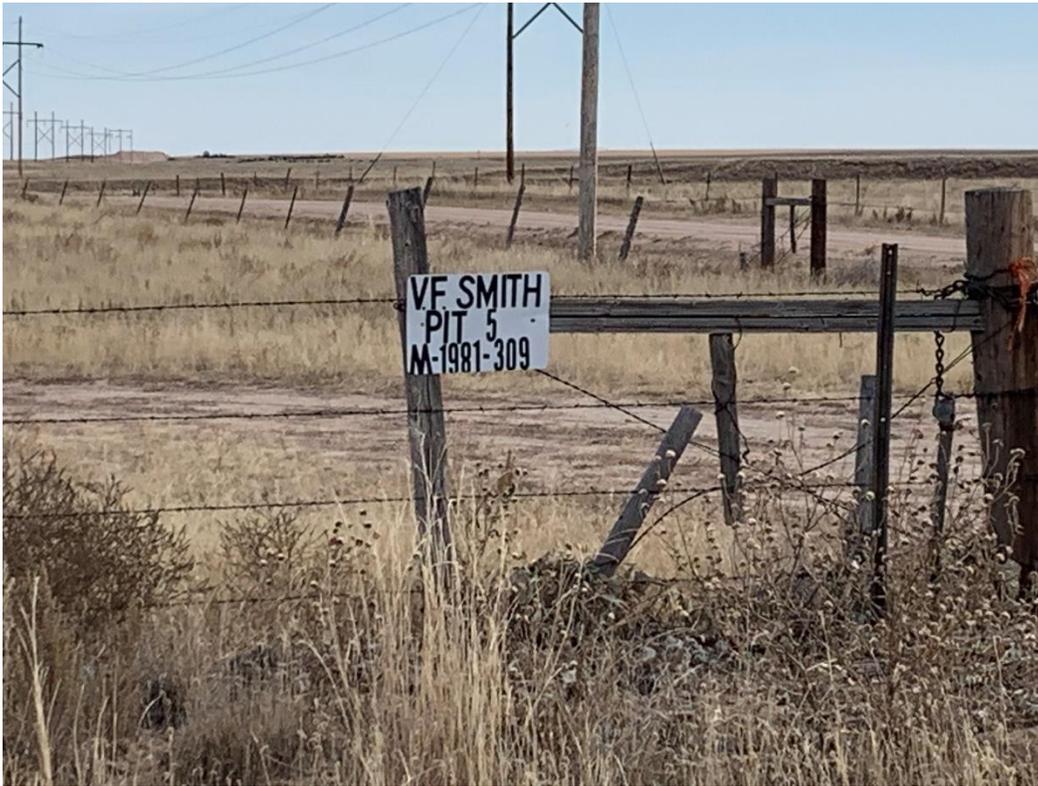
The mine entrance sign was in place with the required information and the permit boundary markers were in place. A front end loader was parked in the pit area and fresh tire tracks indicate that the pit had recently been mined.

Mine entrance sign seen from County Road UU

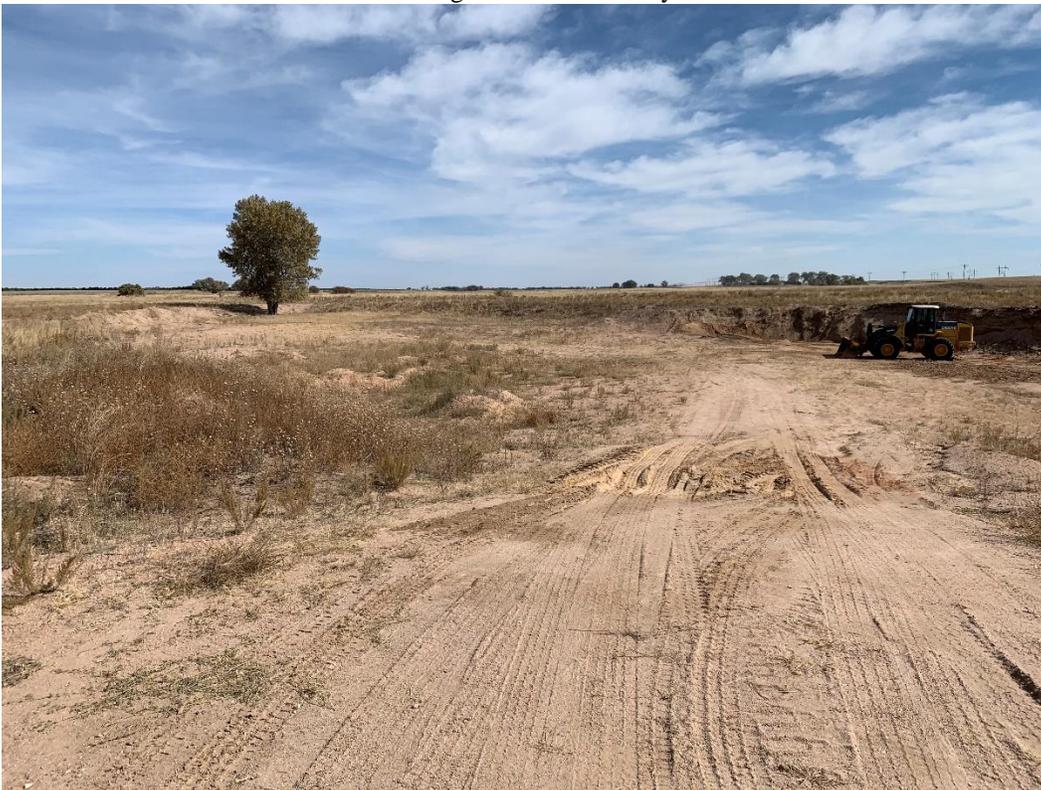
The highwall was approximately 10 feet high and there was no water seen in the bottom of the pit. The internal roads were in passable condition and were well maintained. No noxious weeds were seen in the permit area.

Pit area looking east

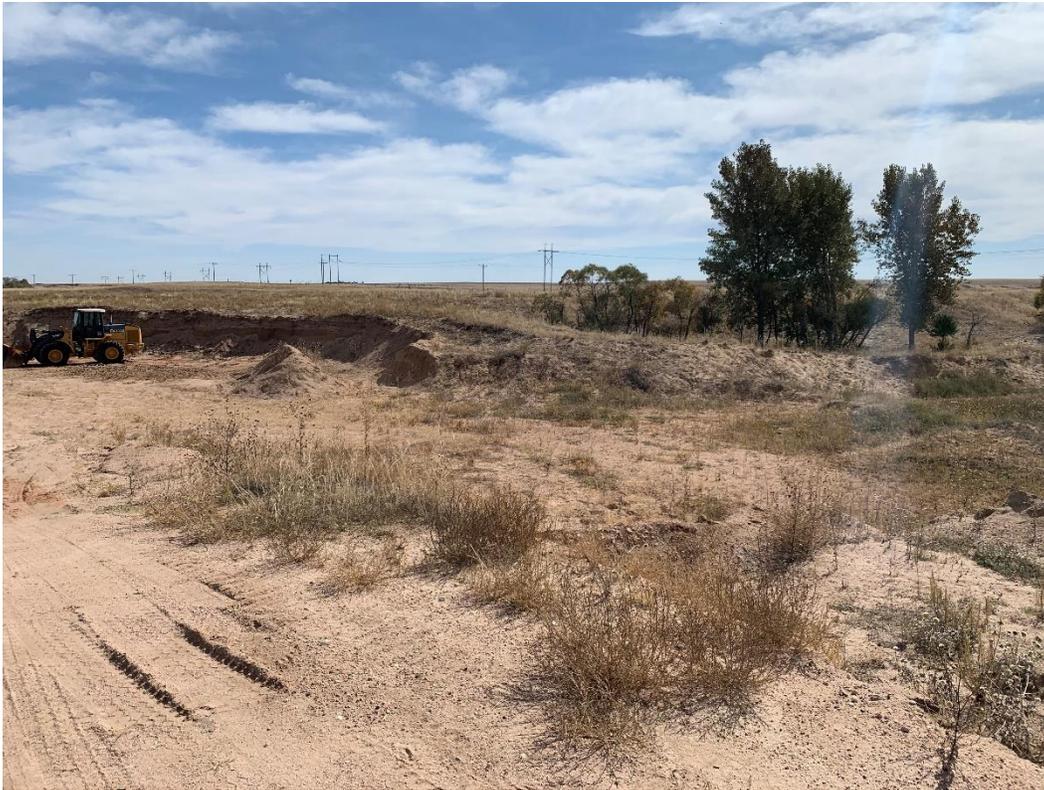
At the time of this inspection, about 2 acres were disturbed as part of the active mining area. To the south of the active mining area, about another 3 acres were historically disturbed. Mr. Mason claimed that this area is pre-law. The permit is silent on any pre-law mining at this site. Although, the historically disturbed area is well vegetated with grasses and a stand of mature trees that can be seen on Google Earth dating back to 1998.

South side of pit area with historical mining area to the right
