MINERALS PROGRAM INSPECTION REPORT
PHONE: (303) 866-3567

MINE NAME: King Pit	MINE/PROSPECTING ID#: M-2004-036	MINERAL: Clay (general) and sand gravel	COUNTY: Washington
INSPECTION TYPE: Monitoring	INSPECTOR(S): Brock Bowles	INSP. DATE: October 16, 2019	INSP. TIME: 13:00
OPERATOR: Mason King	OPERATOR REPRESENTATIVE: Mason King	TYPE OF OPERATION: 110c - Construction Limited Impact

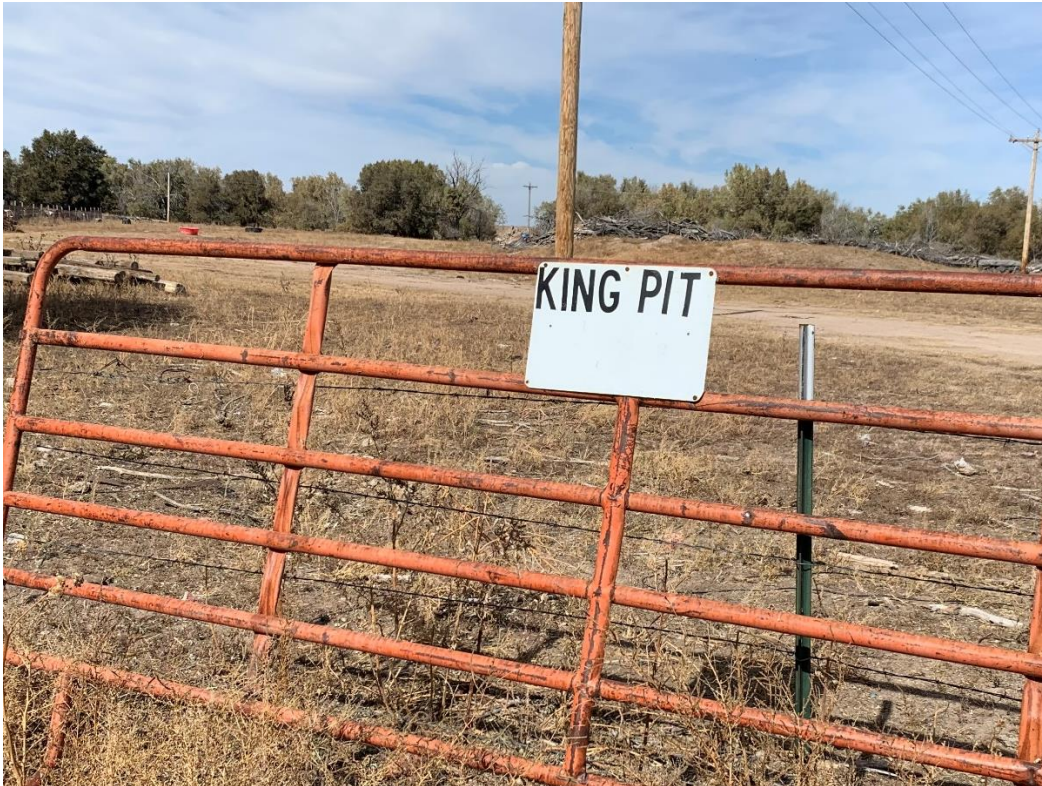
PROBLEM/POSSIBLE VIOLATION: Problem: The mine identification sign did not contain the information required by Rule 3.1.12(1).

The mine entrance sign is missing the required information as required by Rule 3.1.12.(1). The Rules regarding the required information on entrance signs has recently changed to:

Mine entrance sign from County Road XX

CORRECTIVE ACTIONS: Submit a photo of the mine entrance sign with the information required by Rule 3.1.12(1).

Please submit a photo of the mine entrance sign with the required information stated above within 60 days of this report (January 13, 2020).

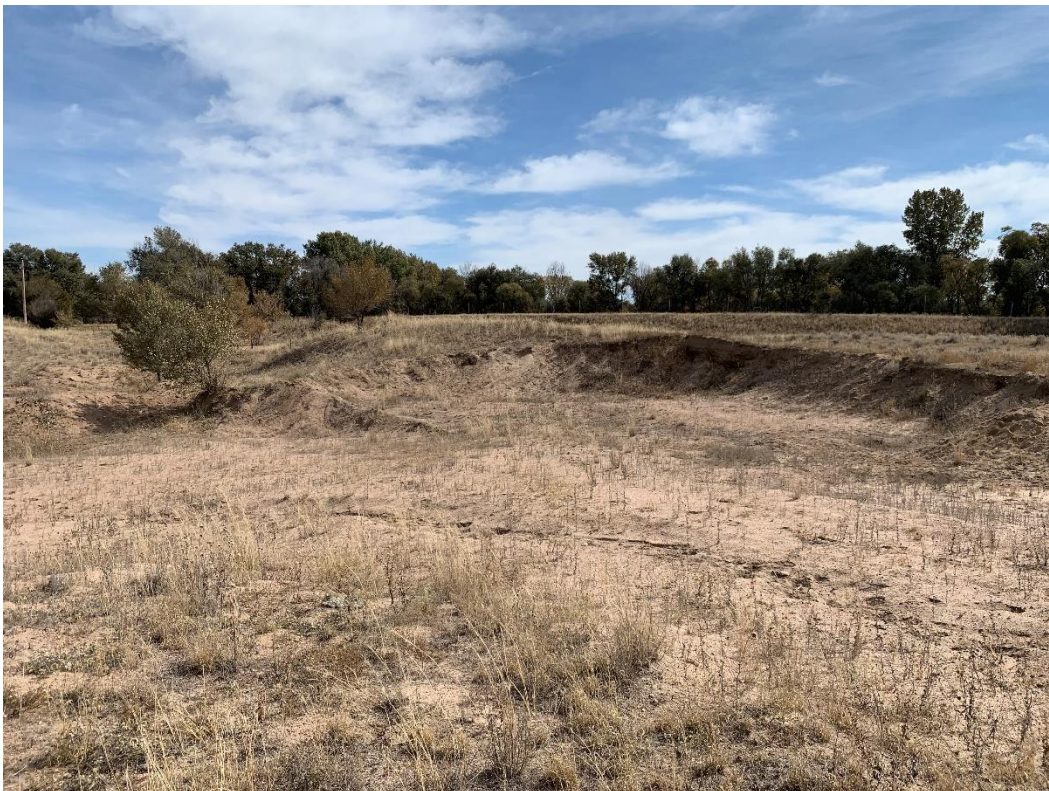
PROBLEM/POSSIBLE VIOLATION: Problem: The current mine plan needs to be updated and clarified pursuant to C.R.S. 34-32.5-112 (1)(c)(VI). The operator must provide sufficient information to describe or identify how the operator intends to conduct the operation. The mine permit states in Exhibit D - Cost Estimate for Reclamation, that the excavations will be graded and sloped as they are mined.

East pit- four permit boundary markers were identified. Topsoil was stockpiled on the north side of the pit, was well vegetated and appeared to be stable. This pit was mined recently because it had fresh tracks. The highwall on the south and east sides were 10 feet high.

The mine permit states in Exhibit D - Cost Estimate for Reclamation, that the excavations will be graded and sloped as they are mined. This statement is interpreted by the Division as the highwalls will not exceed 3h:1v slopes throughout the mining operations. The current highwalls of both pit excavations exceed 3h:1v slopes as required by the permit. Please refer to the Possible Problems, Backfill and Grading section of this report for the Corrective Actions for this issue.

East pit area needs to be graded to 3:1 as per the permit

CORRECTIVE ACTIONS: The operator shall submit a Technical Revision, with the required \$216 revision fee, to update and clarify the current approved mine plan to reflect existing and proposed activities **or** by submitting pictures verifying that the highwalls in both excavations have been reduced to 3h:1v or less by the corrective action date.

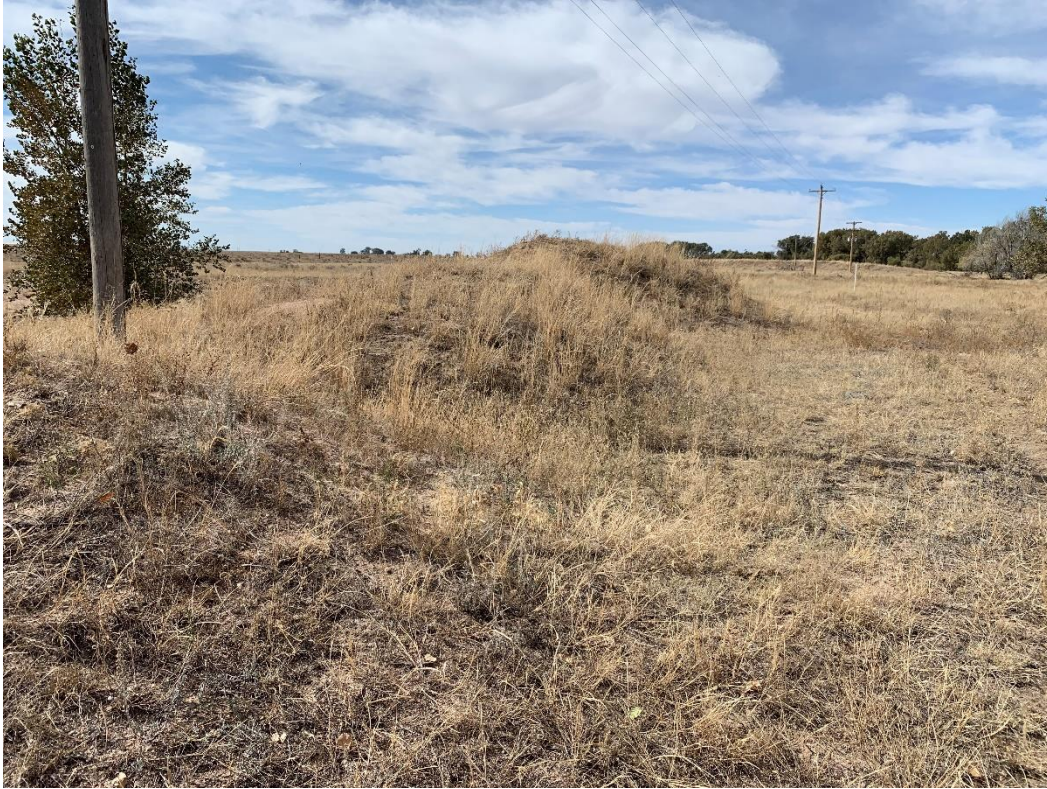
East pit topsoil stockpile

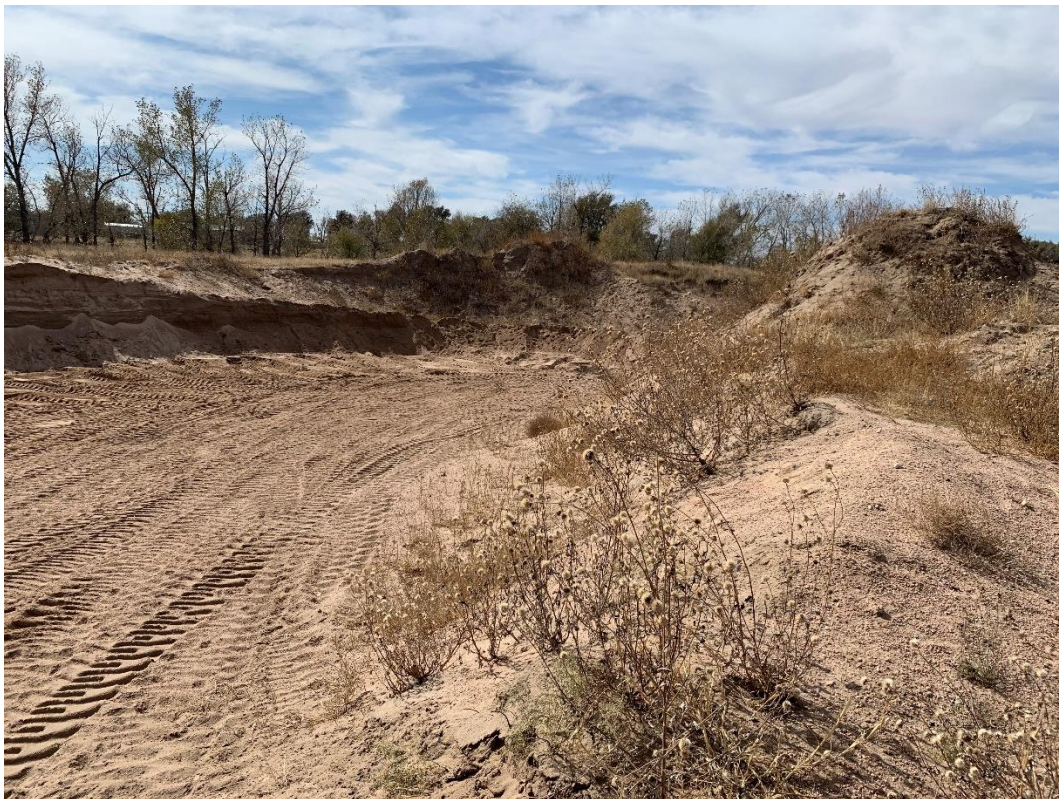
West pit- four permit boundary markers were identified. The topsoil stockpile was on the north side of the pit, was well vegetated and appeared to be stable. It did not appear that this pit had been mined recently due to the vegetation in the bottom of the pit.

West pit highwall need to be graded to 3h:1v as per the permit
