### MINERALS PROGRAM INSPECTION REPORT

<b>MINE NAME:</b> AZCO Pit	<b>MINE/PROSPECTING ID#:</b> M-2004-029	<b>MINERAL:</b> Sand and gravel	<b>COUNTY:</b> Fremont
<b>INSPECTION TYPE:</b> Monitoring	<b>INSPECTOR(S):</b> Timothy Cazier	<b>INSP. DATE:</b> November 8, 2019	<b>INSP. TIME:</b> 10:15
<b>OPERATOR:</b> AZCO Construction, Inc.	<b>OPERATOR REPRESENTATIVE:</b> Ron Walker	<b>TYPE OF OPERATION:</b> 110c - Construction Limited Impact

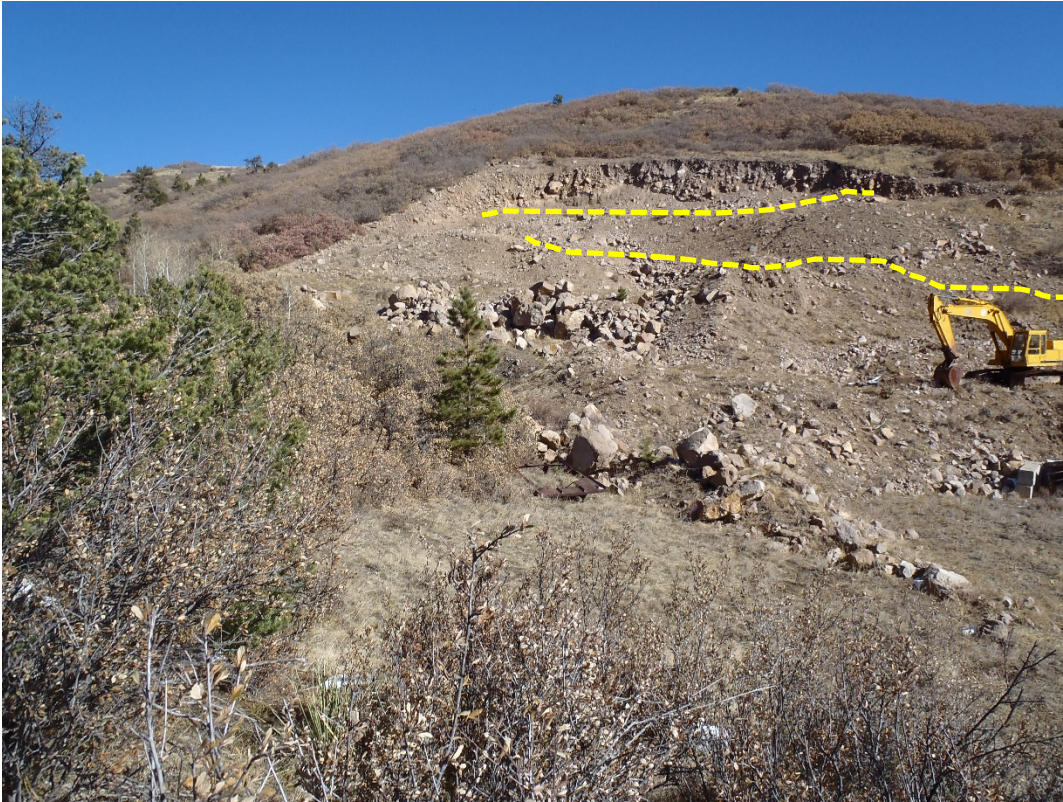
Backfilling and Grading: The approved mine plan states there will not be any benches (Exhibit C, paragraph 1(f)) and the reclaimed backslopes will be 3H:1V (Exhibit D, paragraph 1(b)). The site currently has two benches (see **Photo 1**). The upper bench (see **Photo 2**) currently acts as a rockfall catchment. Mr. Walker indicated he is interested in making the lower bench (see **Photo 3**) available to construct a residence. As the approved post-mine land use is rangeland, the benches will need to be at least partially backfilled. In order to keep the benches after reclamation, an amendment to the permit would be required to change the post-mine land use to residential. The DRMS approved 3H:1V reclaimed slopes may have been feasible were the mining to occur where the original application "Adequacy Letter Reply" Exhibit E maps (dated June 9, 2004) indicated. However, as discovered during this inspection, the permit boundary markers do not coincide with the permit boundary as shown on the Exhibit E maps (*note: this discrepancy is discussed in detail under "Signs and Markers" below*). The area being mined consists of steeper slopes (approximately 2H:1V, pre-disturbance). Whereas, the pre-disturbance slopes in the Exhibit E maps is approximately 3.5H:1V. Given the steeper slopes in the actual mining area, it not feasible to backfill the mined slope to 3H:1V. This requires a revised reclamation plan. The DRMS would accept a revised reclamation plan having 2H:1V backfill on the existing benches. **The need for a revised reclamation plan is cited as Problem No. 2 on page 1 of this report.**

Photo 1. Two site benches marked with yellow dotted lines (looking north).

**CORRECTIVE ACTIONS:** The operator shall submit a Technical Revision, with the required \$216 revision fee, to update and clarify the current approved reclamation plan to reflect existing and proposed activities by the corrective action date.

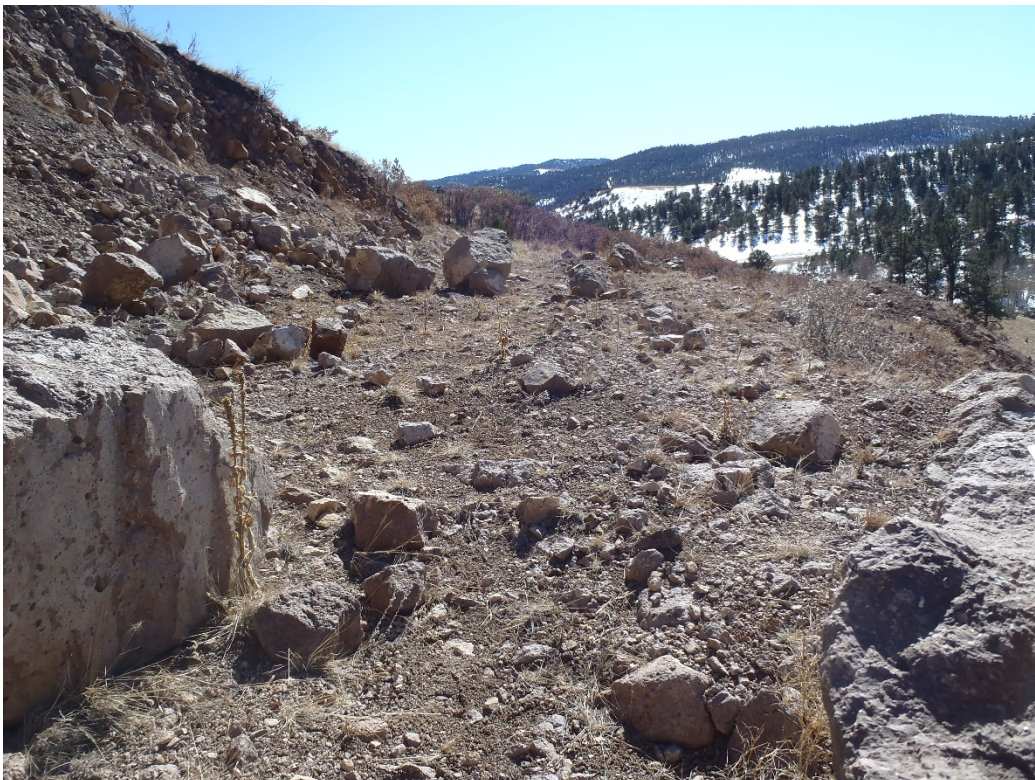
Photo 2. Upper bench (looking east).

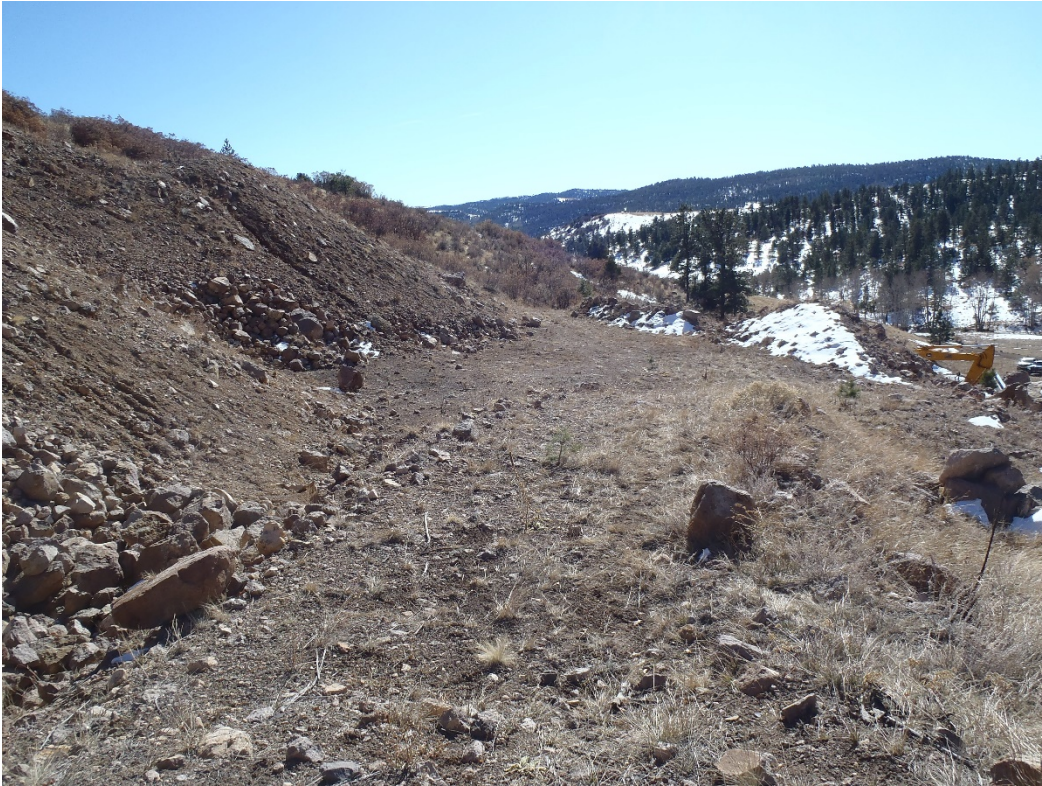
Photo 3. Lower bench (looking east).

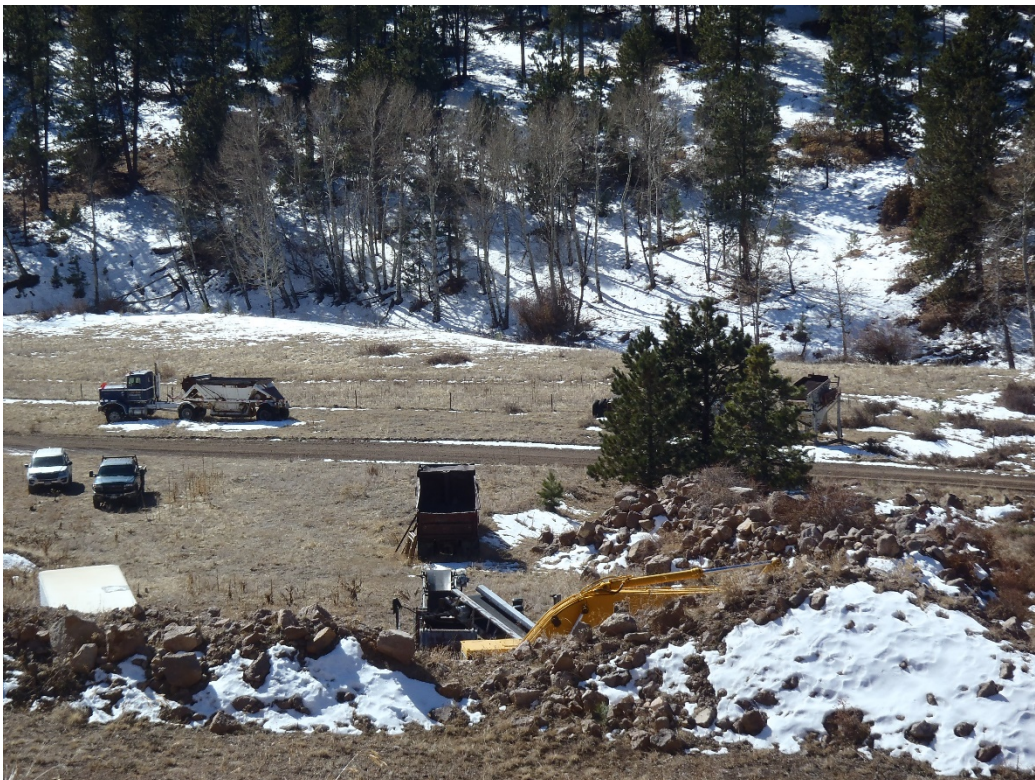
Excess Spoil and Dev. Waste: A stockpile of oversized rock was observed near the access road (see **Photo 4**). Mr. Walker indicated he had sold some as riprap and hopes to sell more as such.

Support Facilities On-site: A screen plant, crusher, excavator, and dump truck were observed on site (see **Photos 4 and 9**).

Photo 4. Screen plant, crusher, excavator, and dump truck (looking south).

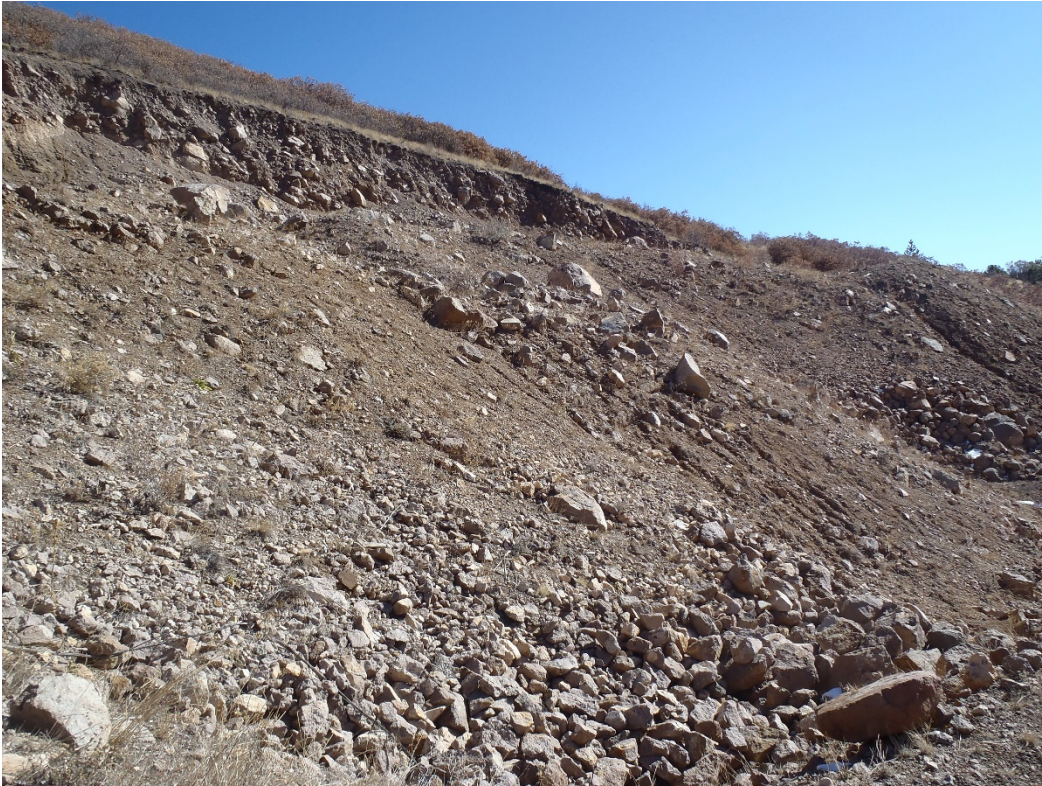
Gen. Compliance with Mine Plan: The maximum allowed disturbed area is 8.86 acres. Google Earth was used to measure the disturbed area, which was estimated to be approximately 2.1 acres, based on 2016 imagery. Highwalls were benched and estimated to be less than 20 feet in height (see **Photo 5**). A product stockpile was observed on the southeast portion of the affected area near the access road (see **Photo 6**)

Photo 5. Full height of highwall between upper and lower bench (looking NE from switchback).

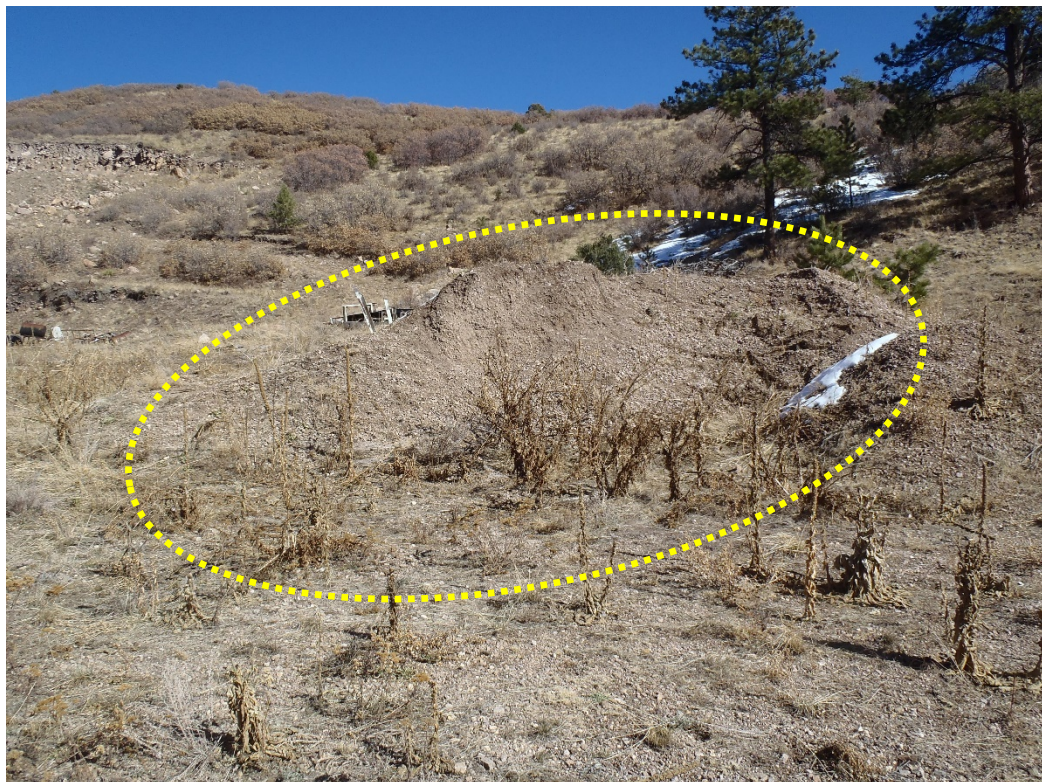
Photo 6. Product stockpile.

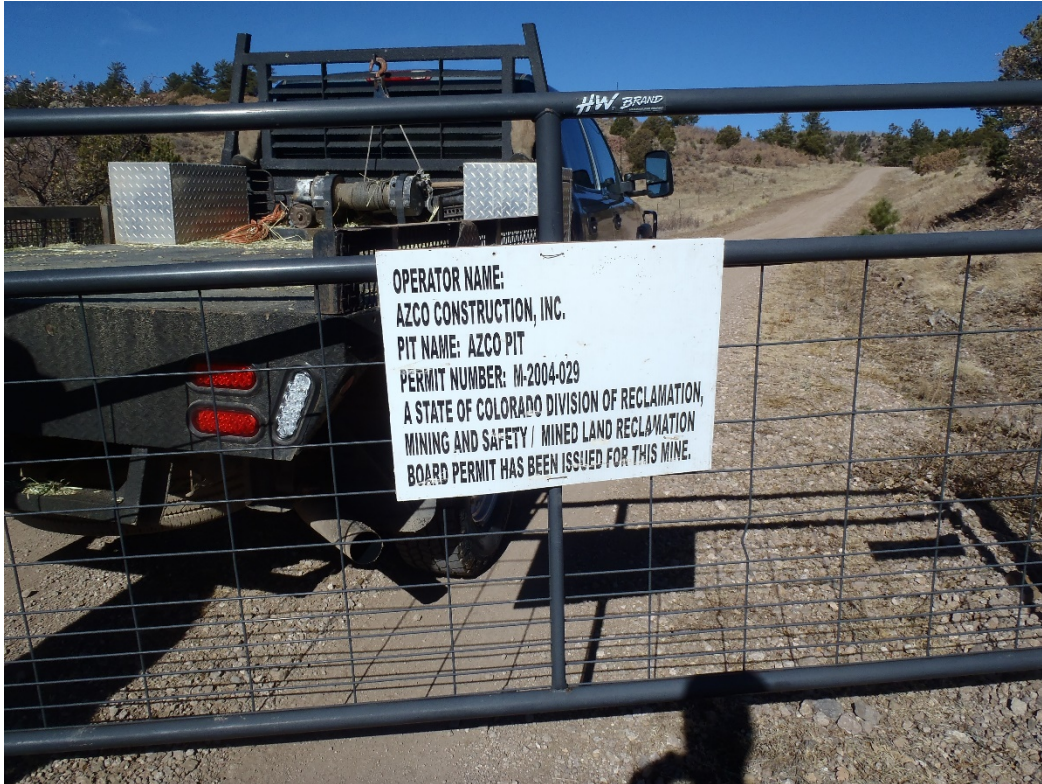
Photo 7. Permit sign (at gate).

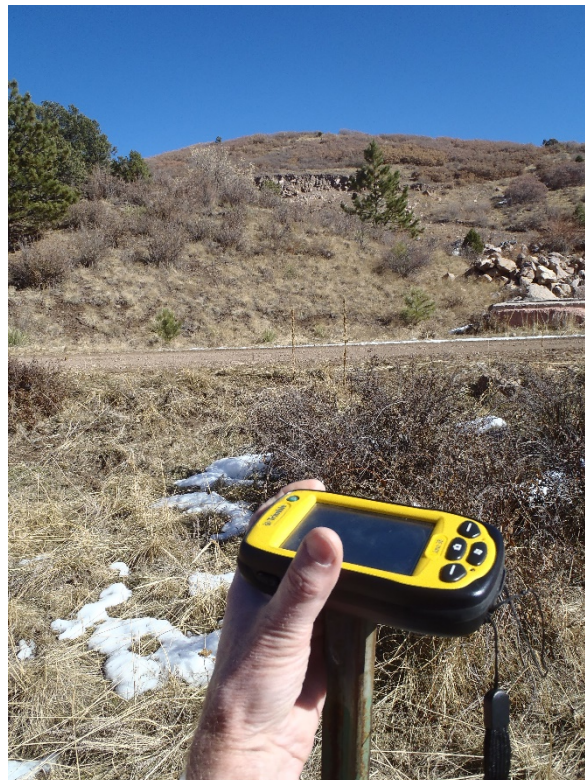
Signs and Markers: The permit sign was posted (see **Photo 7**) at the gate on the access road about X.X miles from the site. Four of the six boundary markers were located (see **Post Inspection Map**) and positions collected using a Trimble Juno 3B hand held GPS unit (see **Photo 8**). The other two marker posts were expected to be well above the upper bench highwall and obscured in a large grove of oak brush. As referenced above under "Backfilling and Grading", the observed boundary markers do not coincide with the permit boundary map approved during the original application review process in 2004. **The discrepancy in the permit boundary between that marked in the field and that in the 2004 application is cited as Problem No. 3 on page 2 of this report.**

Photo 8. GPS recording SW corner boundary marker location (looking north).

**CORRECTIVE ACTIONS:** Submit a technical revision (along with the required \$216 fee) with a map clarifying the permit boundary not to exceed 8.86 acres. [Note: *This can be the same Technical Revision submitted to address Problem No. 2*]

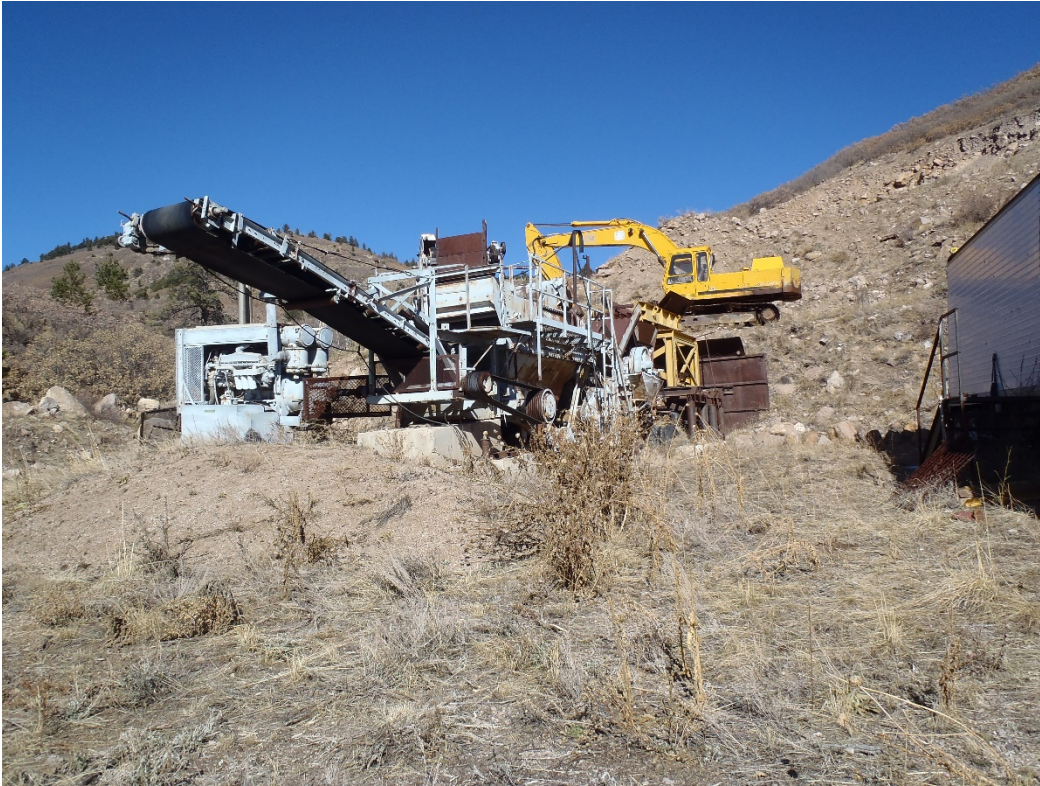
Photo 9. Screen plant, crusher, excavator, and semi-trailer (looking NW).
