Re: Bowie Resources, LLC, Bowie No. 2 Mine  
Coal Mine Waste Banks & Instrumentation Monitoring  
Pond Quarterly Inspections  
Permit C-1996-083

**BOWIE RESOURCES, LLC**  
**Bowie No. 2 Mine**  
**Coal Mine Waste Bank Nos. 1, 2, & 3 Inspections –3rd Quarter 2019**

Subject: Summary of Instrumentation Monitoring  
3<sup>rd</sup> Quarter 2019  
Bowie Coal Waste Disposal Area No. 2  
Paonia, Colorado

**SUBJECT: Summary Report, 3rd Quarter 2019, Inclinator and Active Vibrating Wire Piezometer Data July – September 2019, Bowie Mine #2 Coal Waste Disposal Area (CWDA) #2**

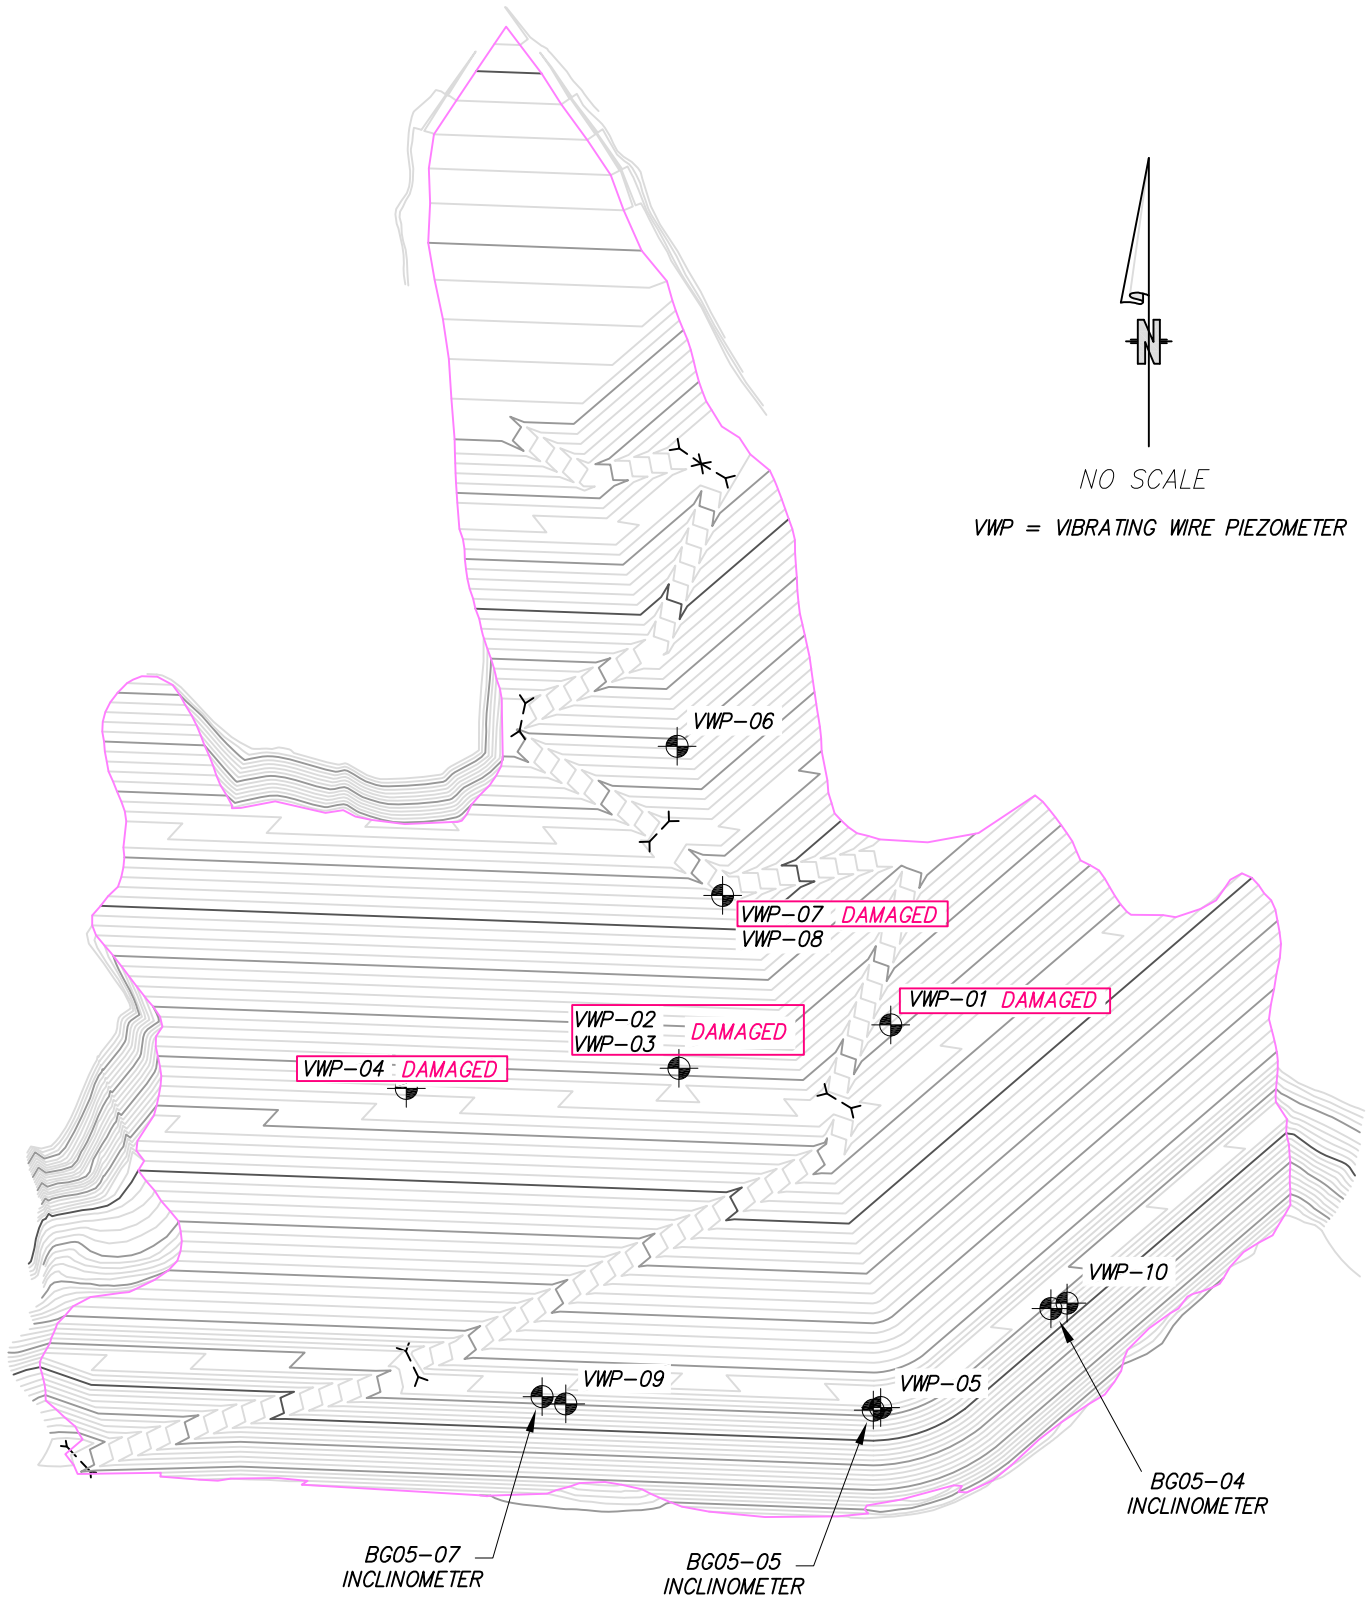
# INSTRUMENTATION SITE PLAN

The physical locations of the piezometers are shown on the attached Instrumentation Site Plan (Map 1). As seen on this map, five of the original VWP's were damaged and some were replaced. Currently, there are five active VWP's and three of them are adjacent to the three inclinometers. The graph of historical data from 5/16/05 through 5/21/14 is presented for reference as Figure 1. A graph of measured pore pressures of active piezometers is presented on the attached Figure 2 and is presented numerically in Table 1 below.

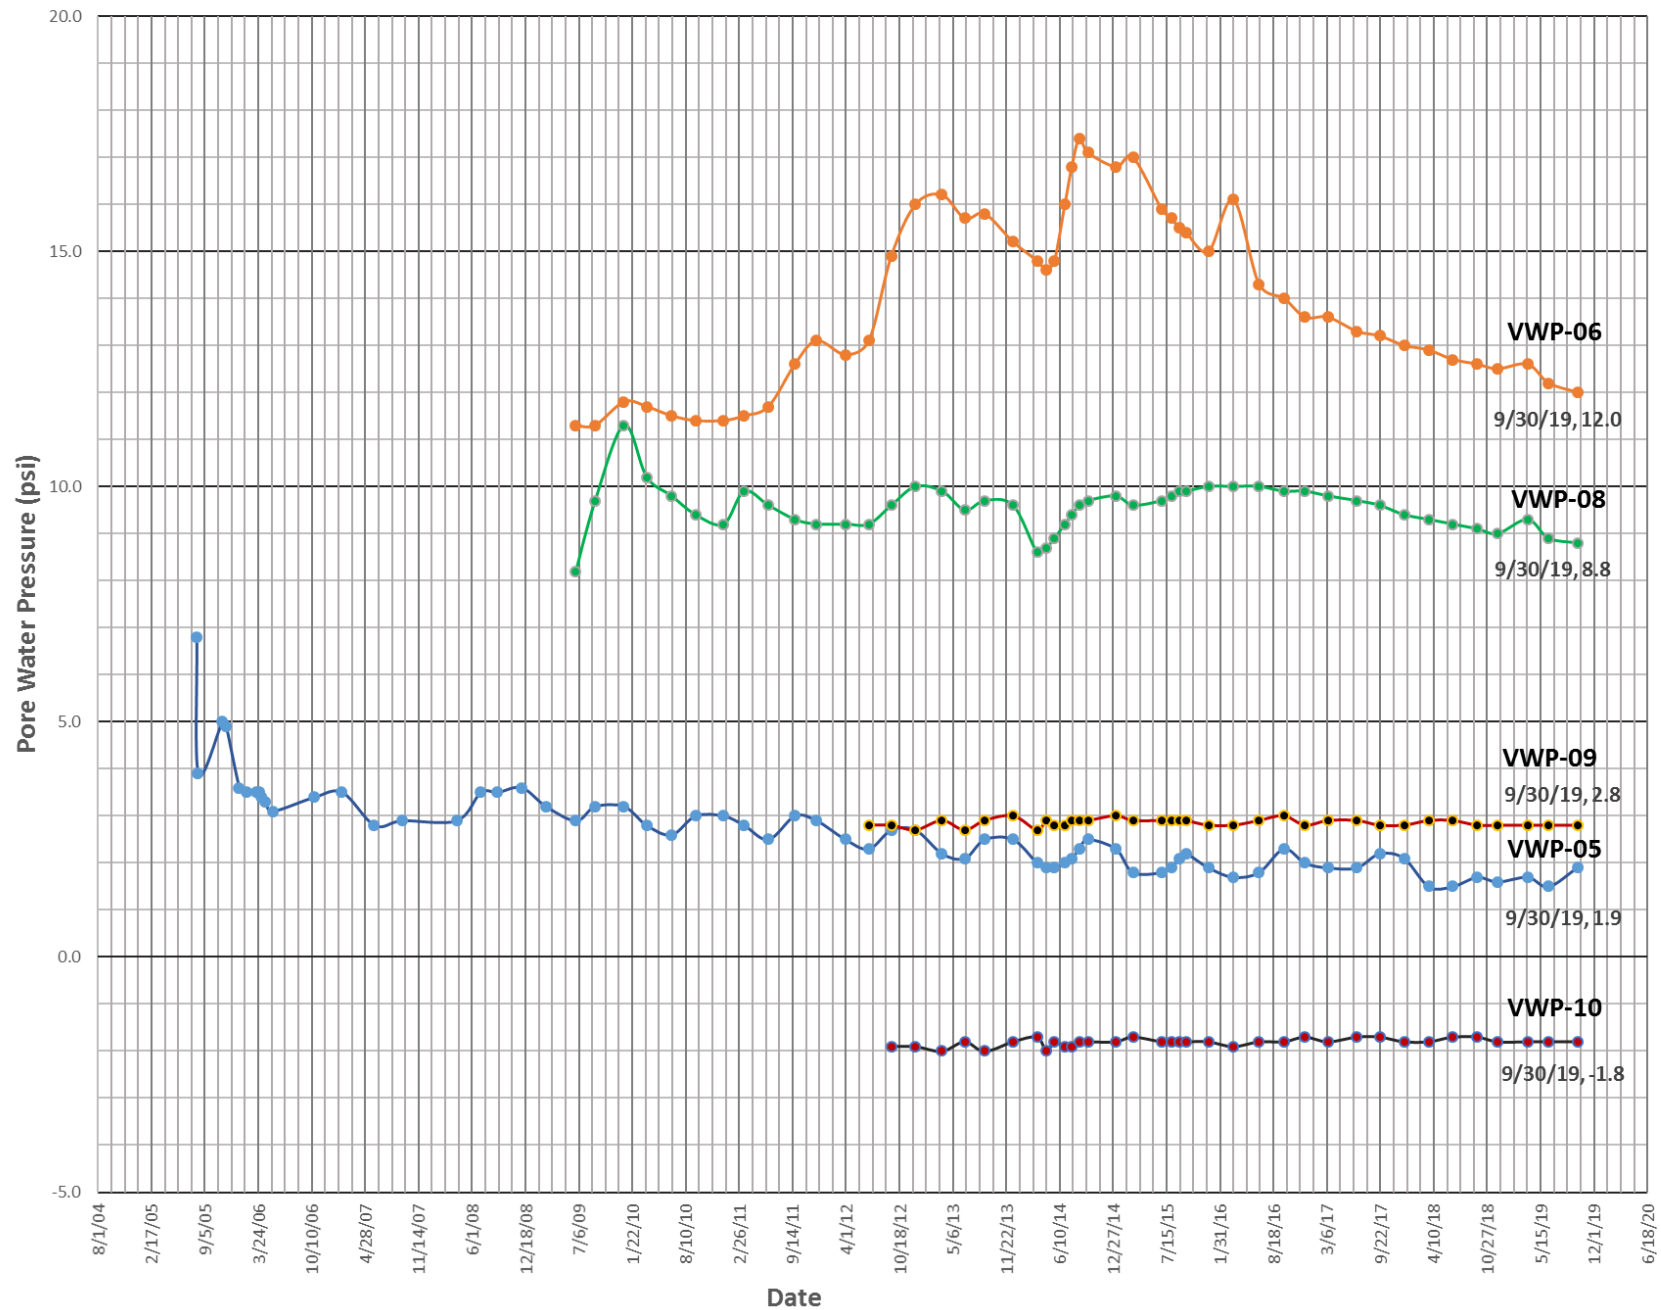
Figure 2 - Bowie Mine #2 - CWDA #2  
Active Vibrating Wire Piezometer Data

VWP-05 was installed on August 3, 2005 near the toe of CWDA No. 2 adjacent to the access road/bench. The pore pressures recorded at VWP-05 have shown some seasonal fluctuations; however, the range of pore pressure changes is fairly small. In general, HBET does not believe that the pore pressures in VWP-05 are cause for concern regarding stability of the gob pile.

VWP-06 was installed on June 5, 2009 near the existing top of CWDA No. 2. The pore pressures recorded at VWP-06 have fluctuated since installation. In general, the fluctuations have been seasonal and reflect the level of coal mine waste placement activity on top of CWDA No. 2. In general, HBET does not believe that the measured pore pressures are an indication of any instability in CWDA No. 2.

VWP-08 was installed on June 5, 2009 at a slightly lower elevation than VWP-06. The pore pressures recorded at VWP-08 have fluctuated since installation. However, the fluctuations have generally been within a narrow range of values. The measured pore pressures are generally consistent with the level of coal mine waste placement activity at CWDA No. 2.

As indicated in the referenced *Stability Evaluation* report, the stability of CWDA No. 2 is sensitive to increases in pore pressures in VWP-08. An increase in the pore pressure of 7 psi in VWP-08 would result in a reduction of the Factor of Safety to below 1.5.

The current pore pressure reflects a piezometric surface elevation of approximately 6096 feet which is much less than the critical elevation of 6113 feet. As a result, HBET does not believe that the measured pore pressures in VWP-08 are any indication of instability in CWDA No. 2.

As seen on Figure 2, the VWP readings are consistent either with previous recent or historic readings. Pore pressure readings went down slightly in two piezometers, up slightly in one piezometer, and stayed the same in two piezometers when compared to the Q2 readings.

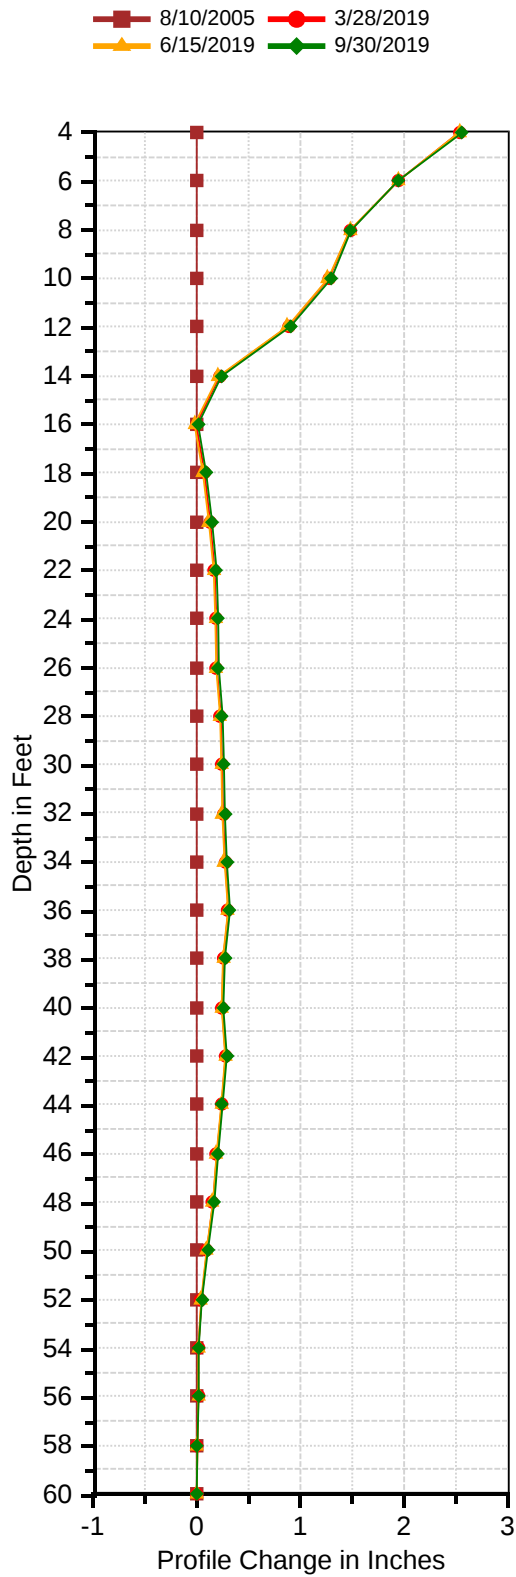
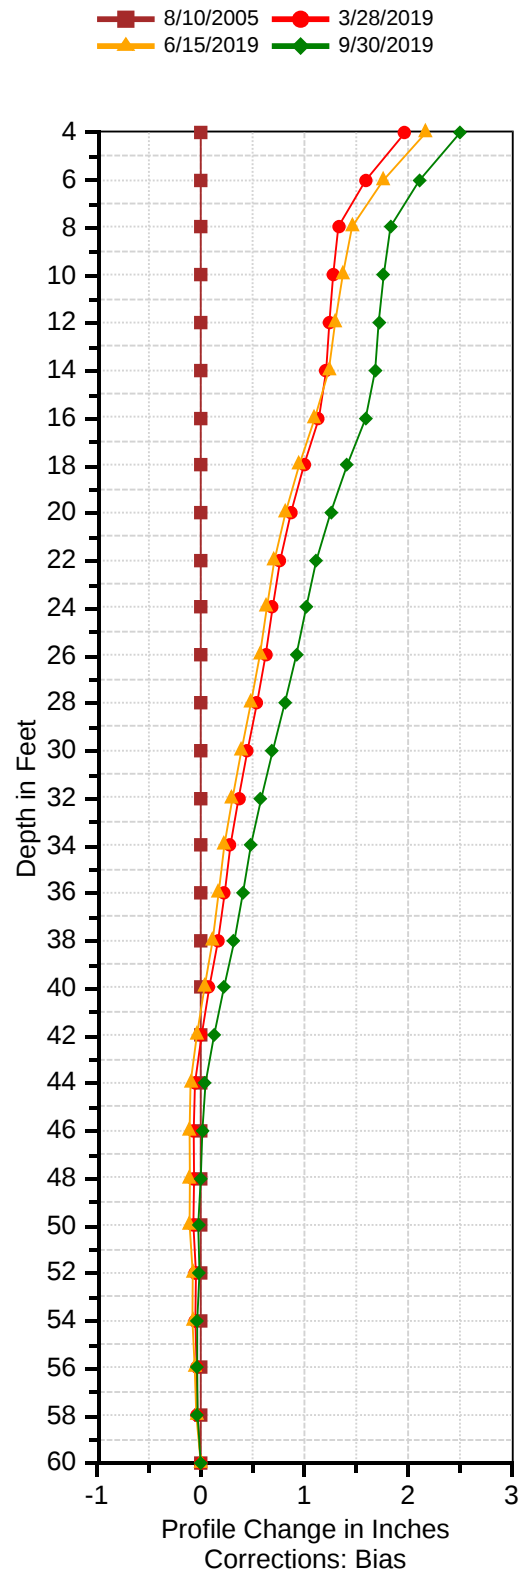
The last two inclinometer readings show deflection in BG05-5. However, the deflection is perpendicular to the slope direction. As a result, HBET does not believe that the reported deflection is an indication of instability. However, the 4<sup>th</sup> Quarter data will provide additional information for evaluation. No significant movements were reported for the other inclinometers.

As described in previous reports, we believe historic displacements indicated on the plots for the approximate upper ten feet of the inclinometers are likely due to placement of cover soil on the face of the waste pile during normal operations for maintenance and revegetation. Recent downslope readings (Axis A) are generally consistent with previous readings. There appears to be some displacement in the orthogonal direction (Axis B) for inclinometer BG05-5B. In March 2019 there was no displacement, but in June the displacement was above 14 feet, and in the recent September the displacement appeared to continue to roughly 42 feet. However, this displacement is not in the downslope direction, so it is not overly concerning, and may be due to a systematic recording error. There is no downslope displacement of any of the three inclinometers. This discrepancy should be evaluated during the next (Q4) reading.
