**MINERALS PROGRAM INSPECTION REPORT**  
**PHONE: (303) 866-3567**

<b>MINE NAME:</b> Henderson Mine	<b>MINE/PROSPECTING ID#:</b> M-1977-342	<b>MINERAL:</b> Molybdenum	<b>COUNTY:</b> Clear Creek, Grand
<b>INSPECTION TYPE:</b> Monitoring	<b>INSPECTOR(S):</b> Stephanie Mitchell	<b>INSP. DATE:</b> August 7, 2019	<b>INSP. TIME:</b> 09:00
<b>OPERATOR:</b> Climax Molybdenum Company	<b>OPERATOR REPRESENTATIVE:</b> Aaron Hilshorst	<b>TYPE OF OPERATION:</b> 112d-3 - Designated Mining Operation	
<b>REASON FOR INSPECTION:</b> Normal I&E Program	<b>BOND CALCULATION TYPE:</b> None	<b>BOND AMOUNT:</b> \$37,993,785.00	
<b>DATE OF COMPLAINT:</b> NA	<b>POST INSP. CONTACTS:</b> None	<b>JOINT INSP. AGENCY:</b> None	
<b>WEATHER:</b> Clear	<b>INSPECTOR'S SIGNATURE:</b>

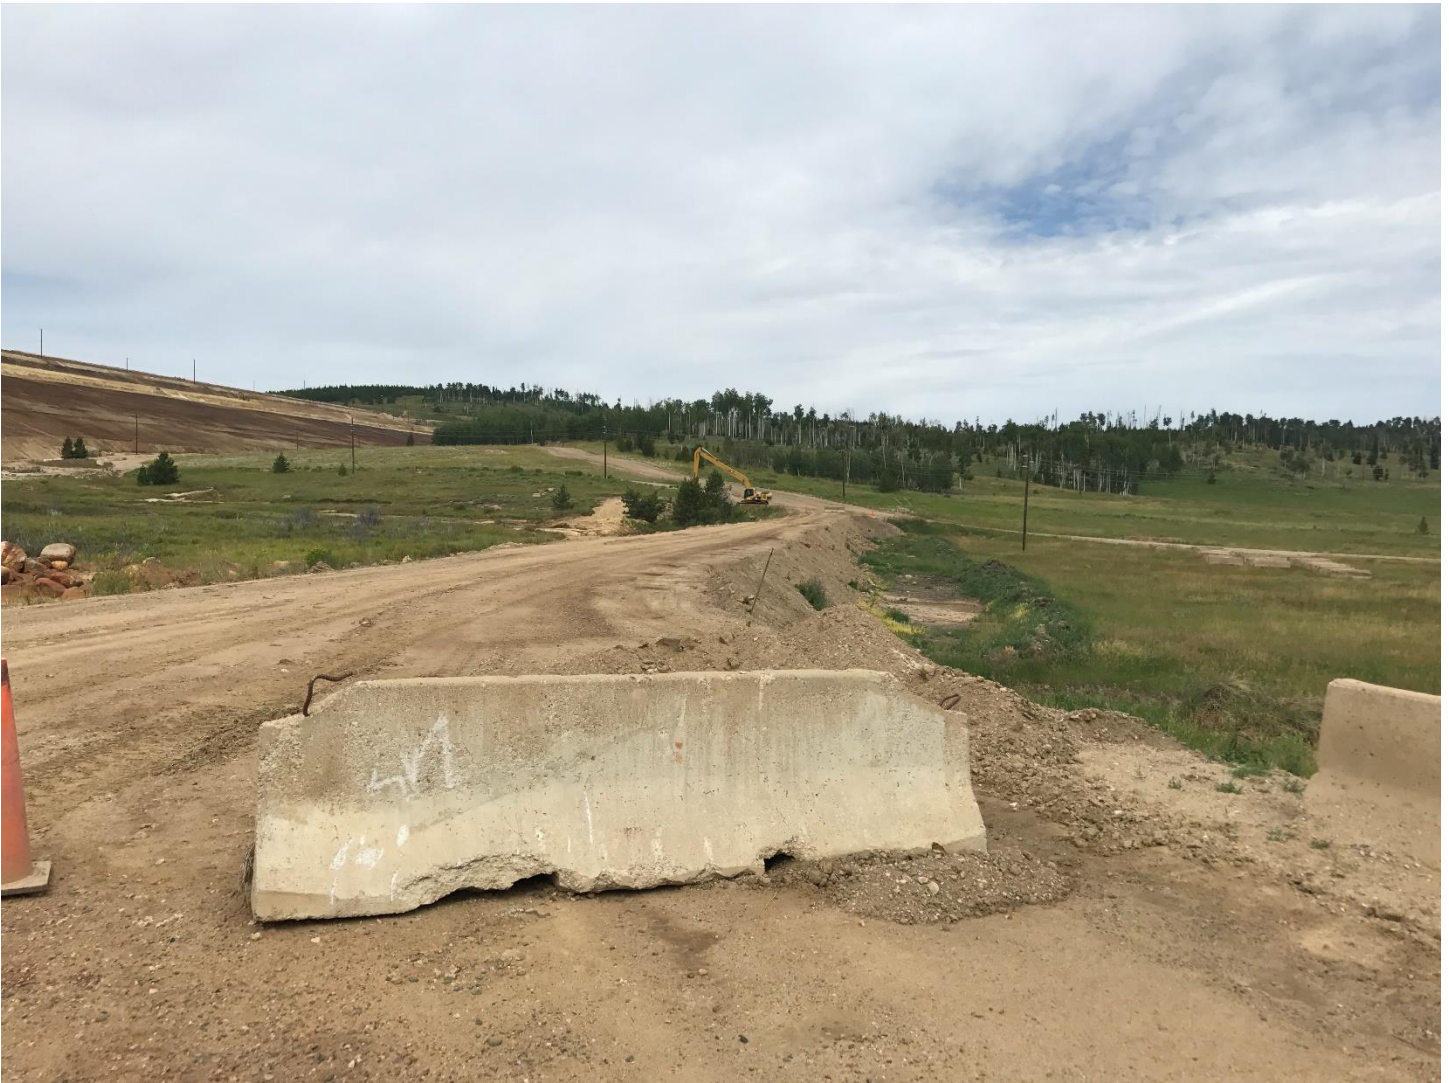
Preparations for road raise include topsoil stockpiled or pushed out of the way. The area is currently closed off. Material for the road raise project is coming from the Ranger Gulch Stockpile.

Road Raise Project- inactive at time of inspection

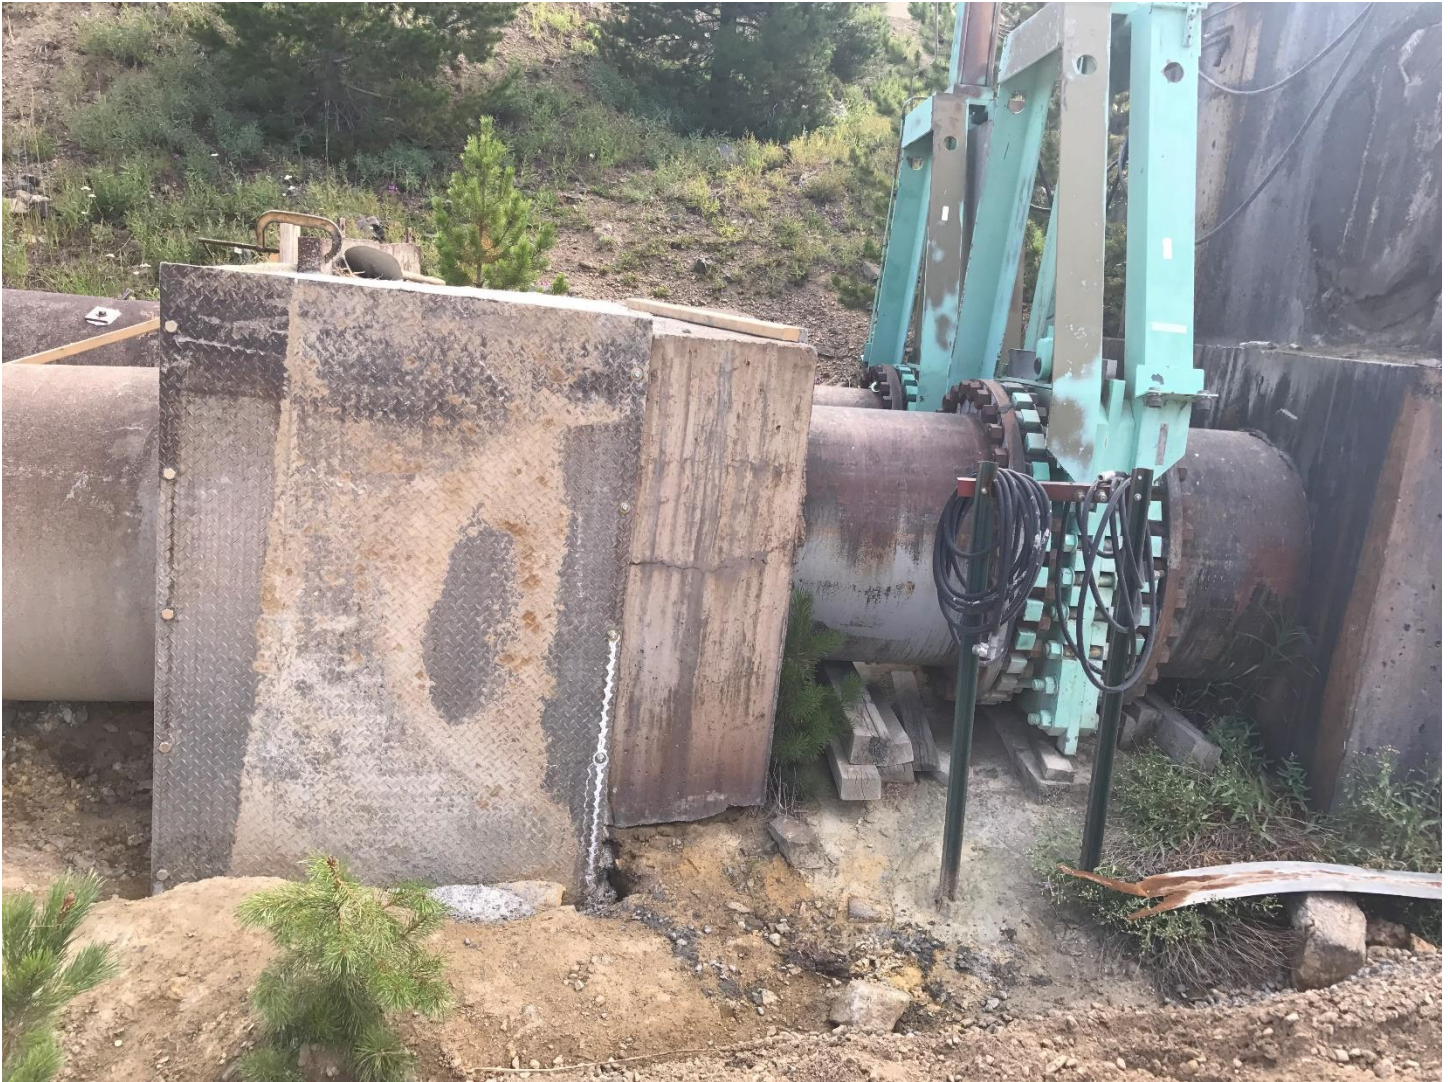
On August 1, 2019 an estimated 10,000 gallons of millwater leaked from the Emergency Cutout Pipeline. The Emergency Cutout (ECO) is part of the tailings delivery system EPF and is an alternative, emergency use pipeline, which can convey tailings to the Henderson Mill tailing storage facility in the event that the tailings delivery line cannot be used. Water was seen flowing from the pipe joint in the ECO just below the splitter box and valve that is used to divert flow from the TDL to the ECO. The water that leaked from the ECO was fully contained in the ditch running along the TDL access road, flowed through the culvert underneath County Road 3 and ultimately ended up in the Henderson Mill TSF.

Concrete Form around pipe joint- source of leak

Hand digging around the pipe joint on the ECO was conducted to investigate the leak. A concrete block was poured around the pipejoint with forms. Once cured the forms will be removed. Henderson Staff will reestablish ditch. Mr. Hilshorst also stated that Henderson is looking into replacing the ECO. Other seals in areas of the ECO are eroding.

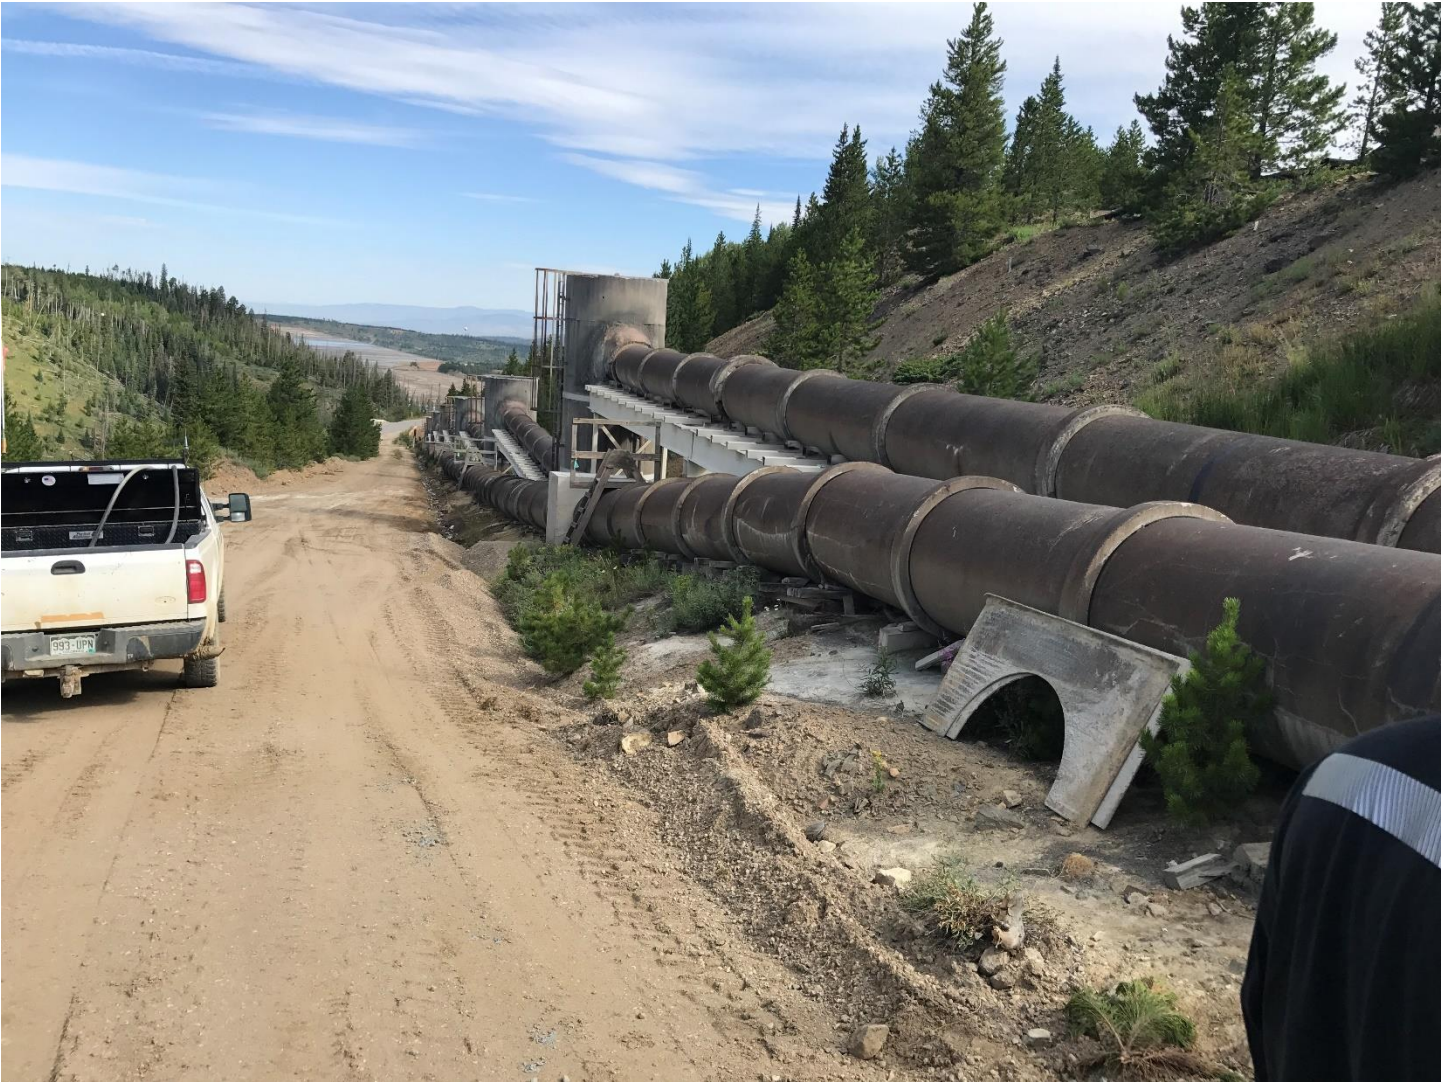
ECO pipeline

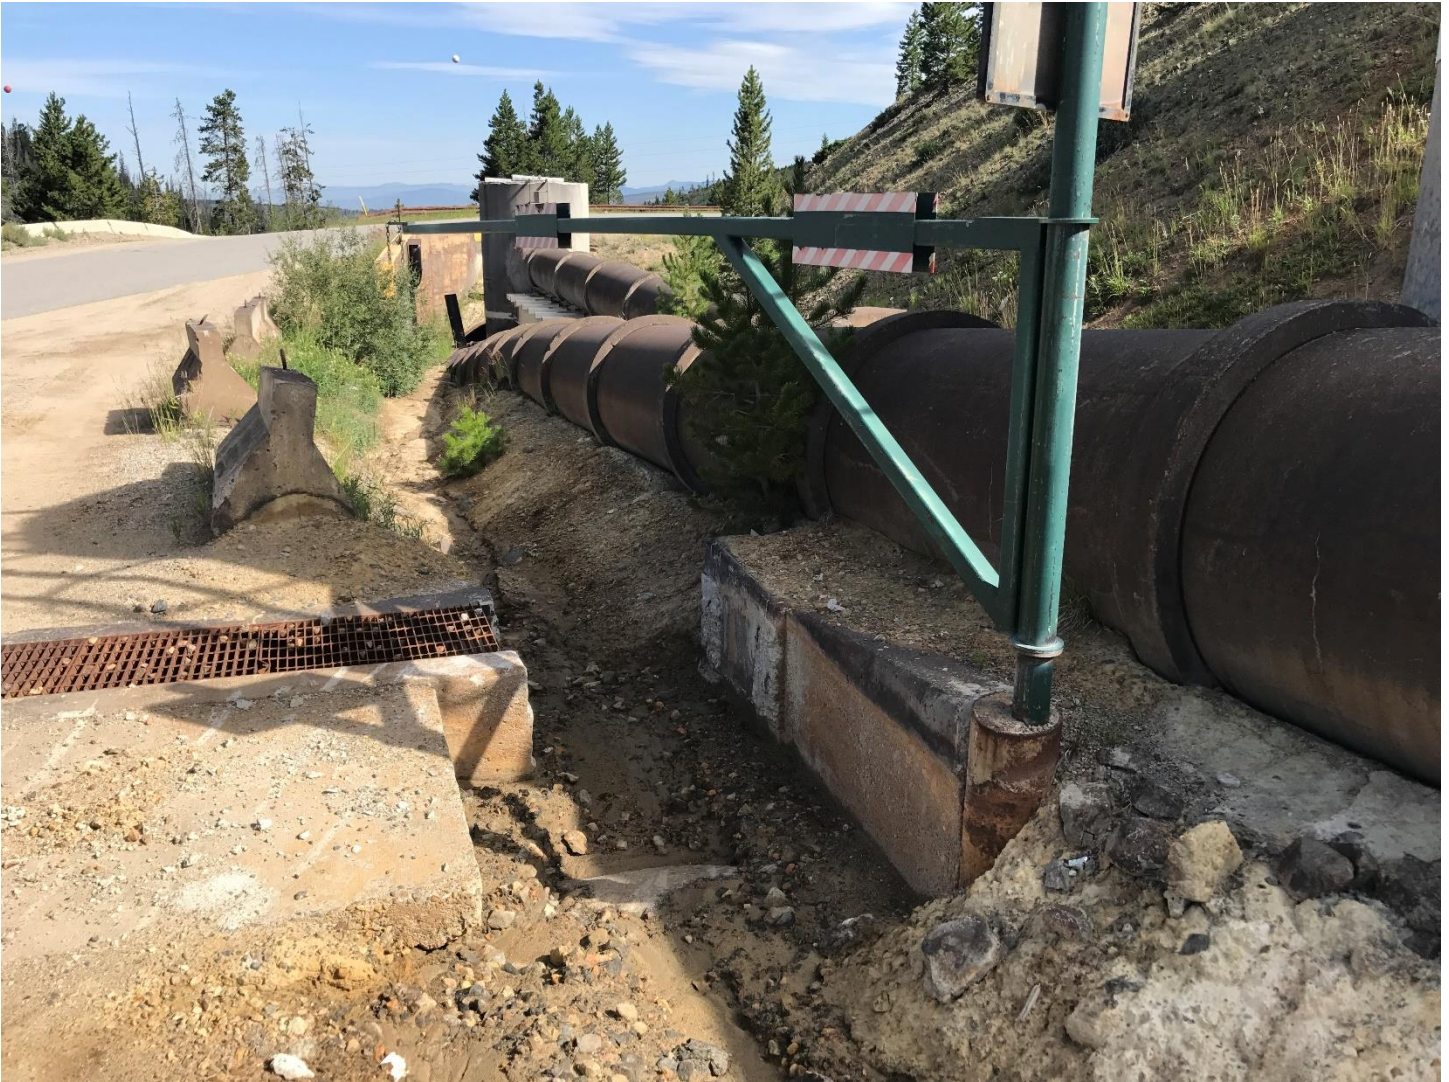
Leak area- ditch where water was conveyed

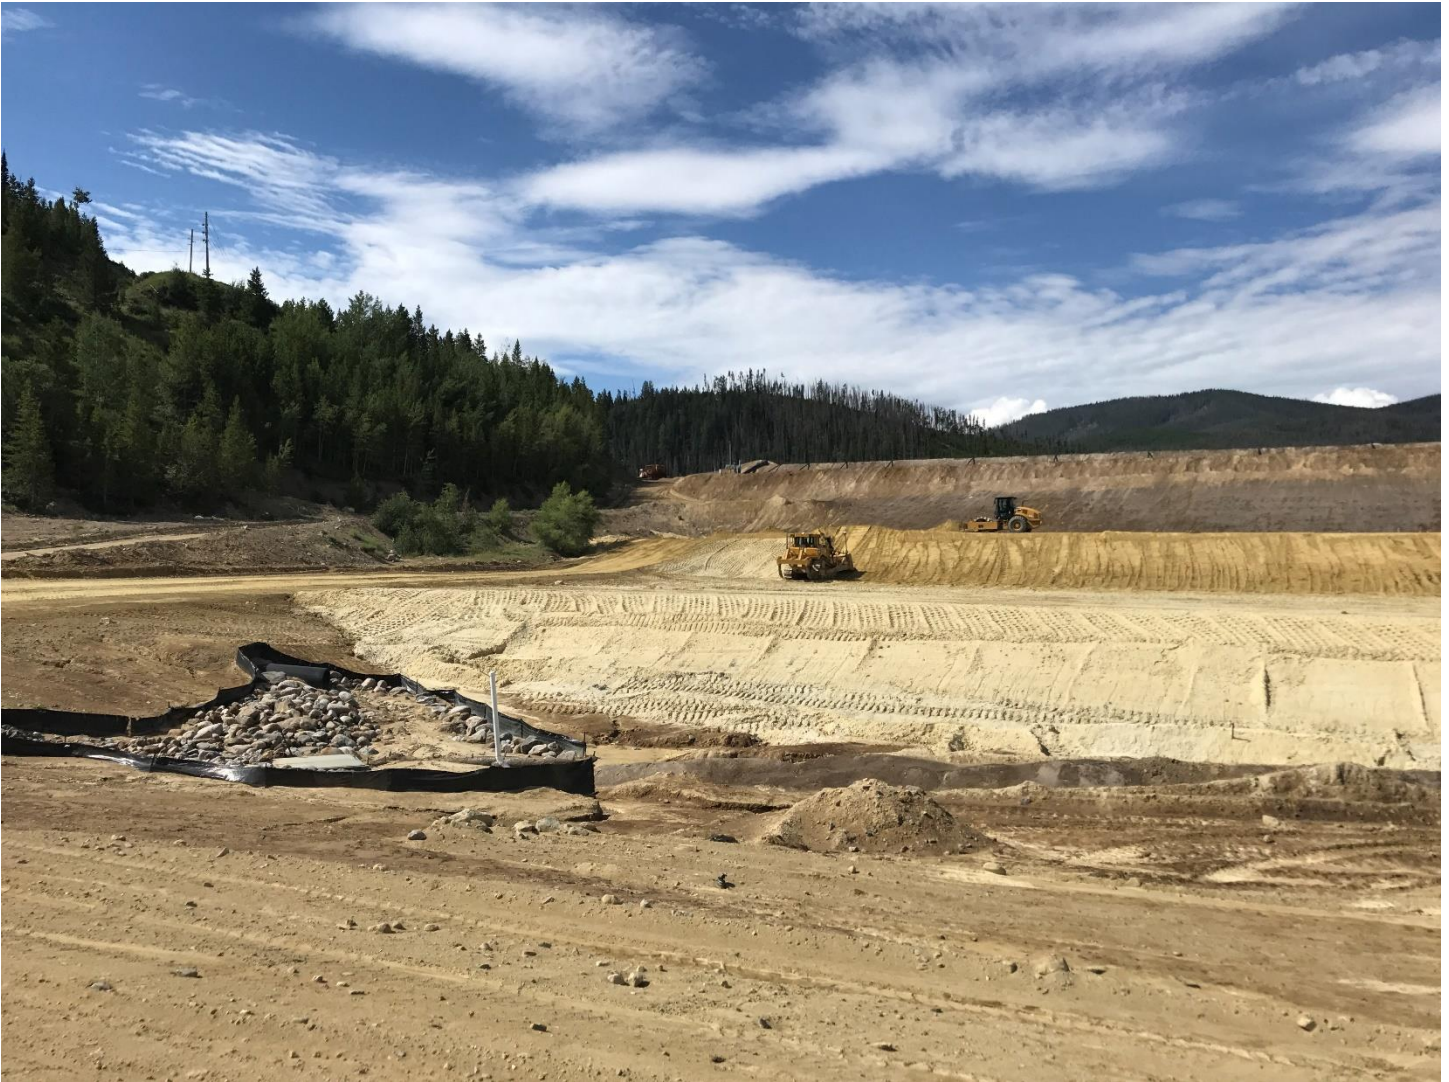
The 3-Dam Buttress – Stage 1 project approved under TR-29 by the Division on April 4, 2018 is expected to be completed in 2 weeks. 82,000 cubic yards have been hauled so far with 2 more feet to go. All buttress material is placed and instrumentation including two (2) piezometers and two (2) inclinometers will be installed. The surface of the buttress was sprayed with Coherex to prevent wind erosion. The Operator will survey the buttress and produce as-built drawings as required by Rule 7.3.1. The design for Phase 2 of the buttress project is expected to occur over the winter with construction of the Phase 2 occurring next summer.

3 Dam Buttress Project

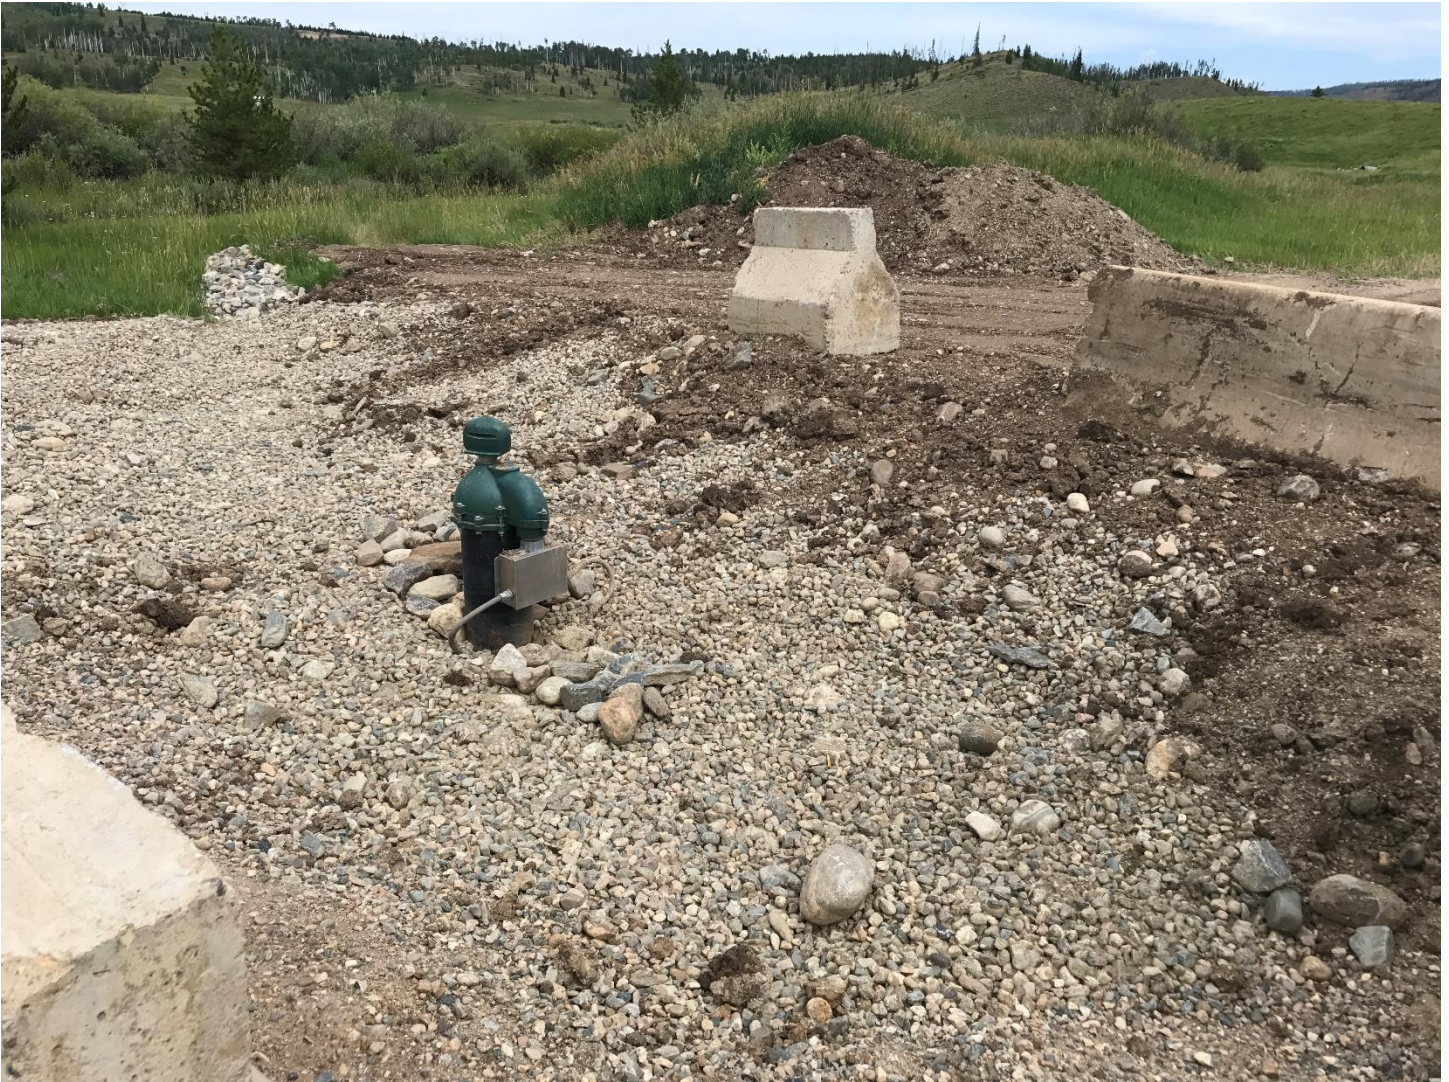
Repairs have been made and appears to be working properly.

MLEX-5 Complete
