**MINERALS PROGRAM INSPECTION REPORT**  
**PHONE: (303) 866-3567**

<b>MINE NAME:</b> Shaffers Crossing	<b>MINE/PROSPECTING ID#:</b> M-1978-208	<b>MINERAL:</b> Sand and gravel	<b>COUNTY:</b> Jefferson
<b>INSPECTION TYPE:</b> Monitoring	<b>INSPECTOR(S):</b> Michael A. Cunningham	<b>INSP. DATE:</b> January 19, 2018	<b>INSP. TIME:</b> 09:00
<b>OPERATOR:</b> Elk Creek Sand & Gravel, LLC	<b>OPERATOR REPRESENTATIVE:</b> Juliet Moores	<b>TYPE OF OPERATION:</b> 110c - Construction Limited Impact

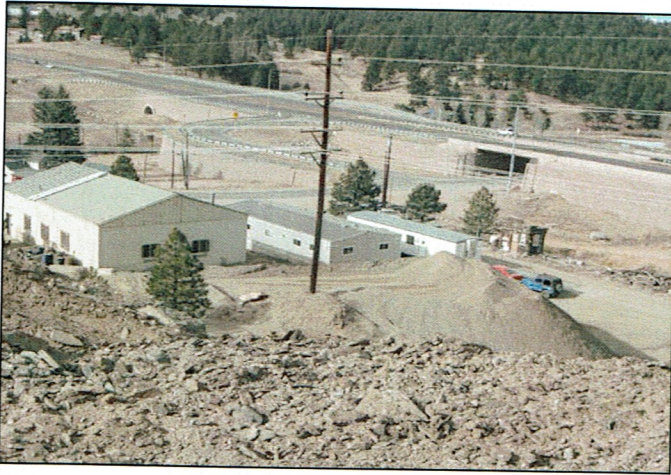
1. Overview of mine facilities.

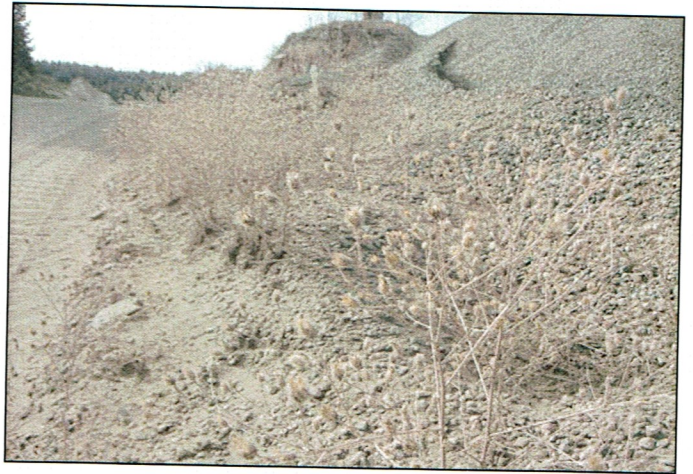
**PROBLEM/POSSIBLE VIOLATION:** Problem: There are state-listed noxious weeds present on site. This is a problem for failure to employ weed control methods for state listed noxious weed species within the permitted area, and to reduce the spread of weeds to nearby areas as required by Section 3.1.10 (6) of the rule.

The Division observed diffuse knapweed throughout the site. Diffuse knapweed is a state listed noxious weed and must be controlled pursuant to Rule 3.1.10(6). A review of the permit file found the Shaffers Crossing operation does not have an approved Weed Control Plan. This matter has been cited as a problem and will require corrective action by the Operator; please see the first page of this report for additional information.

2. Diffuse knapweed growing along internal mine road.

**CORRECTIVE ACTIONS:** Implement approved weed control plan and provide proof to the Division that this has been done. If a weed control plan is not already in place, the operator shall develop a weed control and management plan in accordance with Section 3.1.10 (6) of the Rule. This plan should be developed in consultation with the county extension agency, or weed control district office and should include specific

control measures to be applied, a schedule for when control measures will be applied and a post-treatment monitoring plan. This weed control plan shall be submitted to the Division as a Technical Revision to the approved plan with the appropriate Technical Revision fee of \$216.00 by the corrective action date.

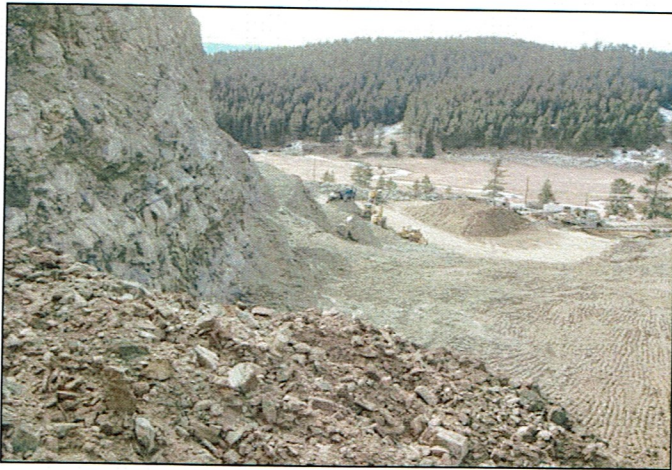
3. Overview of lower quarry. Photo taken from north end of highwall.

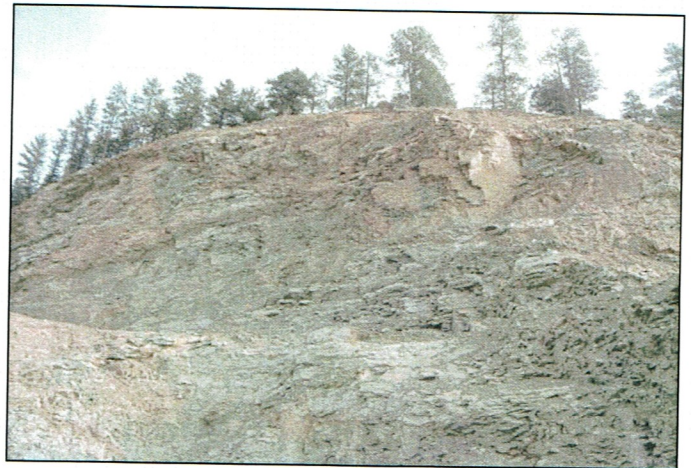
**PROBLEM/POSSIBLE VIOLATION:** Problem: The benches on the highwall do not conform to the approved dimensions specified in the Mining Plan. This is a problem pursuant to C.R.S. 34-32.5-110(1)(a)(VII) for failure to follow the approved Mining Plan.

Measurements of the highwall were taken along the northernmost section and the highwall was determined to be 60 ft. in height (a map showing the location of the highwall measurements has been attached for reference). There is a working platform at the base of the highwall, which when removed will increase the overall height of the highwall. A small bench has been established approximately 30' from the top of the highwall. The Mining Plan calls for creating benches which are 12 ft. wide and 35 ft. in height. The Division could not access the bench to measure the width. However, visual observations were made from the side of the highwall and it was determined the bench was 1 - 2 ft. in width. As previously noted, the top of the highwall is in line with the permit boundary. As a result, the Operator will not be able to create a 12 ft. wide bench along this portion of the highwall. This matter has been cited as a problem and will require corrective action by the Operator; please see the first page of this report for additional information.

4. Northern section of the highwall. Photo taken facing east.

**CORRECTIVE ACTIONS:** The operator shall convert the 110c Reclamation Permit to a 112c Reclamation Permit so the permit boundary may be expanded to allow the benches on the highwall to be constructed in accordance with the approved Mining Plan. The Conversion Application, with a fee of \$2,696.00 shall be submitted to the Division on or before the corrective action date.

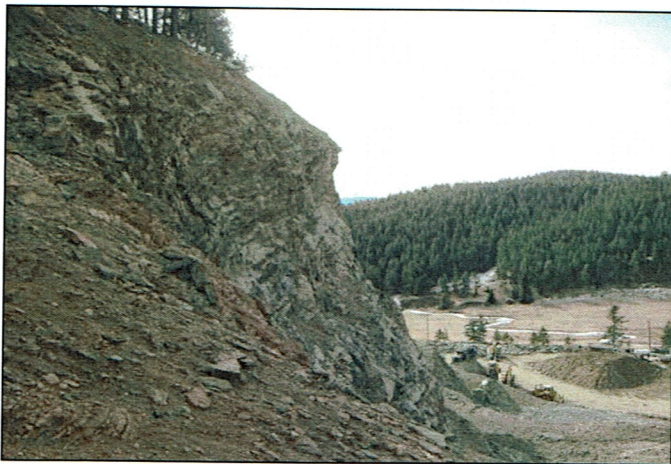
5. Overview of upper section of highwall.

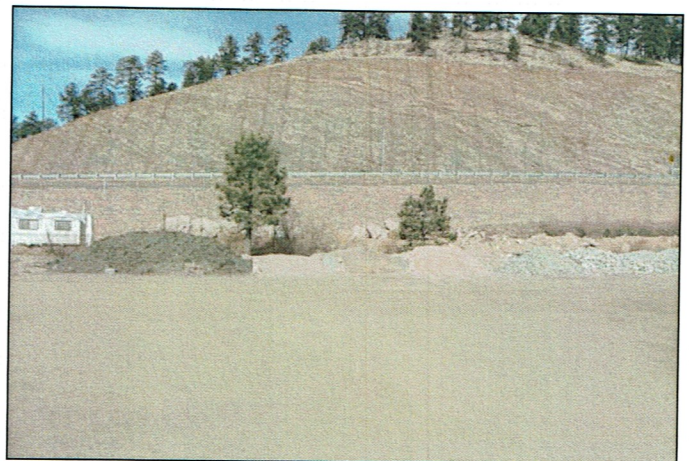
6. Quarry floor and product stockpiles.

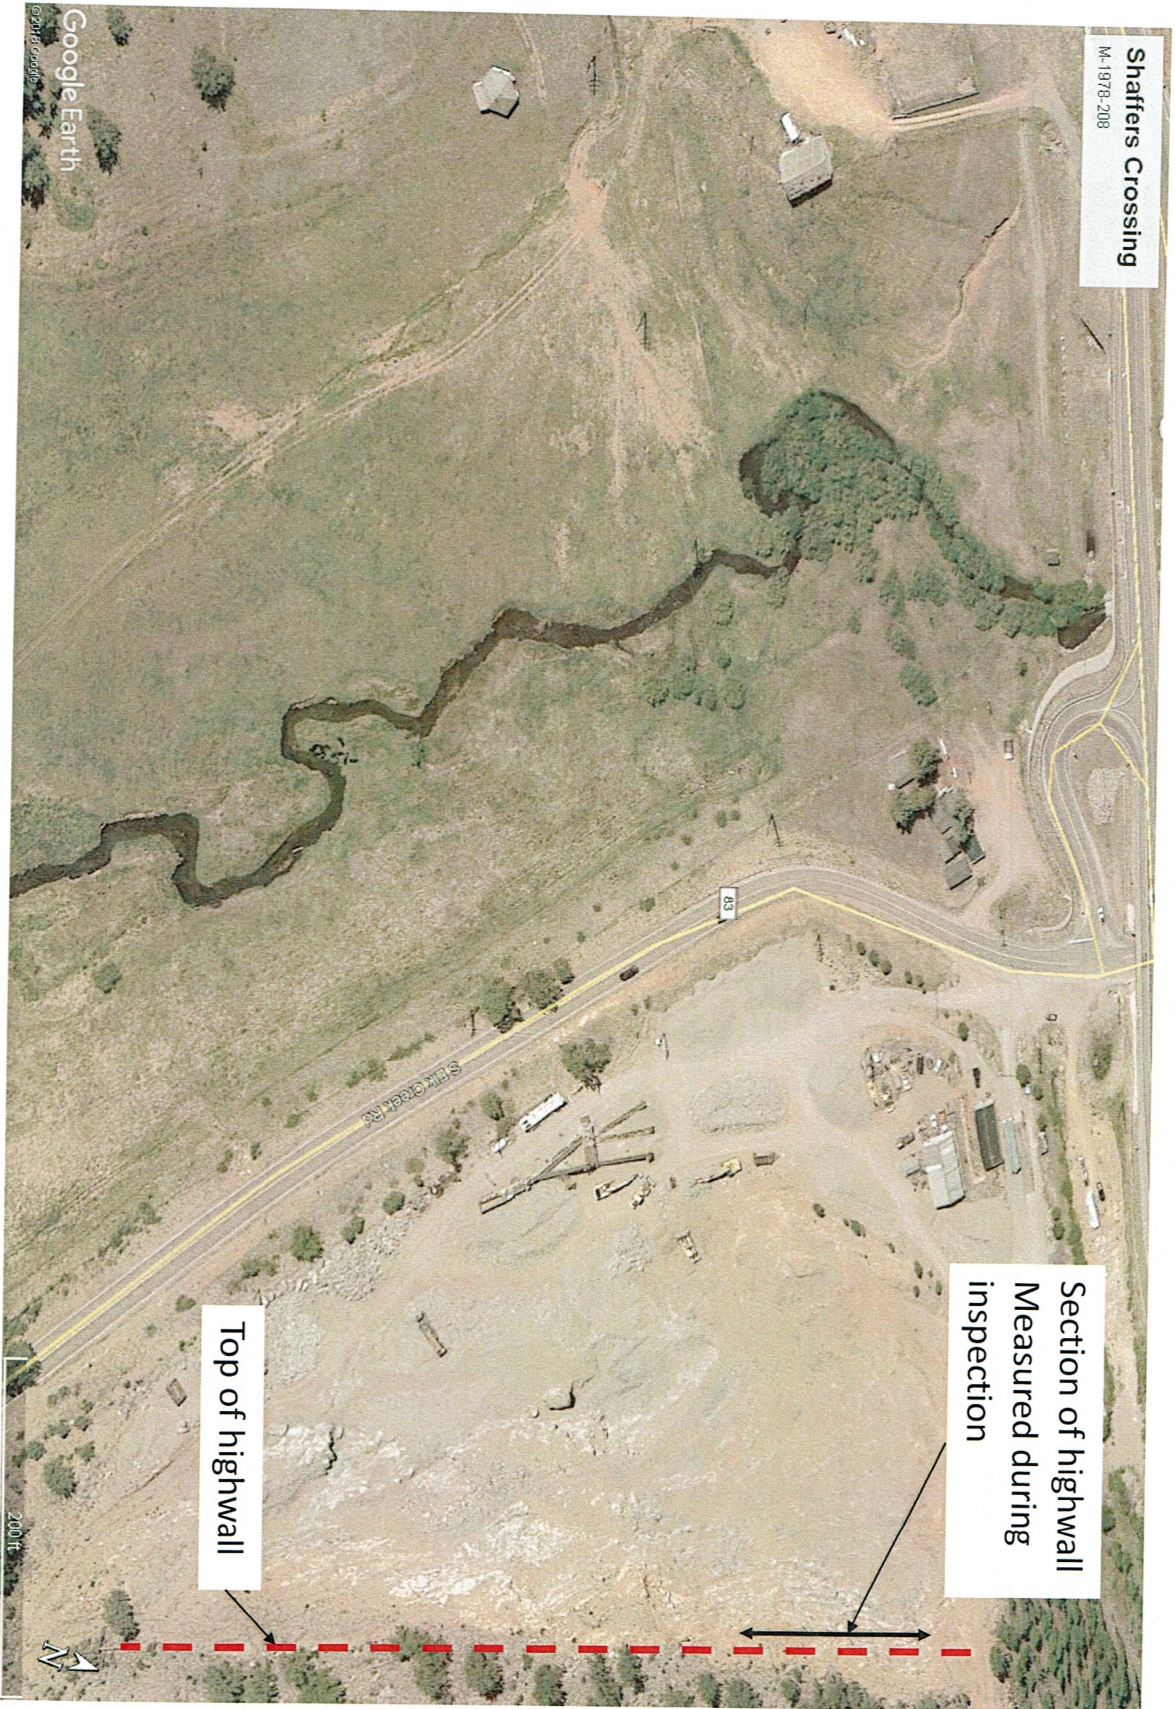
Section of highwall  
Measured during  
inspection
