MINERALS PROGRAM INSPECTION REPORT  
PHONE: (303) 866-3567

| MINE NAME: | Shaffers Crossing | MINE/PROSPECTING ID#: | M-1978-208 | MINERAL: | Sand and gravel | COUNTY: | Jefferson |
| INSPECTION TYPE: | Monitoring | INSPECTOR(S): | Eric Scott | INSPECTION DATE: | December 4, 2019 | INSPECTION TIME: | 07:40 |
| OPERATOR: | Elk Creek Sand & Gravel, LLC | OPERATOR REPRESENTATIVE: | Juliet Moores | TYPE OF OPERATION: | 110c - Construction Limited Impact | | |

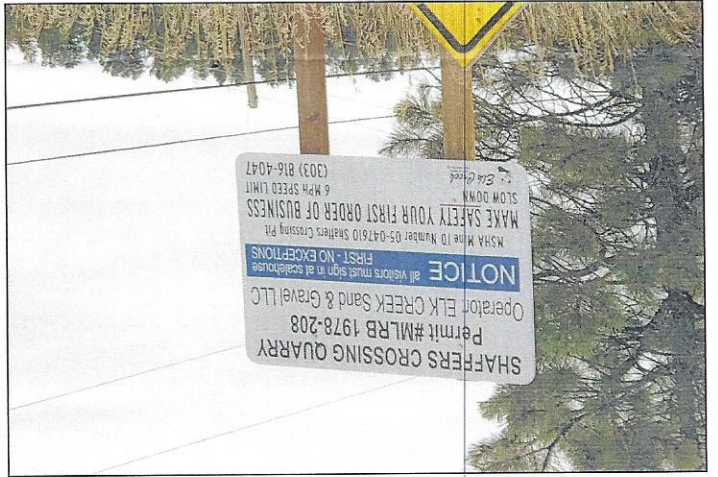
The site was inactive at the time of the inspection. The site identification sign was present at the site entrance, however permit boundary markers were not observed by DRMS during this inspection. Site conditions during this inspection are shown in the attached photos and were generally typical for this type and scale of operation.

Photo 1 – Site identification sign present at site entrance.

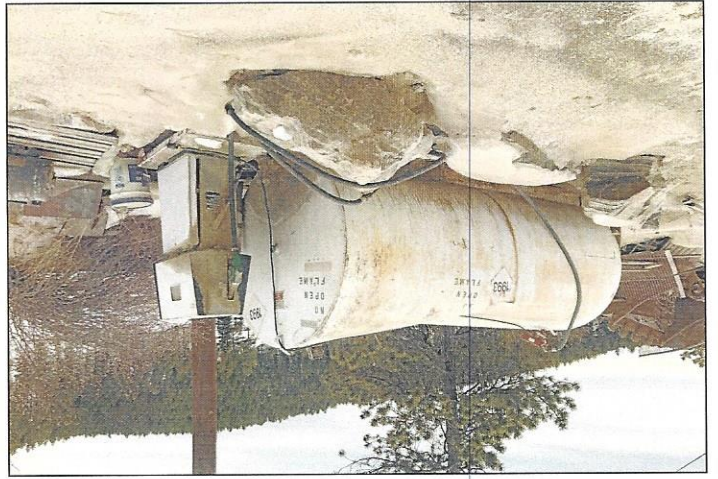
Structures on the site consisted of the scale and an adjacent single-wide trailer as scale house, a double wide trailer adjacent to and south of the scale house, and a cinder-block building, approximately 40' x 60' with a metal roof, immediately south of that (photo 6). Photo 3 shows an equipment fueling station and fuel tank located along the west side of the permit area. DRMS concluded the inspection at approximately 8:20 and left the site.

Photo 3 – Equipment fueling station located on west side of site.

Aside from those factors, the approved post-mining land use of industrial-commercial leaves considerable flexibility in the final state of the permit area. If the post-mining use chose to make use of the existing cinder block structure, and/or required only minimal pre-development site grading, the existing bond would likely cover the majority of the required work, such as removal of the scale and portable trailers, and removal of the fuel station.

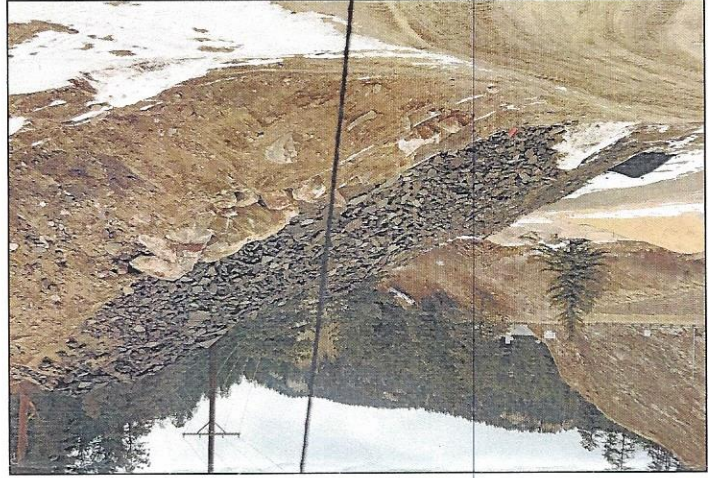
PROBLEM/POSSIBLE VIOLATION: Problem: Asphalt importing and recycling taking place at the site is not part of the currently approved mine plan. The current mine plan needs to be updated and clarified pursuant to C.R.S. 34-32.5-112 (1)(c)(VI). The operator must provide sufficient information to describe or identify how the operator intends to conduct the operation.

MLRB order have not been complied with. The current bond also does not address the removal of the asphalt stockpile currently present on-site, but not part of the approved mining plan.

Photo 5 – Stockpile of imported asphalt present in northeastern area of permit. Material import and recycling is not currently part of the approved mine plan.

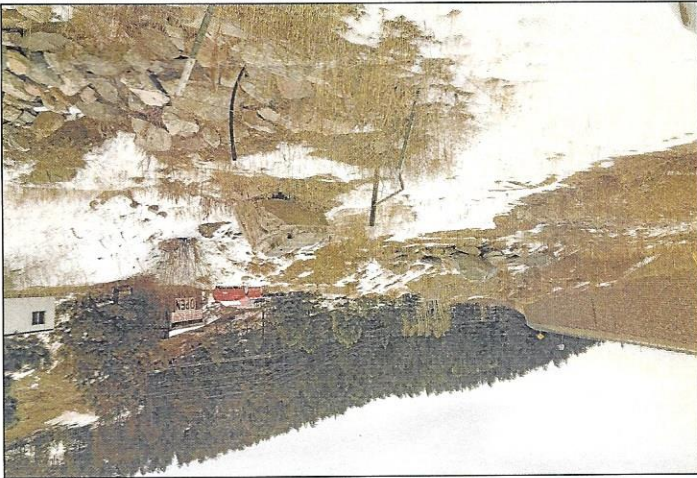
Photo 2 – Northern permit boundary area adjacent to Highway 285. No permit boundary markers present.

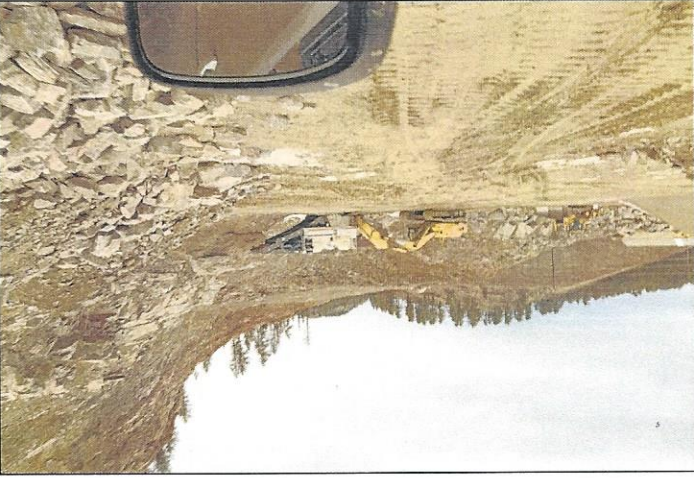
Two areas of more recent excavation activity were noted. The larger, and what appeared to be the primary area, was located near the south end of the permit immediately north of the highwall (Photo 4) where a crusher and sorter were staged nearby. There was no indication that the highwall itself had been worked or advanced recently. There did not appear to be any immediate stability concerns associated with the highwall at the time of this inspection, however, a detailed examination of the highwall was not conducted as part of this inspection. Some additional work to insure the long-term stability of the highwall, or fencing to prevent access, would likely be required if it is to be left in its current configuration. The second, smaller excavated area was located behind an imported asphalt stockpile (Photo 5). It should be noted that importing and recycling of materials such as concrete and asphalt were not part of the approved mining plan.

Heavy equipment and processing equipment typical of this type of operation (dozer, end loaders, crusher, crusher/screener, track-hoe, etc.) was present on-site, but idle, near areas of previous activity (Photo 4). Product stockpiles of various materials and size were located throughout the permit area.

Photo 4 – Area of recent excavation located in South-center area of permit at base of high-wall.

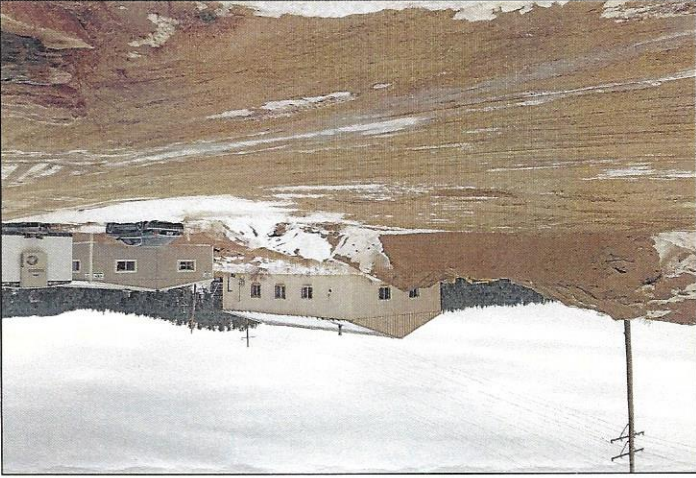
Photo 6 – Material stockpile near scale-house shows signs of recent activity.
