DRMS SUPPLEMENTAL REPORT: Concerns in re COMPLIANCE RE BENCHING within HIGHWALL  
12/6/18

MLRB 1978-208 Shaffers Crossing

ADDENDUM TO 2019 Annual DRMS Report

Shaffer Crossing Quarry Facility

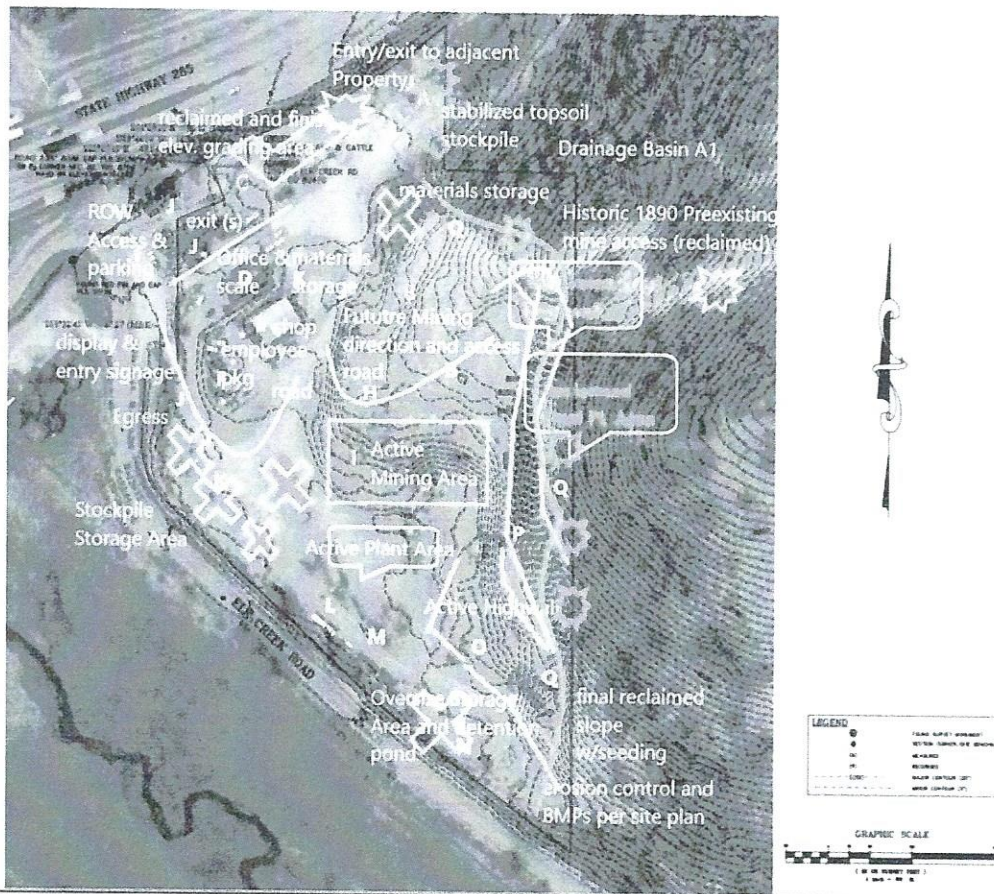
## TOPOGRAPHIC SURVEY

Exhibit 1 Indicates detail of activities superimposed on topographic map depicting the boundary locations and location of reclaimed acreages as indicated in the annual report pursuant to the Colorado Mined Land Reclamation Act and/ or the Colorado Land Reclamation Act for the Extraction of Construction Materials (C.R.S. 34-32-116 or 34-32.5-116). Shows the current affected acreages and area under production. Due to the restricted area and nature of the cut this typically does not see a wide variety of changes annually.

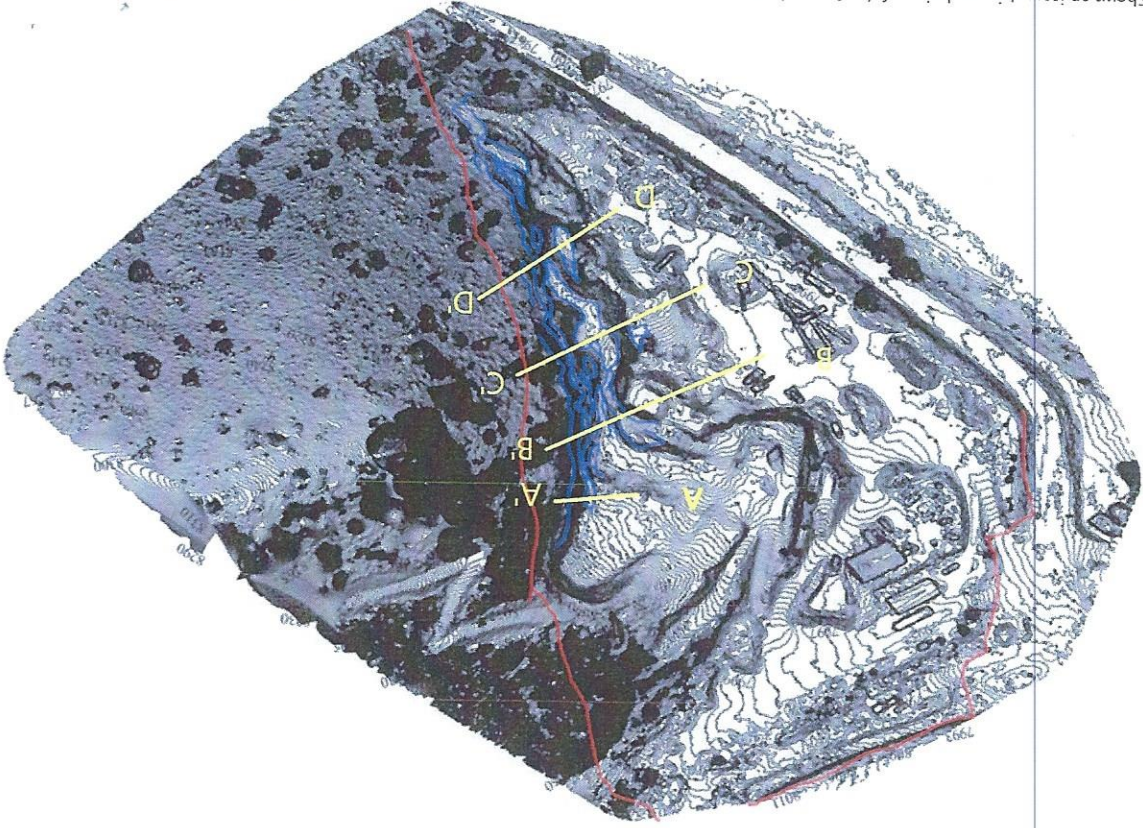
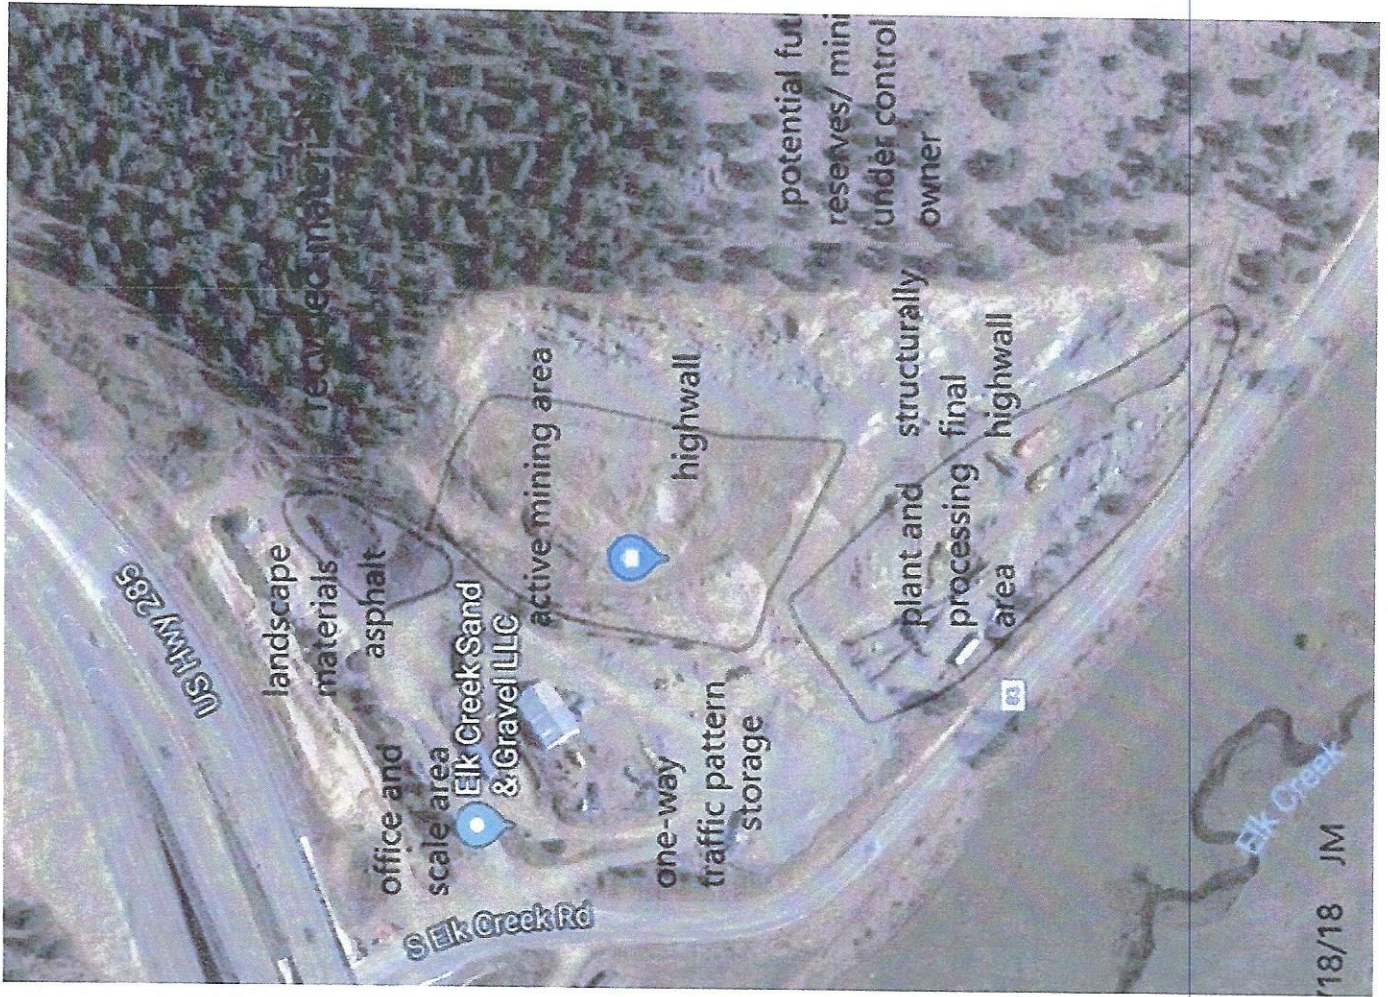
Fig. 2. Shows an isometric rendering of the Quarry indicating contours (5ft intervals) and demonstrating the defined benches (bl established from the top of highwall and declining. These indicate bench patterns fall within the prescribed configuration as ap permitted and on file with DRMS (2006). Mining is partly complete and thus bench configuration is not final. Pit perimeter ind
