MINERALS PROGRAM INSPECTION REPORT
PHONE: (303) 866-3567

MINE NAME: May Day Idaho Mine Complex	MINE/PROSPECTING ID#: M-1981-185	MINERAL: Gold and silver	COUNTY: La Plata
INSPECTION TYPE: Monitoring	INSPECTOR(S): Lucas West	INSP. DATE: November 13, 2019	INSP. TIME: 11:00
OPERATOR: Sunrise Mining LLC	OPERATOR REPRESENTATIVE: None	TYPE OF OPERATION: 112d-2 - Designated Mining Operation	
REASON FOR INSPECTION: Normal I&E Program	BOND CALCULATION TYPE: None	BOND AMOUNT: \$204,562.00	
DATE OF COMPLAINT: NA	POST INSP. CONTACTS: None	JOINT INSP. AGENCY: None	
WEATHER: Clear	INSPECTOR'S SIGNATURE:

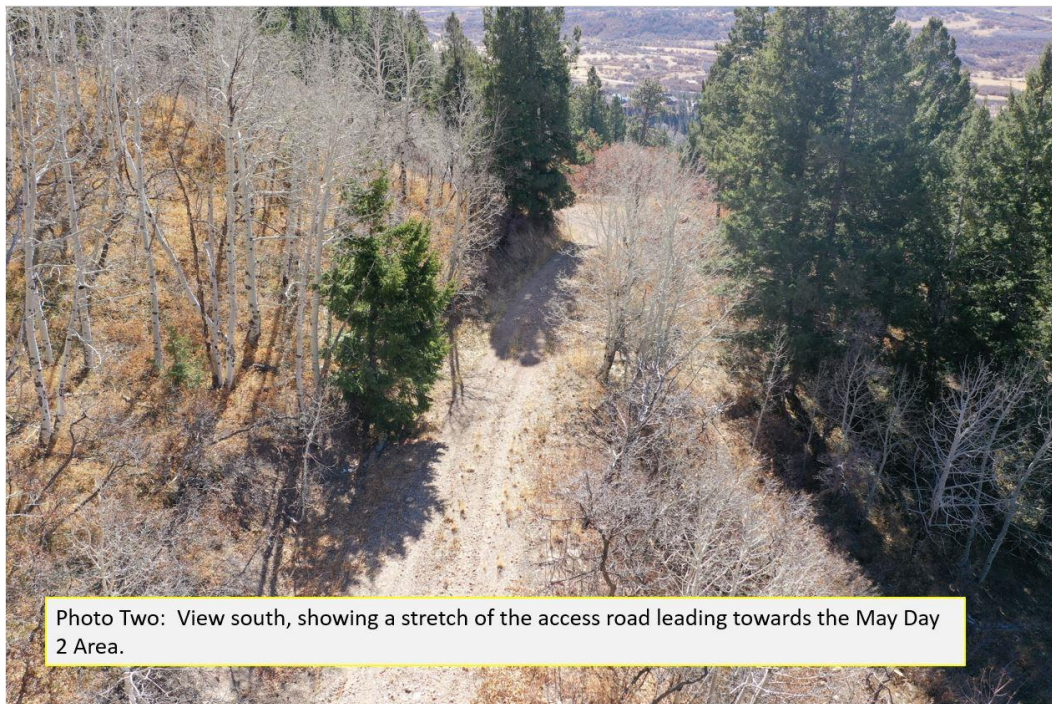
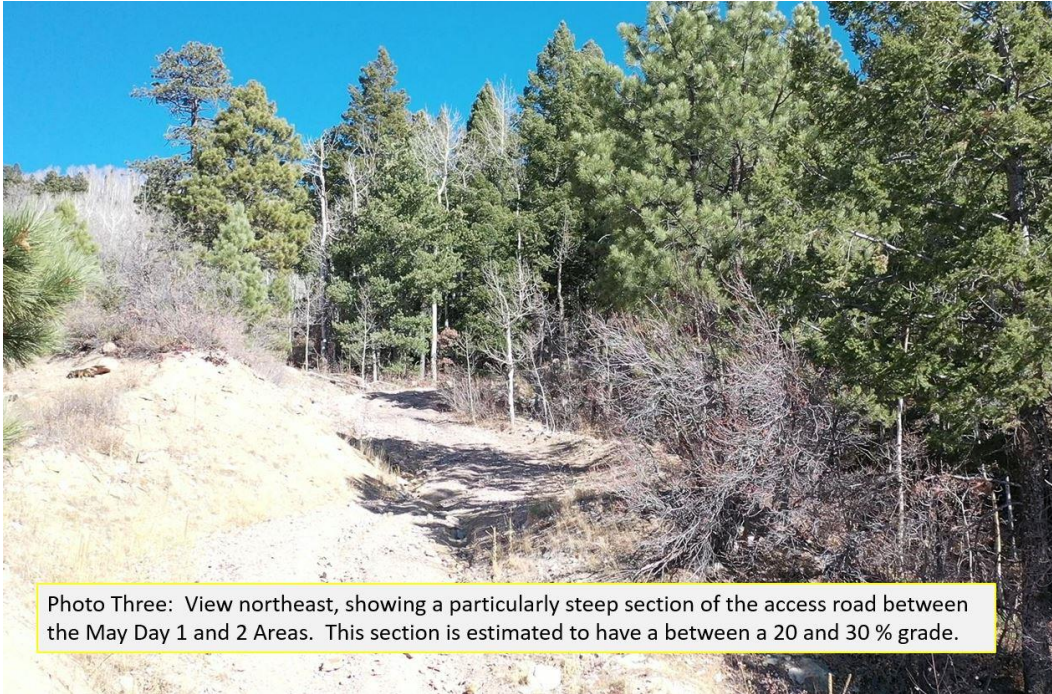
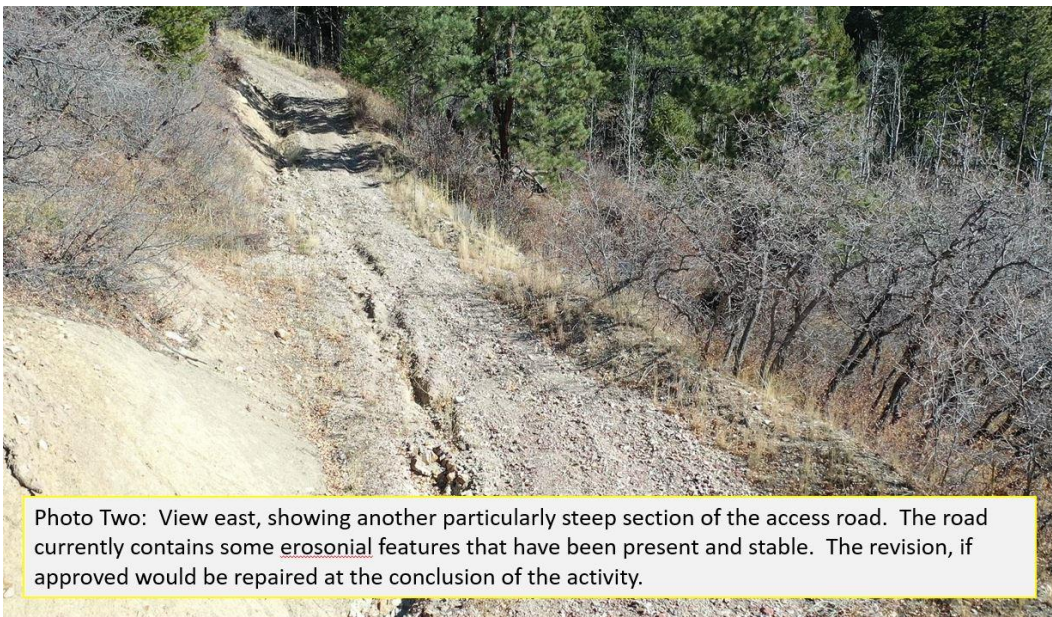
As stated previously, this inspection serves as a "pre-operational" inspection for activities proposed under TR-09. If approved, TR-09 will allow for the removal of a ball mill from the May Day 1 area. The ball mill is a large piece of equipment that is proposed to be moved with a dozer and an excavator down the access road, through the May Day 2 Area, down to the La Plata River Bridge, across the river via a one-time use of the low water crossing, and up to the Base of Operations Area where it will be loaded and removed from the site. The revision also proposes the removal of a large generator and camper trailer as well as other various items located on site. Also included in the revision will be the dismantling of the old mill building to remove the mill, the repair of the building after its removal, and the repair of the road after any significant damage during the removal of the mill. The old mill building appears stable at this time and can be seen in Photo One. The access road leading from the May Day 1 Area down to the May Day 2 Area is very steep, and includes several switch backs. This section of road is of particular concern for damage during the removal process. Photos Two through Four show this section of the access road.
