MINERALS PROGRAM INSPECTION REPORT
PHONE: (303) 866-3567

MINE NAME: Hawkeye Mine	MINE/PROSPECTING ID#: M-1978-311	MINERAL: Uranium and vanadium	COUNTY: San Miguel
INSPECTION TYPE: Monitoring	INSPECTOR(S): Lucas West	INSP. DATE: November 21, 2019	INSP. TIME: 09:05
OPERATOR: Gold Eagle Mining, Inc.	OPERATOR REPRESENTATIVE: Kyle Turley, Navarro	TYPE OF OPERATION: 110d - Designated Limited Impact	
REASON FOR INSPECTION: Normal I&E Program	BOND CALCULATION TYPE: None	BOND AMOUNT: \$100.00	
DATE OF COMPLAINT: NA	POST INSP. CONTACTS: None	JOINT INSP. AGENCY: None	
WEATHER: Clear	INSPECTOR'S SIGNATURE:

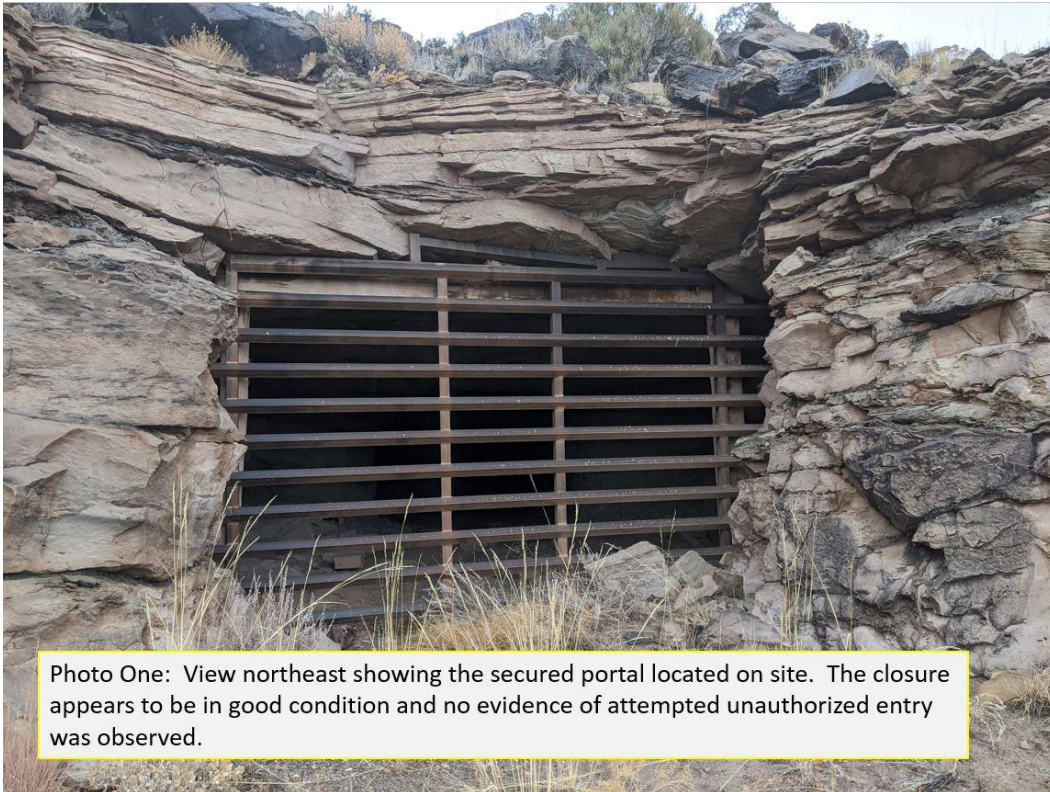
The site contains a secured portal onsite leading to the underground workings that is closed with a welded steel closure. The portal closure, seen in Photo One, is stable and in good condition. It shows no signs of vandalism or attempted unauthorized entry. The access road leading to the portal is equipped with various storm water control structures and appears to be stable. The access road can be seen in Photo Two. Adjacent to the portal is a natural drainage leading down toward the county road. The storm water controls lead through the site, down the natural drainage to a small "sediment pond" near the County Road. The sediment pond is well vegetated to dissipate flows and was in good condition. The previously observed noxious weeds on site were not observed during this inspection. Further monitoring should be conducted to ensure they do not return during the spring.

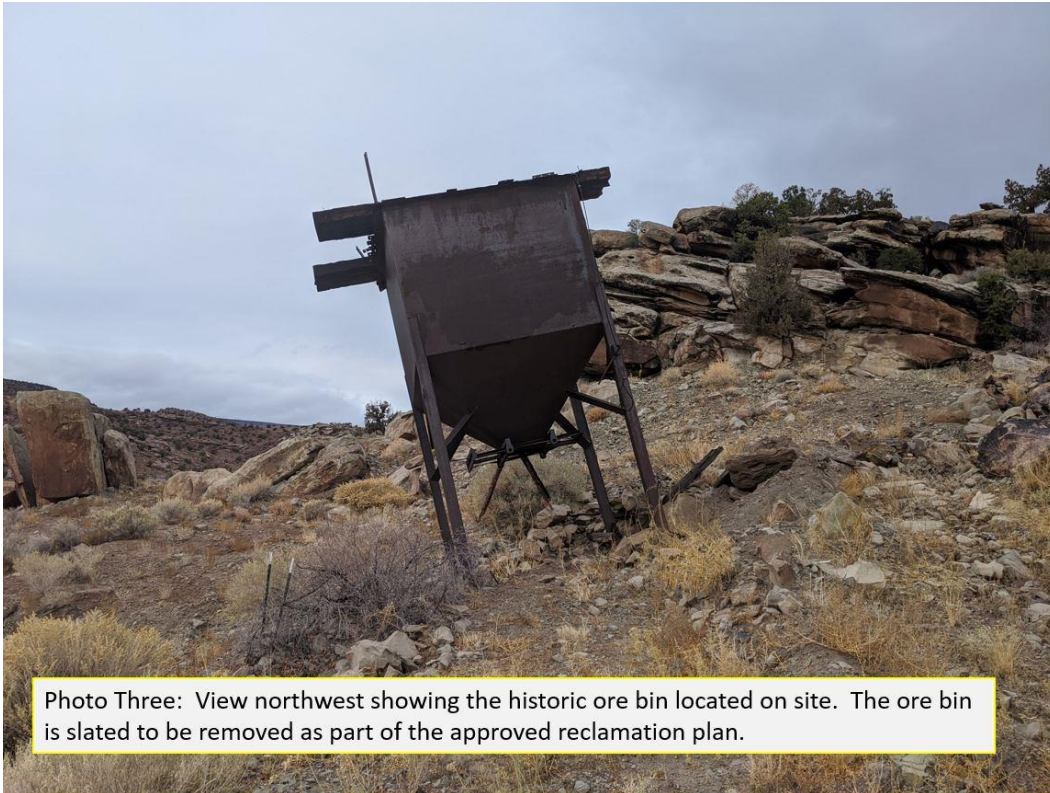
The site includes a steel ore hopper, as seen in Photo Three. The hopper is empty and free standing in a natural drainage located on the site. The ore bin appears to be in similar condition to the previous inspection and has the potential to be a public safety hazard. The bin is to be removed and disposed of in accordance with the approved reclamation plan and should be done as soon as is allowed. Removal and disposal of the ore bin is one of the last remaining reclamation tasks to be completed at the site. Also located on site is the historic waste rock pile that had been recontoured and topsoiled some time ago. The vegetation is well established and appears to be healthy given the time of year and growing season.
