**MINERALS PROGRAM INSPECTION REPORT**  
**PHONE: (303) 866-3567**

| <b>MINE NAME:</b><br>Ellison Mine | <b>MINE/PROSPECTING ID#:</b><br>M-1978-342 | <b>MINERAL:</b><br>Uranium and vanadium | <b>COUNTY:</b><br>San Miguel |
| <b>INSPECTION TYPE:</b><br>Monitoring | <b>INSPECTOR(S):</b><br>Lucas West | <b>INSP. DATE:</b><br>November 21, 2019 | <b>INSP. TIME:</b><br>09:30 |

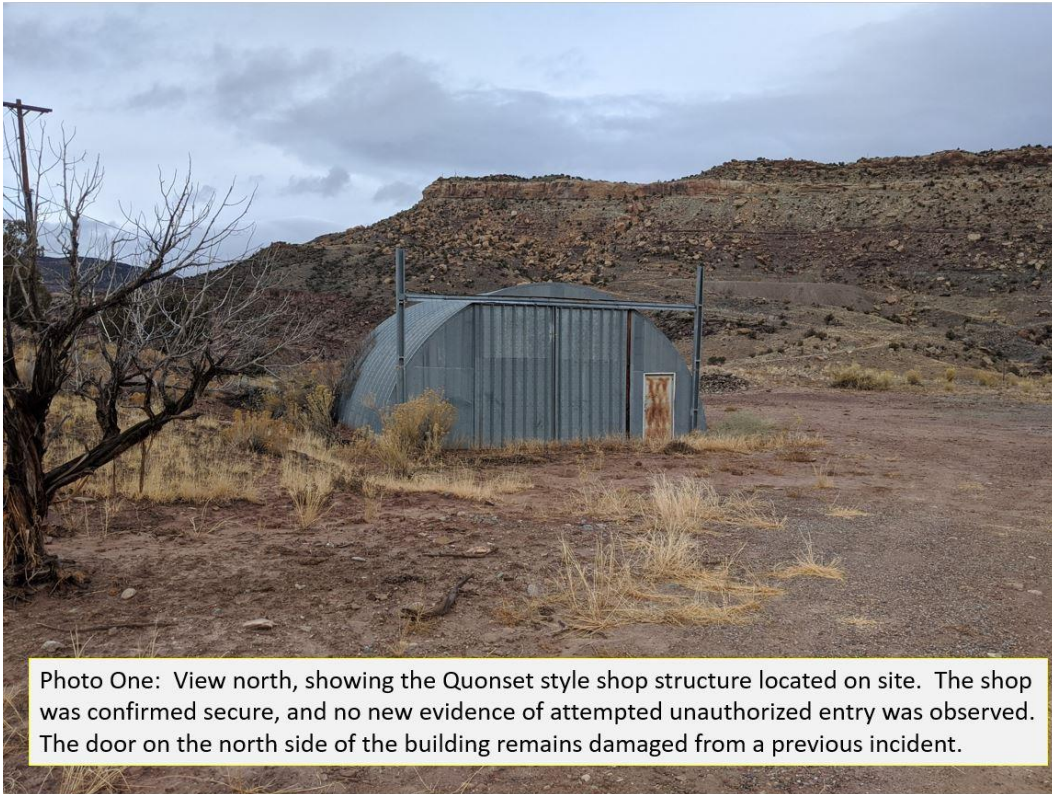
Photo One shows the Quonset hut style structure located on site. The structure was secure and in good condition at the time of this inspection. The door to the structure was vandalized in the past and remains in the same condition as it was during the previous inspection. Also located on is a shipping container used for storage that was also secured and in good condition. The main pad and work area that the structure, container and portal are located on was in good condition and well vegetated with native grasses and shrubs. The pad and work area can be seen in Photo Two and the shipping container can be seen in Photo Three. The portal, shown in Photo Four is enforced with a Quonset style structure leading underground, and secured with a locked, welded steel grate. All components associated with the portal are in good condition and show no signs of attempted unauthorized entry.

Photo One: View north, showing the Quonset style shop structure located on site. The shop was confirmed secure, and no new evidence of attempted unauthorized entry was observed. The door on the north side of the building remains damaged from a previous incident.

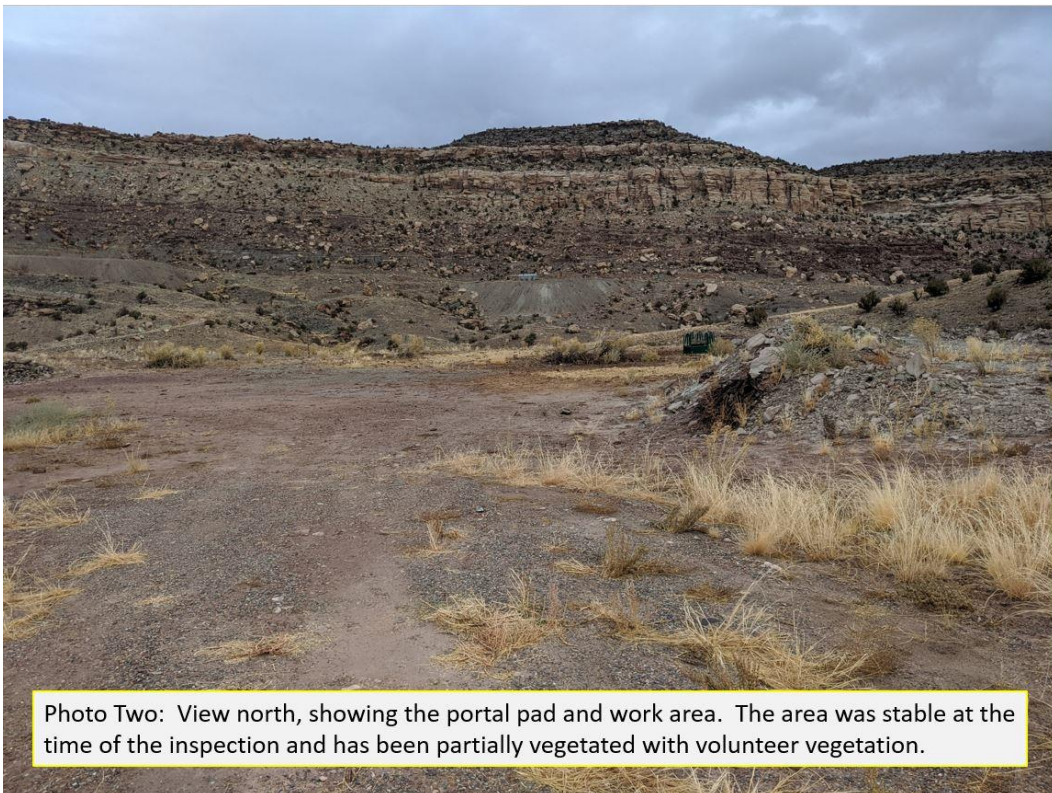
Permit boundary markers were observed, and all disturbance was inside the permitted area. The storm water controls were also observed and appeared to be functioning as designed. Evidence of storm water control device maintenance was observed. The maintenance work was approved and supervised by the DOE. No erosional issues were observed during this inspection. The slopes of the main pad and work area were all well vegetated and appear to be stable.

Photo Two: View north, showing the portal pad and work area. The area was stable at the time of the inspection and has been partially vegetated with volunteer vegetation.

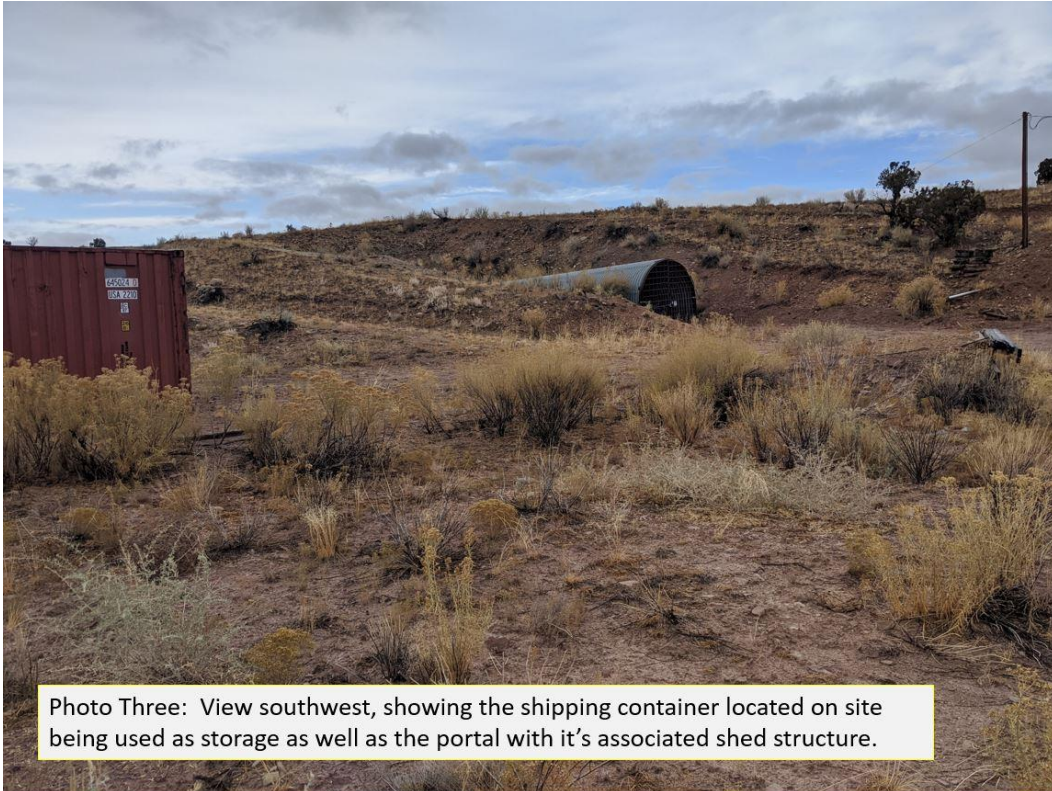
Photo Three: View southwest, showing the shipping container located on site being used as storage as well as the portal with it's associated shed structure.

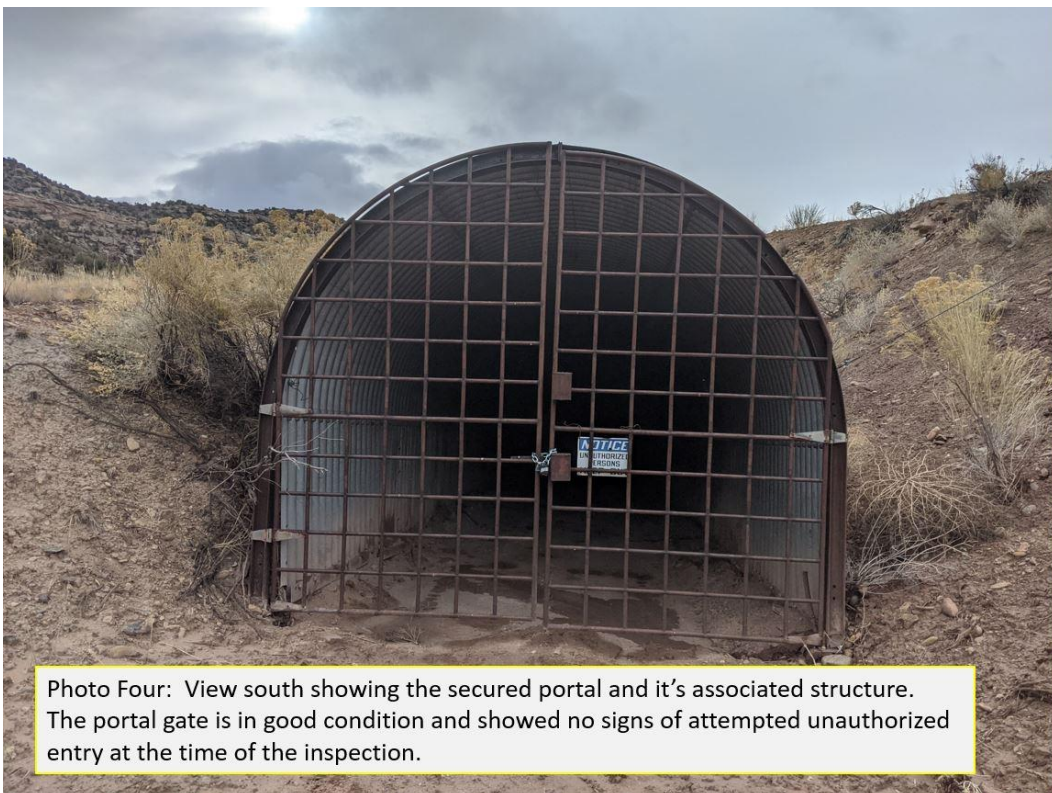
Photo Four: View south showing the secured portal and it's associated structure. The portal gate is in good condition and showed no signs of attempted unauthorized entry at the time of the inspection.
