**Re: Magpie Diversion**

I do have some thoughts about why the Magpie Diversion needs additional repair that I have attached as a report named Magpie Diversion 2.pdf.

## MAGPIE DIVERSION

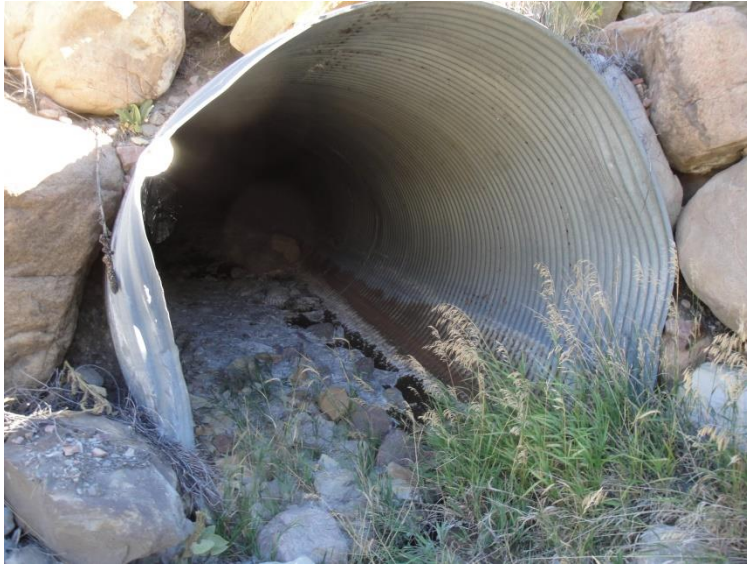
The inlet of the 8.8 ft. culvert that the Magpie Diversion empties into has been damaged and bent so that its flow properties are not equal to the ideal undamaged 8.8 ft. culvert. This damage was confirmed by the DRMS inspection report on Nov. 7, 2017, plus additional deficiencies such as insufficient channel depth and a lack of adequate freeboard.<sup>11</sup>

Picture 1. Damaged inlet of 8.8 ft. culvert.

The cross-sectional area of the inlet is reduced 16%.<sup>8</sup> The culvert outlet is also bent reducing the flow capacity.

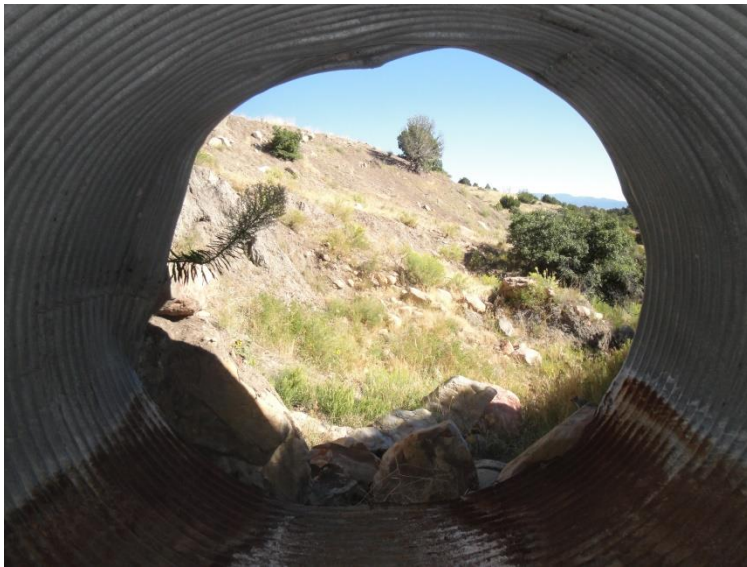
Picture 2. Damaged outlet of 8.8 ft. culvert.

The center portion of the culvert directly underneath the haul road has been compressed so that the cross-sectional area is reduced. How much reduction in flow caused by these problems is unknown because Federal Culvert Charts do not have information covering this type of culvert inlet, outlet, and compression damage.

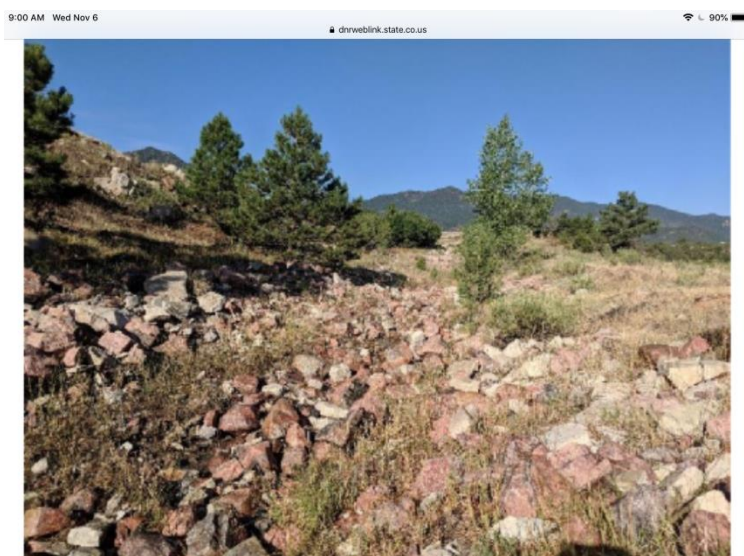
Since the construction of the permanent Diversion, there has never been a large enough 24 hour rain event to cause a significant flow of water in the Diversion. Since the 2016 removal of the rip-rap creating the bare area there has never been any significant flow of water in the Diversion channel. While the records may show that there was a 1.68 inch rain in Florence on July 24, 2018, there is no evidence at the Southfield Mine site that there was any significant flow of water in the Diversion. The photographs taken on July 25, 2018, in the DRMS inspection report<sup>9</sup> do not show the grass stems to be bent the day after the Florence rain. Flowing water would have left the grass flattened.

Picture 3. Magpie Diversion on July 25, 2018.<sup>9</sup>

I would agree that the bare area still appears stable, *but without flowing water on July 24, 2018, there is no proof that the Diversion will be stable in a 100 year event.* Please note that according to NOAA Atlas 2<sup>13</sup>, which was in use in 2002 when TR32 was approved for the Diversion construction, a 100 year 24 hour event was predicted to be 4.67 inches for the specific Magpie drainage area. This Atlas has been superseded by NOAA Atlas 14<sup>14</sup>, and a 100 year 24 hour event is now predicted to be 4.96 inches. Using the latest 100 year 24 hour NOAA data, the predicted flow in the Diversion would be far greater than flow depth, volume, and velocity than shown on Southfield Map 25A.
