MINERALS PROGRAM INSPECTION REPORT

MINE NAME: Phillips Ranch Property Gravel Pit #2	MINE/PROSPECTING ID#: M-2000-046	MINERAL: Sand and gravel	COUNTY: Fremont
INSPECTION TYPE: Monitoring	INSPECTOR(S): Timothy A. Cazier	INSP. DATE: August 28, 2019	INSP. TIME: 09:25
OPERATOR: Pioneer Sand Company, Inc.	OPERATOR REPRESENTATIVE: Jason Ulmer	TYPE OF OPERATION: 112c - Construction Regular Operation	
REASON FOR INSPECTION: Normal I&E Program	BOND CALCULATION TYPE: Partial Bond	BOND AMOUNT: \$117,123.00	
DATE OF COMPLAINT: NA	POST INSP. CONTACTS: None	JOINT INSP. AGENCY: Colo. Land Board	
WEATHER: Clear	INSPECTOR'S SIGNATURE:

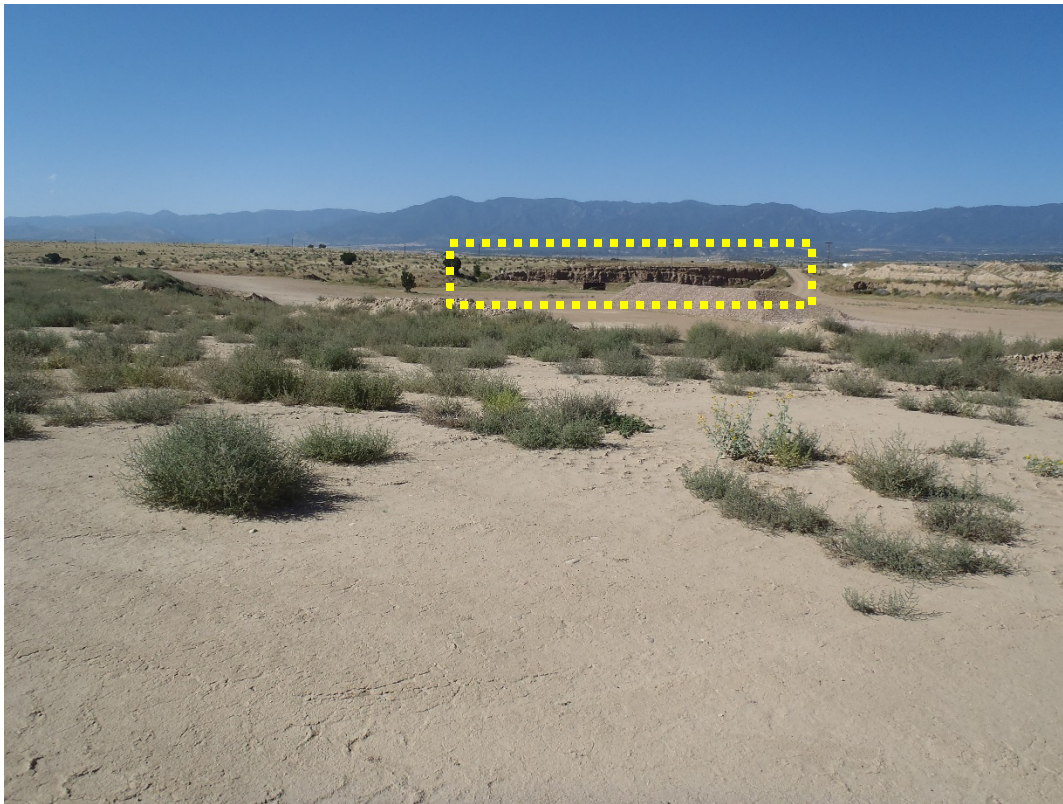
Photo 1. Active highwall (looking SW).

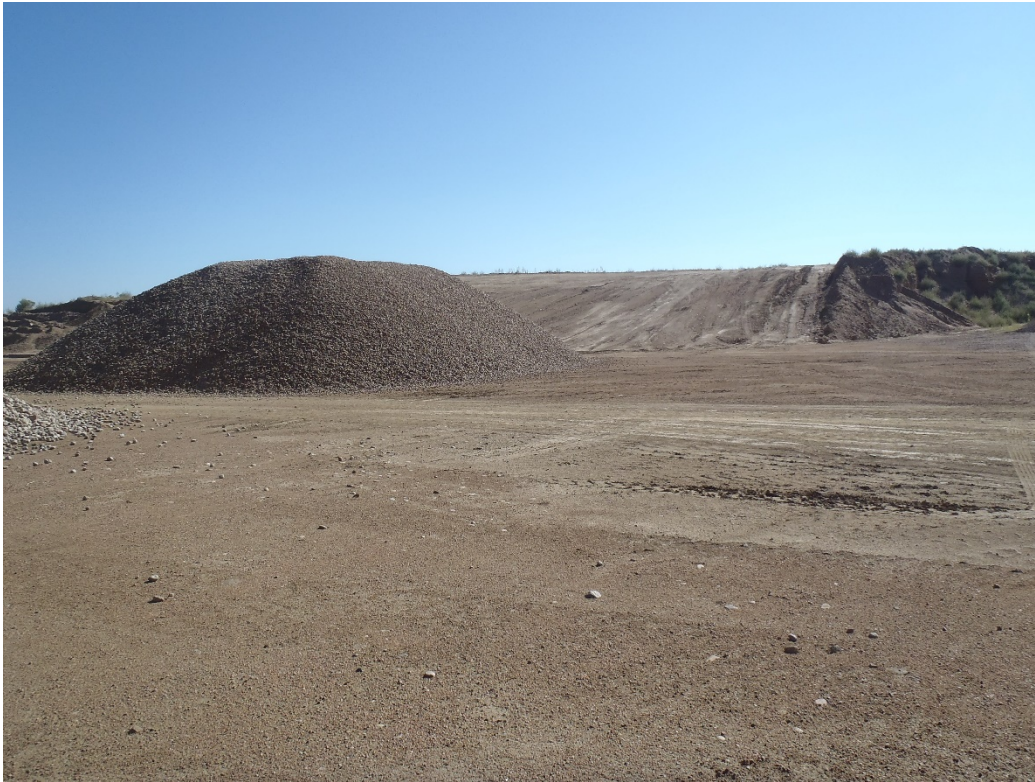
Photo 2. Product stockpile and sloped area beyond (looking east).

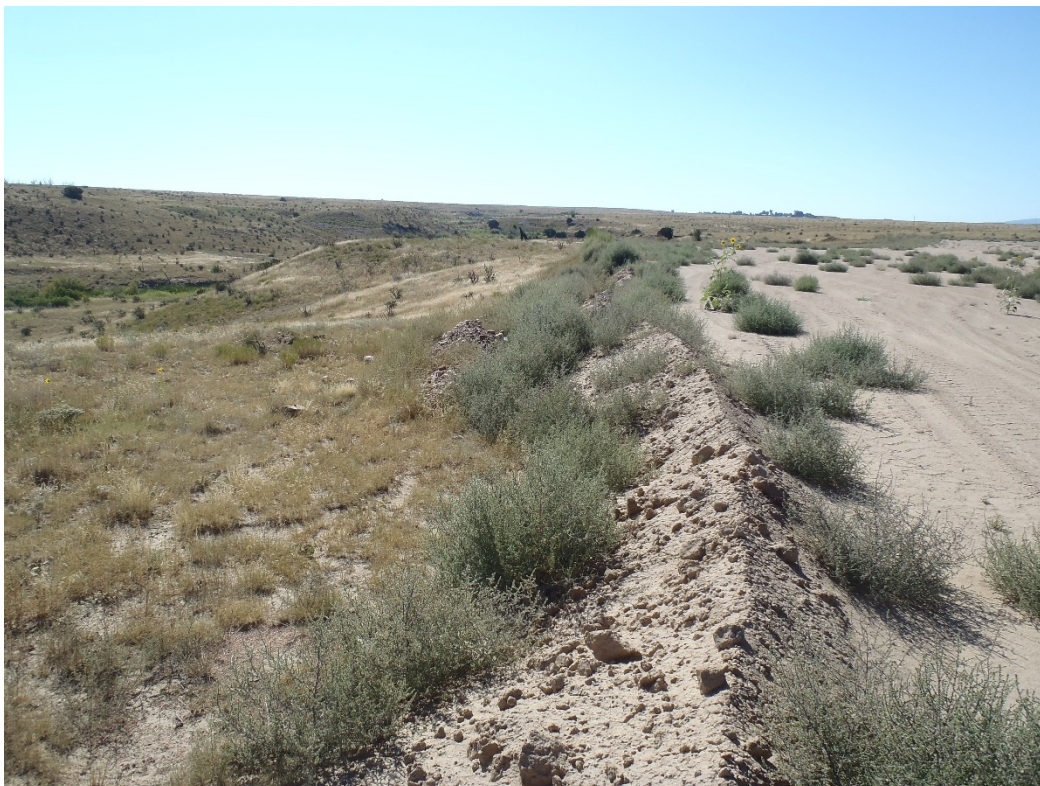
Gen. Compliance with Mine Plan: The operation appeared to be in compliance with the approved mine plan. Google Earth was used to measure the disturbed area, which was estimated to be approximately 34.2 acres, based on 2018 imagery (see attached **Post Inspection Map**). Highwalls were estimated to less than 15 feet in height and appeared stable (see **Photo 1**) or had been flattened to ear 3H:1V (see **Photo 2**). Mr. Ulmer indicated the plan is to continue mining north to Low Back Creek (see **Photo 3**), then south to the permit boundary.

Photo 3. North end of active mine area (looking east towards Low Back Creek).

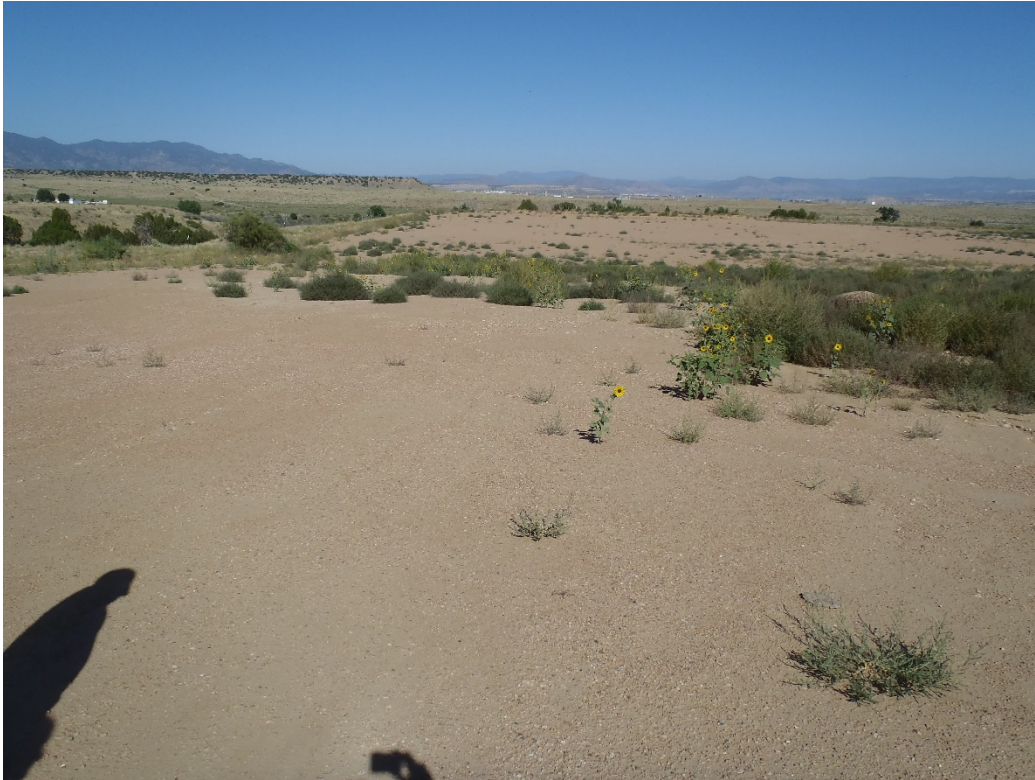
Reclamation Success: The southwest disturbed area (see **Photo 4**) was regraded and ready for topsoil placement. Other areas had been backfilled/sloped at 3H:1V, but Mr. Ulmer indicated some of those might be temporary.

Photo 4. Southwest affected area, ready for topsoil (looking west).

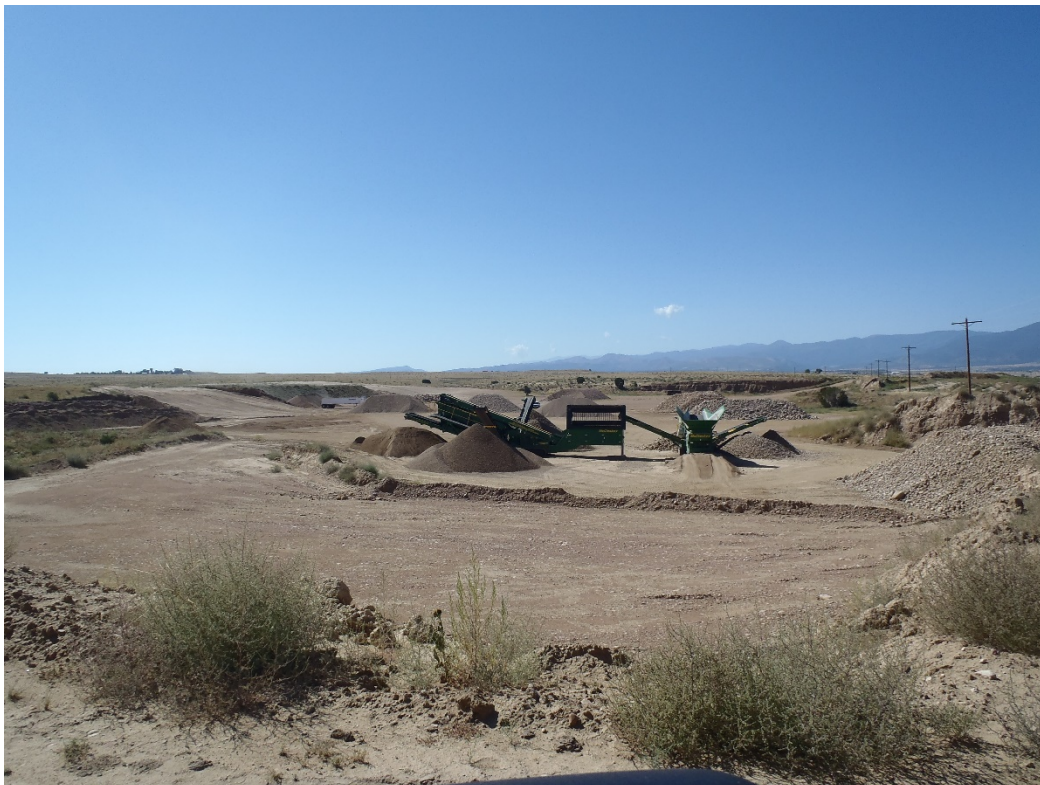
Support Facilities On-site: A screen plant was observed on site (see **Photo 5**).

Photo 5. Screen plant in active mine area (looking south, note powerline on right).

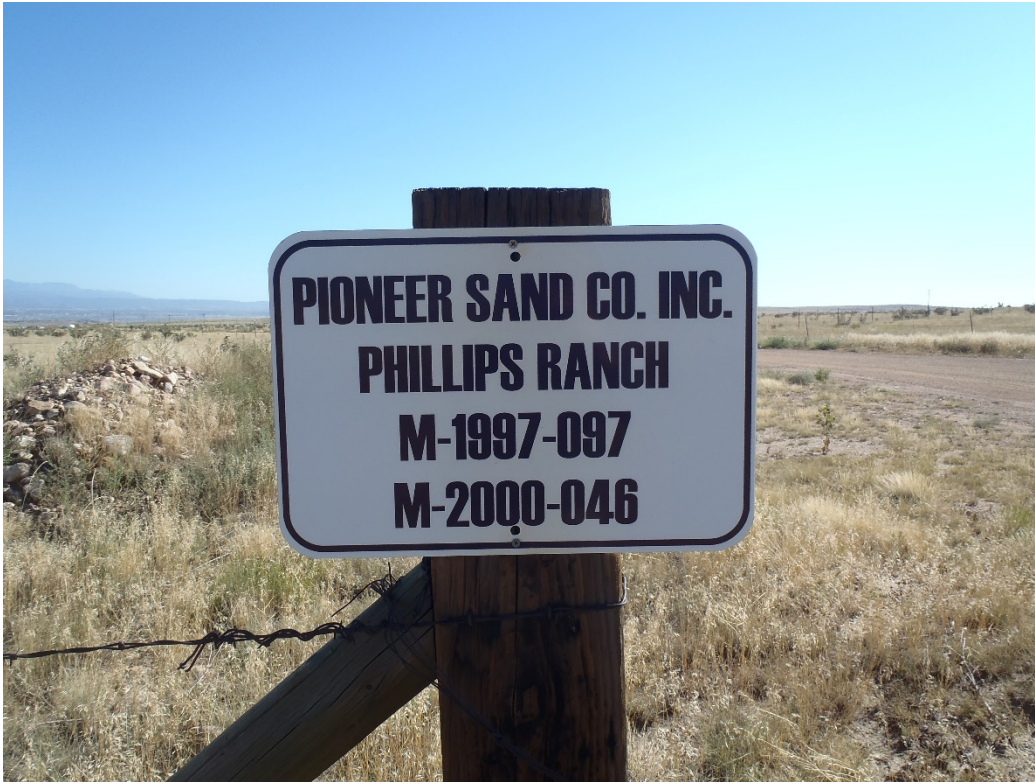
Signs and Markers: The permit sign was properly posted (see **Photo 6**). The east boundary is marked with a fence. The south boundary is delineated by the east-west power line. Low Back Creek would need to be crossed to extend mining to the north. We were unable to locate sufficient boundary markers on the west side. Pioneer should add boundary markers on the west side (towards Hardscrabble Creek) such that line-of-site can be used from each marker to recognize the west boundary sufficiently to prevent the equipment operators from mining outside the affected area boundary. The north end of the site is split estate with the SLB managing the minerals. Mr. Freese noted there were no boundary markers delineating this area from the privately held minerals area to the south.

Photo 6. Permit sign at entrance.
