MINERALS PROGRAM INSPECTION REPORT
PHONE: (303) 866-3567

MINE NAME: Burros Mine	MINE/PROSPECTING ID#: M-1977-297	MINERAL: Uranium and vanadium	COUNTY: San Miguel
INSPECTION TYPE: Monitoring	INSPECTOR(S): Lucas West	INSP. DATE: November 21, 2019	INSP. TIME: 09:45
OPERATOR: Gold Eagle Mining, Inc.	OPERATOR REPRESENTATIVE: Kyle Turley, Navarro	TYPE OF OPERATION: 110d - Designated Limited Impact	
REASON FOR INSPECTION: High Priority	BOND CALCULATION TYPE: None	BOND AMOUNT: \$100.00	
DATE OF COMPLAINT: NA	POST INSP. CONTACTS: None	JOINT INSP. AGENCY: None	
WEATHER: Clear	INSPECTOR'S SIGNATURE:

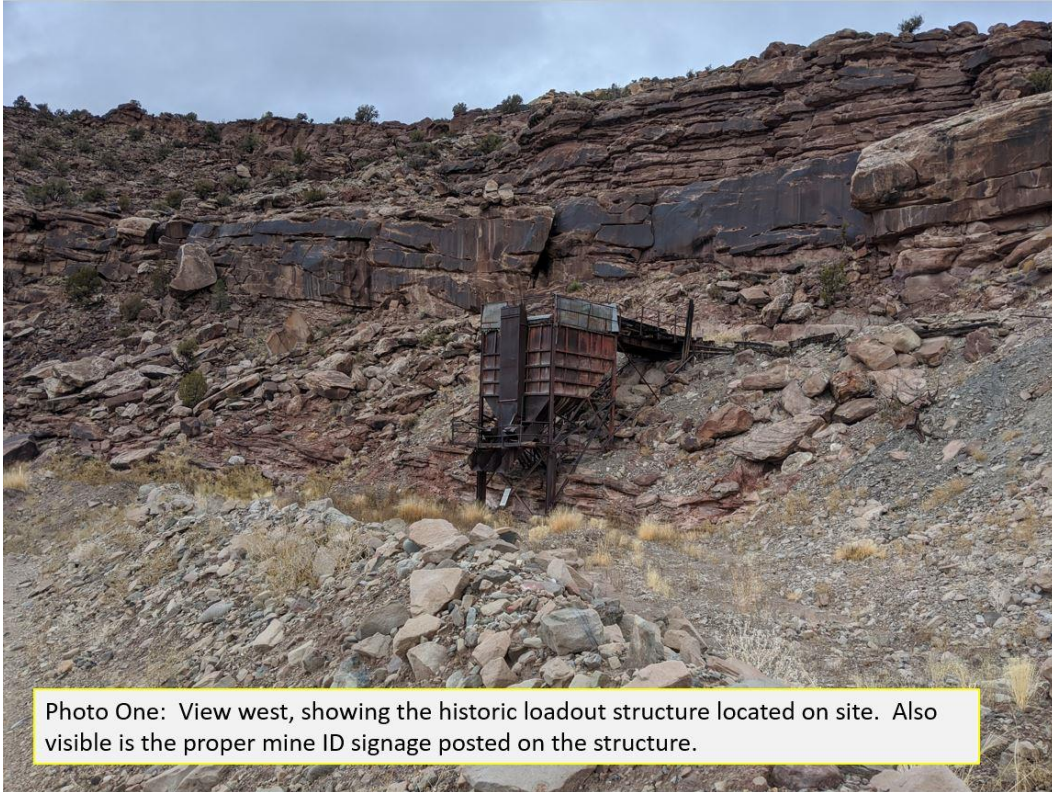
The proper mine identification signage was posted at the entrance to the site. The sign is posted on a historical loadout that is within the permitted area. The loadout appears to be stable and in a similar condition to the previous inspection conducted by the Division. The loadout can be seen in Photo One. The only work that is approved to take place on the site is ongoing weed management and the maintenance of the storm water controls on site. The storm water controls that were observed appear to be stable and functioning as designed. They will however require maintenance soon as there have been recent precipitation events in the area that have impacted the features. The waste rock dump was observed and was stable at the time of the inspection. Photo Two shows the top pad area of the waste rock dump.

Photo One: View west, showing the historic loadout structure located on site. Also visible is the proper mine ID signage posted on the structure.

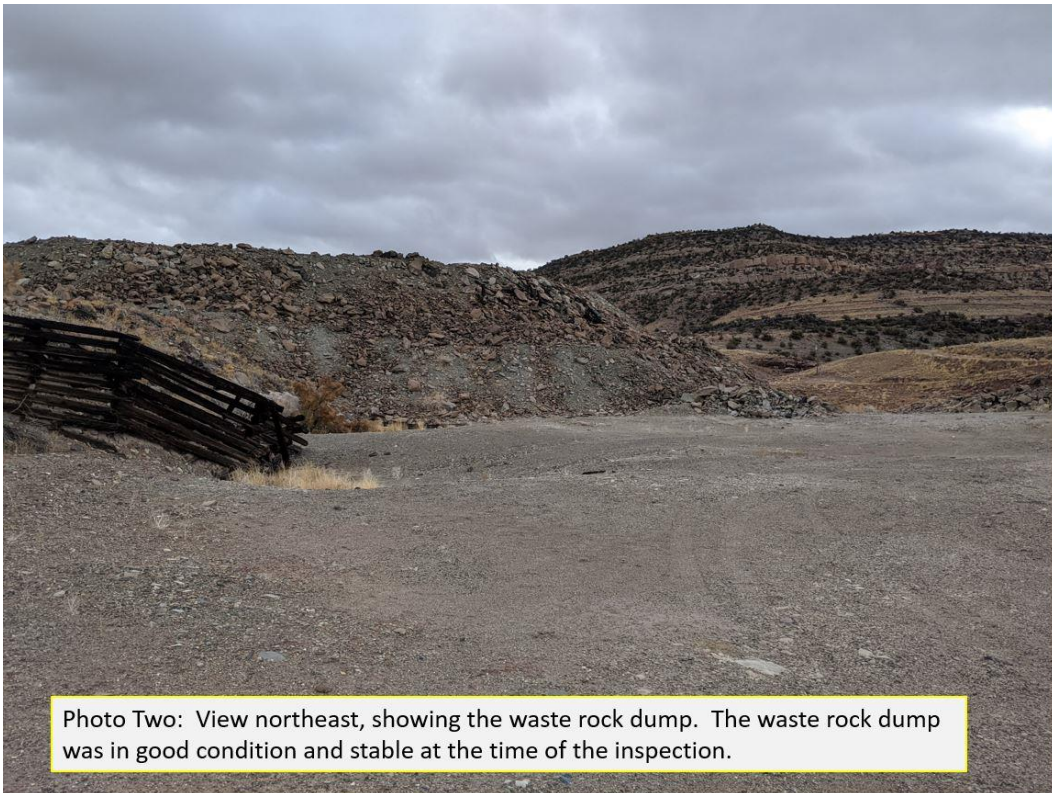
Photo Two: View northeast, showing the waste rock dump. The waste rock dump was in good condition and stable at the time of the inspection.

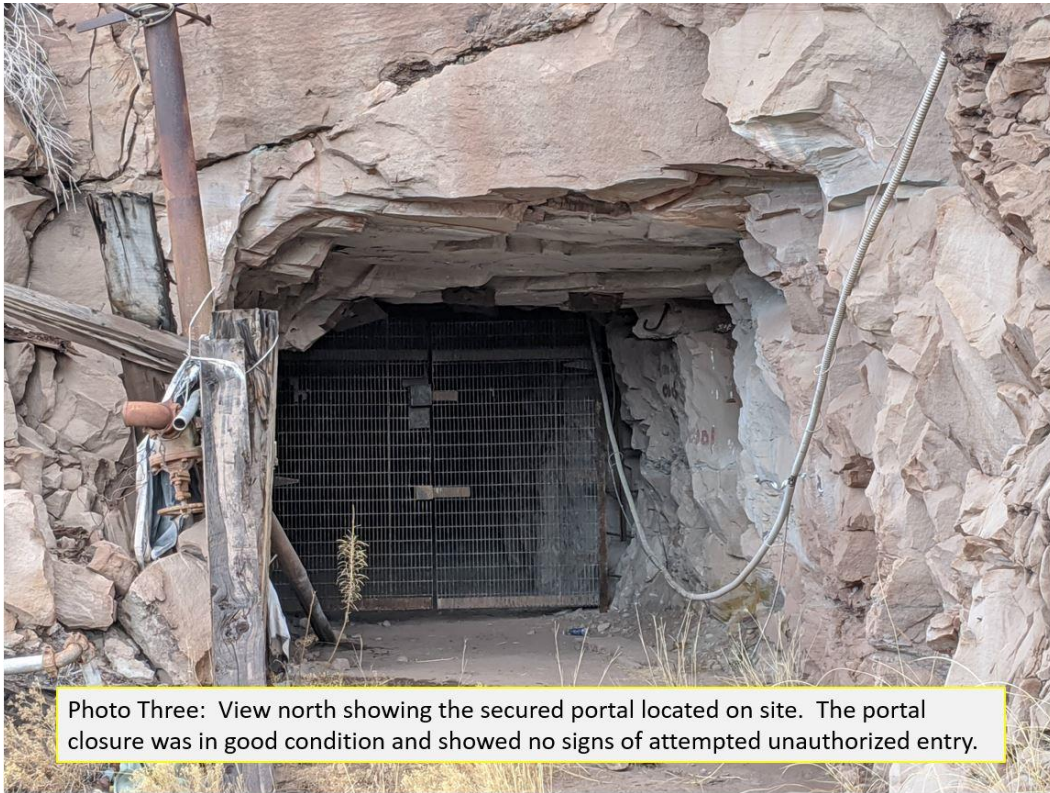
The portal has been secured with a safety closure to prevent entry. The closure is a locked steel grate closure that is in good condition and shows no signs of attempted unauthorized entry. Various pipes, lines and historic debris surround the portal and all appear to be stable and in a similar condition from the Division's previous inspection. The closure and the surrounding area can be seen in Photos Three.

Photo Three: View north showing the secured portal located on site. The portal closure was in good condition and showed no signs of attempted unauthorized entry.
