MINERALS PROGRAM INSPECTION REPORT
PHONE: (303) 866-3567

MINE NAME: SR-13A Mine	MINE/PROSPECTING ID#: M-1977-311	MINERAL: Uranium and vanadium	COUNTY: San Miguel
INSPECTION TYPE: Monitoring	INSPECTOR(S): Lucas West	INSP. DATE: November 21, 2019	INSP. TIME: 10:15
OPERATOR: Cotter Corporation	OPERATOR REPRESENTATIVE: Kyle Turley, Navarro	TYPE OF OPERATION: 110d - Designated Limited Impact	
REASON FOR INSPECTION: Normal I&E Program	BOND CALCULATION TYPE: None	BOND AMOUNT: \$100.00	
DATE OF COMPLAINT: NA	POST INSP. CONTACTS: None	JOINT INSP. AGENCY: None	
WEATHER: Clear	INSPECTOR'S SIGNATURE:

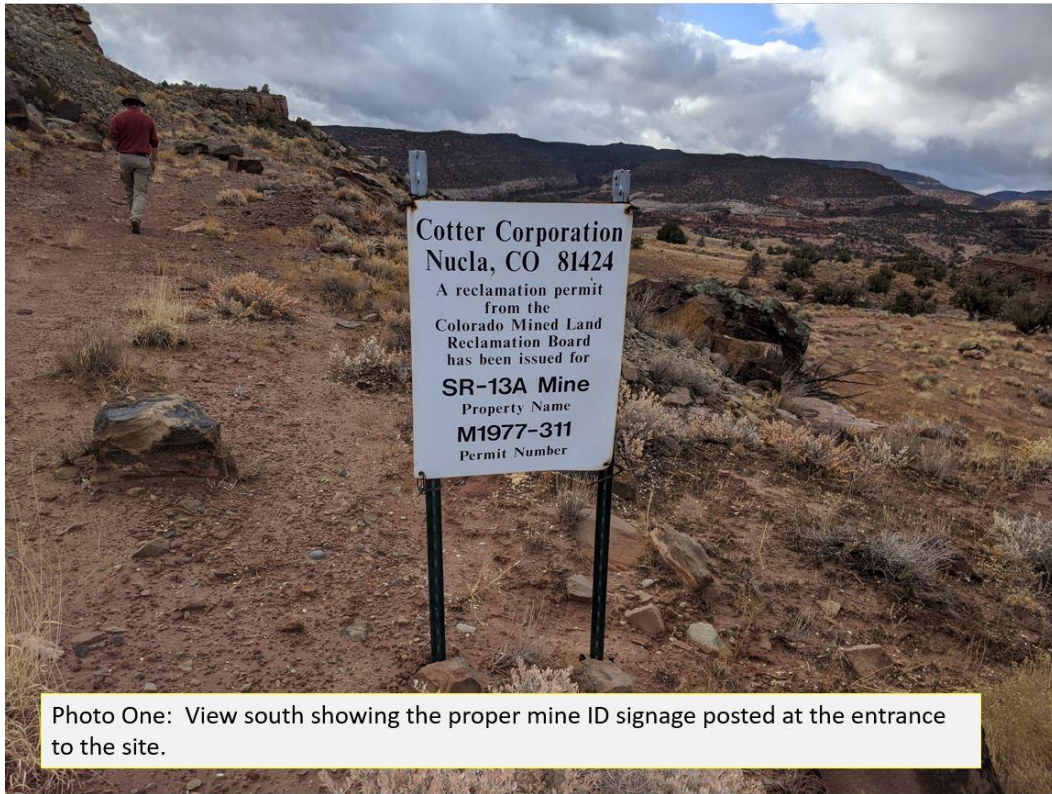
The proper mine identification signage was posted at the entrance to the site and can be seen in Photo One. There was no equipment on site and the site was not active during the inspection. Final reclamation has been completed at the site. Monitoring and active weed control is conducted by the DOE contractor, Navarro. The waste piles have on site have been graded to a 2H: 1V or shallower configuration and appear to be stable and in good condition. Examples of the reclaimed slopes can be seen in Photos Two and Three. The slopes were all "pocked" to prevent erosion and assist the vegetation growth. The slopes show no significant signs of erosion and the vegetation appears to be as good as or better than surrounding undisturbed areas. The vegetation is adequate in both density and diversity, and multiple years biomass was observed indicating it is self-sufficient.

Photo One: View south showing the proper mine ID signage posted at the entrance to the site.

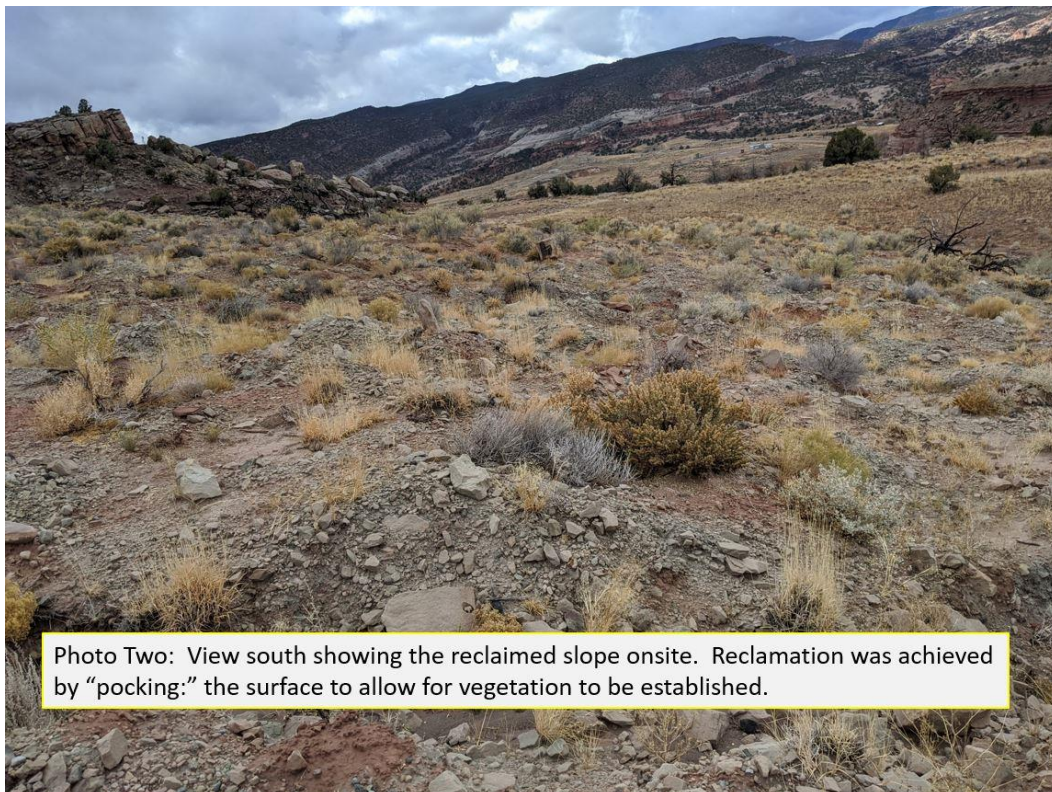
Photo Two: View south showing the reclaimed slope onsite. Reclamation was achieved by "pocking:" the surface to allow for vegetation to be established.
