MINERALS PROGRAM INSPECTION REPORT
PHONE: (303) 866-3567

MINE NAME: SR-11 Mine	MINE/PROSPECTING ID#: M-1977-451	MINERAL: Uranium and vanadium	COUNTY: San Miguel
INSPECTION TYPE: Monitoring	INSPECTOR(S): Lucas West	INSP. DATE: November 21, 2019	INSP. TIME: 11:10
OPERATOR: Cotter Corporation	OPERATOR REPRESENTATIVE: Kyle Turley, Navarro	TYPE OF OPERATION: 112d-1 - Designated Mining Operation	
REASON FOR INSPECTION: Normal I&E Program	BOND CALCULATION TYPE: Complete Bond	BOND AMOUNT: \$100.00	
DATE OF COMPLAINT: NA	POST INSP. CONTACTS: None	JOINT INSP. AGENCY: None	
WEATHER: Clear	INSPECTOR'S SIGNATURE:

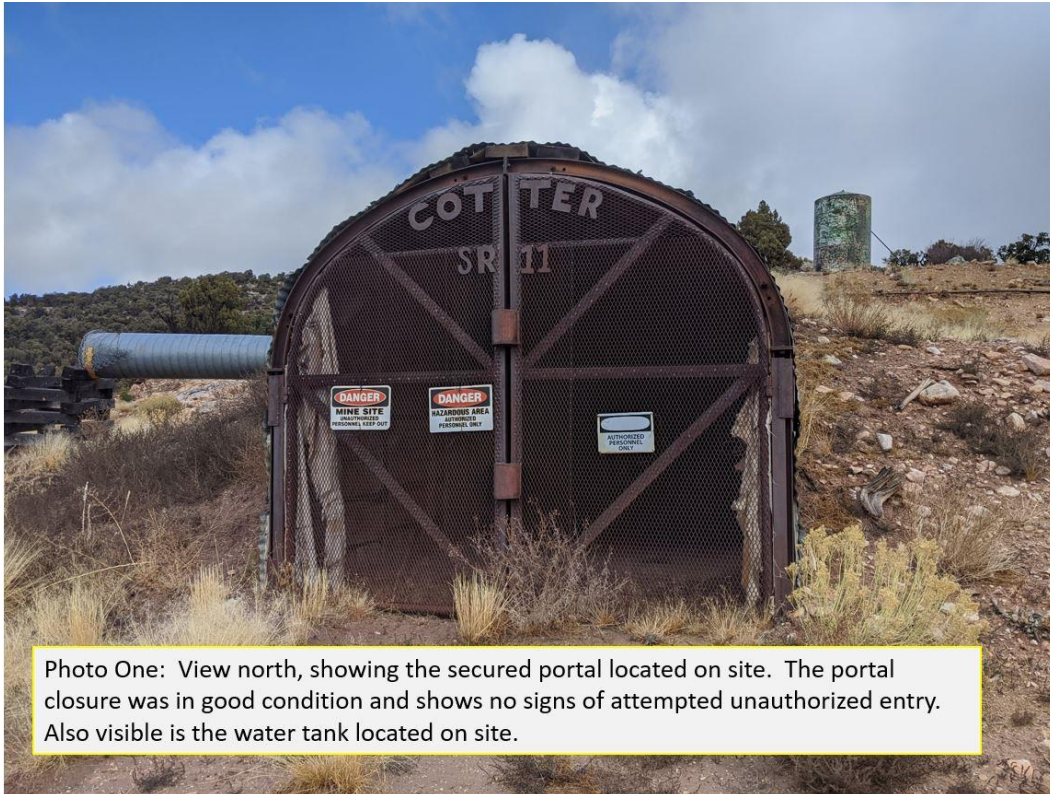
The proper mine identification signage was posted at the entrance to the site, and the permit boundaries are clearly marked. There was no equipment on site during the inspection. No activity has taken place on site since the previous inspection. This inspection was limited to the surface facilities. The portal has been secured by a locked gate shown in Photo One. The portal closure is in good condition and shows no signs of attempted unauthorized entry. Adjacent to the portal is an administrative office trailer which has also been secured. Photo Two shows the trailer, which is in good condition, the windows are all secured and the office remains vacant.

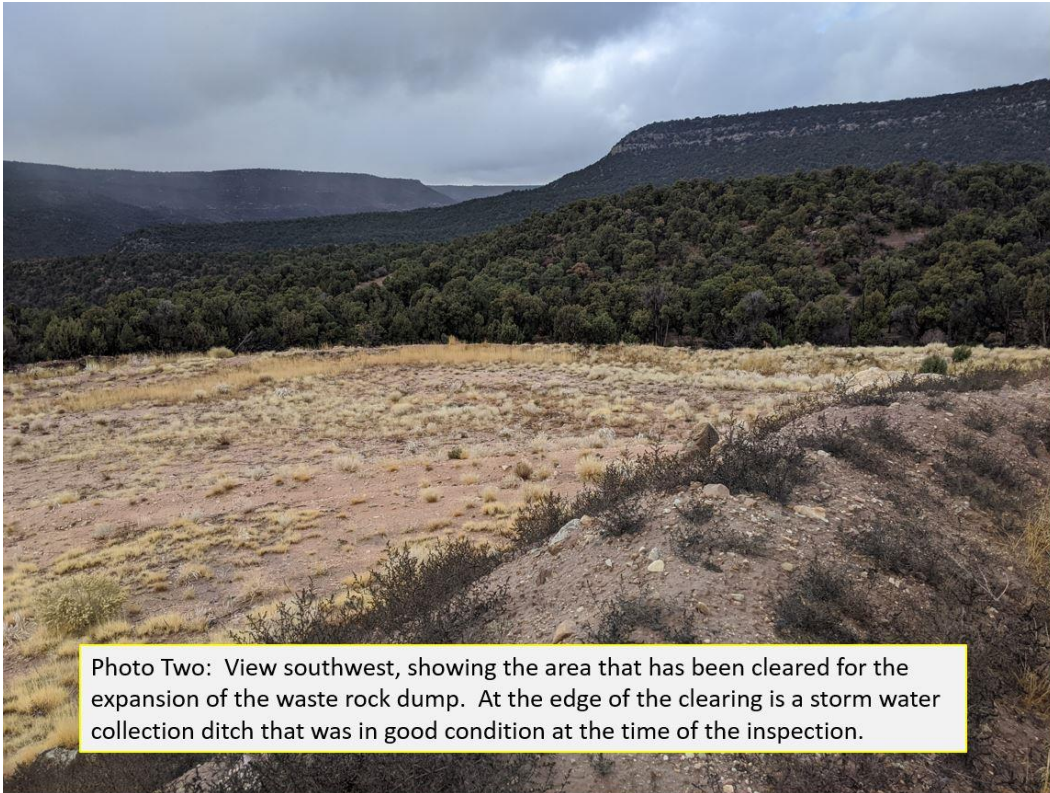
Photo Two: View southwest, showing the area that has been cleared for the expansion of the waste rock dump. At the edge of the clearing is a storm water collection ditch that was in good condition at the time of the inspection.

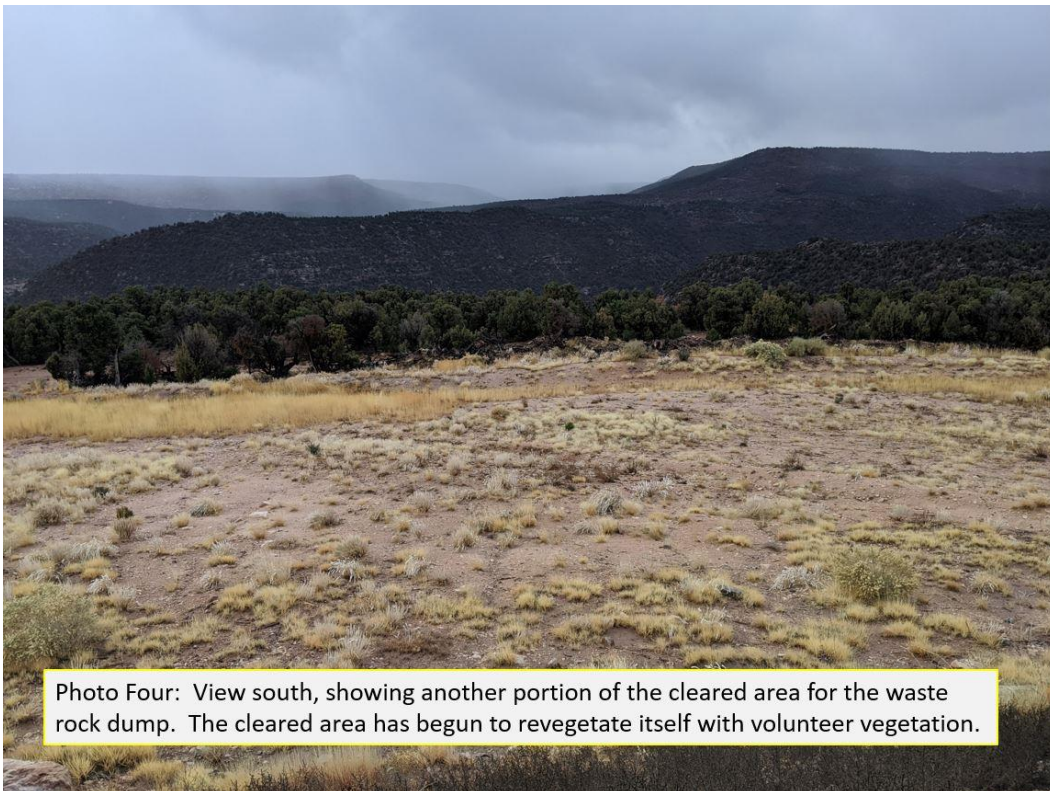
Photo Four: View south, showing another portion of the cleared area for the waste rock dump. The cleared area has begun to revegetate itself with volunteer vegetation.
