**MINERALS PROGRAM INSPECTION REPORT**  
**PHONE: (303) 866-3567**

<b>MINE NAME:</b> Parkdale Project	<b>MINE/PROSPECTING ID#:</b> M-1997-054	<b>MINERAL:</b> Sandstone (silica, stone, quartzite), gravel and granite, granite gneiss	<b>COUNTY:</b> Fremont
<b>INSPECTION TYPE:</b> Monitoring	<b>INSPECTOR(S):</b> Timothy Cazier	<b>INSP. DATE:</b> July 24, 2019	<b>INSP. TIME:</b> 14:15
<b>OPERATOR:</b> Front Range Aggregates, LLC	<b>OPERATOR REPRESENTATIVE:</b> Dave Bieber	<b>TYPE OF OPERATION:</b> 112c - Construction Regular Operation	
<b>REASON FOR INSPECTION:</b> Normal I&E Program	<b>BOND CALCULATION TYPE:</b> Partial Bond	<b>BOND AMOUNT:</b> \$1,174,724.00	
<b>DATE OF COMPLAINT:</b> NA	<b>POST INSP. CONTACTS:</b> None	<b>JOINT INSP. AGENCY:</b> None	
<b>WEATHER:</b> Cloudy	<b>INSPECTOR'S SIGNATURE:</b>

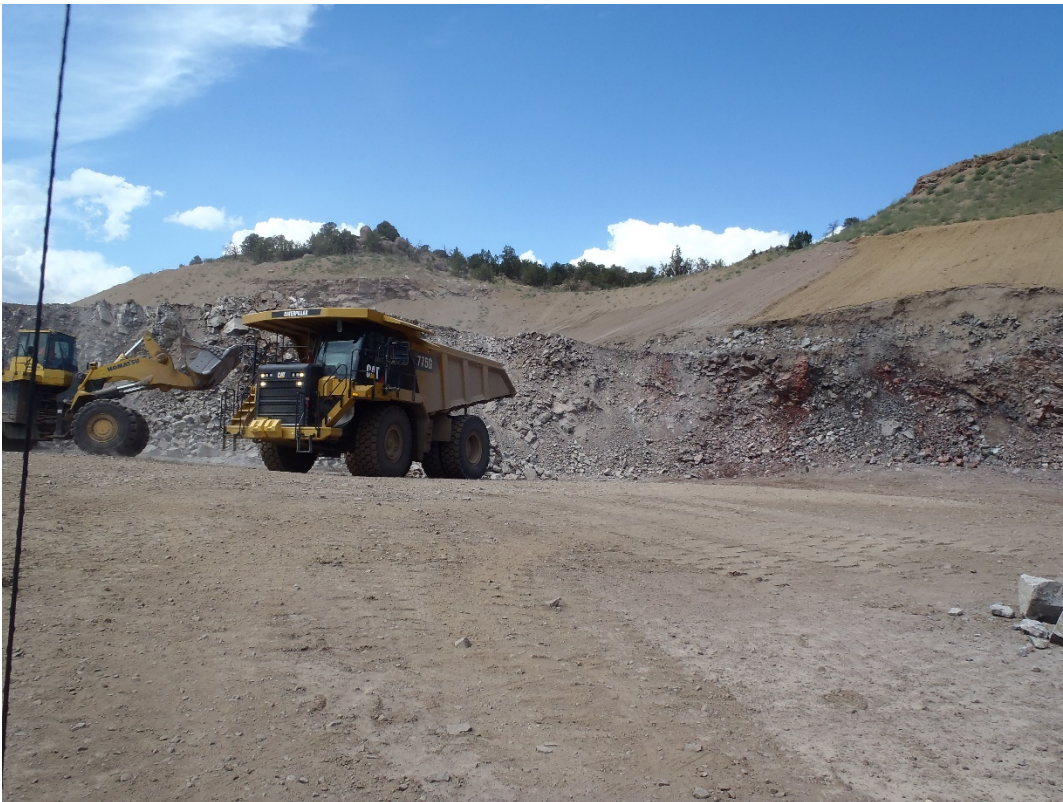
Gen. Compliance with Mine Plan: The operation appeared to be in compliance with the approved mine plan. File review indicates the maximum allowed disturbed area is 200 acres. Google Earth was used to measure the disturbed area, which was estimated to be approximately 176 acres, based on 2016 imagery. Highwalls in the granite quarry were estimated to be 40 feet in height and appeared stable (see **Photos 1 and 2**).

Photo 1. Highwalls in the granite quarry (1 of 2, looking NW).

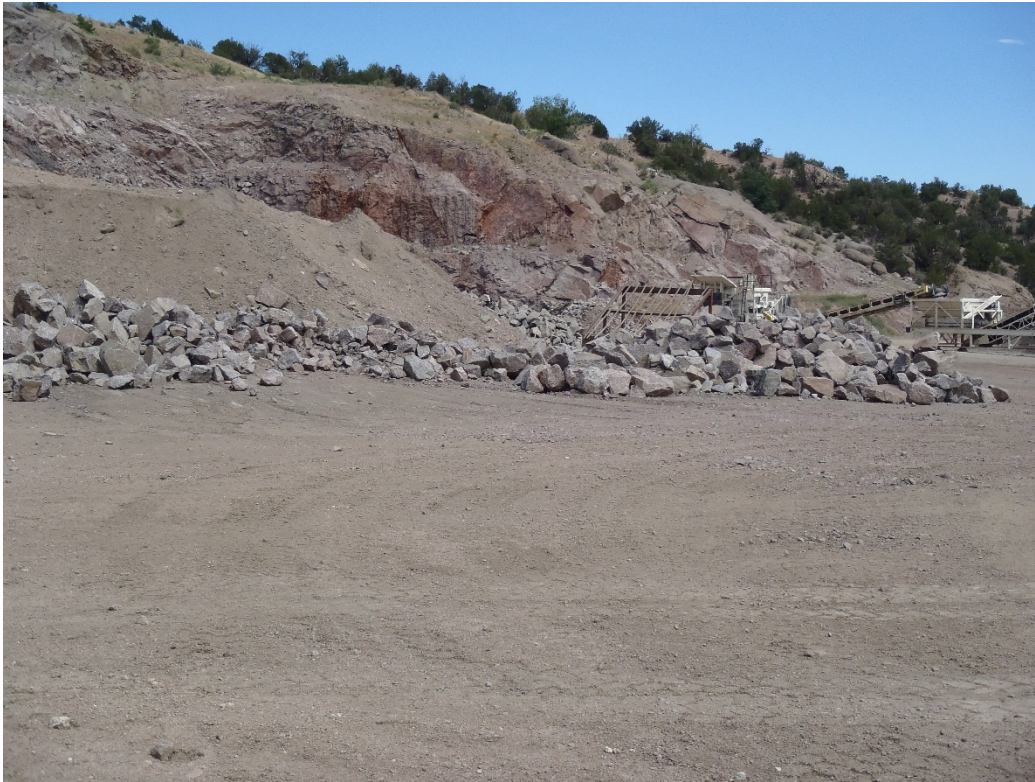
Photo 2. Highwalls in the granite quarry (2 of 2, looking east).

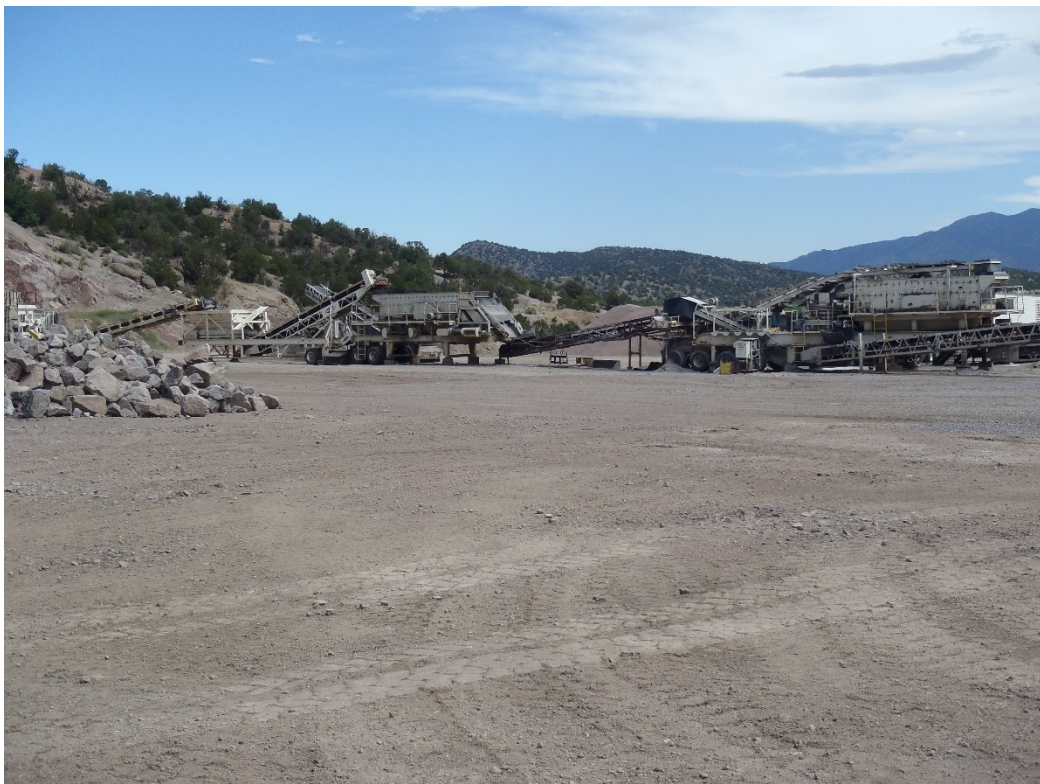
Processing Waste: The mine process results in a lot of fines. Two separate crushing/screening plants were operating during the inspection: one at the base of the granite quarry (see **Photo 3**) and another near the east end of the alluvial pit (see **Photo 4**). These materials are then used for backfill and reclamation.

Photo 3. Granite quarry screen plant (contractor operated).

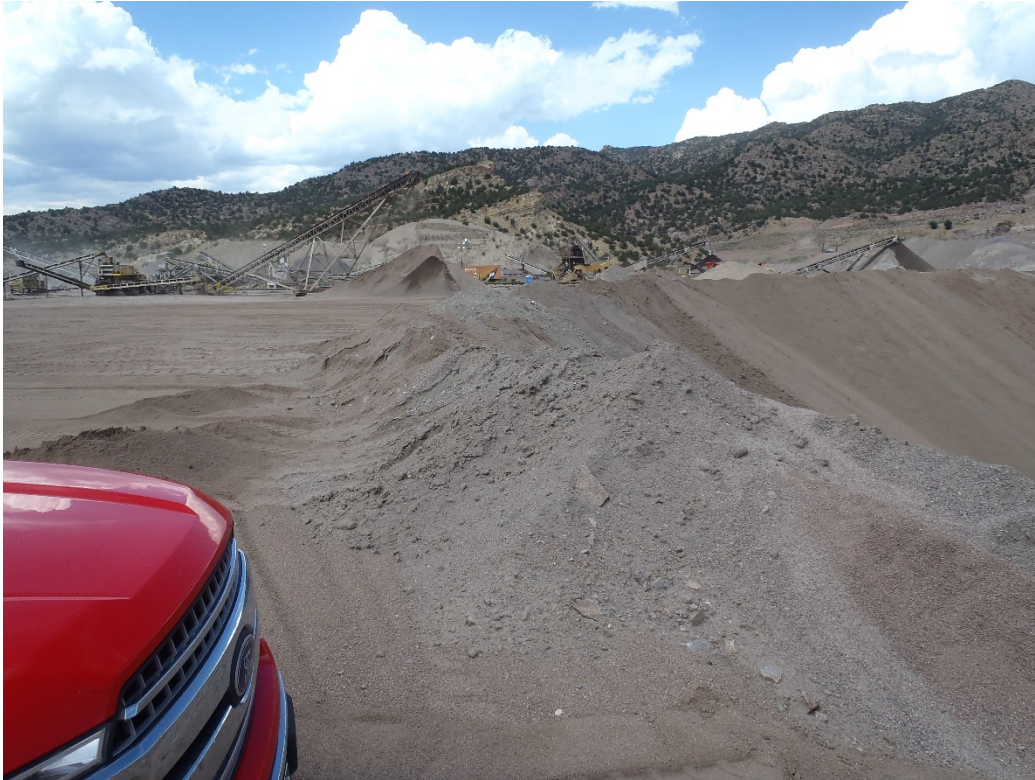
Photo 4. Alluvial pit screen plant and east end backfill with fines (looking NW).

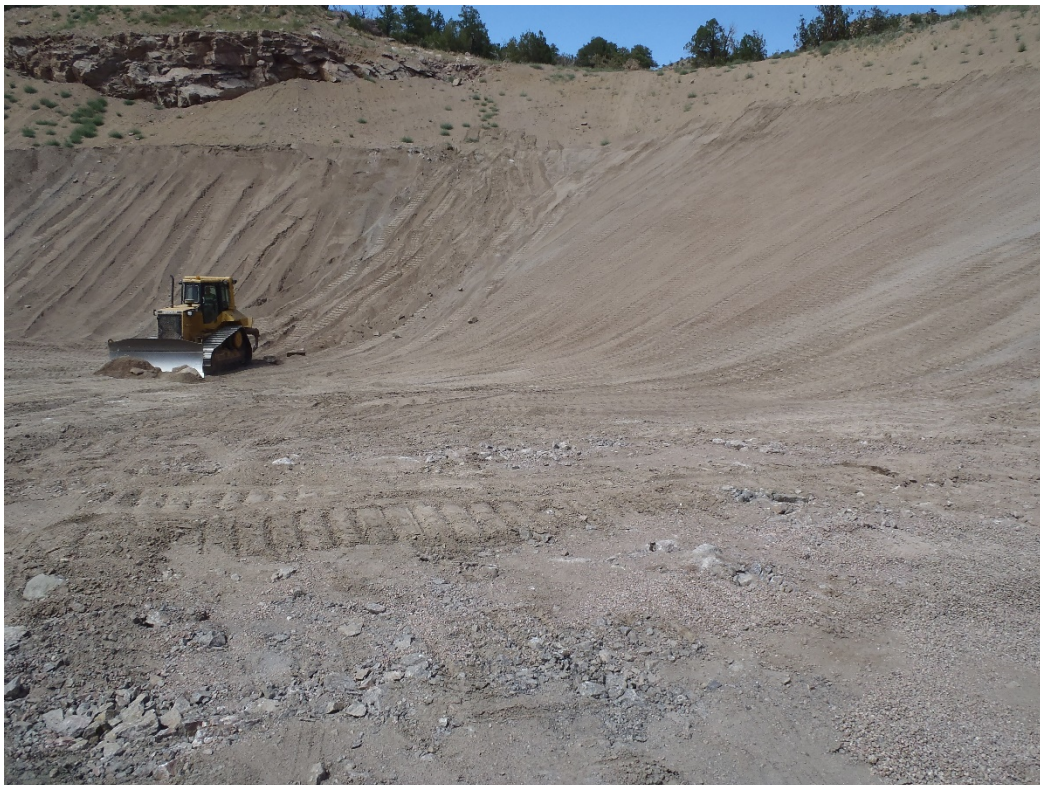
Reclamation Success: Concurrent reclamation was observed both at the granite quarry where the upper benches were being backfilled and hydro-mulched (see **Photos 5 and 6**); and the alluvial pit where the east end is nearing backfill completion (see **Photo 7**).

Topsoil: Process fines are used on the granite quarry benches (see **Photo 5**), but topsoil for the alluvial pit was stripped and stockpiled on the south side of the west end of the alluvial pit by the previous operator.

Photo 5. Granite quarry upper benches being backfilled (dozer work) and hydro-mulched (upper bench).

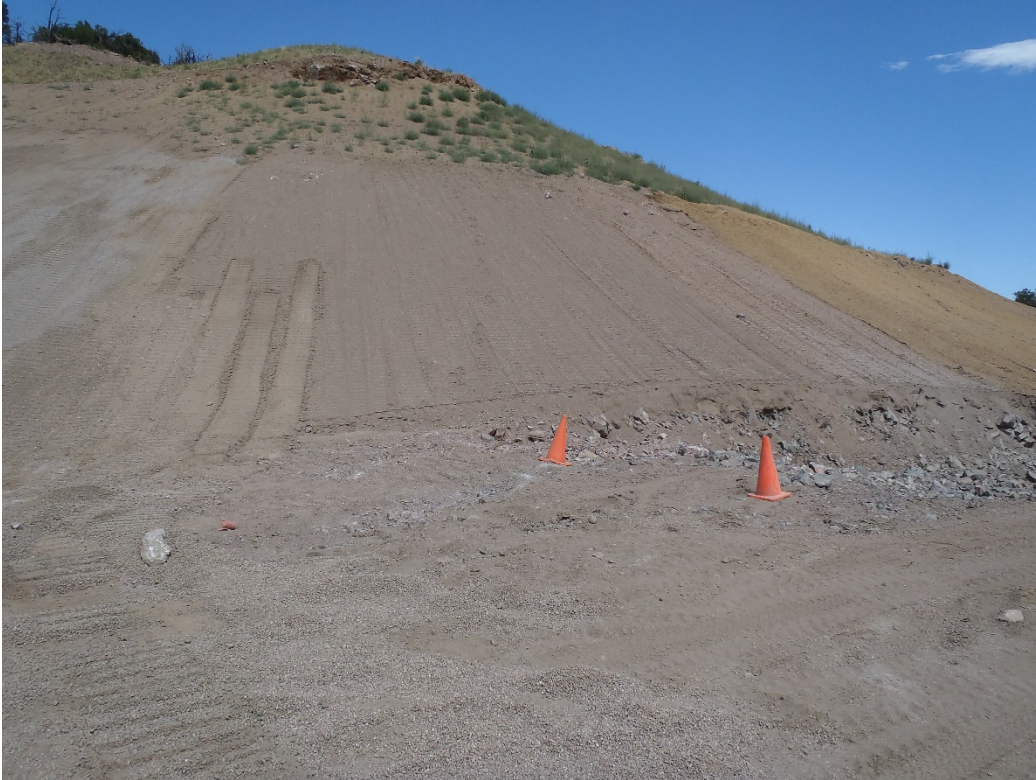
Revegetation: Some of the upper benches of the granite quarry had been seeded this year, but no vegetation had emerged at the time of the inspection (see **Photo 6**). No noxious weeds were observed.

Photo 6. Granite quarry upper benches backfilled (center & left) and hydro-mulched (far right).

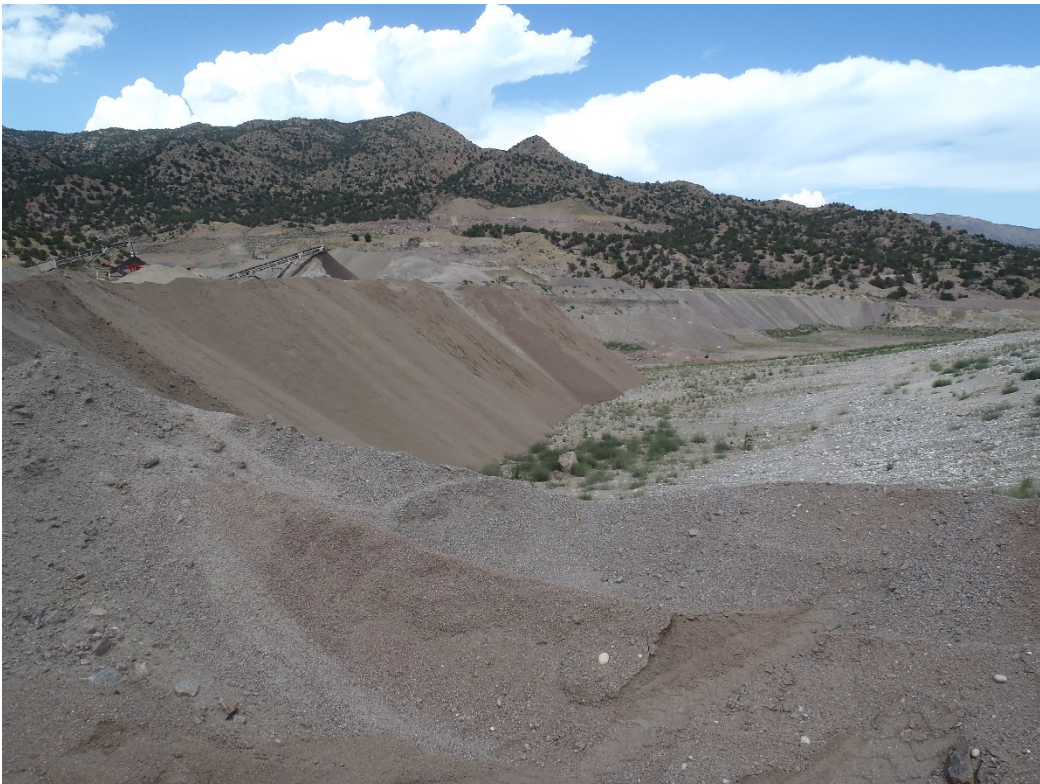
Photo 7. Nearly completed east alluvial pit backfill (looking east).

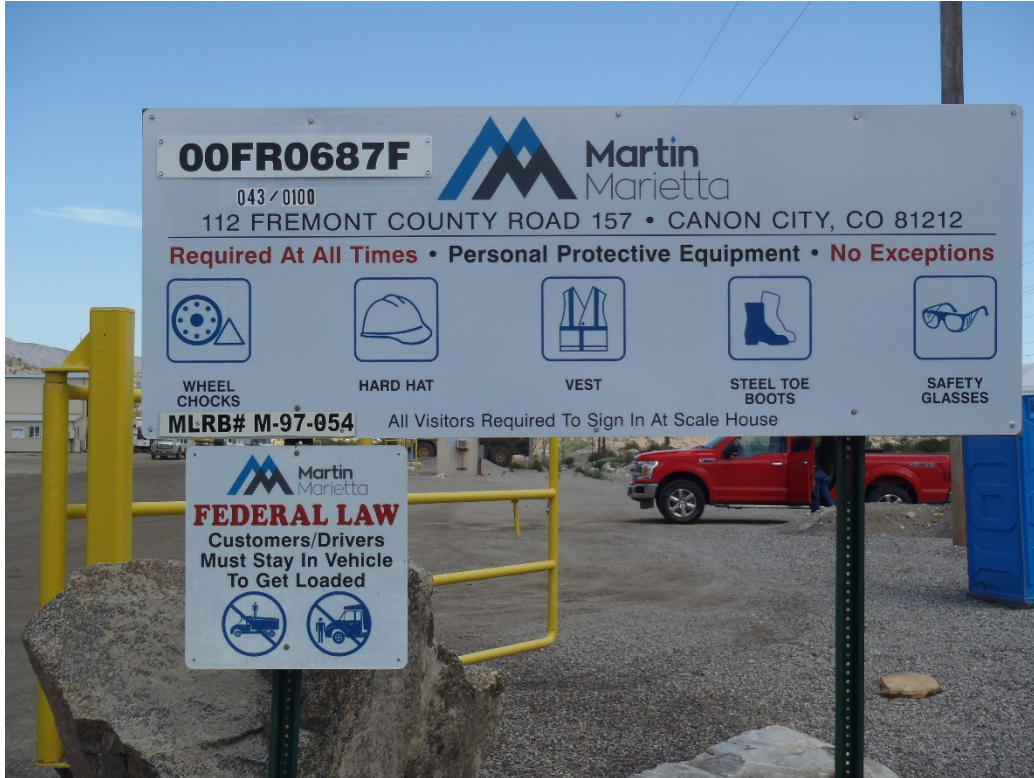
Signs and Markers: The permit sign was properly posted (see **Photo 8**) and boundary markers were observed to delineate the permit boundary (see **Photo 9**).

Photo 8. Permit sign (near scale house).

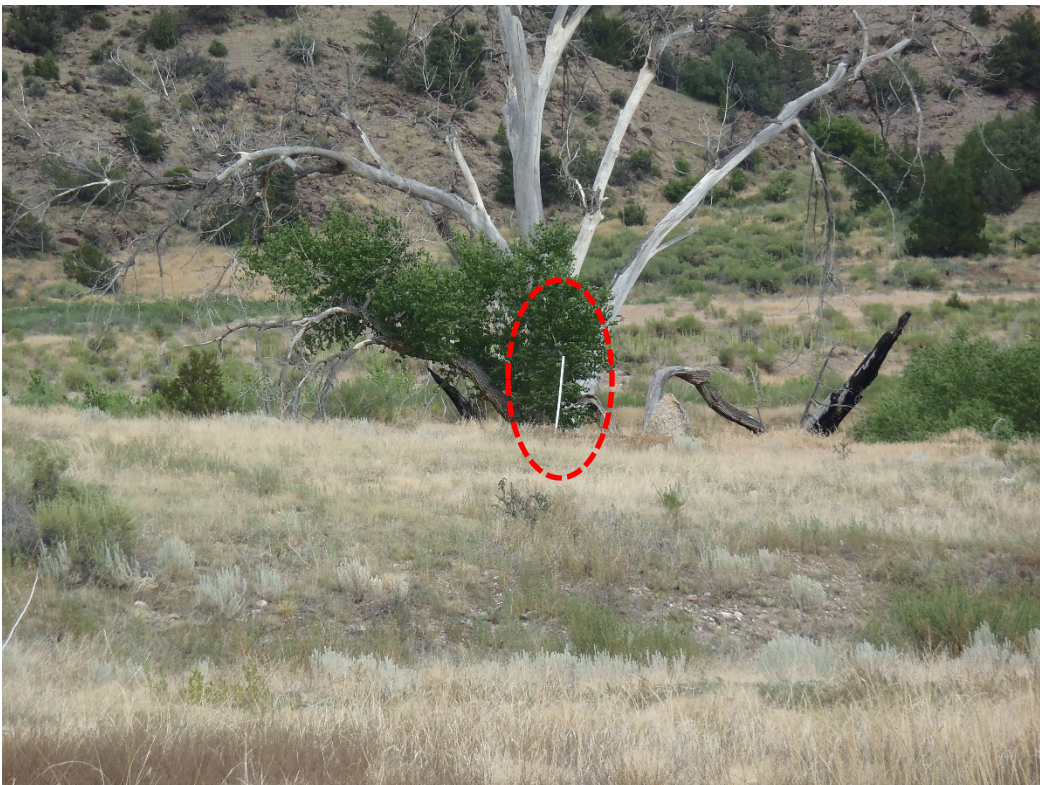
Photo 9. Typical permit boundary marker (NW corner).
