MINERALS PROGRAM INSPECTION REPORT
PHONE: (303) 866-3567

MINE NAME: Orlando Pit	MINE/PROSPECTING ID#: M-2001-106	MINERAL: Sand and gravel	COUNTY: Huerfano
INSPECTION TYPE: Monitoring	INSPECTOR(S): Patrick Lennberg	INSP. DATE: December 12, 2019	INSP. TIME: 10:00
OPERATOR: Huerfano County	OPERATOR REPRESENTATIVE: Bill Brunelli	TYPE OF OPERATION: 112c - Construction Regular Operation	
REASON FOR INSPECTION: Normal I&E Program		BOND CALCULATION TYPE: None	BOND AMOUNT: \$0.00
DATE OF COMPLAINT: NA		POST INSP. CONTACTS: None	JOINT INSP. AGENCY: None
WEATHER: Windy	INSPECTOR'S SIGNATURE:

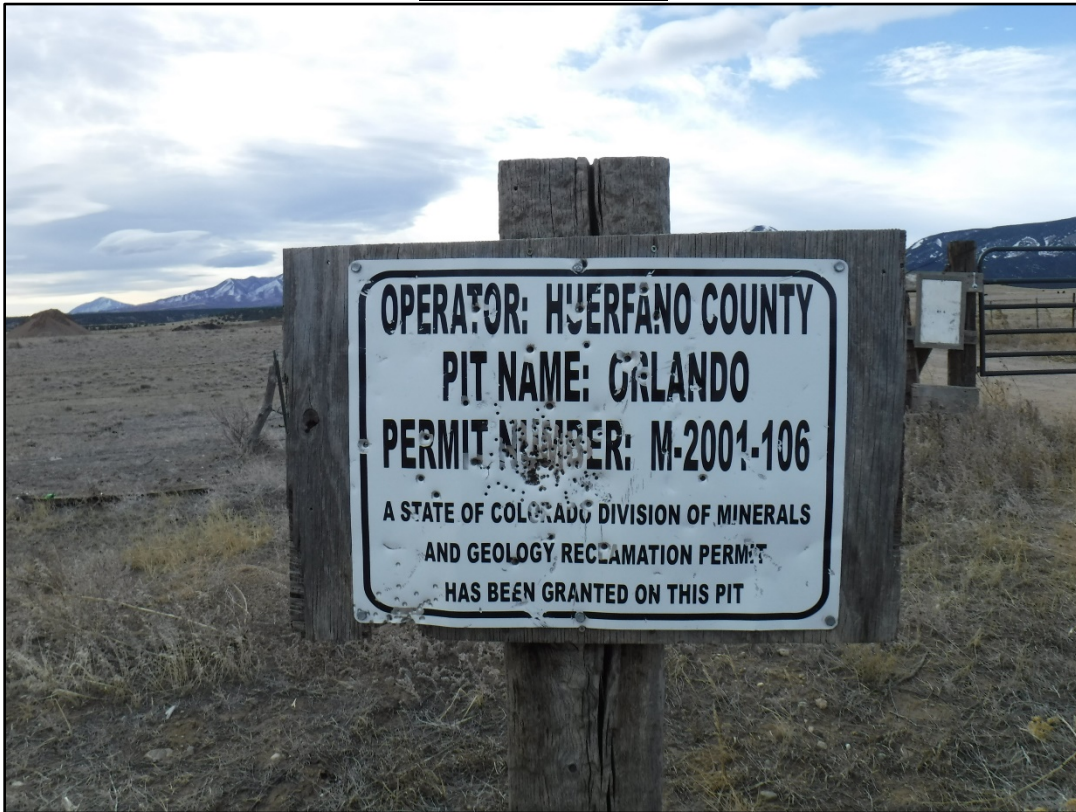
Photo 1: Mine sign off County Road 543

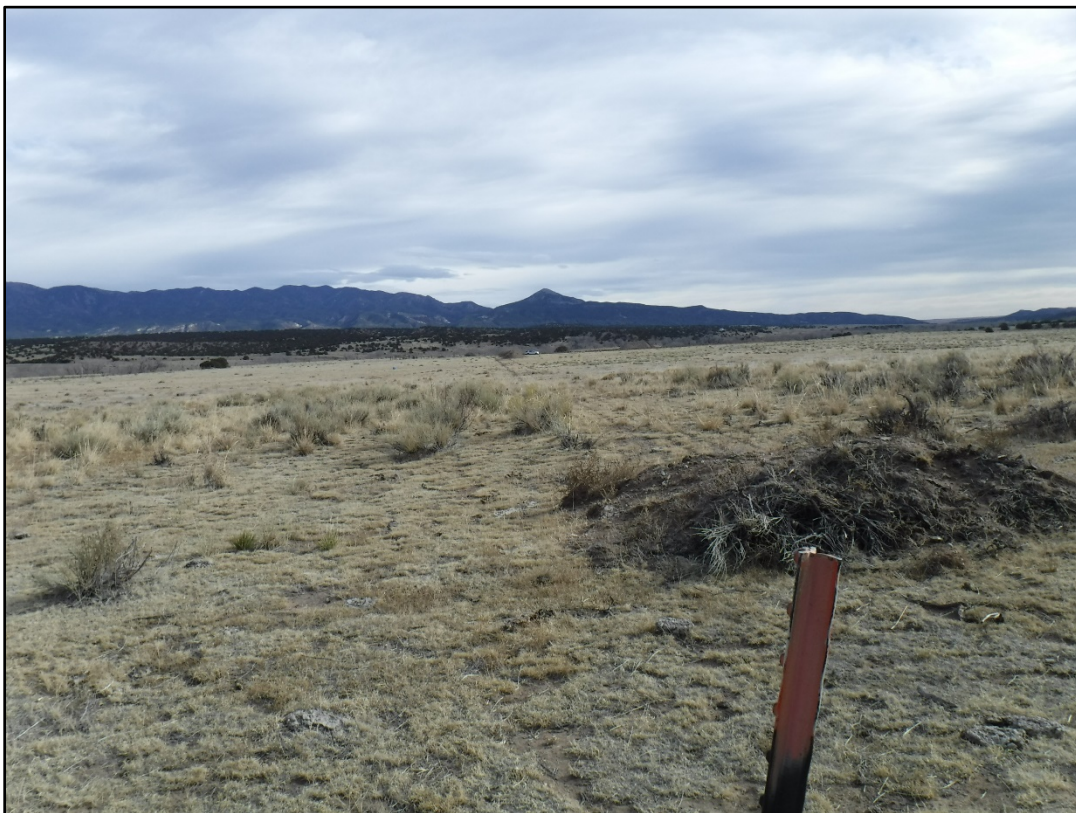
Photo 2: Looking across the permit area from the northwest corner towards the east

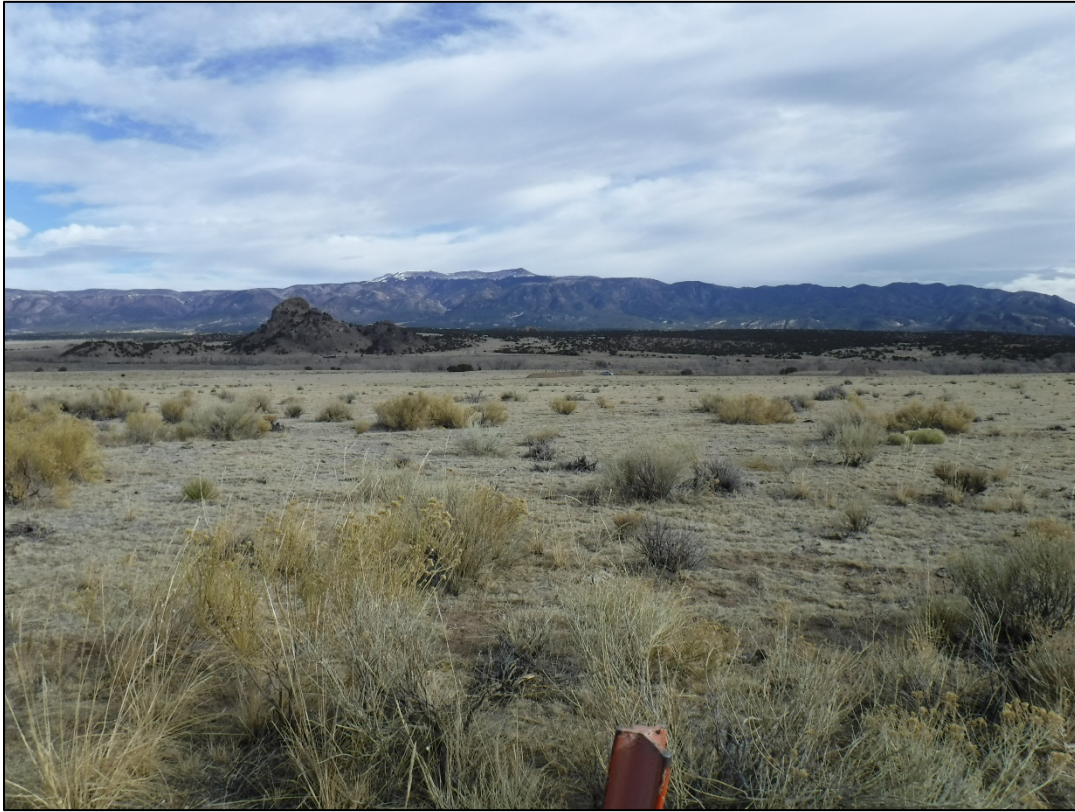
Photo 3: Looking across the permit area from the southwest corner towards the north

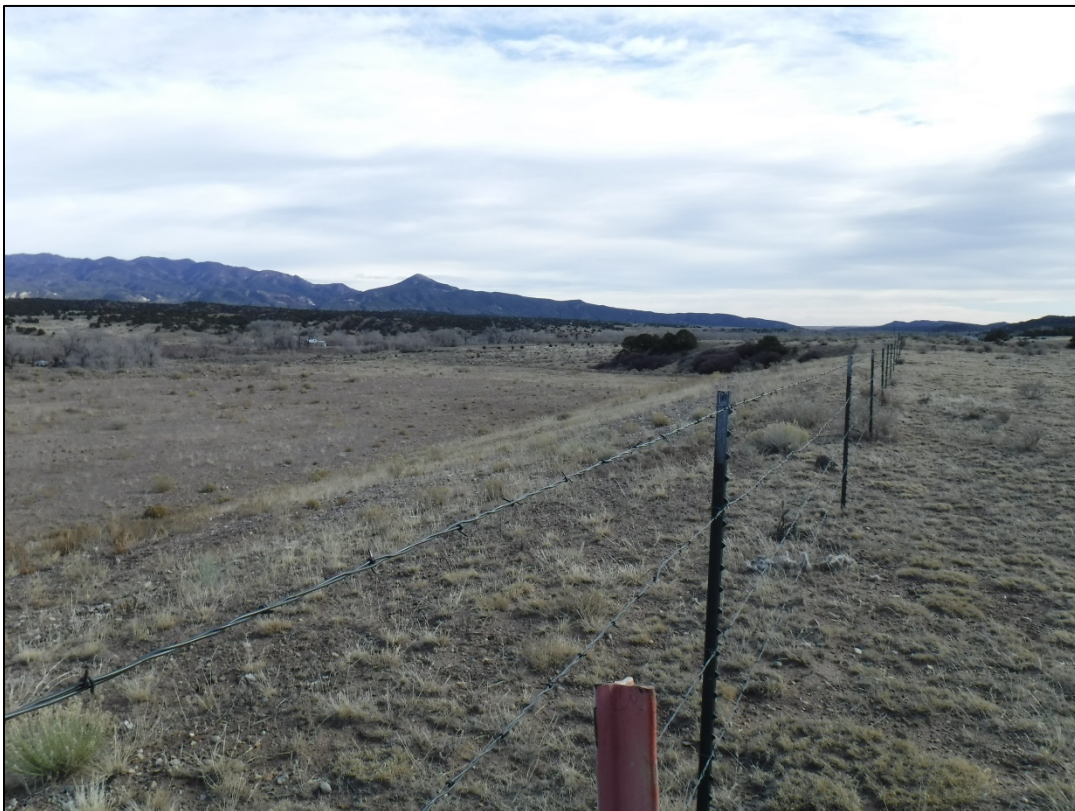
Photo 4: Looking into the previous mined portions of the pit with reclaimed 3H:1V slopes

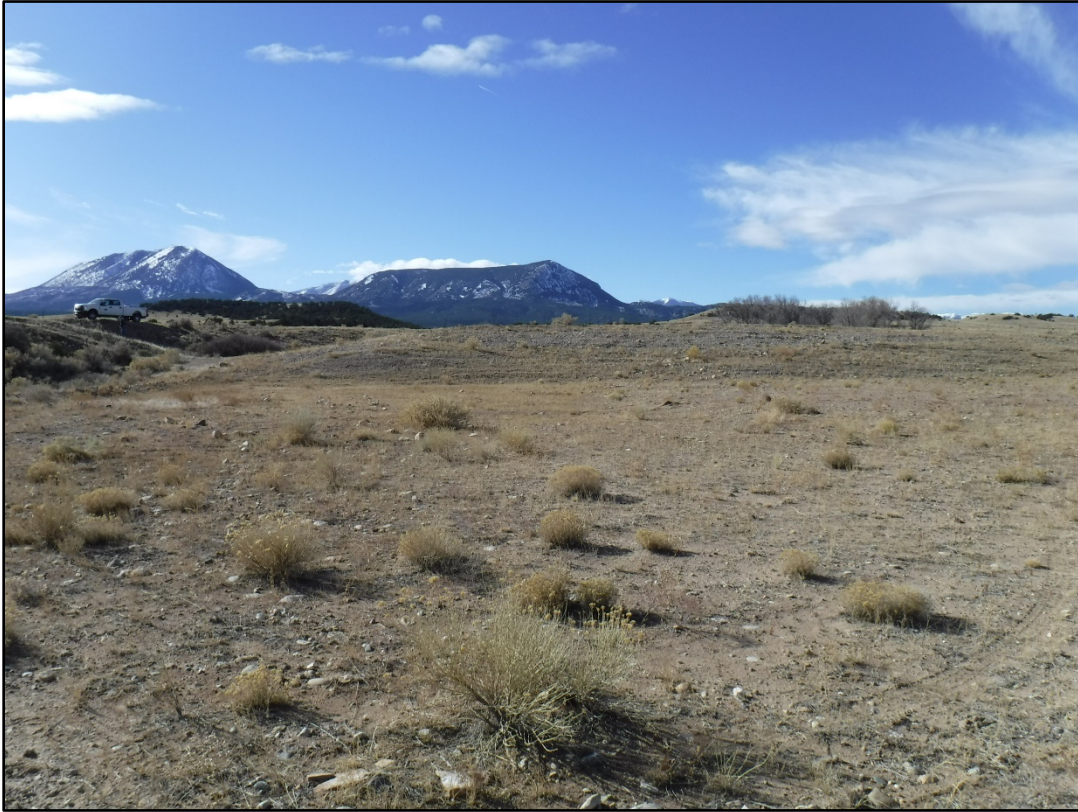
Photo 5: Looking southeast across the pit floor where revegetation is taking place

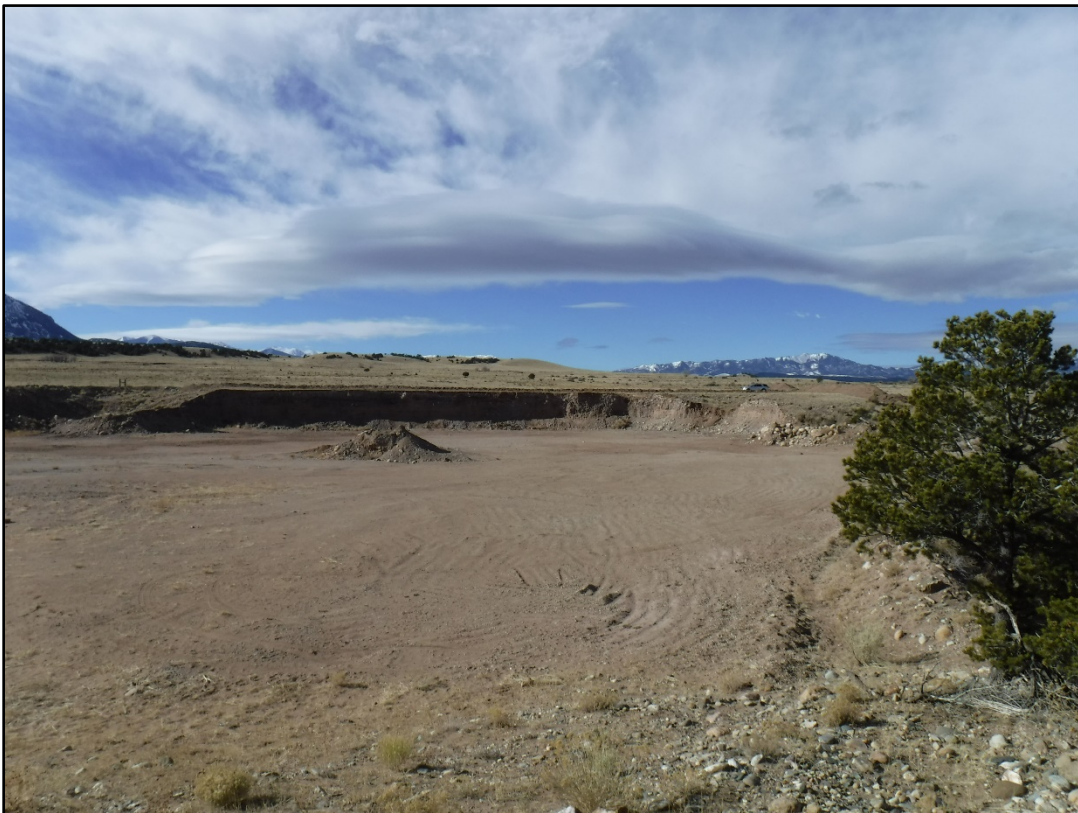
The pit was originally a 110c permit that was converted to a 112c in 2012 and was active at the time of inspection. Mining has been moving from east to west towards the access road. Currently there is a highwall that runs parallel and just east of the access road. The highwall has an average height of approximately 15 feet and is approximately 250 ft long, running roughly north-south. The highwall has an approximate slope of .5H:1V to just flatter than 1H:1V. All mined areas daylight the terrace to the east. The site has been graded between the crest of the terrace to the active highwall along the southern affected land boundary. The Operator has graded portions of the affected land to 3H:1V or flatter. There is a topsoil stockpile located on top of the highwall just east of the access road. The topsoil stockpile has some vegetative cover and appears stable. The current level of disturbance is estimated to be between 9-10 acres where the permit allows for 15 acres of affected land.

Photo 6: Looking at the active portions of the pit with the highwall along the road center left of picture

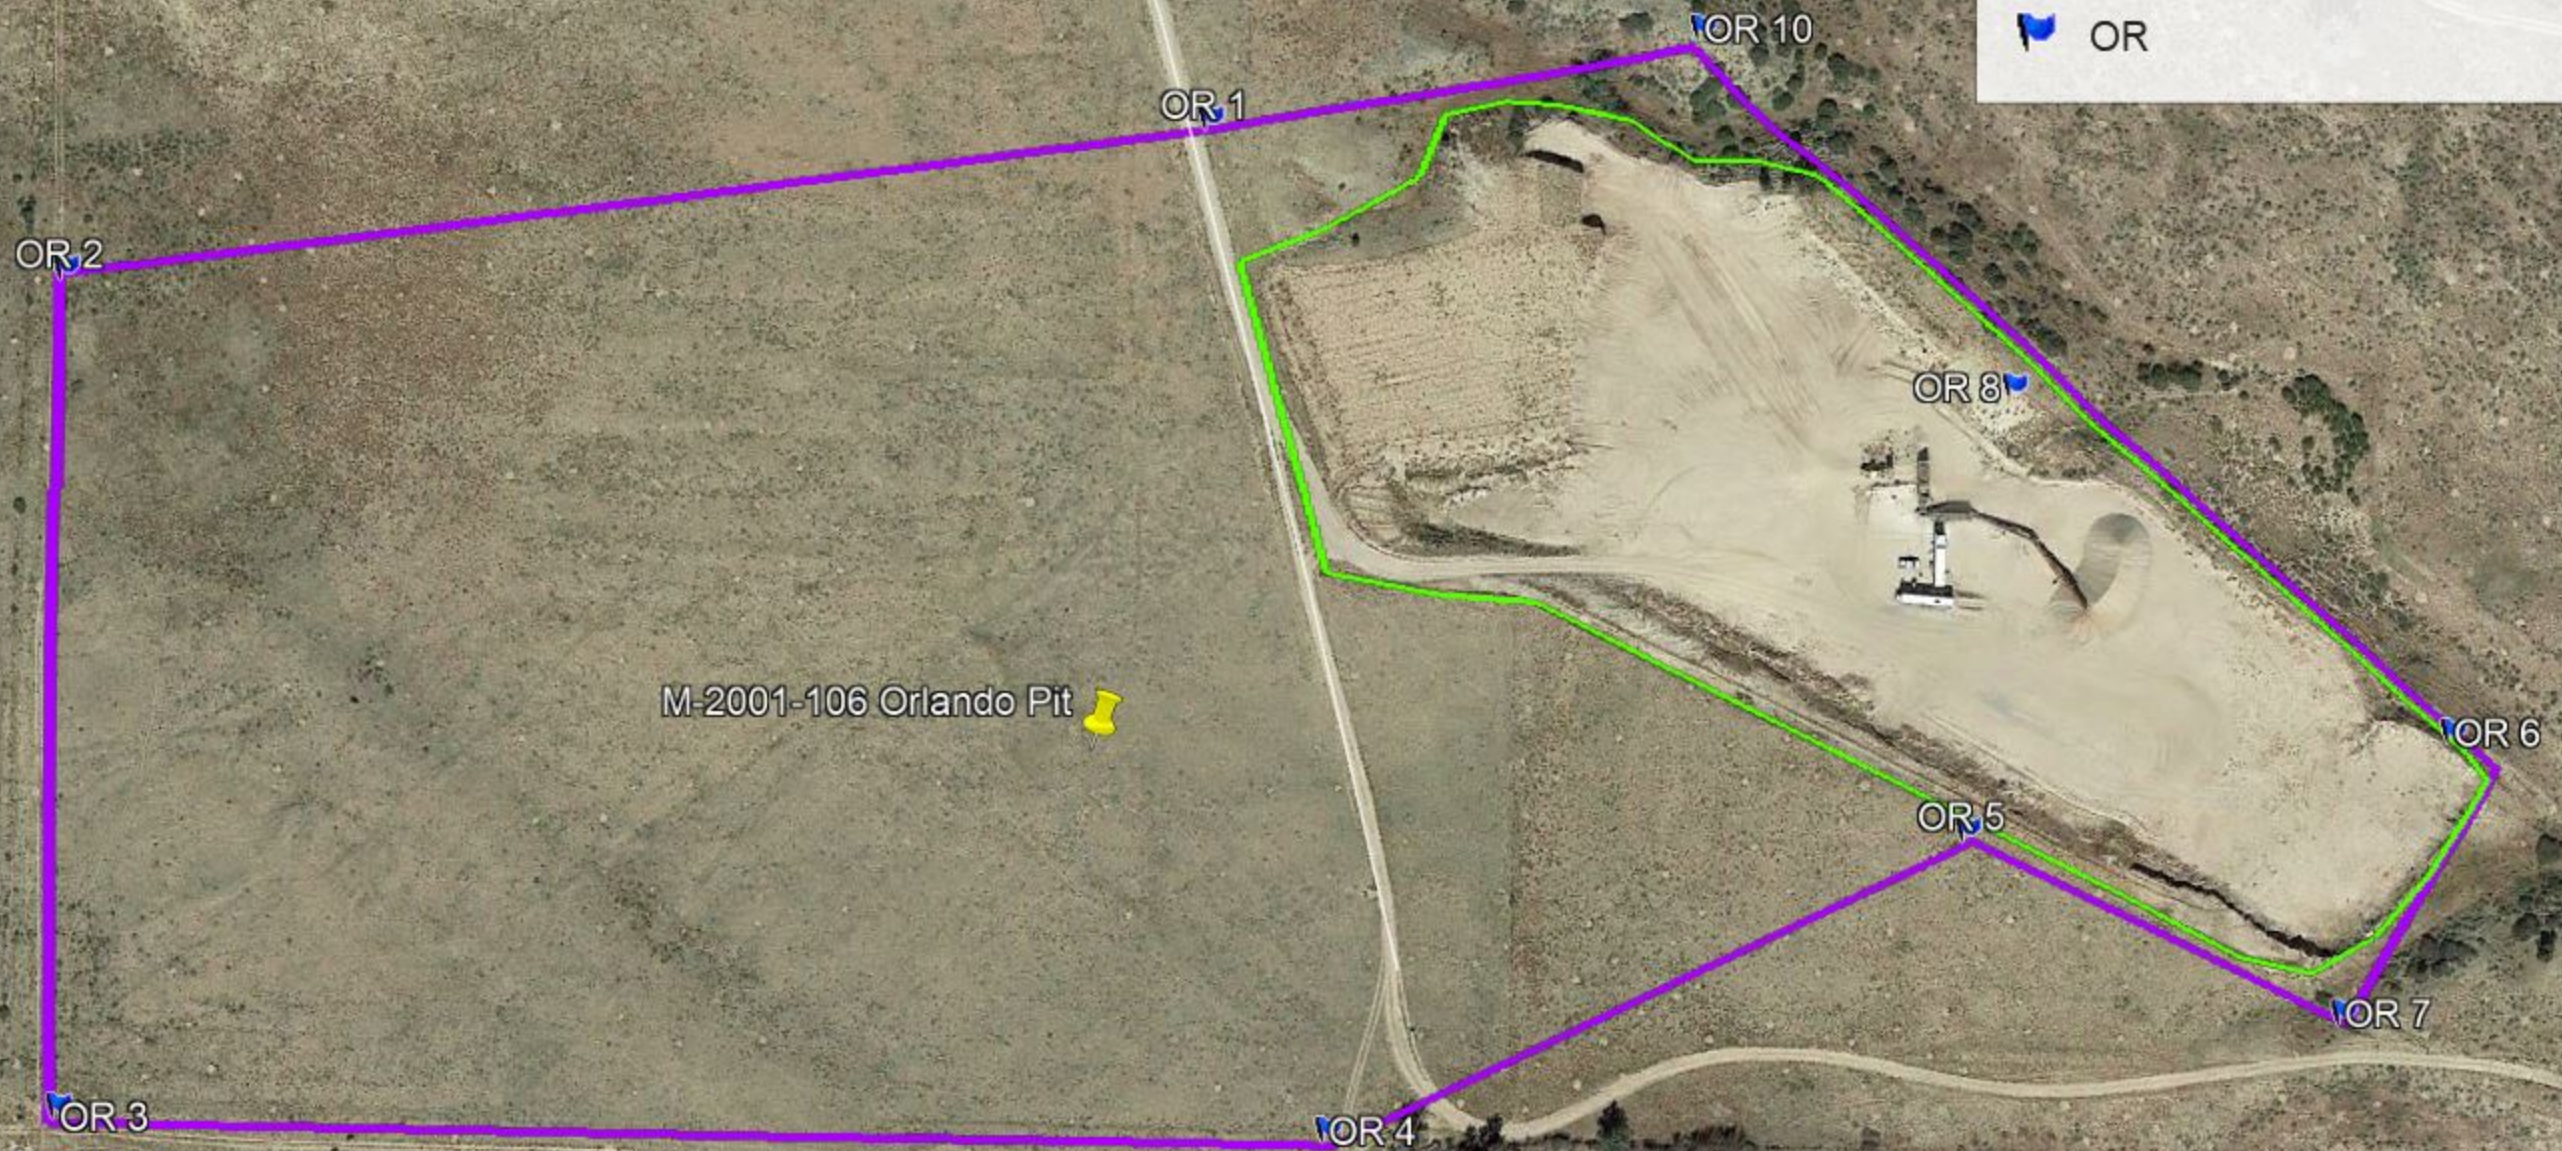
- 2019 Inspection 35.4 acres
- Disturbance Area 9.7 acres
- M-2001-106 Orlando Pit
- OR

PROBLEM: The affected area boundary markers are incorrectly placed. This is a problem for failure to maintain boundary markers around the affected area as required by Section 3.1.12(2) of the rule.

After marking all the permit boundary markers with a GPS and performing a permit review it appears that the boundary markers are misplaced. The misplaced boundary markers are being cited as a problem within this report. Attached to this report is a map of the boundary markers located by the Division during the inspection and another map, the Mining Plan Map, provided for reference.

CORRECTIVE ACTIONS: The operator shall conduct a survey and replace the boundary markers in the correct location(s). The operator shall provide proof to the Division that this has been done by the corrective action date.
