Re: King I Mine, C-1981-035
Stoner Engineering: Quarterly Inspection: Refuse Pile
4th Quarter 2019

Date: December 2, 2019

Re: King Coal I – Quarterly Waste Pile/Embankment Inspection

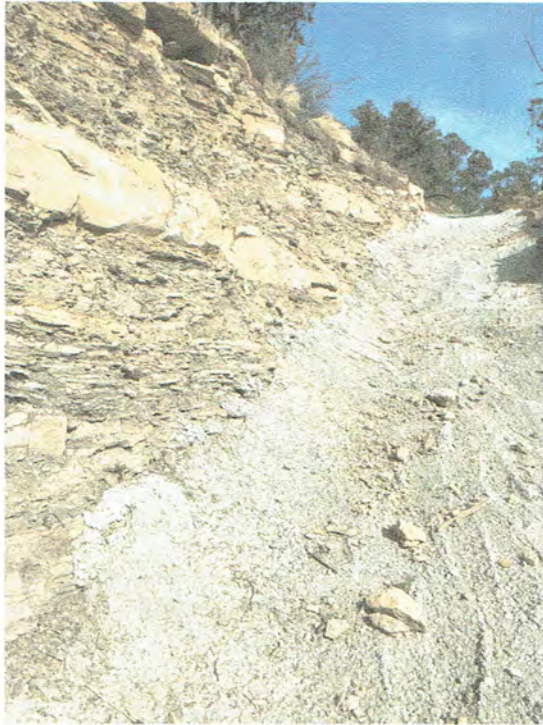
The south treated water ditch (Reach 10) was found to be in generally good condition. The portion of the Reach 10 channel identified in the previous report requiring maintenance is still in need of attention. The section of concrete channel has been constructed connecting the new upper section of Reach 1 to the lower existing section of Reach 1 (see Pic. 1). The upper culvert of Reach 10 has been cleaned out and the haul road bermed just upstream to prevent runoff from bypassing the culvert (see Pic. 2). All the waste material located on the top of the pile has been placed in the embankment waste pile.

Pic. 1 –Reach 1 concrete channel section connecting new upper section.

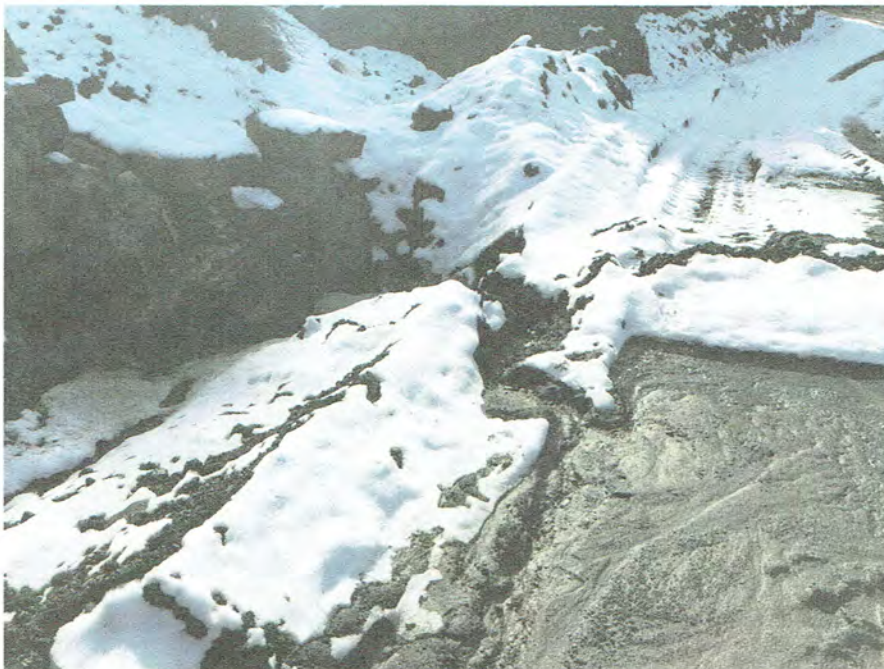
Pic. 2 – Berming at lower culvert of haul road.

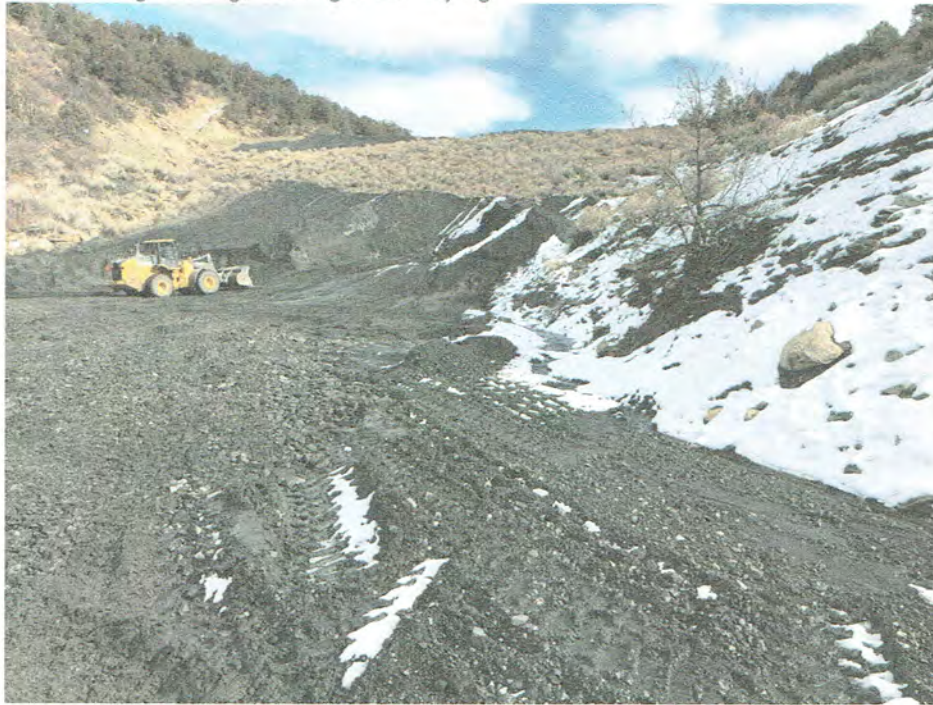
Waste material continues to be hauled to and dumped at the base of the existing waste pile/embankment where it is collected and being placed in accordance with TR-27 (see Pic. 3). The slope of the top of the existing pile is currently in excess of that defined in the Waste Bank Design produced by Don May, 1997. Specifically the cross slope from north to south across the top of the waste pile embankment.

Pic. 3 – Waste material being installed placed below existing waste embankment pile.

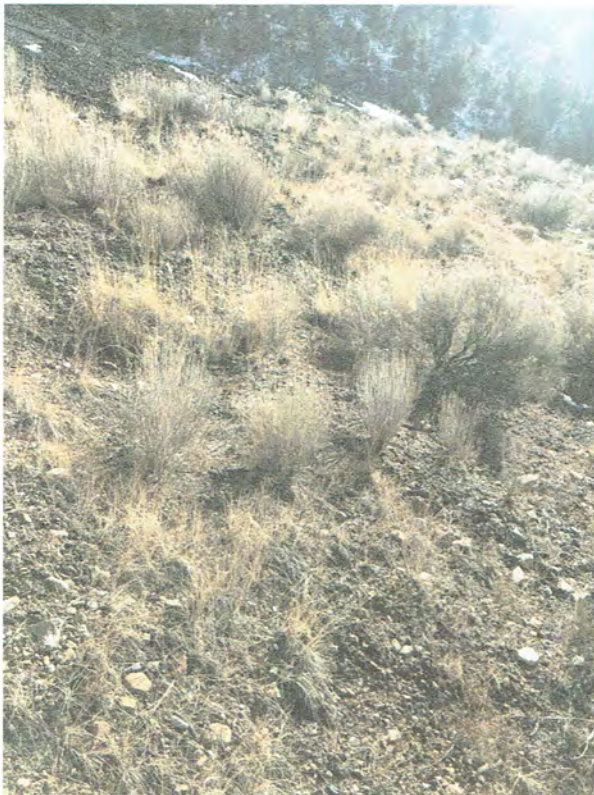
The face of the embankment appeared to be in good condition as there were no signs of excessive erosion, instability or weakness (see Pic. 4). The outlet of the under-drain at the base of the waste pile has been exposed.

Pic. 4 – Face of waste pile in good condition.
