**MINERALS PROGRAM INSPECTION REPORT**  
**PHONE: (303) 866-3567**

<b>MINE NAME:</b> Coaldale Quarry	<b>MINE/PROSPECTING ID#:</b> M-1977-247	<b>MINERAL:</b> Anhydrite, gypsum	<b>COUNTY:</b> Fremont
<b>INSPECTION TYPE:</b> Monitoring	<b>INSPECTOR(S):</b> Timothy Cazier	<b>INSP. DATE:</b> November 7, 2019	<b>INSP. TIME:</b> 14:30
<b>OPERATOR:</b> Holcim (US) Inc.	<b>OPERATOR REPRESENTATIVE:</b> Jullion Villon	<b>TYPE OF OPERATION:</b> 112c - Construction Regular Operation	
<b>REASON FOR INSPECTION:</b> Priority	<b>BOND CALCULATION TYPE:</b> None	<b>BOND AMOUNT:</b> \$707,000.00	
<b>DATE OF COMPLAINT:</b> NA	<b>POST INSP. CONTACTS:</b> None	<b>JOINT INSP. AGENCY:</b> None	
<b>WEATHER:</b> Clear	<b>INSPECTOR'S SIGNATURE:</b>

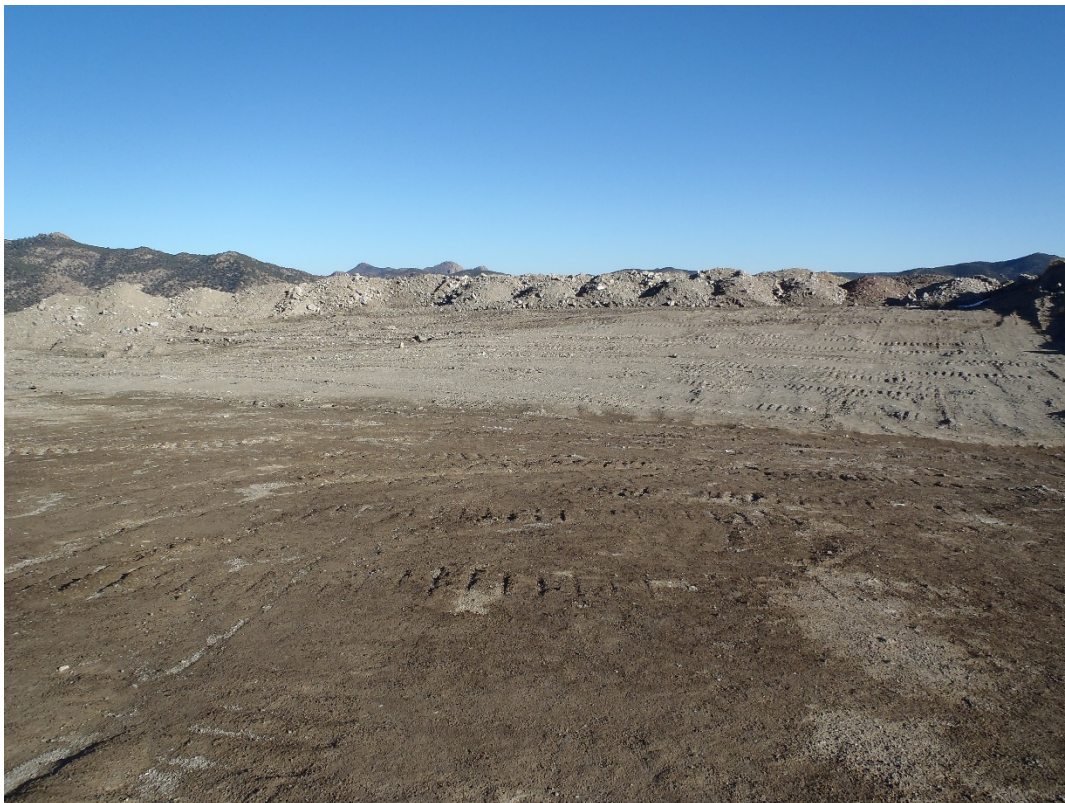
**PROBLEM/POSSIBLE VIOLATION:** Possible Violation: Land has been affected outside of the approved permit boundary. This is a possible violation pursuant to C.R.S. 34-32.5-116(4)(i) for failure to protect areas outside of the affected land from slides or damages occurring during the mining operation.

Off-site Damage: Permit boundaries in the vicinity of the topsoil pushed outside the affected area boundary observed during the June 18, 2019 inspection were double checked to determine how much area was affected. Boundary survey was provided by Holcim to the DRMS to assist in this assessment and compared with GPS data collected by the DRMS on June 18, 2019. The topsoil in question (see **Photo 1**) was confirmed to be out of the DRMS approved affected area boundary (coincident with the permit boundary in this case). The out-of-bounds affected area was determined to be just under two acres at 1.98 acres (see enclosed **Post Inspection Map**). During this follow-up inspection the equipment operator reiterated he did not realize the area was outside the affected area boundary when he placed the topsoil there.

Photo 1. Topsoil placed outside affected area boundary (looking NE).

**CORRECTIVE ACTIONS:** This possible violation will require a hearing before the Mined Land Reclamation Board. The schedule and other details for the MLRB hearing will be provided under a separate document to be sent via certified mail to the operator.
