MINERALS PROGRAM INSPECTION REPORT
PHONE: (303) 866-3567

MINE NAME: Sand Arroyo	MINE/PROSPECTING ID#: M-1978-283	MINERAL: Sand and gravel	COUNTY: Huerfano
INSPECTION TYPE: Preoperation Inspection	INSPECTOR(S): Patrick Lennberg	INSP. DATE: December 12, 2019	INSP. TIME: 09:00
OPERATOR: The Walsenburg Sand and Gravel Company	OPERATOR REPRESENTATIVE: Larry Martinez	TYPE OF OPERATION: 112c - Construction Regular Operation	
REASON FOR INSPECTION: Preoperation Inspection	BOND CALCULATION TYPE: Complete Bond	BOND AMOUNT: \$19,000.00	
DATE OF COMPLAINT: NA	POST INSP. CONTACTS: None	JOINT INSP. AGENCY: None	
WEATHER: Windy	INSPECTOR'S SIGNATURE:

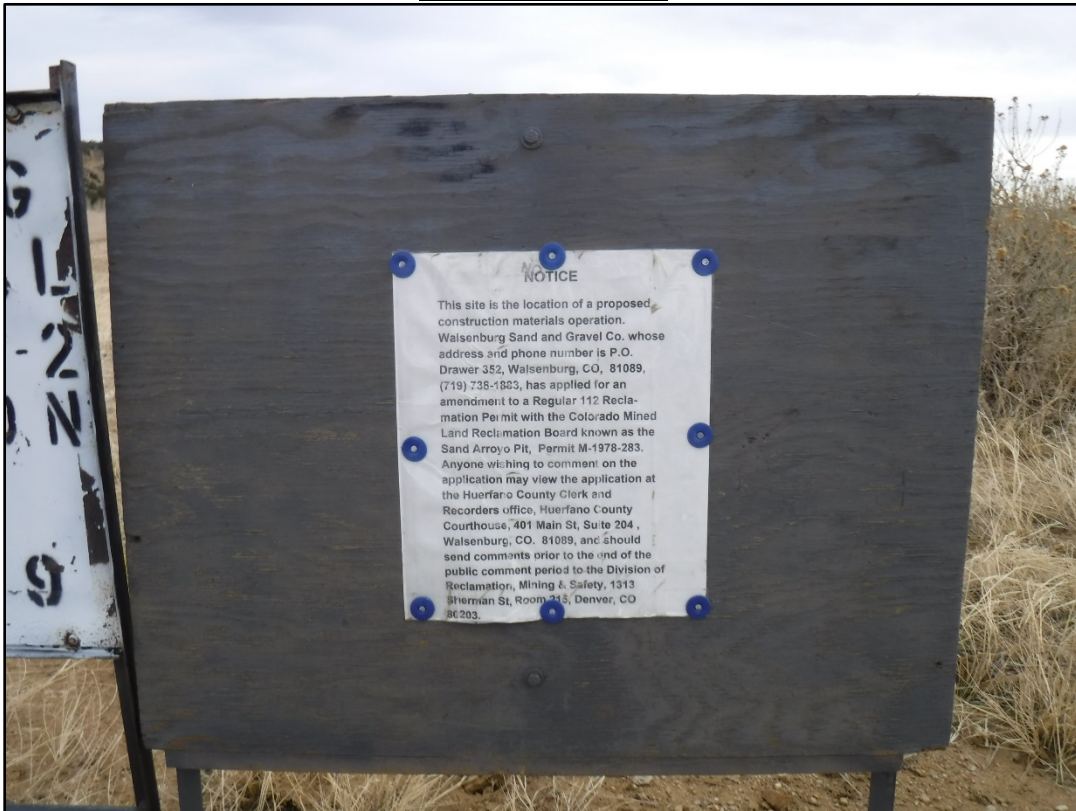
The Sand Arroyo Pit is located approximately 6 miles west of Walsenburg, Colorado. The Sand Arroyo Pit is a 112 permit for the removal of sand and gravel from an arroyo that is periodically recharged through runoff. Currently, the approved permit area is 52 acres with maximum allowed disturbance of 25 acres. The amendment proposes increasing the permit acreage to 67.65 acres incorporating the existing adjacent 111 permit in the permit boundary and squaring off the current irregular permit boundary. The approved post mining land use is rangeland. A mine and permit notice sign were observed at the mine entrance.

Photo 1: Posted notice sign at mine entrance

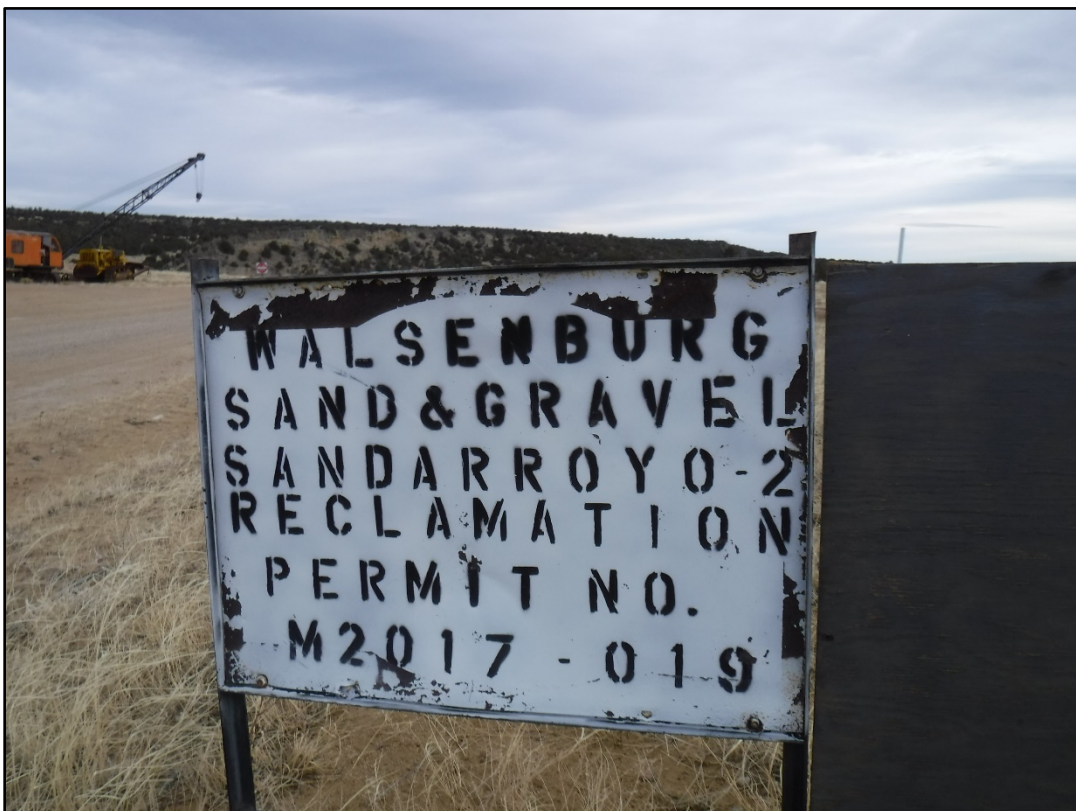
Photo 2: Mine sign for the 111 permit

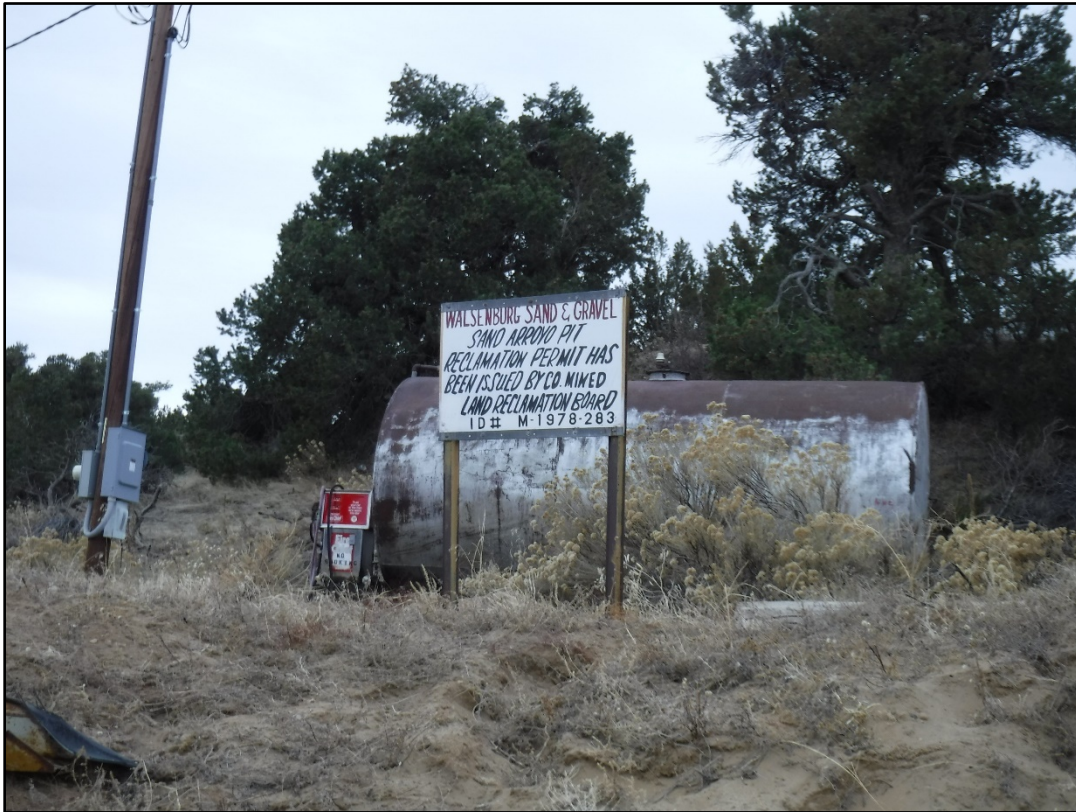
Photo 3: Mine sign for the 112 permit

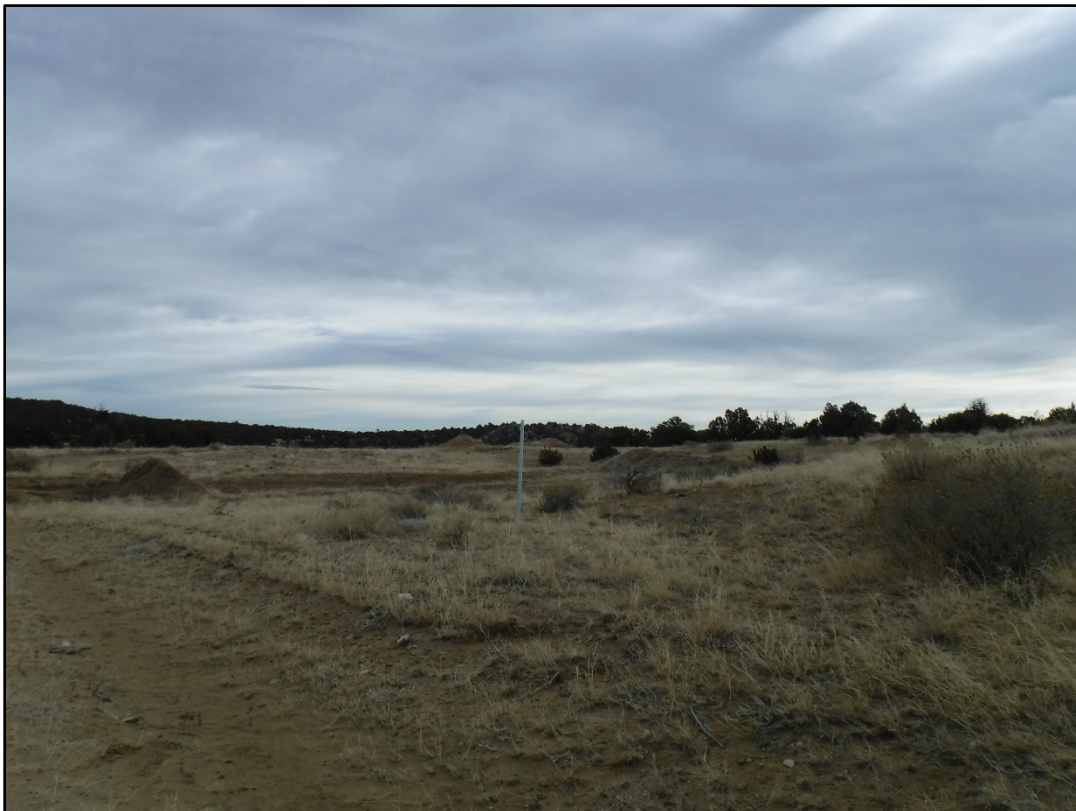
Photo 4: Typical mine permit boundary marker

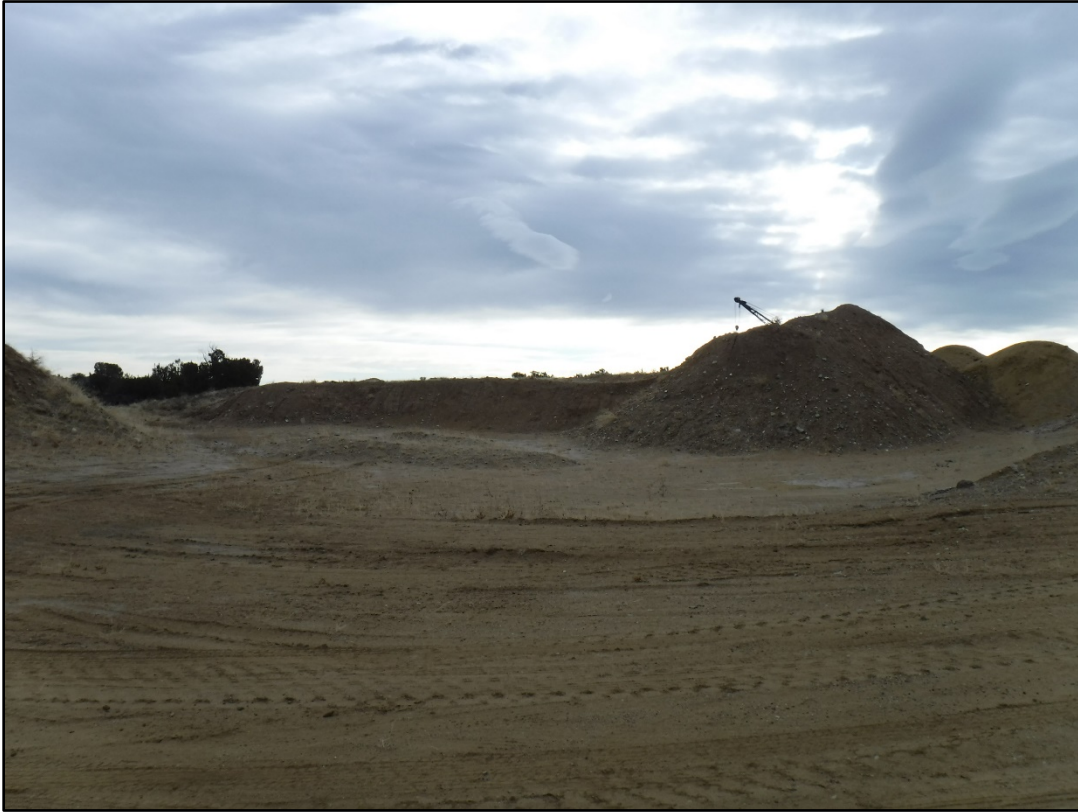
Photo 5: Affected area associated with the 111 permit area

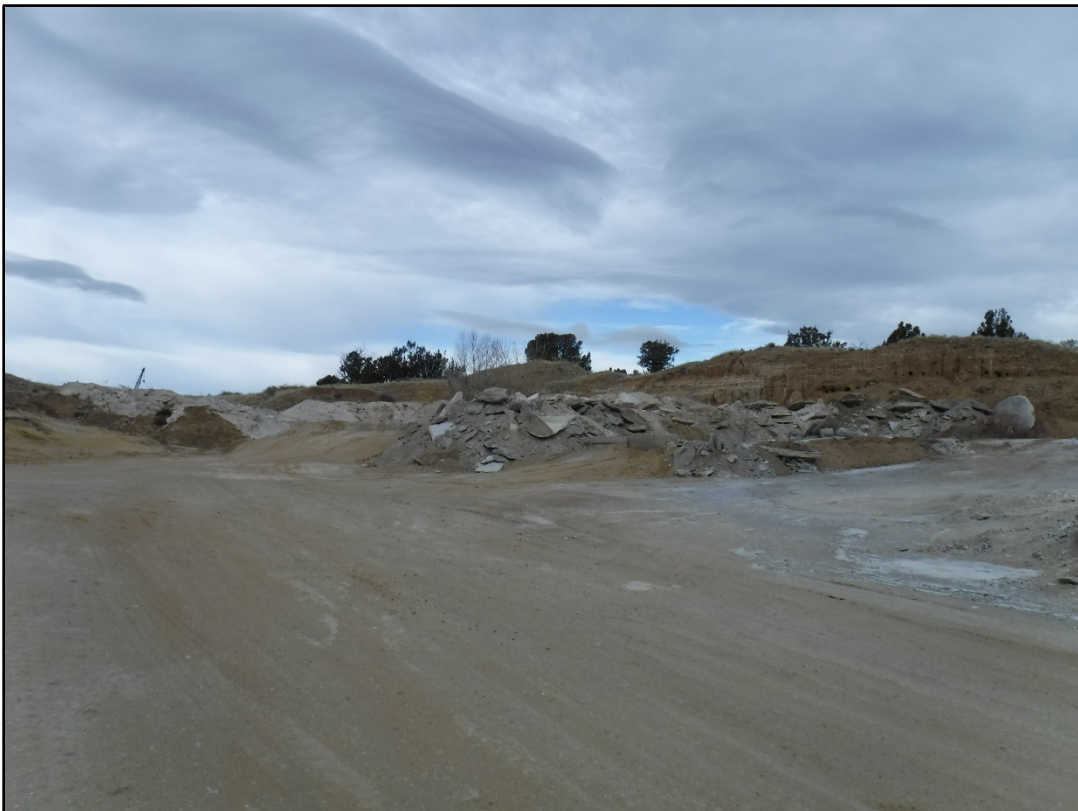
Photo 6: Affected area belonging to the batch plant

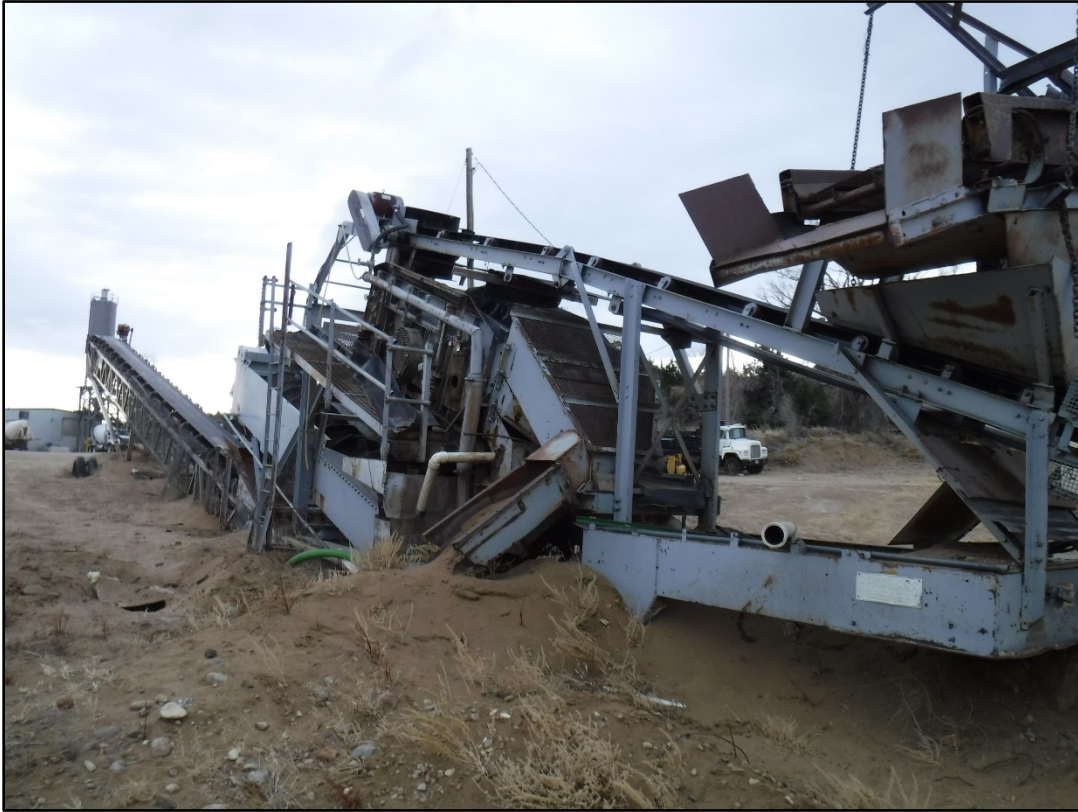
Photo 7: Sand processing plant

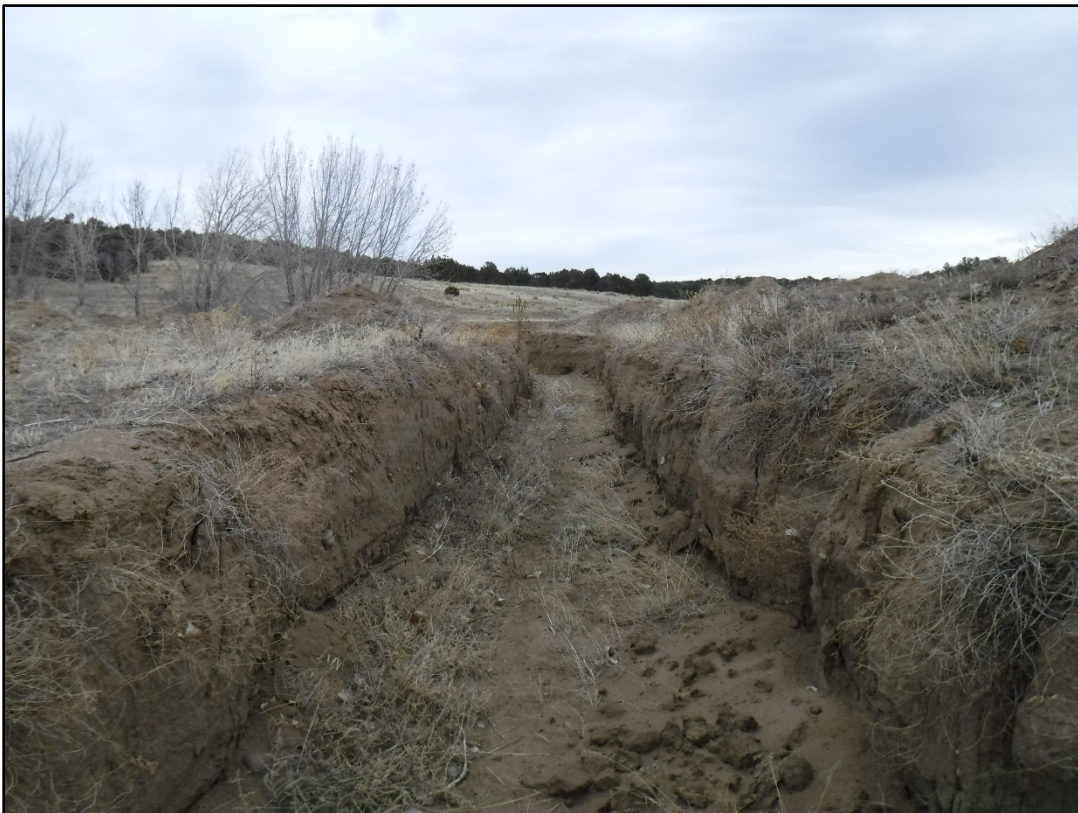
Photo 8: Conveyance ditch for the water used during processing

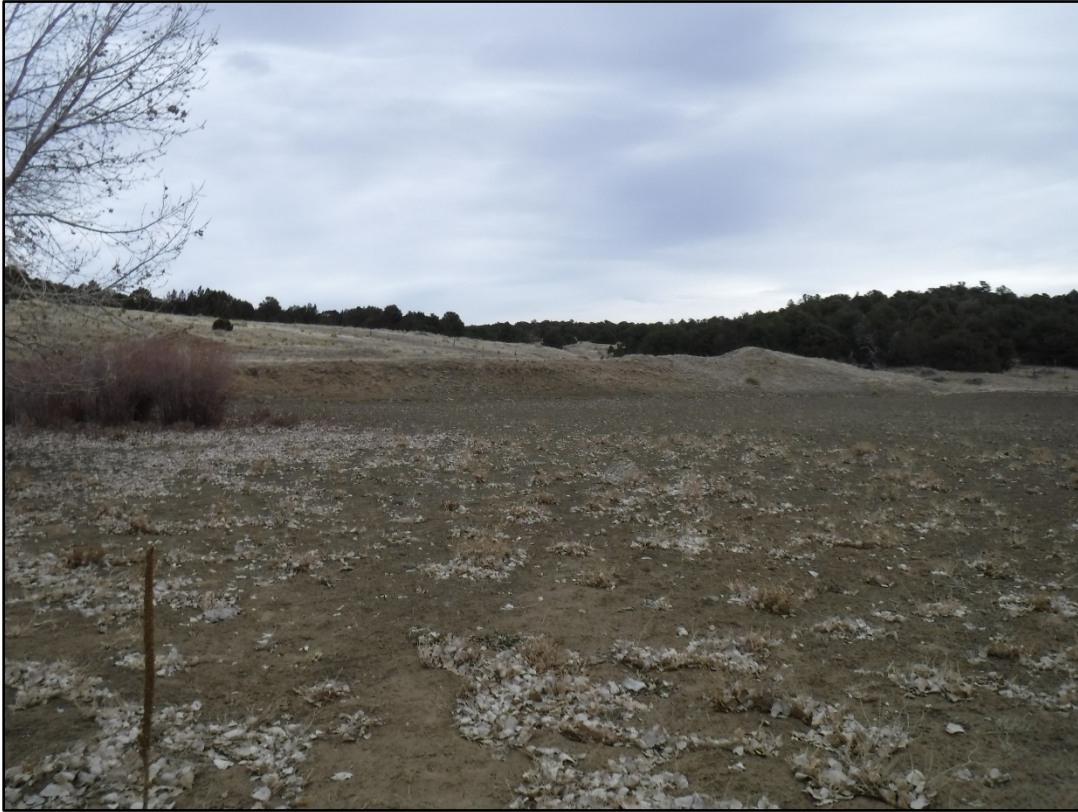
Photo 9: Settling area for water infiltration

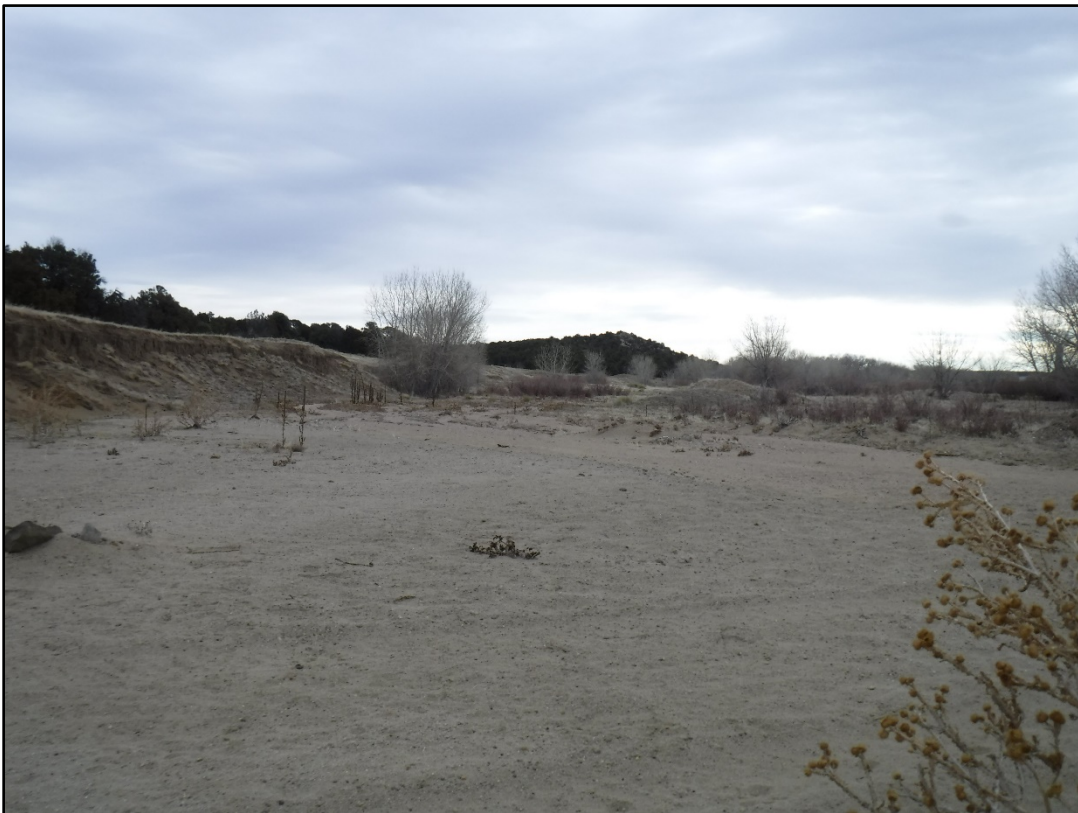
All the excavation of sand material occurs within the dry arroyo. Current disturbance appears to be approximately 25 acres. The representative stated that mining has not occurred recently at the site because there has not been a runoff event large enough to replenish with suitable material. He stated that in order to get suitable material they had to expose groundwater and were not interested in exposing groundwater. All structures observed during the inspection were accurately depicted on the maps within the permit application.

Photo 10: Typical stream channel to be mined once replenished
