**MINERALS PROGRAM INSPECTION REPORT**  
**PHONE: (303) 866-3567**

<b>MINE NAME:</b> Ula Pit	<b>MINE/PROSPECTING ID#:</b> M-1991-083	<b>MINERAL:</b> Gravel	<b>COUNTY:</b> Custer
<b>INSPECTION TYPE:</b> Monitoring	<b>INSPECTOR(S):</b> Timothy Cazier	<b>INSP. DATE:</b> June 19, 2019	<b>INSP. TIME:</b> 11:00
<b>OPERATOR:</b> Seifert Construction dba Seifert Enterprises, LLC	<b>OPERATOR REPRESENTATIVE:</b> Kent Beach	<b>TYPE OF OPERATION:</b> 112c - Construction Regular Operation	
<b>REASON FOR INSPECTION:</b> Normal I&E Program	<b>BOND CALCULATION TYPE:</b> Partial Bond	<b>BOND AMOUNT:</b> \$30,950.00	
<b>DATE OF COMPLAINT:</b> NA	<b>POST INSP. CONTACTS:</b> None	<b>JOINT INSP. AGENCY:</b> None	
<b>WEATHER:</b> Cloudy	<b>INSPECTOR'S SIGNATURE:</b>

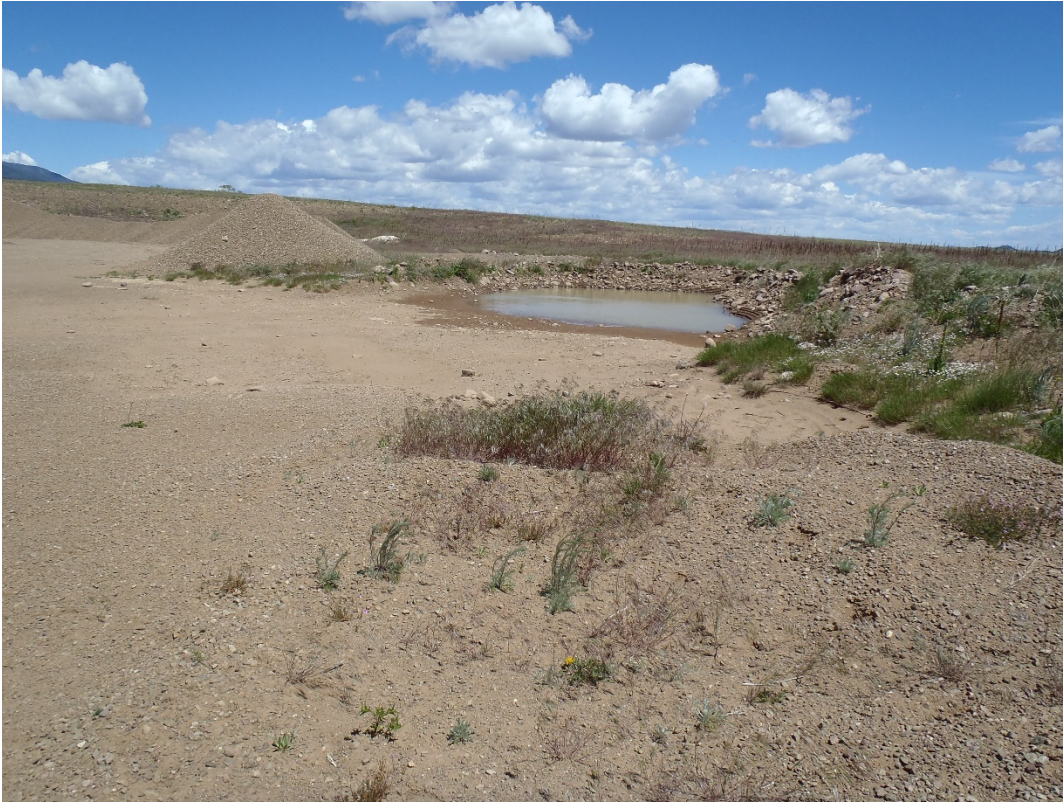
Hydrologic Balance: No standing water was observed in the pit and no exposed groundwater was observed. Some water was observed in the sediment pond from the recent rain (see **Photo 1**).

Storm Water MGT Plan: No oil or fuel spills observed. Stormwater is directed to the site sediment pond (see **Photo 1**) where it infiltrates.

Photo 1. Sediment pond (east side of pit, looking north).

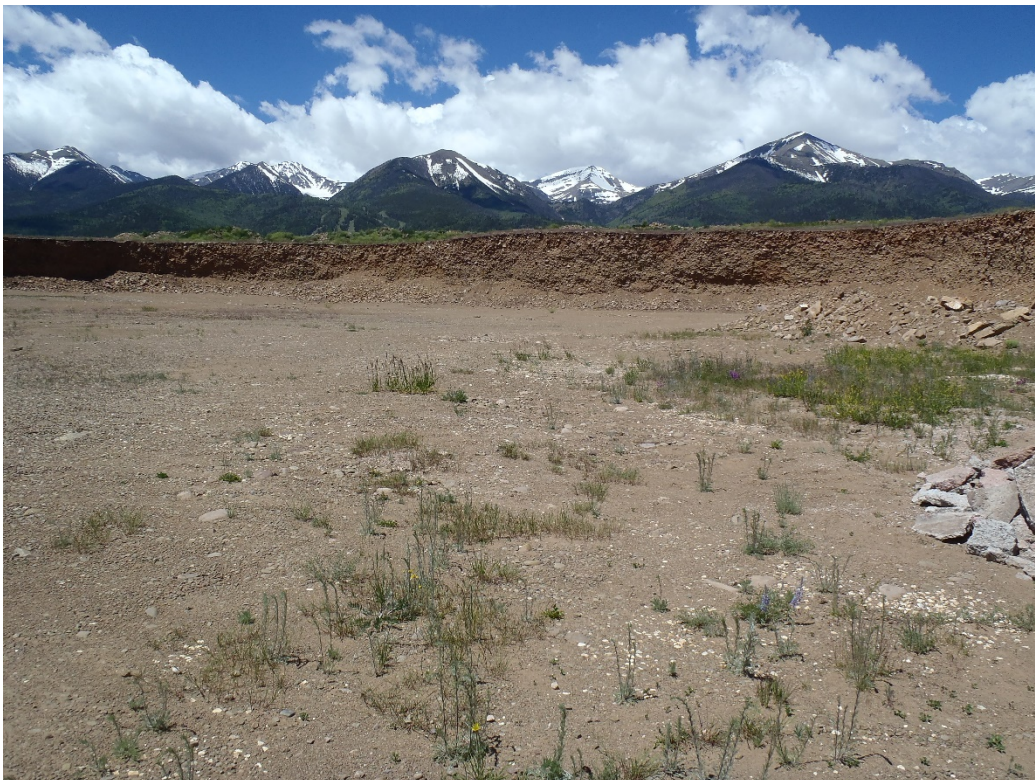
**PROBLEM/POSSIBLE VIOLATION:** Problem: The current approved mine plan requires mining at 3H:1V to reduce the financial warranty. The mine plan needs to be updated to allow mining at near vertical pursuant to C.R.S. 34-32.5-112 (1)(c)(VI), or the highwalls need to be flattened to no steeper than 3H:1V.

Gen. Compliance with Mine Plan: The first adequacy response in the July 23, 2004 letter from LJ Development states the highwalls will be mined at 3H:1V in order to reduce the earthmoving required for reclamation. This was pointed out in the December 2, 2014 inspection report. The highwall at the time of inspection was observed to be near vertical (see **Photo 2**). **Not mining at a 3H:1V slope is cited as a problem on page 1 of this report.** The maximum allowed disturbed area is 15 acres. Google Earth was used to measure the disturbed area, which was estimated to be approximately 10.3 acres, based on 2016 imagery. Highwalls were estimated to vary between 8 and 12 feet in height with a length of approximately 400 feet (see **Photo 3**). The DRMS estimates 450 cubic yards of material would need to be pushed down from the highwall crest to achieve a cut/fill balance to reslope this 400 feet of highwall to 3H:1V (see attached **Task #100.1 Highwall Backfill Volume Estimate**).

Photo 2. Near vertical highwall (north end, west side, looking west).

**CORRECTIVE ACTIONS:** The operator shall either: A) submit a Technical Revision, with the required \$216 revision fee, to update the current approved mine plan to reflect the current near vertical highwall mine practice or B) flatten the existing highwalls to no steeper than 3H:1V by the corrective action date.

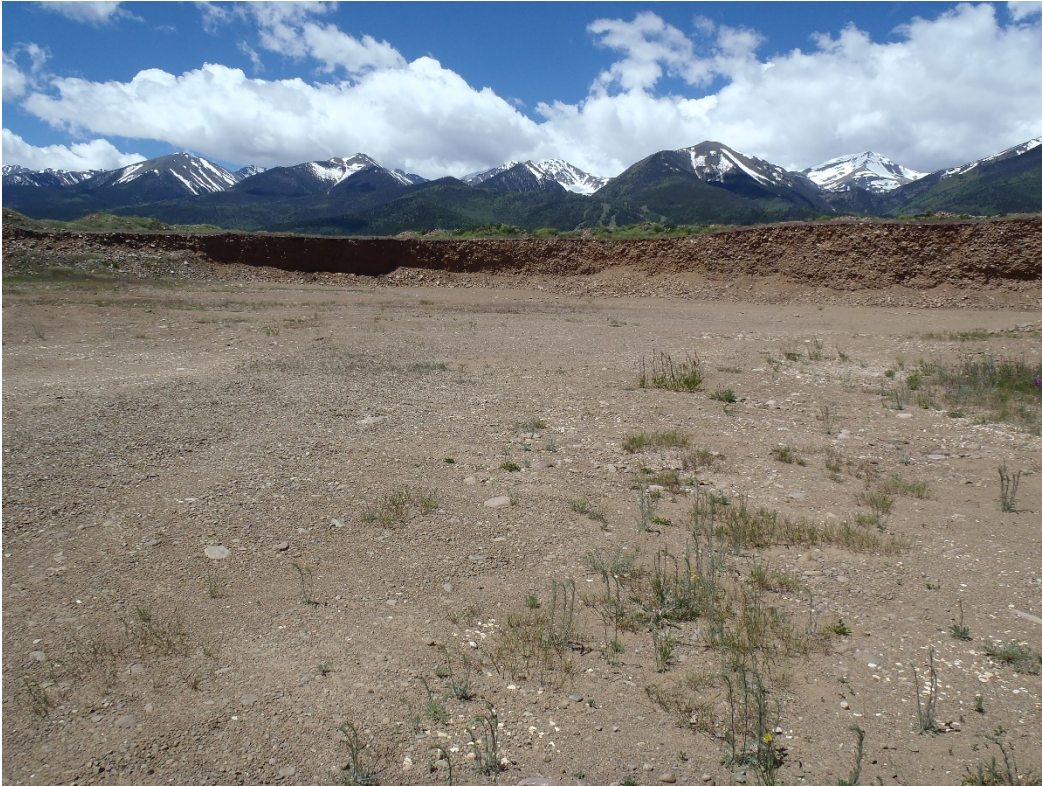
Photo 3. Near vertical highwall (south end, west side, looking SW).

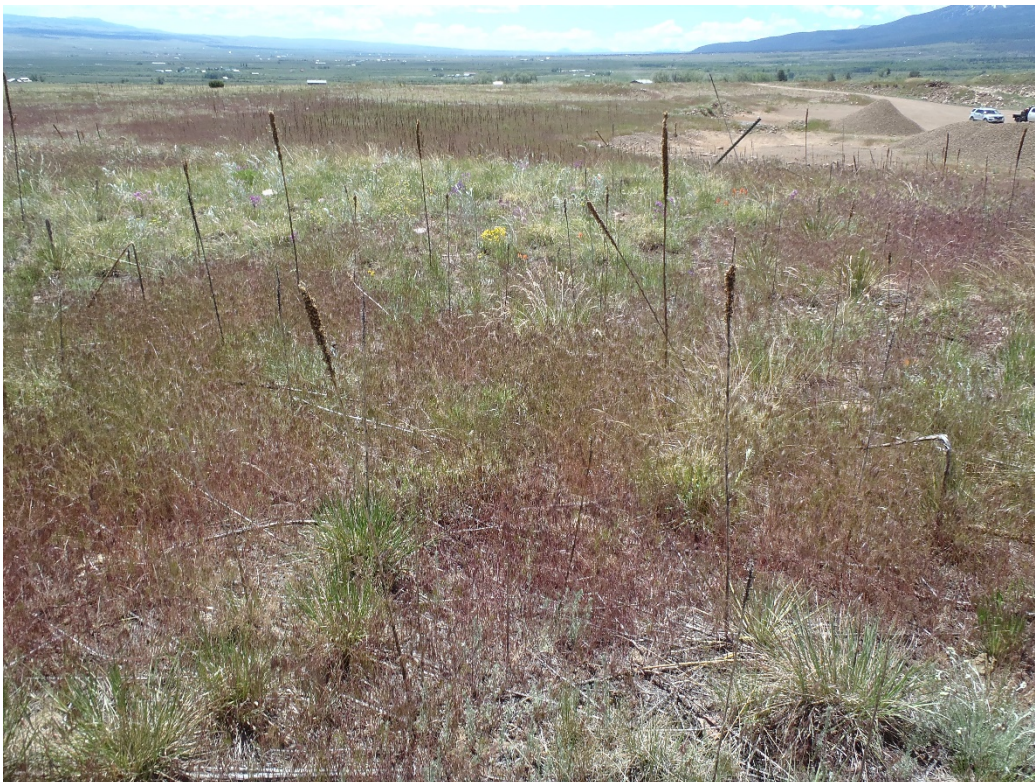
Revegetation: The adjacent undisturbed area, both within and outside the permit area has a considerable amount of downy brome (see **Photo 4**) also known as cheat grass, a List C noxious weed species. Mr. Beach stated that was the grass grown for hay and showed this inspector hayfields full of cheat grass. This being the case, the presence of cheat grass onsite is not cited as a problem. No revegetation effort had been initiated at the time of the inspection.

Photo 4. Cheat grass in undisturbed area (looking SE from north side of pit).

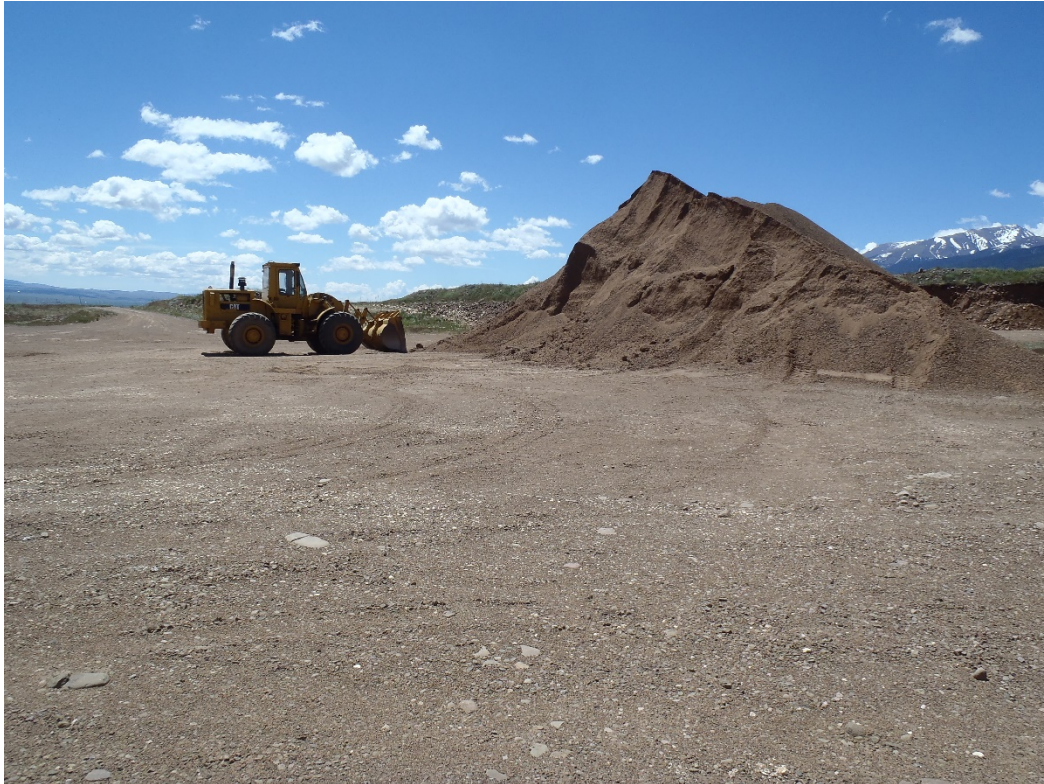
Support Facilities On-site: A loader was observed on site (see **Photo 5**) and the product stockpile showed signs of recent material removal.

Photo 5. Product stockpile and loader (pit floor, looking south).

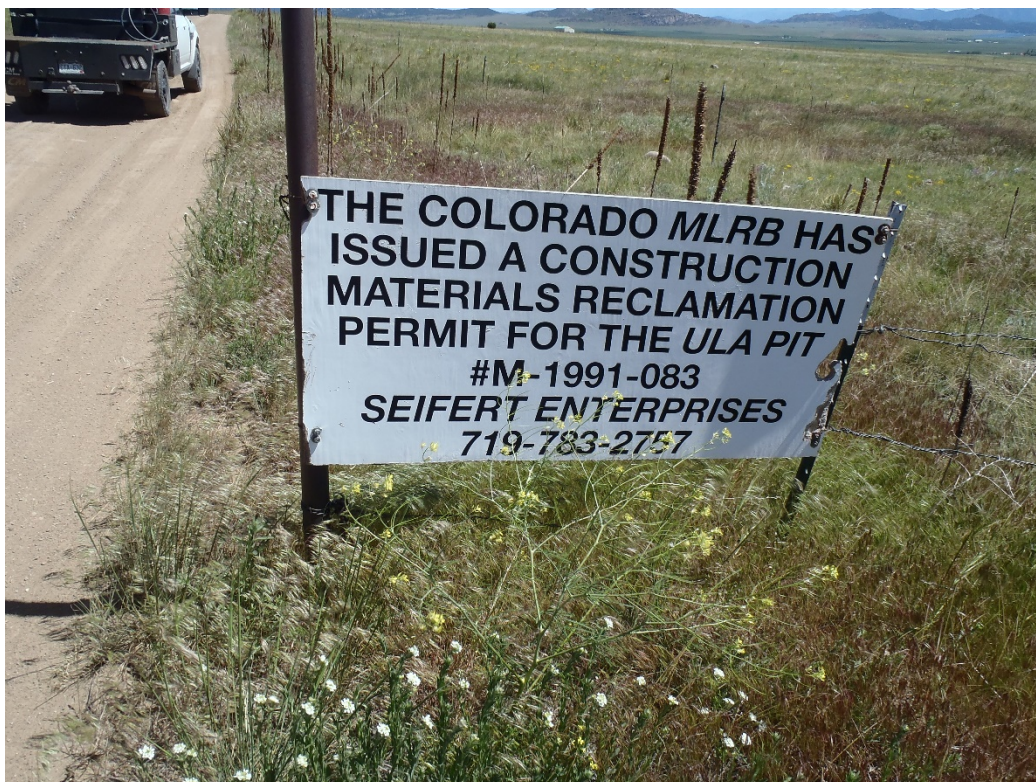
Signs and Markers: The permit sign was properly posted (see **Photo 6**) and boundary fences were observed to delineate the permit boundary (see **Photos 7 and 8**).

Photo 6. Permit sign at entrance from Hermit Road.

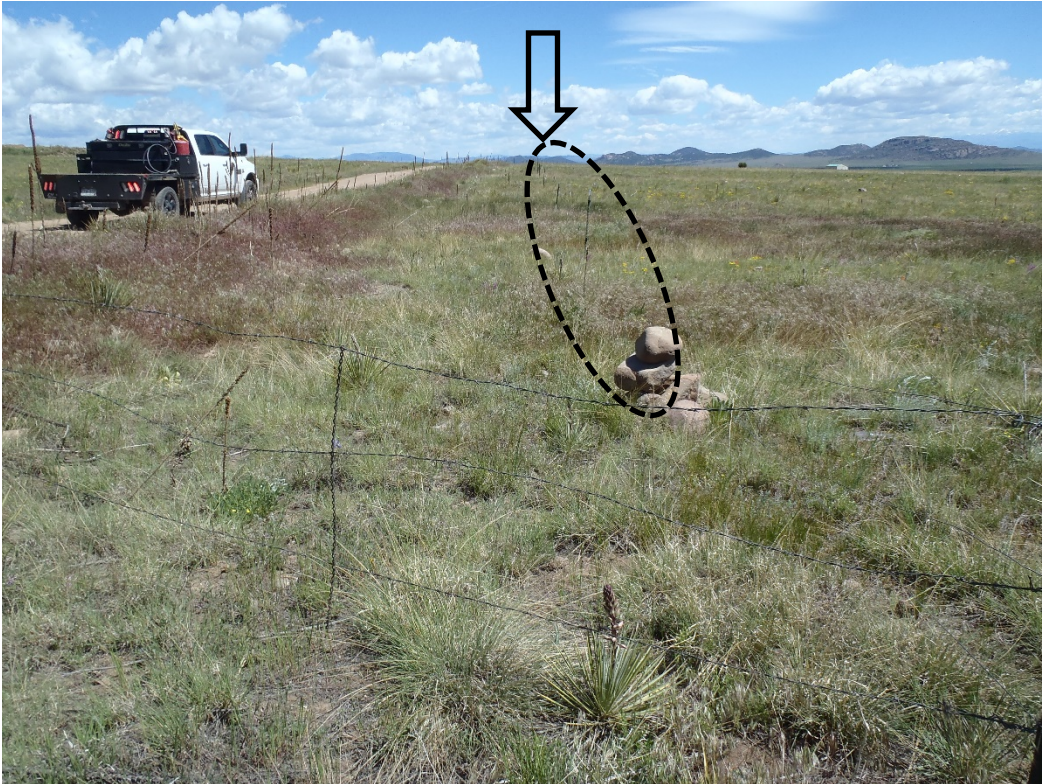
Photo 7. Boundary fence (east side, looking north, posts circled).

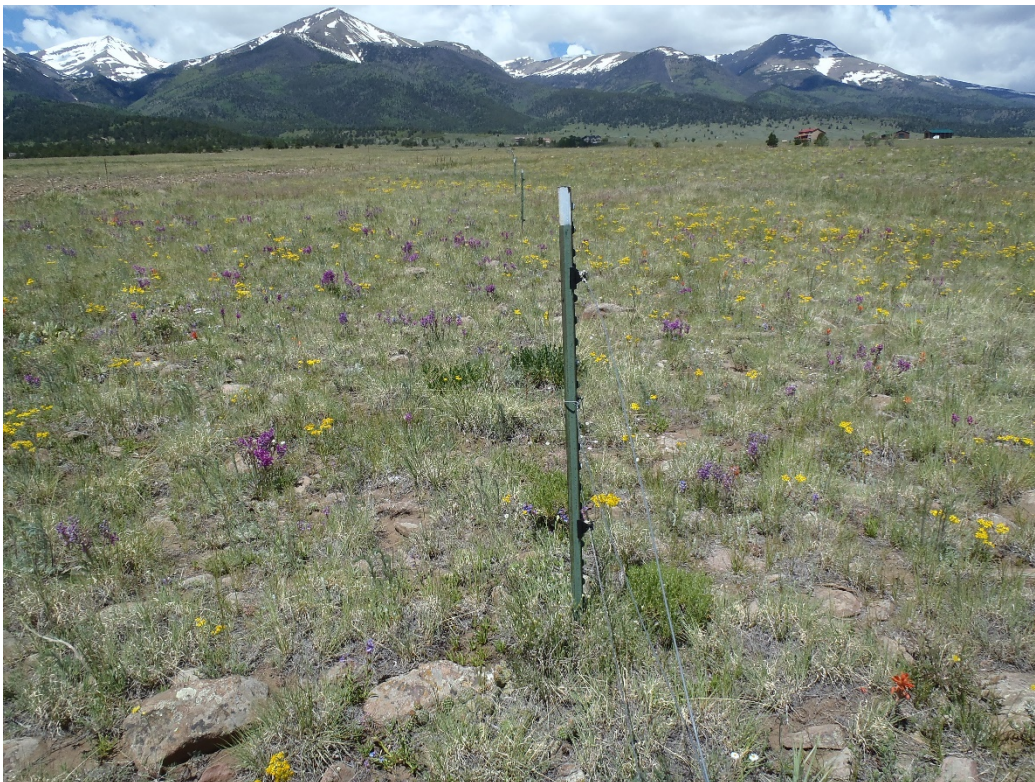
Photo 8. Boundary fence (north side, looking west).

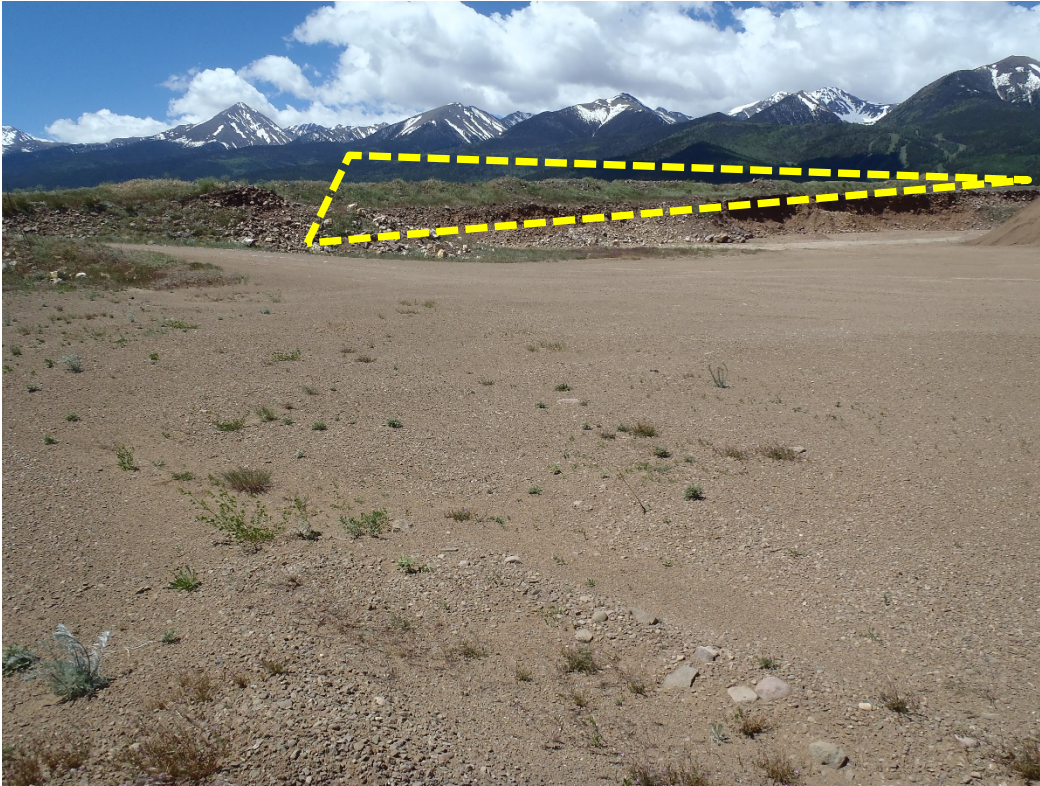
Topsoil: Topsoil was observed to be stockpiled above the highwall crest on the south side (see **Photo 9**) and on the west side.

Photo 9. Topsoil stockpile (south side, looking SW).
