## MINERALS PROGRAM INSPECTION REPORT

<b>MINE NAME:</b> Schwartzwalder Mine	<b>MINE/PROSPECTING ID#:</b> M-1977-300	<b>MINERAL:</b> Uranium	<b>COUNTY:</b> Jefferson
<b>INSPECTION TYPE:</b> Monitoring	<b>INSPECTOR(S):</b> Amy Eschberger	<b>INSP. DATE:</b> November 7, 2019	<b>INSP. TIME:</b> 08:30
<b>OPERATOR:</b> Colorado Legacy Land, LLC	<b>OPERATOR REPRESENTATIVE:</b> Billy Ray and Liz Busby	<b>TYPE OF OPERATION:</b> 112d-2 - Designated Mining Operation	
<b>REASON FOR INSPECTION:</b> Normal I&E Program	<b>BOND CALCULATION TYPE:</b> None	<b>BOND AMOUNT:</b> \$8,900,000.00	
<b>DATE OF COMPLAINT:</b> NA	<b>POST INSP. CONTACTS:</b> None	<b>JOINT INSP. AGENCY:</b> None	
<b>WEATHER:</b> Clear	<b>INSPECTOR'S SIGNATURE:</b> 	<b>SIGNATURE DATE:</b> December 17, 2019

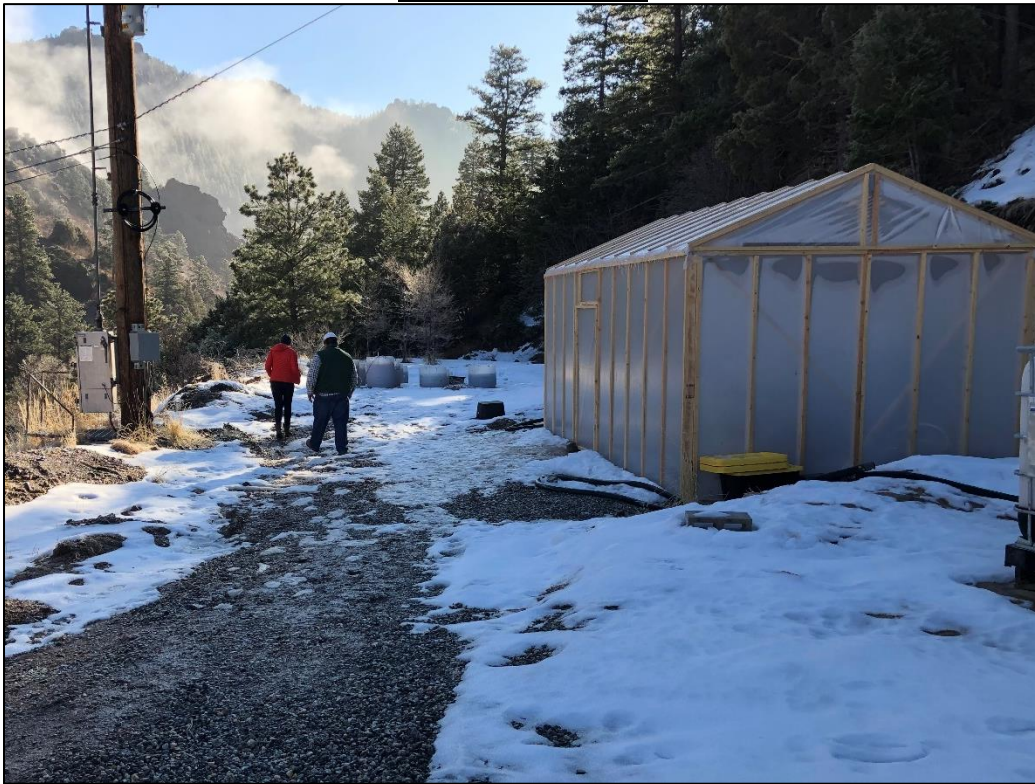
The wetland and biochemical reactor (BCR) pilot-scale study continues on top of the mesa, in an area east of the water treatment plant. The primary focus of the study is to evaluate whether uranium can be treated biologically. The study is operated seasonally (May – October) and monitored for inflow and outflow metals concentrations. The wetland treatment system consists of four cells in a series with local plants. Two series are built with bulrush and the other two series are built with aquatic sedge. The operator indicated they observed promising results with the bulrush plants over the summer. The BCR system consists of five separate columns, two of which have a solid carbon source (food for microbes), two of which have a liquid ethanol carbon source, and one of which is a control with no carbon added. A small greenhouse structure has been constructed around the BCRs to keep them above 50°F over the winter. The operator anticipates running the BCRs until about mid-December, at which time, the system will be put into hibernation for the winter. If, based on the results of this study, the operator decides to incorporate passive treatment methods into the reclamation plan for the site, these changes could be proposed through the appropriate permit revision.

**Photo 1.** View looking southeast at area east of water treatment plant where wetland and biochemical reactor (BCR) pilot-scale study occurs. Note small greenhouse constructed around BCR system to protect it over the winter.

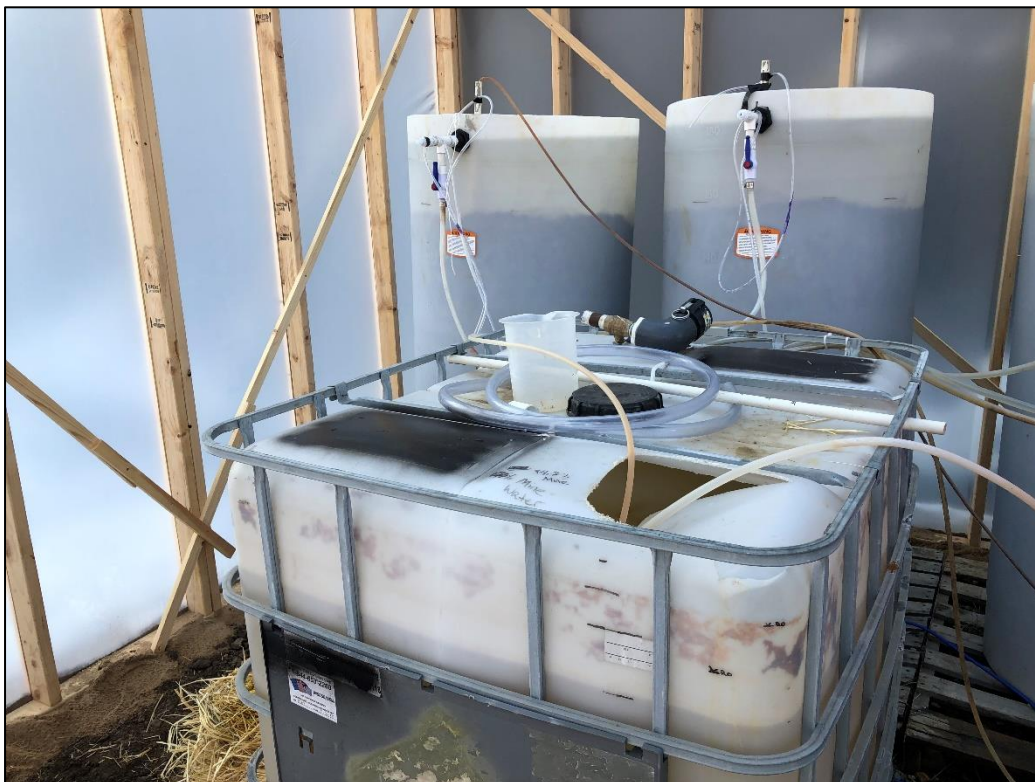
**Photo 2.** View of BCR system inside small greenhouse, located east of water treatment plant.

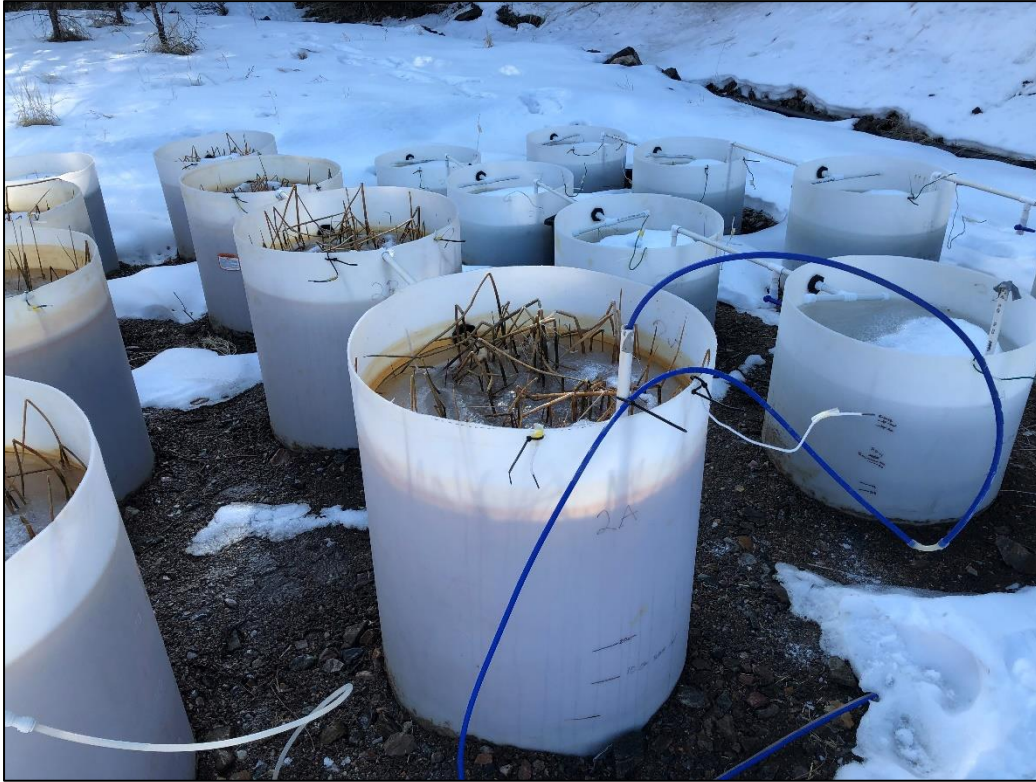
**Photo 3.** View of wetland treatment system constructed with bulrush and aquatic sedge, located east of water treatment plant (east of greenhouse).

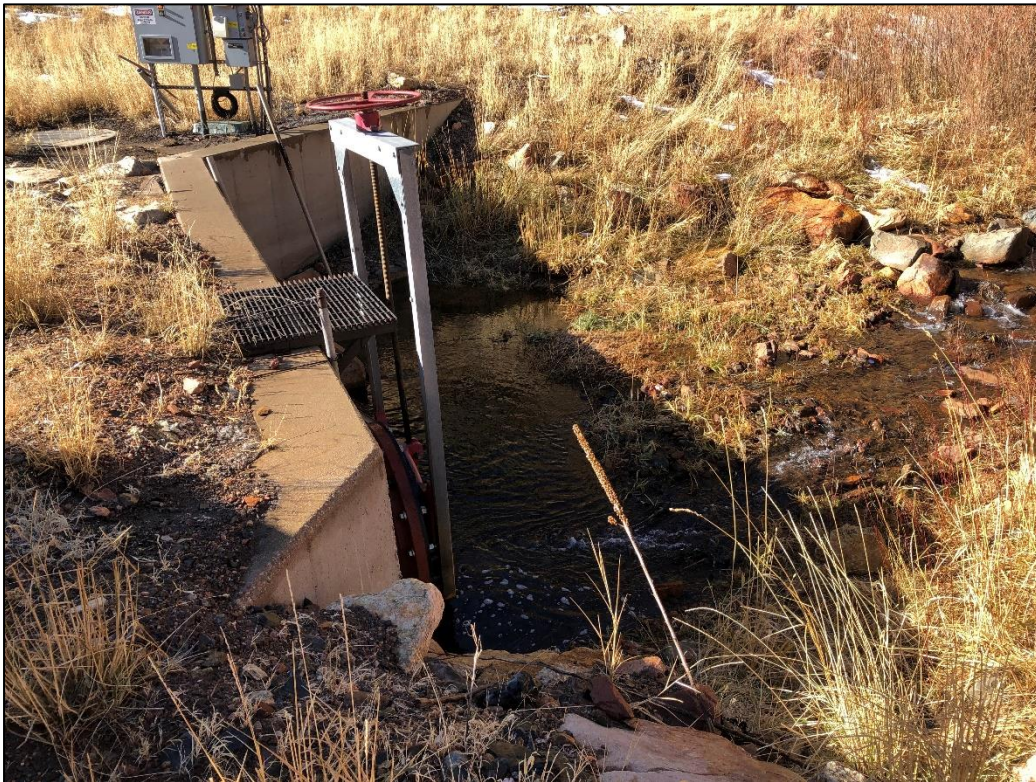
The Division inspected the upgradient cutoff wall and observed that all flows in Ralston Creek were being routed through the bypass pipeline. According to the operator, the creek was not flowing above the cutoff wall just a few weeks ago, prior to significant snowmelt occurring in the valley. The Division also inspected the areas adjacent to Glencoe Valley Road (near the toe of the NWRP) located upstream from the cutoff wall, where red- and green-colored ponded water (believed to be seep water from the NWRP) was observed during the inspection conducted on March 22, 2019. These areas were dry during the current inspection.

**Photo 4.** View looking at upgradient cutoff wall/head gate in Ralston Creek, showing creek flowing during inspection.

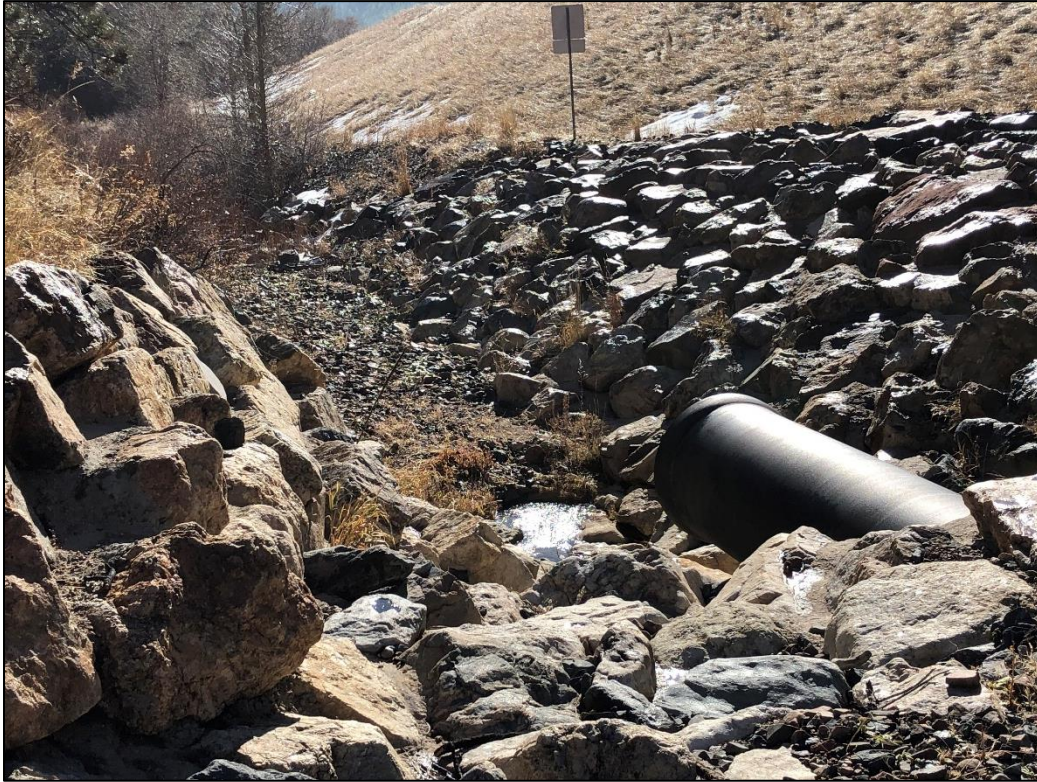
**Photo 5.** View looking downstream from upgradient cutoff wall in Ralston Creek, showing creek dry during inspection.

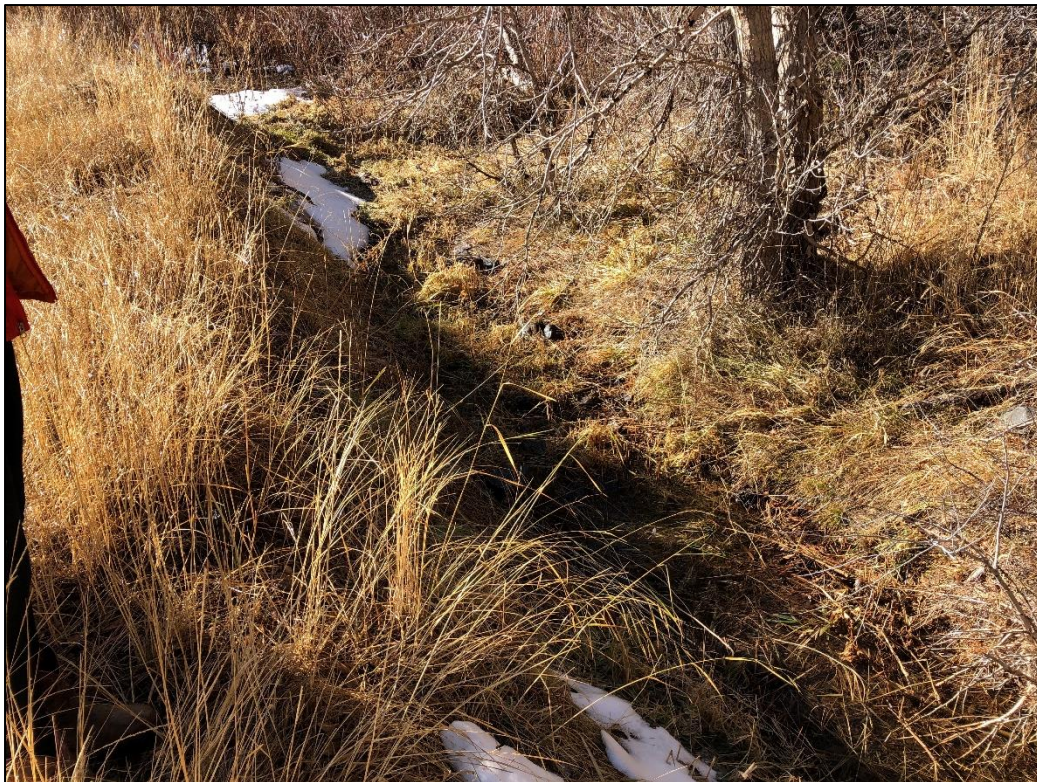
**Photo 6.** View looking south along ditch adjacent to Glencoe Valley Road (near toe of NWRP), where a pool of green-colored water was observed this summer. Note this area was dry during the inspection.

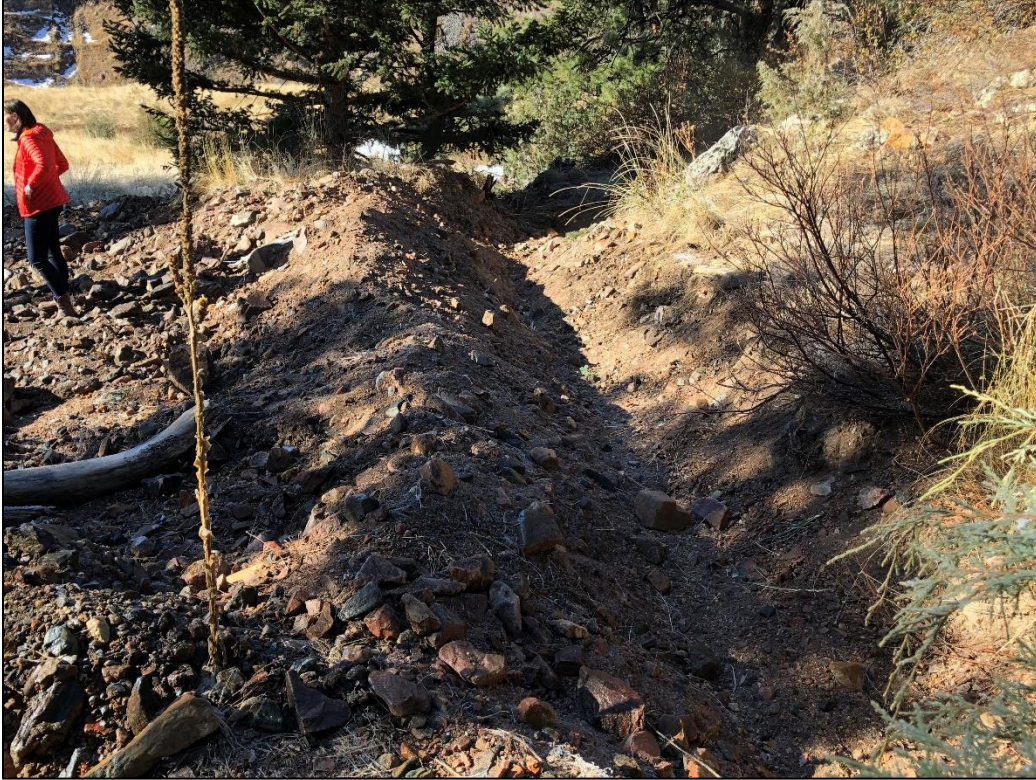
The Division inspected the top of the NWRP, where saturated conditions were observed during the Division's March 22, 2019 inspection. Saturated conditions were not observed on top of the pile during the current inspection. The Division is currently reviewing Technical Revision No. 28 (TR-28; submitted on May 9, 2019) to revise the stormwater control plan for the NWRP that was approved in 2017 (through Technical Revision No. 23). The decision date for TR-28 is currently set for January 10, 2020. The operator believes that installation of the revised stormwater control structure(s) will address any seep issues with the NWRP by diverting water from the above drainage around the pile, and discharging the water to the creek below.

**Photo 7.** View looking down ditch along northern edge of top of NWRP which operator has cleaned out as a temporary stormwater control measure while TR-28 is under review.

The operator initially expected to install the revised stormwater control structure(s) during the 2019 construction season. However, due to the extensions needed for addressing the Division's concerns in TR-28, the operator now expects the system will be installed during the 2020 construction season. In the meantime, the operator has cleaned out the ditch along the northern edge of the top of the NWRP to allow stormwater to flow more easily around the pile until the revised structures can be approved and installed next spring/summer. The operator indicated the affected lands boundary may need to be slightly expanded around the NWRP to accommodate disturbances associated with installation of the stormwater control structures. Any proposed increase to the approved affected area could be included in the same Amendment application submittal to propose disposing of excavated valley fill material inside the Black Forest Mine.

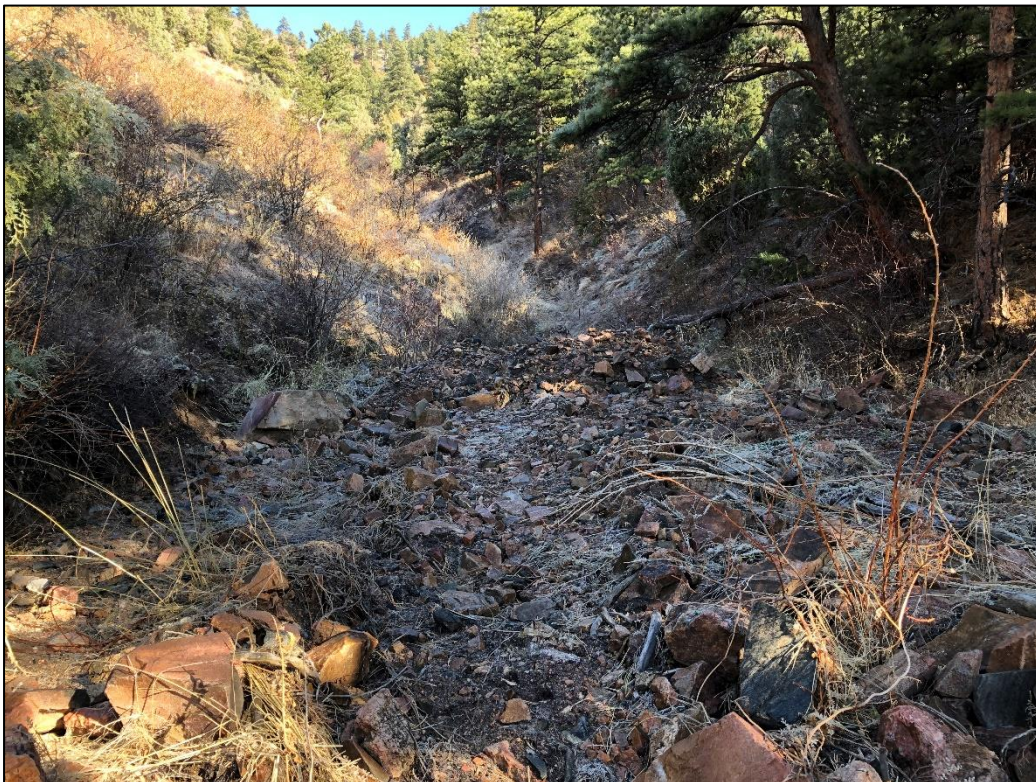
**Photo 8.** View standing on top of NWRP, looking up drainage above the pile.

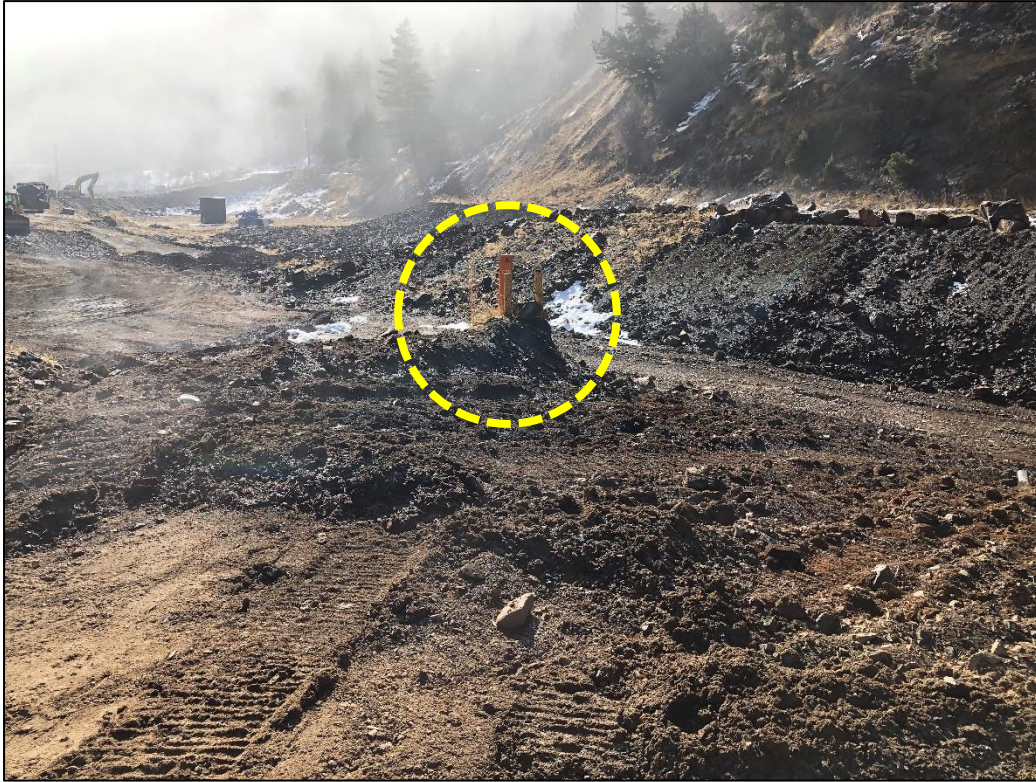
**Photo 9.** View looking southwest across excavation area, showing shallow monitoring well MW-1 (circled) which will be removed per TR-29.

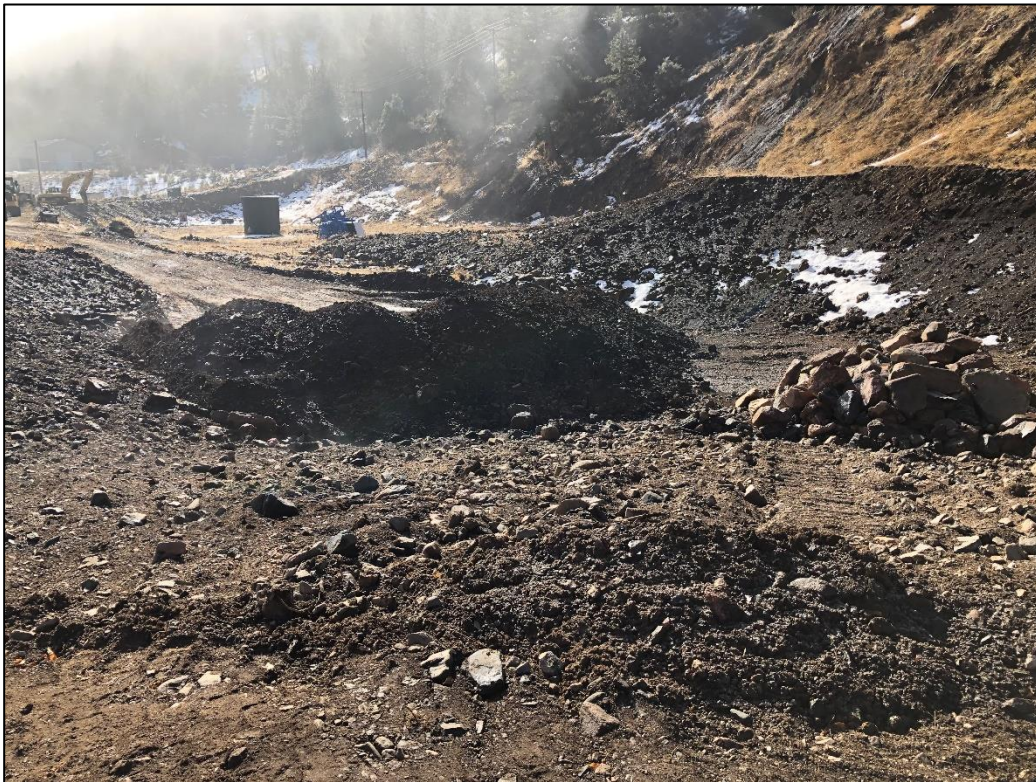
No excavation or hauling activities were occurring on site during the inspection. However, the operator anticipates excavation activities will continue into the winter season as long as weather conditions are favorable. Excavation activities are currently located near the Black Forest portal, just south of the South Waste Rock Pile (SWRP). The operator has graded most of the slopes in the excavation area to a stable configuration in preparation for the winter season. The operator is temporarily stockpiling excavated material on the floor of the excavated pit until it can be hauled up to the Minnesota Mine for disposal. Thus far, the operator has placed approximately 15,790 cubic yards of excavated material into the CV Glory Hole (in the Minnesota Mine) in accordance with the approved reclamation plan. The operator estimates the CV Glory Hole to have a remaining capacity of approximately 12,000 cubic yards. As the excavation project continues, the operator has found the contaminated alluvial fill to be more extensive than originally estimated. Therefore, it is likely that more material will need to be excavated (potentially up to 30,000 cubic yards) than can be placed inside the CV Glory Hole.

**Photo 10.** View looking southeast across excavation area, showing excavated material stockpiled on pit floor.

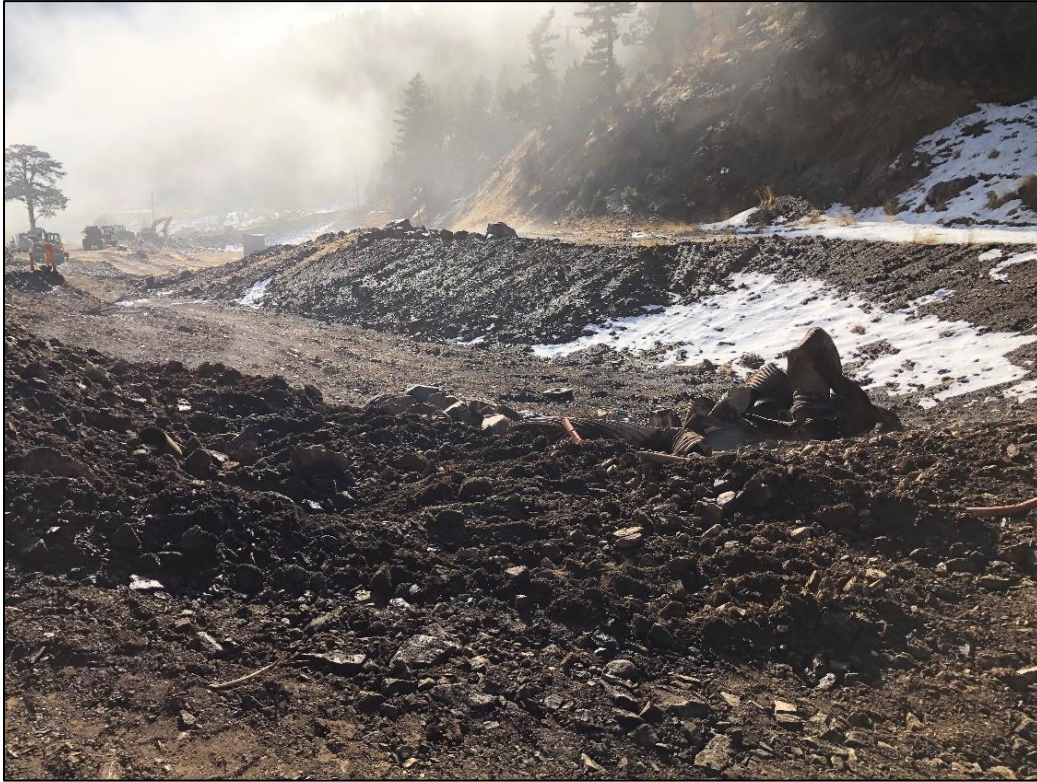
**Photo 11.** View looking southeast across excavation area. Note slopes graded to a stable configuration for winter.
