MINERALS PROGRAM INSPECTION REPORT

MINE NAME: Fremont Gravel Pit	MINE/PROSPECTING ID#: M-1984-117	MINERAL: Sand & gravel	COUNTY: Fremont
INSPECTION TYPE: Monitoring	INSPECTOR(S): Timothy A. Cazier	INSP. DATE: September 15, 2018	INSP. TIME: 13:15
OPERATOR: Fremont County	OPERATOR REPRESENTATIVE: Sterling Rife	TYPE OF OPERATION: 110c - Construction Limited Impact	
REASON FOR INSPECTION: Normal I&E Program	BOND CALCULATION TYPE: None	BOND AMOUNT: \$0.00	
DATE OF COMPLAINT: NA	POST INSP. CONTACTS: None	JOINT INSP. AGENCY: None	
WEATHER: Clear	INSPECTOR'S SIGNATURE:

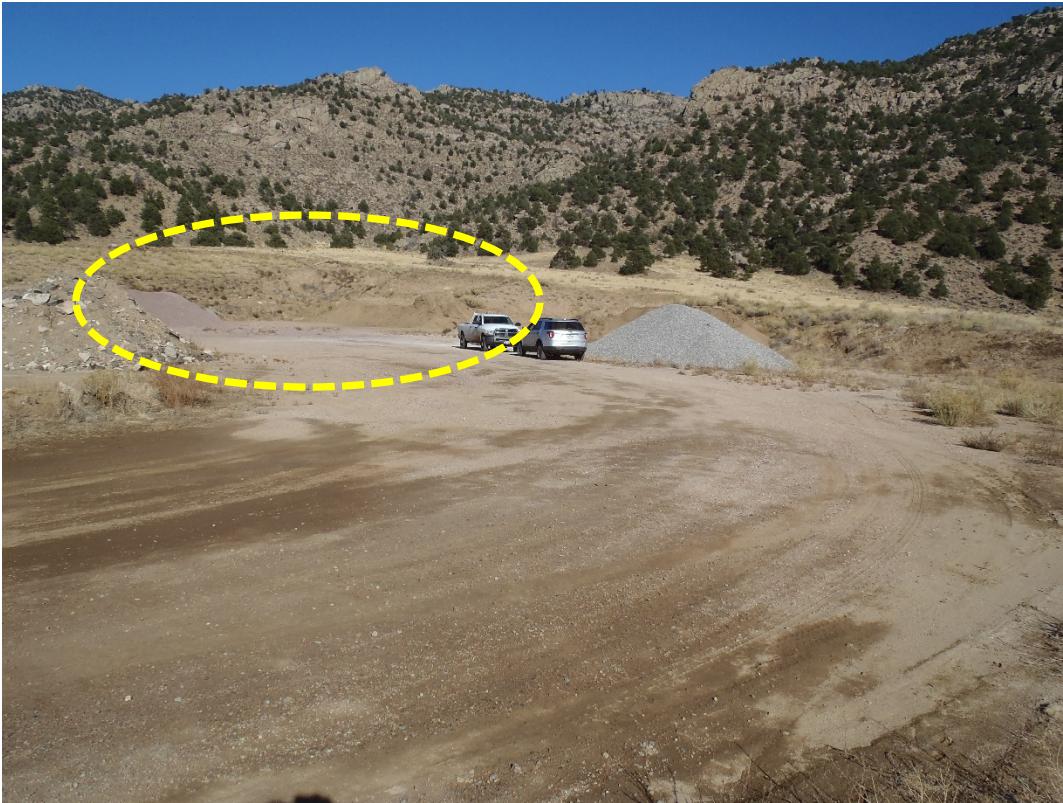
Gen. Compliance with Mine Plan: The operation appeared to be in compliance with the approved mine plan. The maximum allowed disturbed area is 9.9 acres. Google Earth was used to measure the disturbed area, which was estimated to be approximately 6 acres, based on 2016 imagery. Highwalls were not vertical and appeared stable (see **Photo 1**). Mine progression is planned to the north.

Photo 1. NE highwall, circled (looking NE).

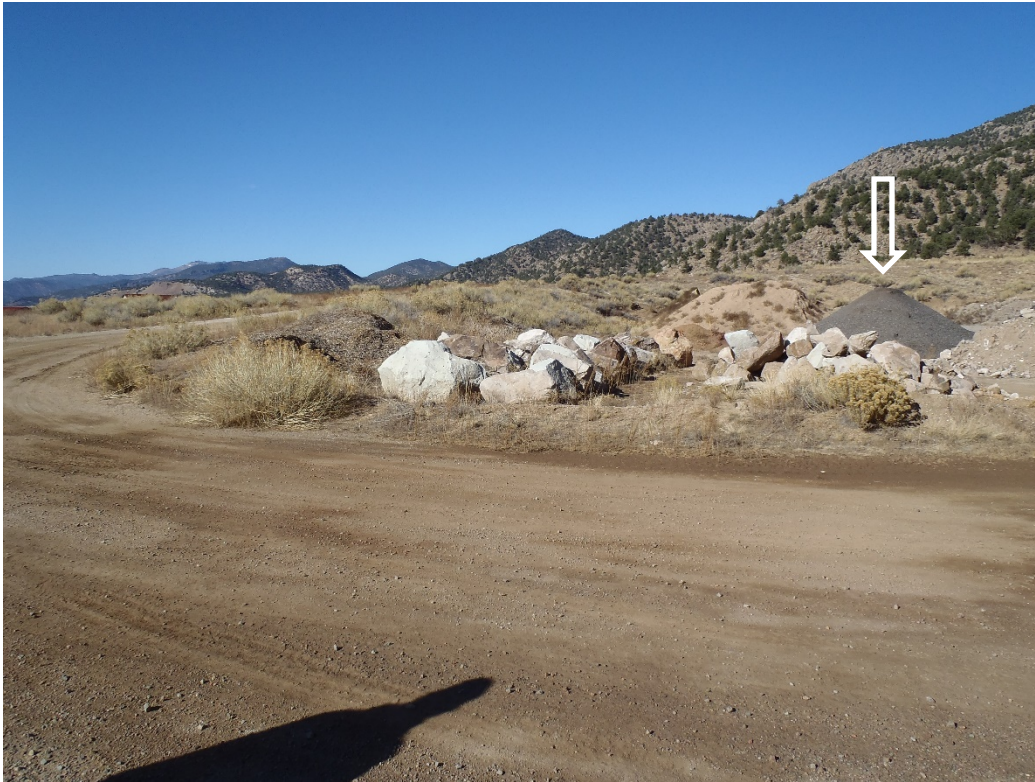
Processing Waste: Some oversize material, a recycled asphalt stockpile and, according to Mr. Rife, material from the SH69 Pit (M-2018-010) were observed (see **Photo 2**).

Photo 2. Oversize material & recycled asphalt (arrow).

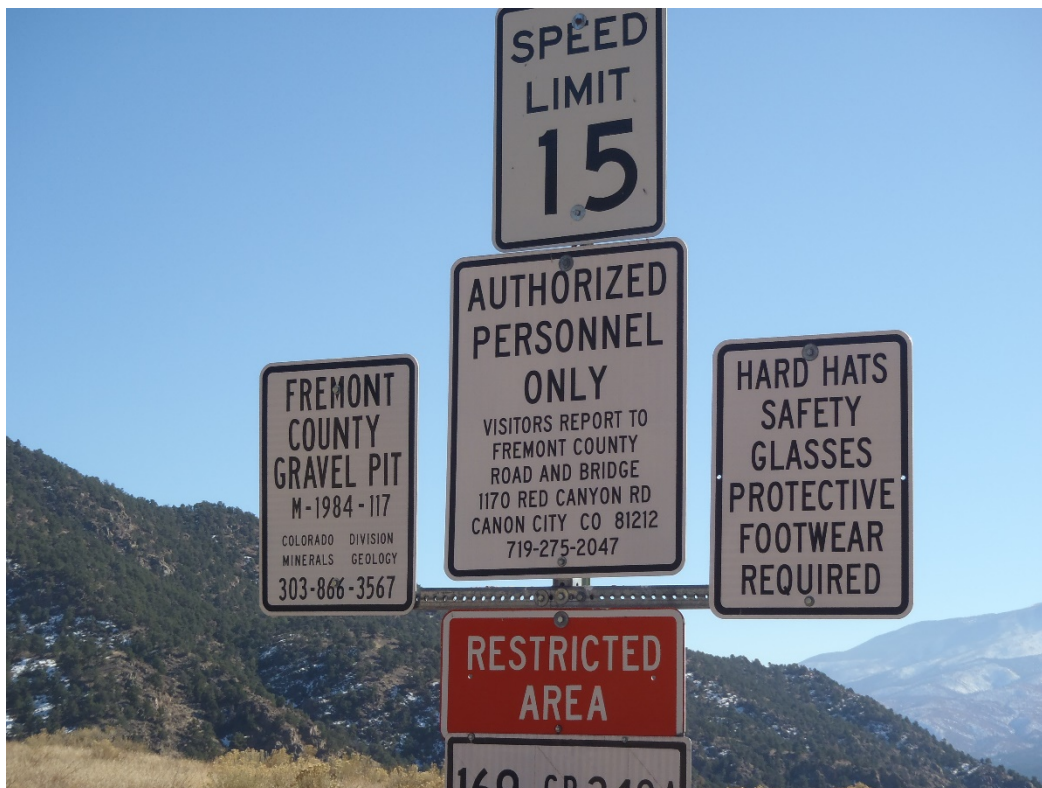
Signs and Markers: The permit sign was properly posted (see **Photo 3**) and the boundary was marked with T-posts. Locations of each T-post marker (see **Photo 4**) were collected using a Trimble Juno 3B hand held GPS unit. The locations appeared consistent with the approved permit boundary maps (see enclosed **Post Inspection Map**).

Photo 3. Permit sign (at entrance).

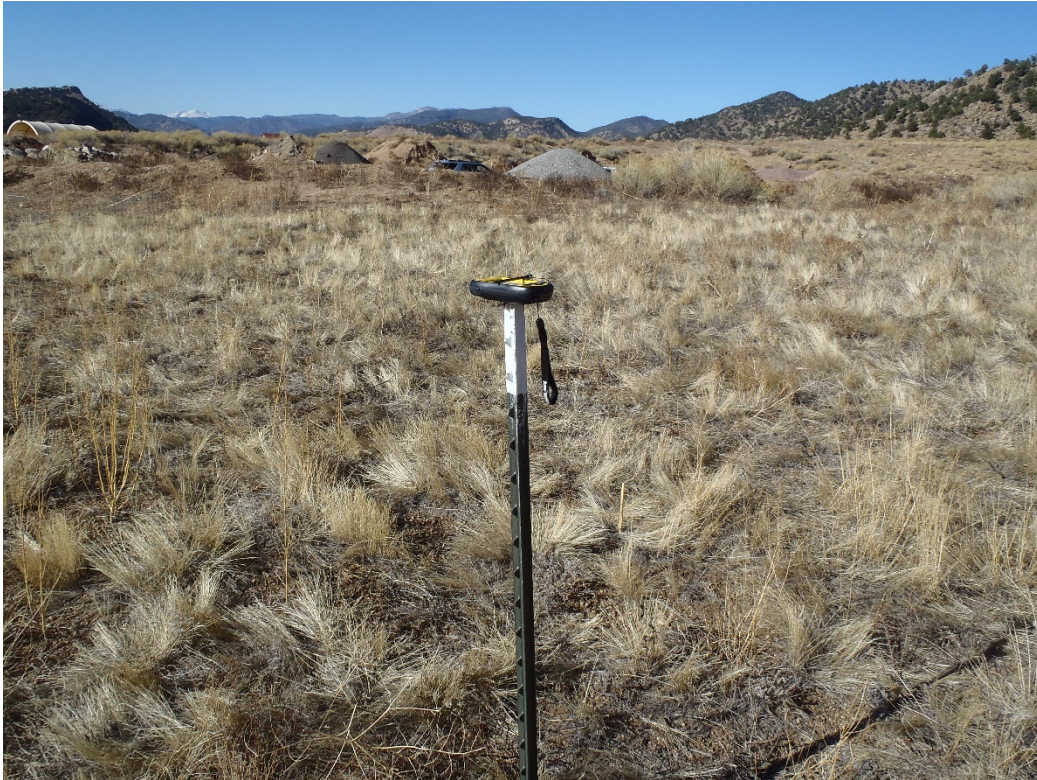
Photo 4. Typical permit boundary marker with GPS unit recording location (SE corner, looking NW).

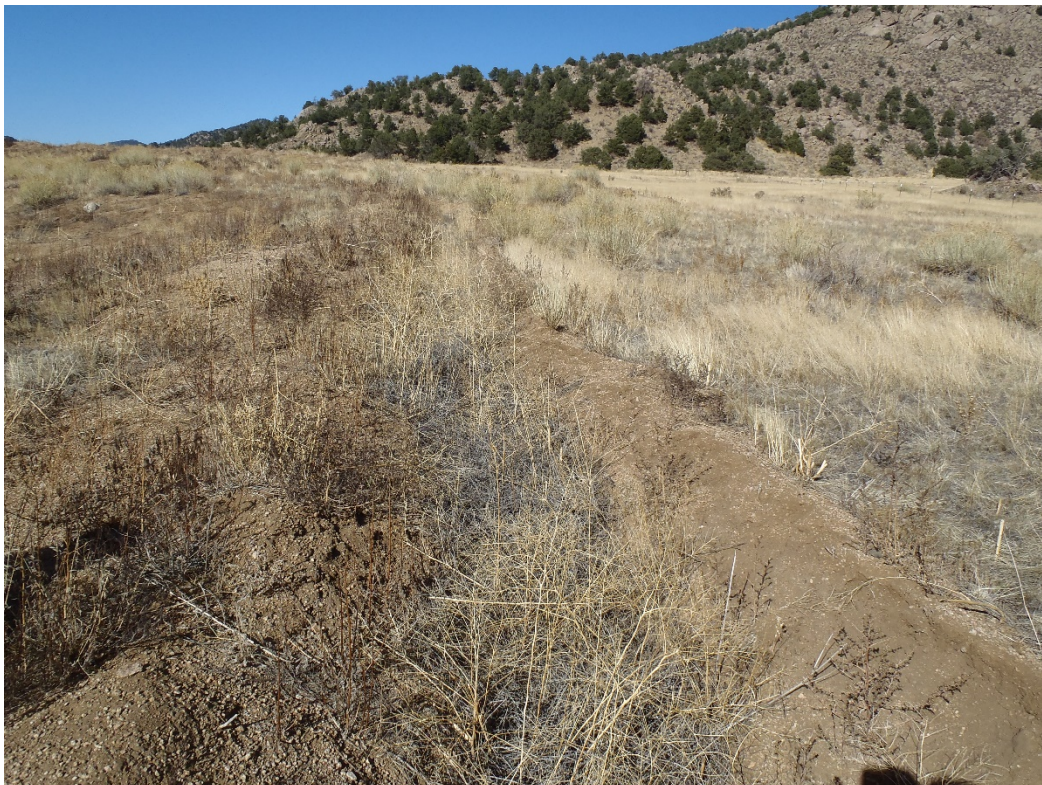
Photo 5. Diversion ditch on east side – needs some maintenance (looking north).

Storm Water MGT Plan: No oil or fuel spills observed. A diversion ditch (see **Photo 5**) was observed above the highwall. It should be cleaned out next spring prior to the late spring and summer rain storms. Stormwater drains to the pit and is prevented from leaving the site using straw wattles (see **Photo 6**) at the edge of the pit in the southwest corner.

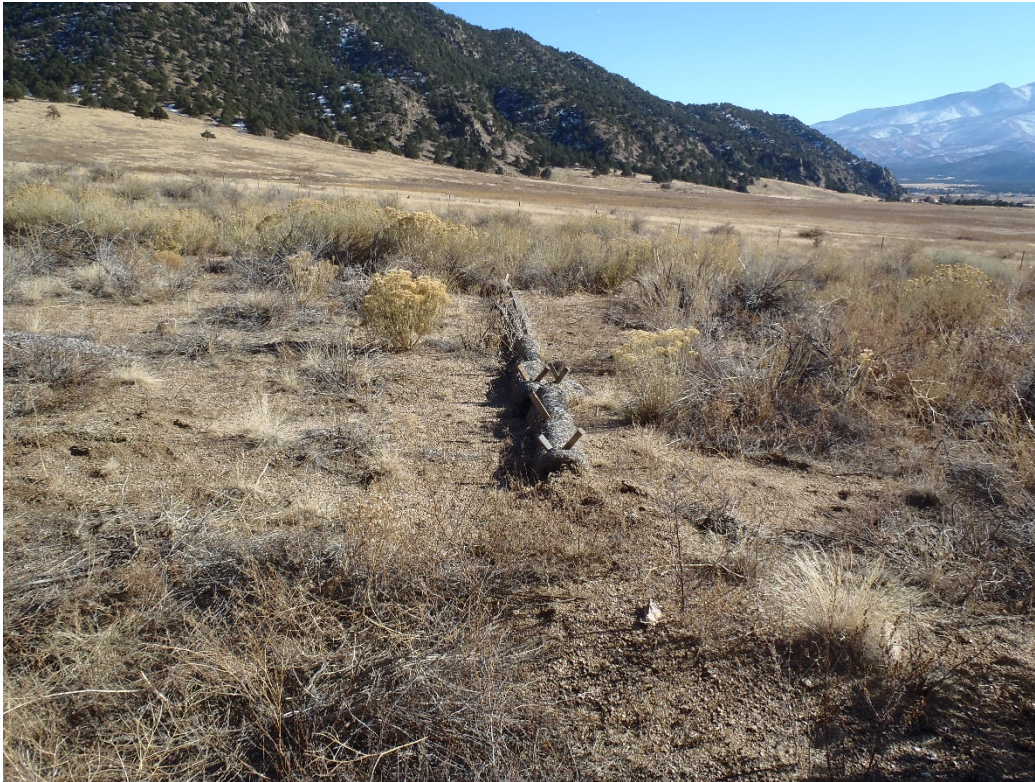
Photo 6. Straw wattles downgradient of pit near SW corner (looking SE).
