**MINERALS PROGRAM INSPECTION REPORT**  
**PHONE: (303) 866-3567**

<b>MINE NAME:</b> Cucharas Pit	<b>MINE/PROSPECTING ID#:</b> M-2002-109	<b>MINERAL:</b> Borrow material	<b>COUNTY:</b> Huerfano
<b>INSPECTION TYPE:</b> Monitoring	<b>INSPECTOR(S):</b> Patrick Lennberg	<b>INSP. DATE:</b> December 12, 2019	<b>INSP. TIME:</b> 13:00
<b>OPERATOR:</b> A. Blasi & Son Trucking & Earthmoving, LLC	<b>OPERATOR REPRESENTATIVE:</b> None	<b>TYPE OF OPERATION:</b> 110c - Construction Limited Impact	
<b>REASON FOR INSPECTION:</b> Normal I&E Program	<b>BOND CALCULATION TYPE:</b> Complete Bond	<b>BOND AMOUNT:</b> \$7,756.00	
<b>DATE OF COMPLAINT:</b> NA	<b>POST INSP. CONTACTS:</b> None	<b>JOINT INSP. AGENCY:</b> None	
<b>WEATHER:</b> Clear	<b>INSPECTOR'S SIGNATURE:</b>

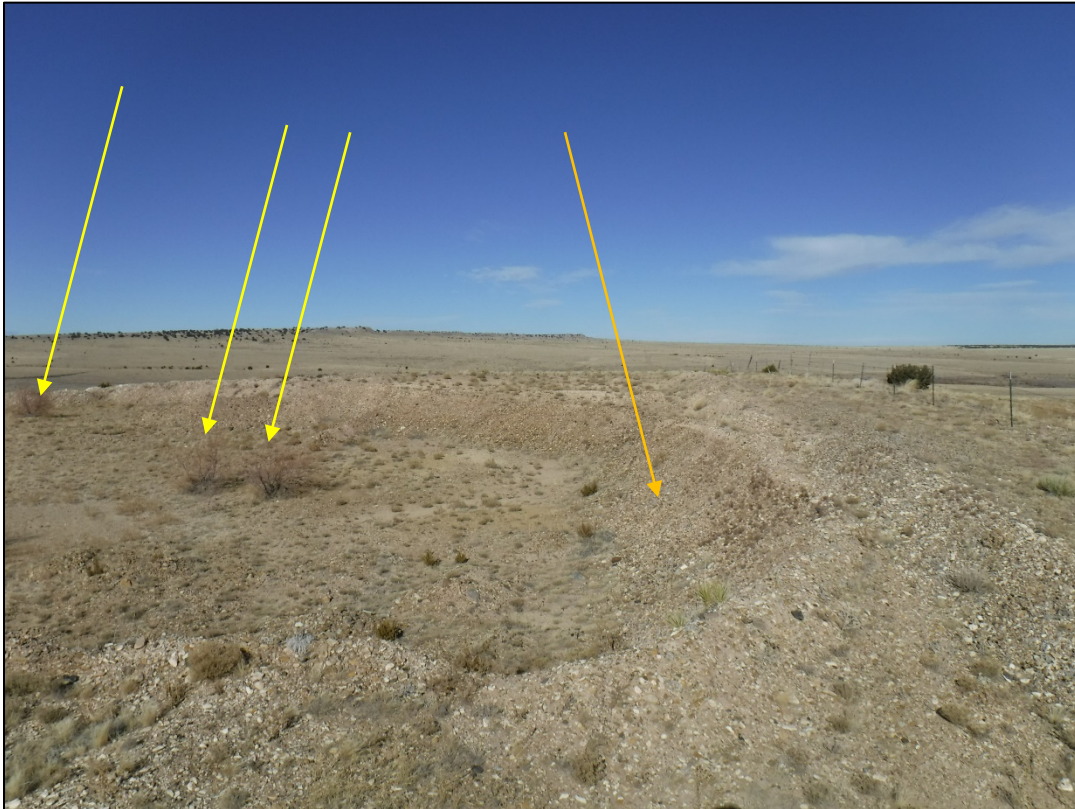
**PROBLEM:** Tamarisk (salt cedar) trees are present within or have volunteered into the permit area and are becoming established. This is a problem for failure to employ weed control methods for a state listed noxious weed species within the permitted area, and to reduce the spread of weeds to nearby areas as required by Rule 3.1.10 (6).

As noted in the previous inspection, the topsoil is fairly rocky in these areas, and native vegetation has volunteered into the disturbed areas and is fairly well-established and diverse, being comprised of native grasses, some forbs and trees, fringed sagebrush, and yucca. However, there were five Tamarisk (salt cedar) trees that have become established within the permit boundary. Tamarisk trees are a list B noxious weeds a fact sheet for Tamarisk has been included with this report. The number of Tamarisk trees at the site is being cited as a problem within this report and will have to be removed.

**Photo 1:** The northeast portion of mined area, tamarisk trees yellow arrows, and highwall indicated by orange arrow

**CORRECTIVE ACTIONS:** The operator will provide photo documentation that the Tamarisk trees and stumps have been removed from the site.

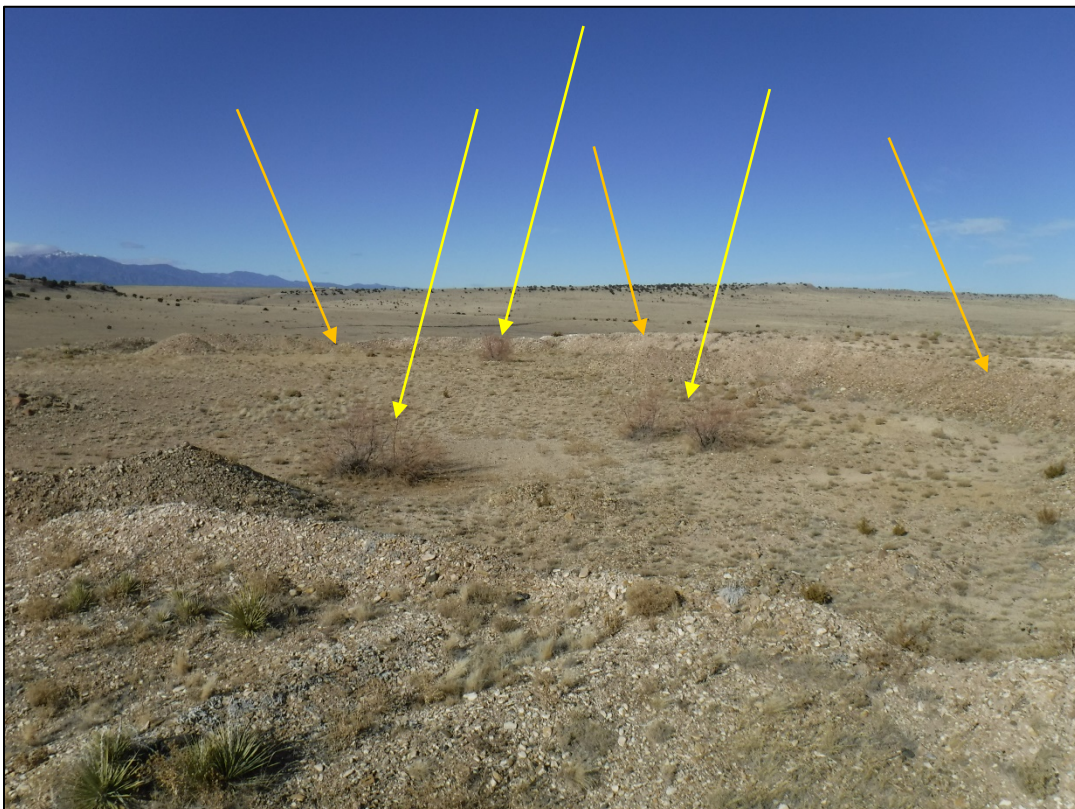
**Photo 2:** Looking west across the pit, tamarisk trees yellow arrows highwall orange arrows

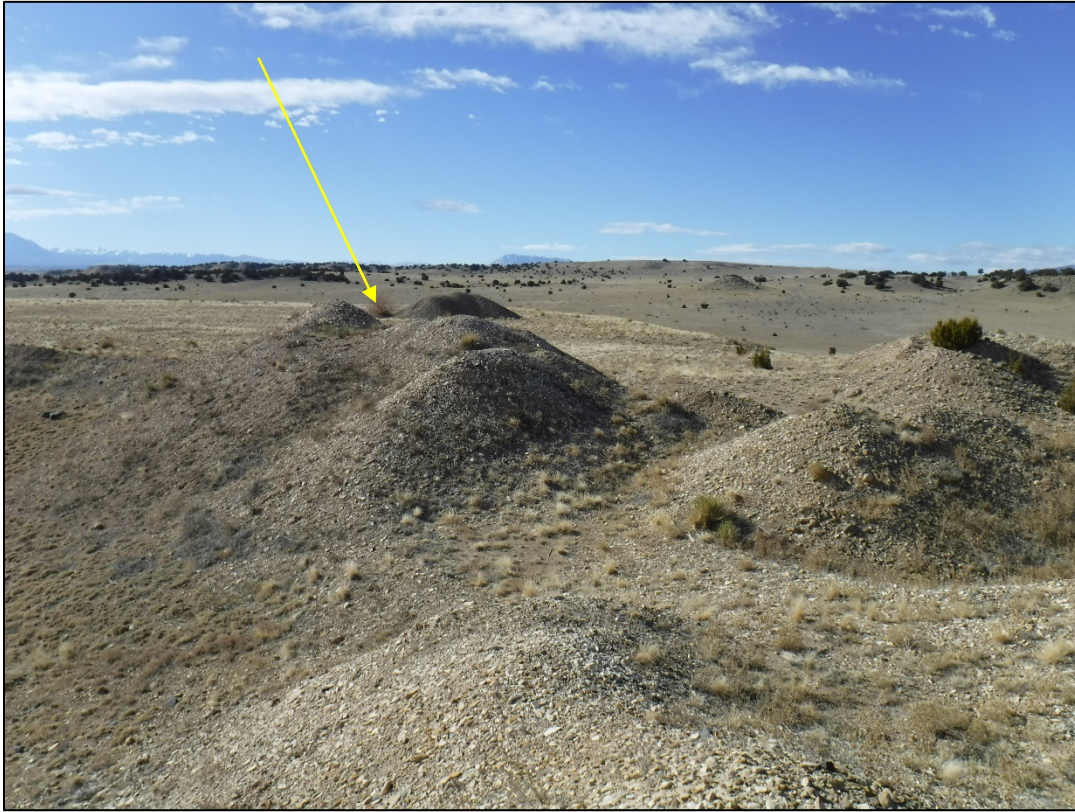
It does not appear that there has been any activity at the site since the 2015 inspection which noted that there had been no activity since 2007. During the inspection the Division noted that there are still several product and overburden stockpiles on site. It was noted in the previous inspection report that the landowner may wish to have some of the processed stockpiles to remain for personal use. The stockpile can remain after reclamation if the operator submits a signed and dated letter from the landowner stating his desire to leave the stockpiles. Additionally, there is a berm or relic highwall, ~900 feet long, that ranges in height from 3 to 8 feet that forms the perimeter of the mined area. Failure to complete reclamation in a timely manner as indicated in the approved reclamation plan is being cited as problem within this report. The operator shall submit a Technical Revision to update and clarify the current approved reclamation plan to reflect existing and proposed activities.

**Photo 3:** Various product and overburden stockpiles, tamarisk tree yellow arrow

**CORRECTIVE ACTIONS:** The operator shall submit a Technical Revision, with the required \$216 revision fee, to update and clarify the current approved reclamation plan to reflect existing and proposed activities by the corrective action date.

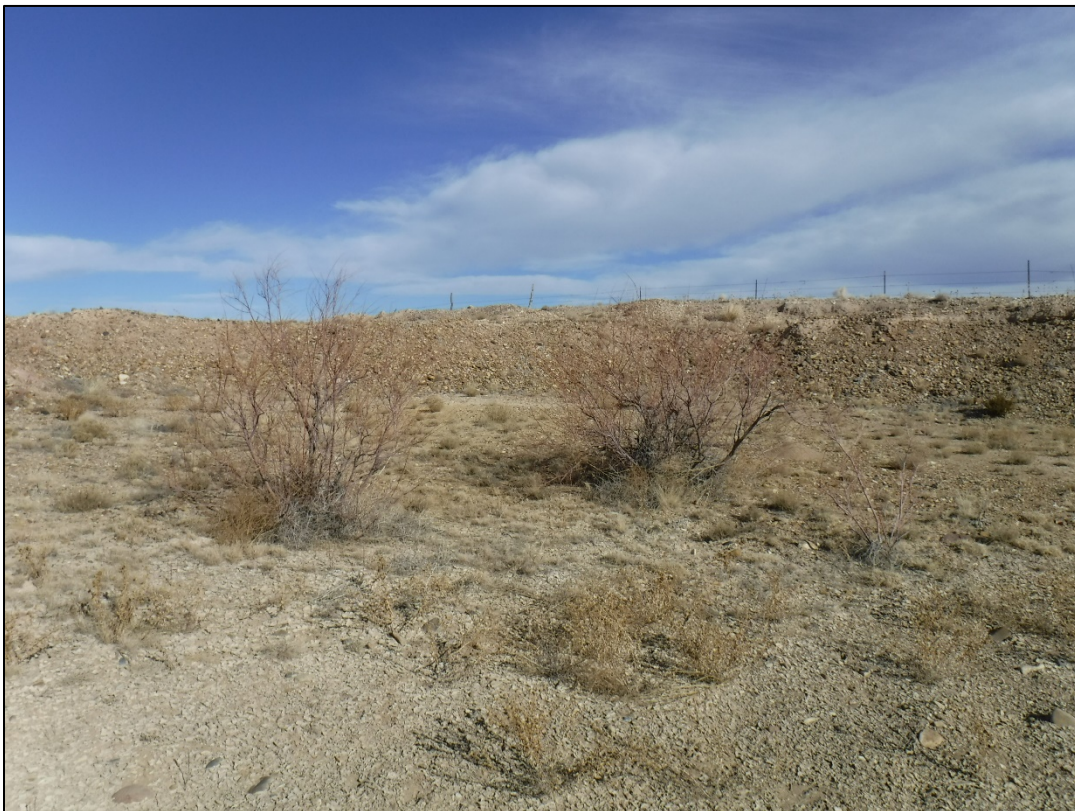
**Photo 4:** Tamarisk trees and highwall

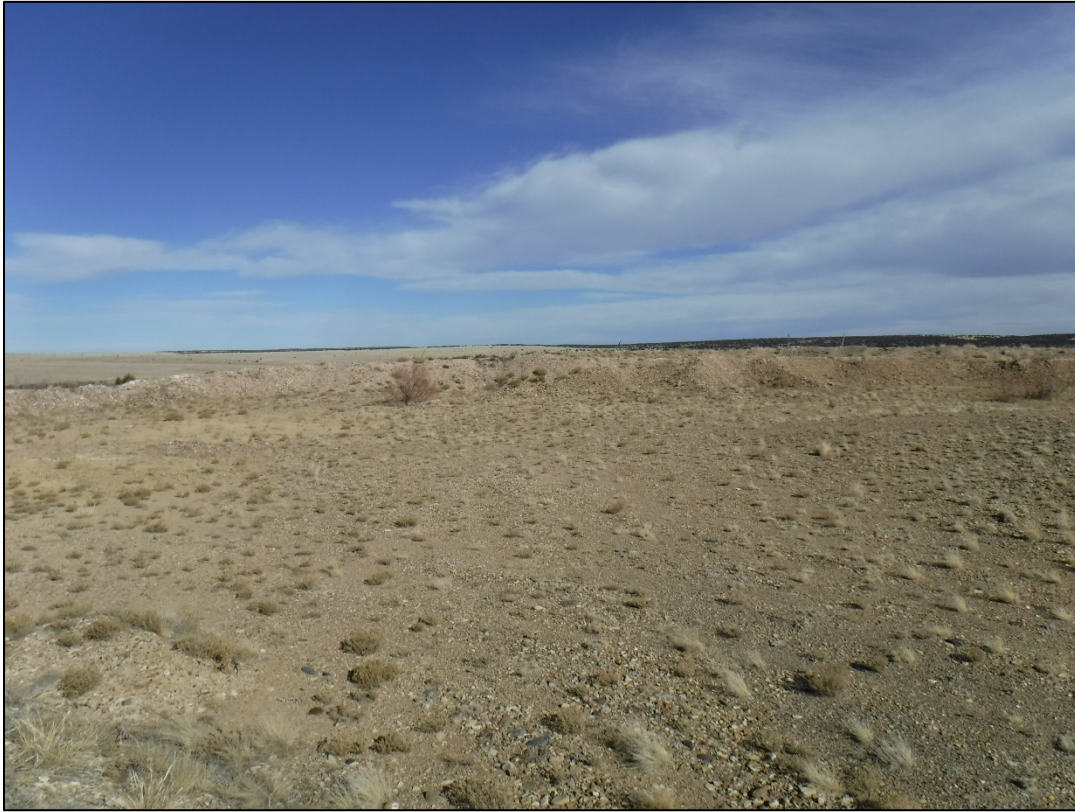
**Photo 5:** Looking east from the west rim of pit

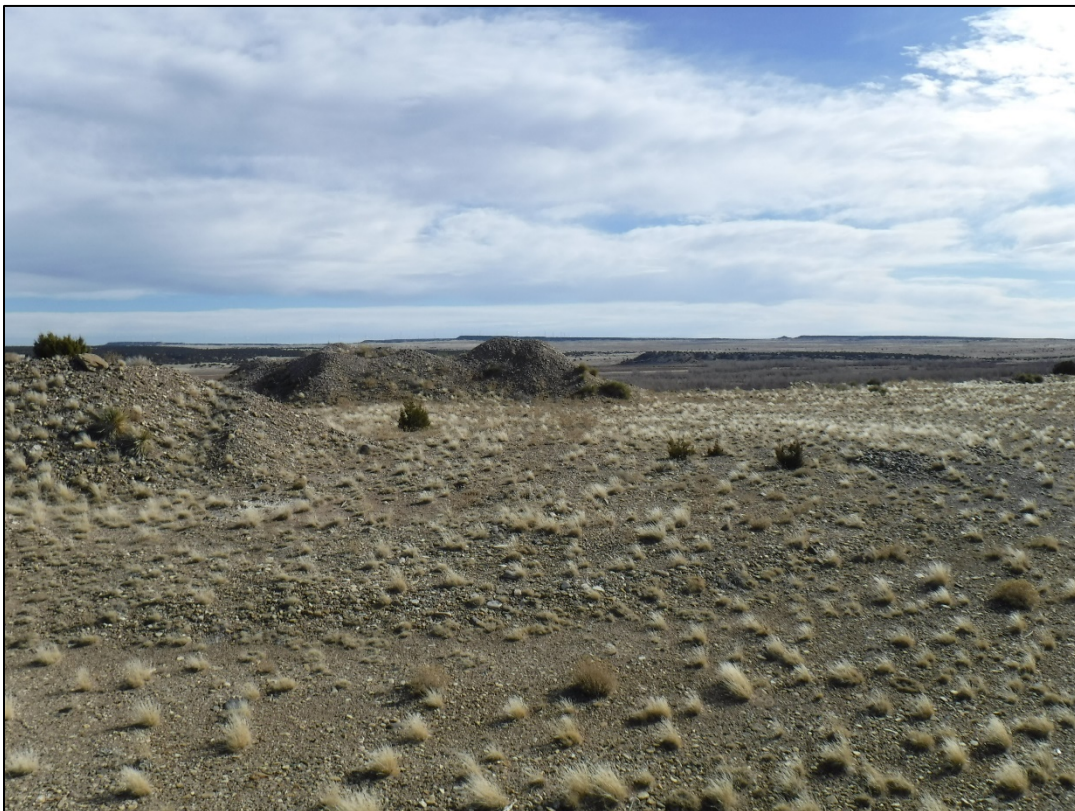
**Photo 6:** Conditions of the southern permit area

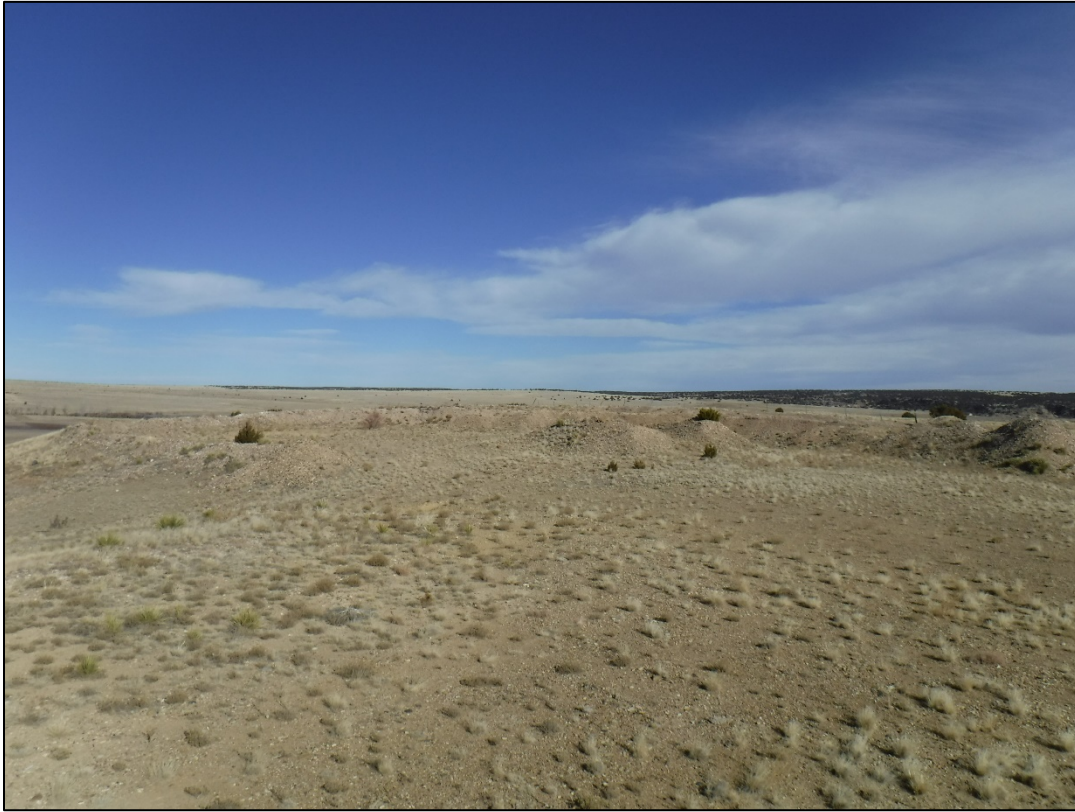
**Photo 7:** Looking north from a product stockpile to the pit area

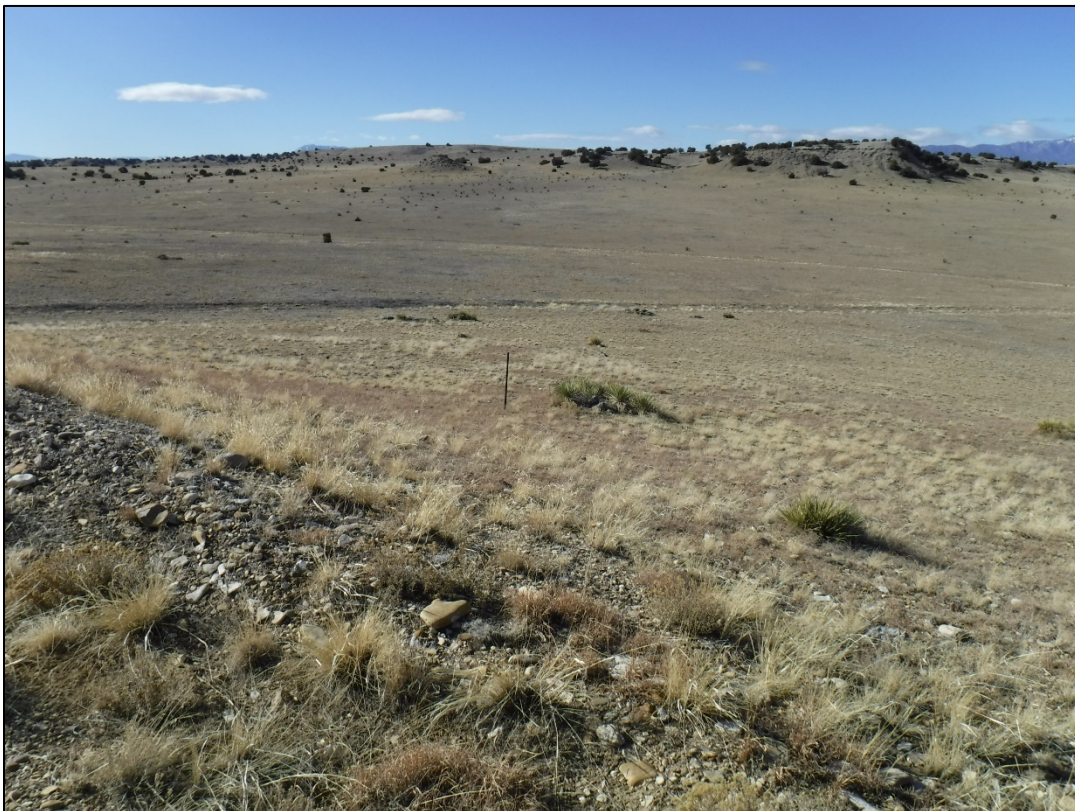
The Division was not able to GPS all the permit boundary markers but was able to identify some of the tee-posts being used as boundary markers.

**Photo 8:** Permit boundary marker

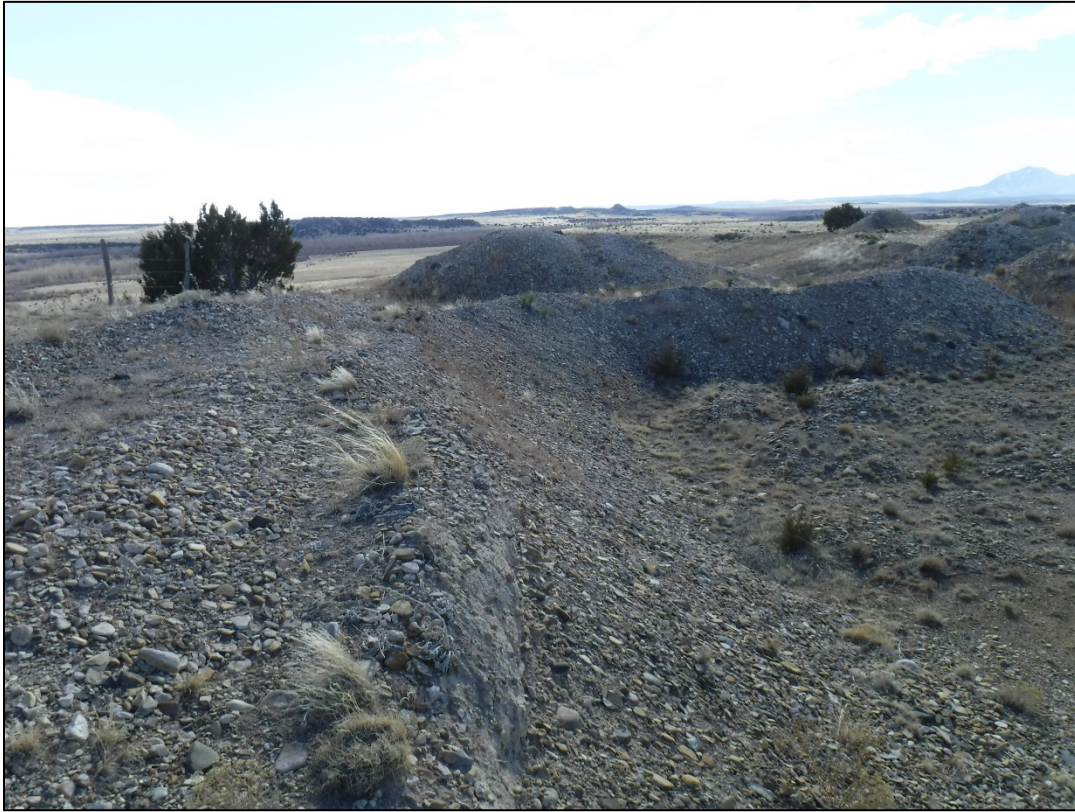
**Photo 9:** Eastern highwall

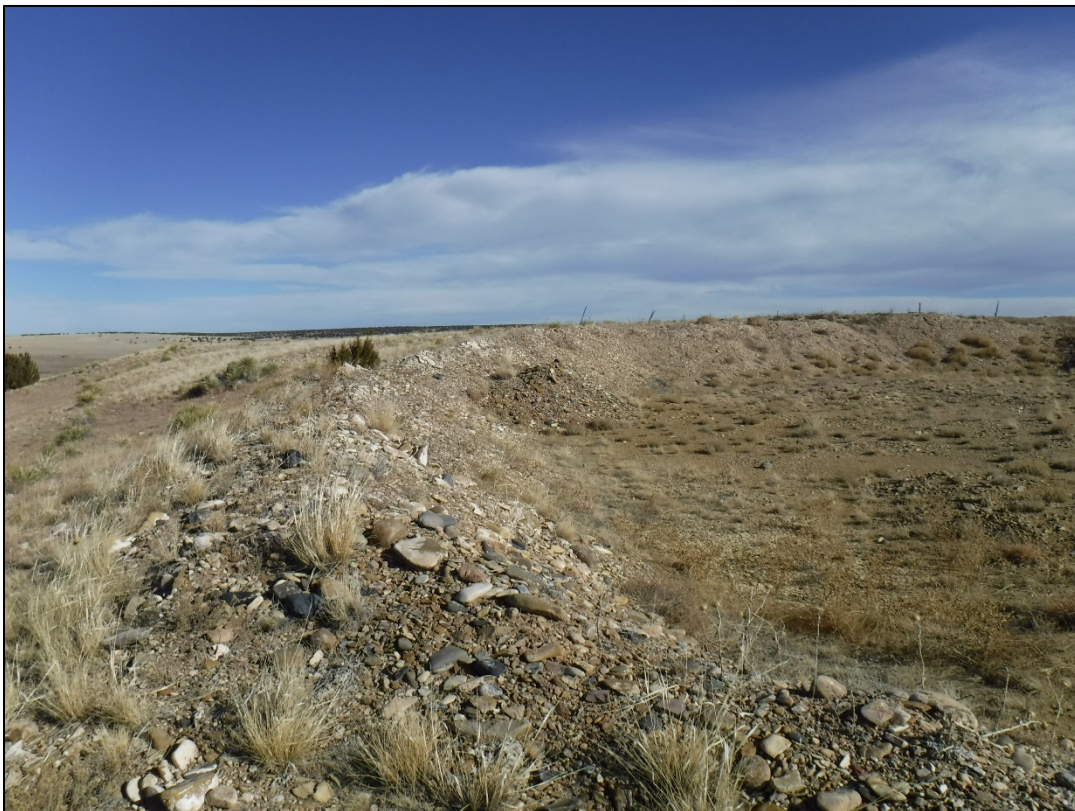
**Photo 10:** Northern highwall
