**MINERALS PROGRAM INSPECTION REPORT**  
**PHONE: (303) 866-3567**

<b>MINE NAME:</b> 10 Miles South Pit	<b>MINE/PROSPECTING ID#:</b> M-1978-066	<b>MINERAL:</b> Sand and gravel	<b>COUNTY:</b> Rio Grande
<b>INSPECTION TYPE:</b> Monitoring	<b>INSPECTOR(S):</b> Stephanie Mitchell	<b>INSP. DATE:</b> November 7, 2019	<b>INSP. TIME:</b> 12:00
<b>OPERATOR:</b> Rio Grande County	<b>OPERATOR REPRESENTATIVE:</b> Patrick Sullivan	<b>TYPE OF OPERATION:</b> 112c - Construction Regular Operation	
<b>REASON FOR INSPECTION:</b> Normal I&E Program	<b>BOND CALCULATION TYPE:</b> None	<b>BOND AMOUNT:</b> \$0.00	
<b>DATE OF COMPLAINT:</b> NA	<b>POST INSP. CONTACTS:</b> None	<b>JOINT INSP. AGENCY:</b> None	
<b>WEATHER:</b> Clear	<b>INSPECTOR'S SIGNATURE:</b>

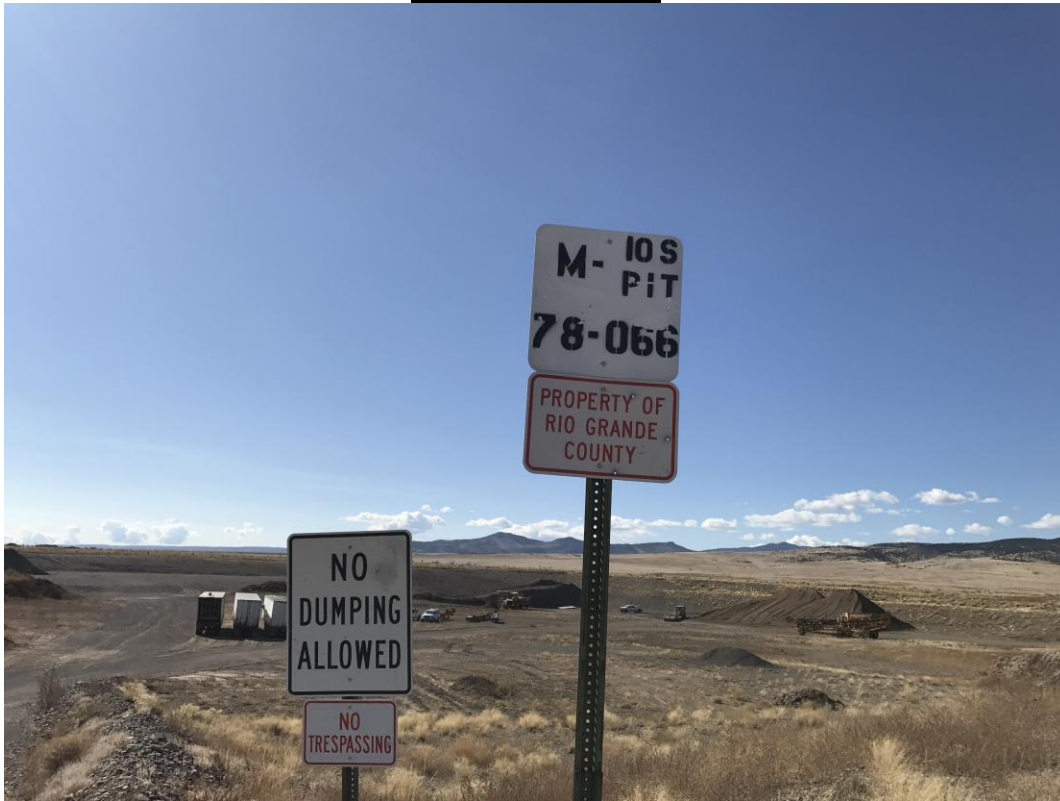
This was a routine inspection performed by the Division as part of its monitoring of Construction Materials 112c permits. The operator named on page one was present throughout the inspection. The required permit ID sign and permit boundary markers were observed.

Mine ID Sign

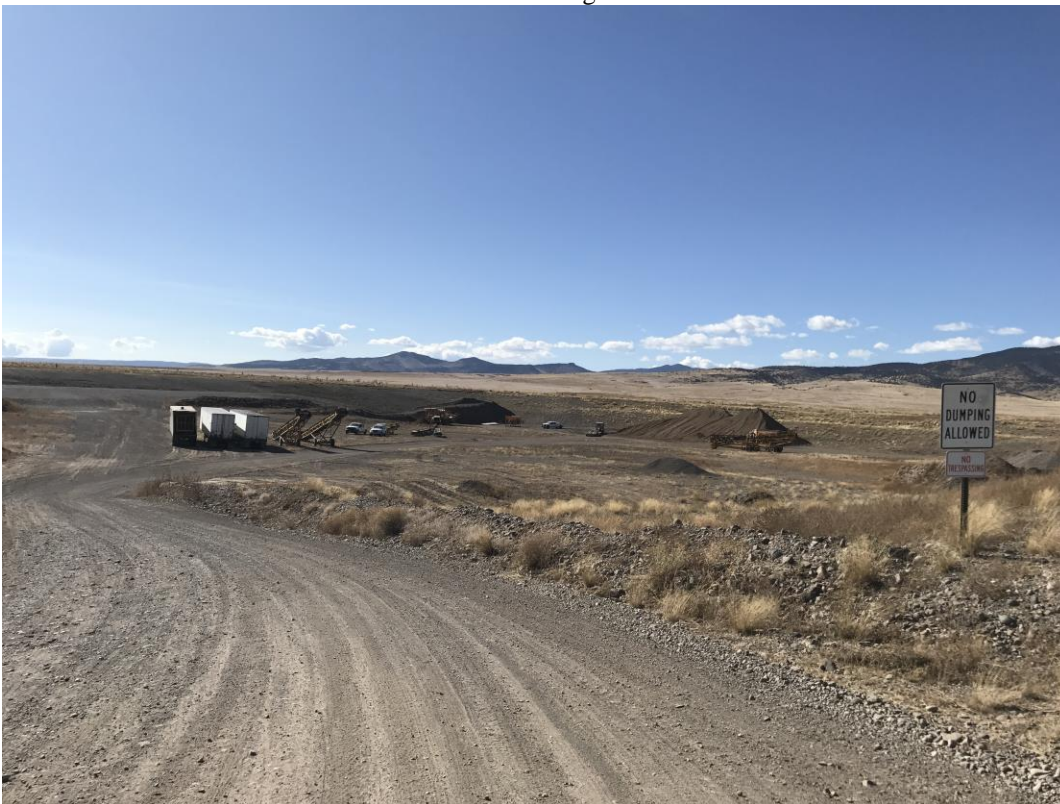
This pit is currently being actively operated by Southway Construction, mainly crushing operations. There were several stockpiles of materials in the pit floor, and a dozer and loader also. Operations are proceeding across the southern edge of the site, with active excavation in the SW corner, and moving toward the SE. There is still a significant amount of unexcavated land across the southern side of the permit.

Southway Crushing Operations

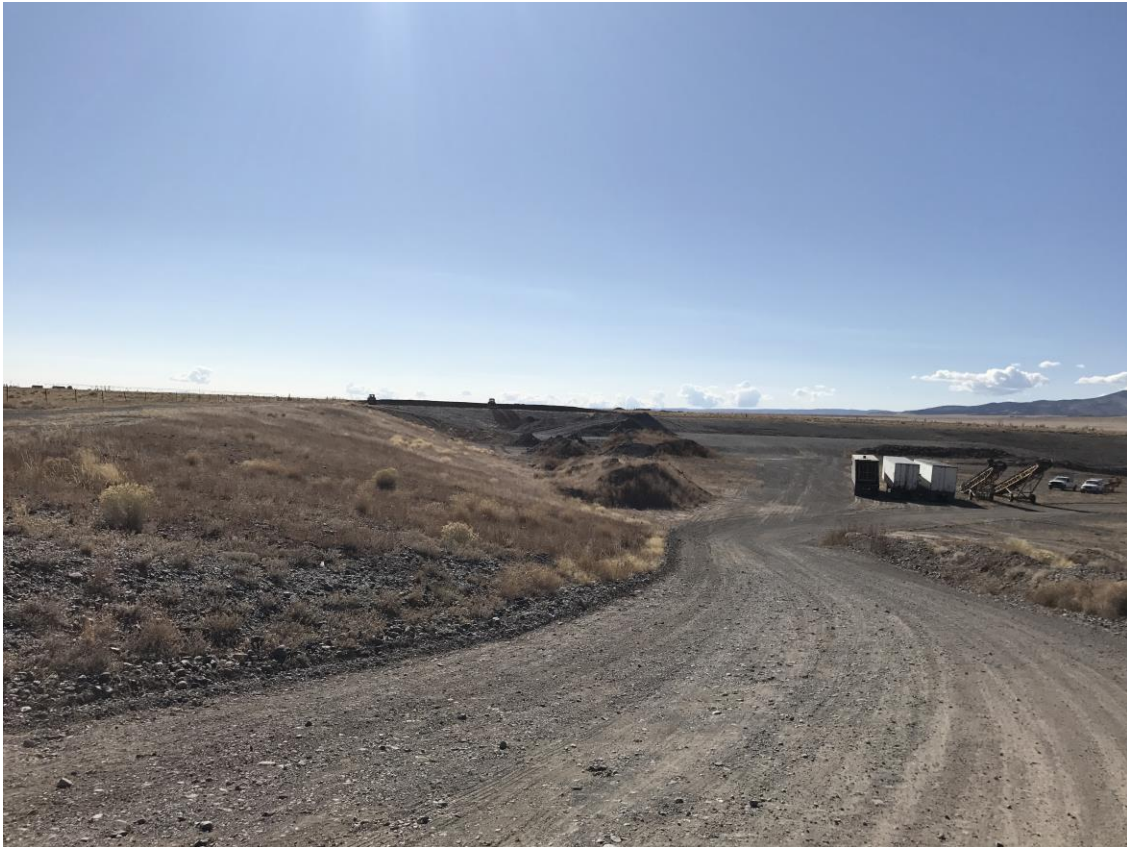
Roads down into the pit are at the NE and NW corners of the site. The east, north and west pit walls are sloped and revegetated.

Reclaimed area

Topsoil is stripped ahead of mining, and is windrowed along the south side of the permit. The operator is reminded to replace topsoil promptly on sloped reclaimed areas, and to seed topsoil in stockpiles to protect them from wind erosion in this exposed location. Topsoil must be kept free of noxious weeds too.
