MINERALS PROGRAM INSPECTION REPORT
PHONE: (303) 866-3567

MINE NAME: Camenish Borrow	MINE/PROSPECTING ID#: M-2006-078	MINERAL: Sand and gravel	COUNTY: Weld
INSPECTION TYPE: Monitoring	INSPECTOR(S): Peter Hays	INSP. DATE: December 12, 2019	INSP. TIME: 13:30
OPERATOR: Flatiron Constructors, Inc.	OPERATOR REPRESENTATIVE: None	TYPE OF OPERATION: 111 - Construction by Government Agency	
REASON FOR INSPECTION: Normal I&E Program		BOND CALCULATION TYPE: Partial Bond	
DATE OF COMPLAINT: NA		BOND AMOUNT: \$127,000.00	
POST INSP. CONTACTS: None		JOINT INSP. AGENCY: None	
WEATHER: Clear	INSPECTOR'S SIGNATURE:

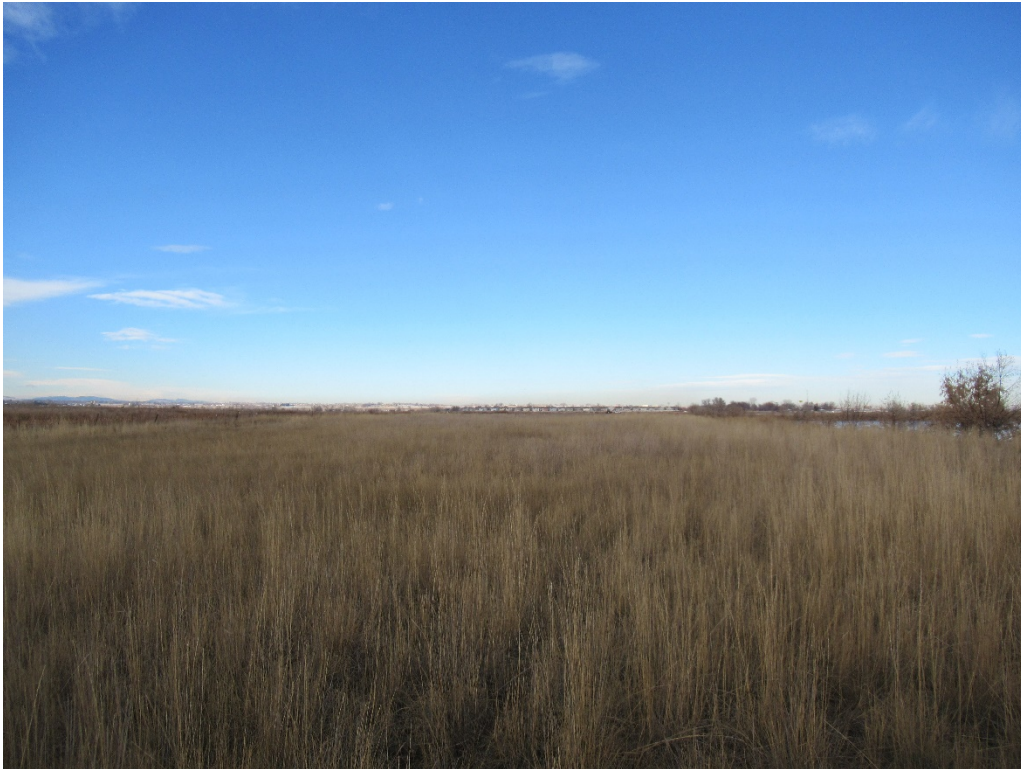
The site vegetation was well-established and consisted of several varieties of wheatgrasses and brome grass. The grasses were previously mowed around the lake shoreline. The site was stable and no erosion features were observed during the inspection. A patch of Kochia was observed in the southeast corner of the site.

View of vegetation from the southwest corner looking north

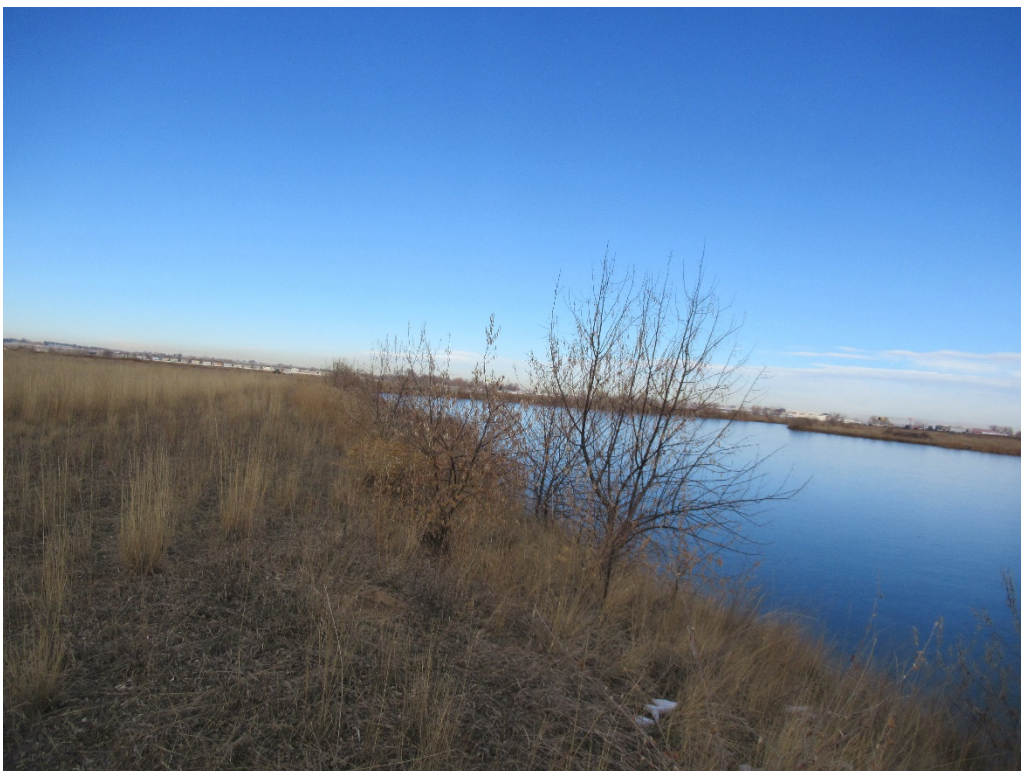
PROBLEM: Russian olive trees are present within or have volunteered into the permit area and are becoming established. This is a problem for failure to employ weed control methods for a state listed noxious weed species within the permitted area, and to reduce the spread of weeds to nearby areas as required by Rule 3.1.10(6).

As cited as a problem, noxious weeds including; Russian olive trees, chamomile and Halogeton were observed on-site. The Russian olive trees have volunteered along the perimeter of the shoreline. Patches of chamomile and Halogeton were observed in the northern upland area. The Operator shall either implement the existing weed control plan, or develop a weed control and management plan in accordance with Rule 3.1.10(6). The weed control plan or proof of weed control measures shall be submitted to the Division by the corrective action date.

View of Russian olive trees along the west shoreline looking north

CORRECTIVE ACTIONS: The Operator shall either implement the existing weed control plan, or develop a weed control and management plan in accordance with Rule 3.1.10(6). This plan should be developed in consultation with the county extension agency, or weed control district office and should include specific control measures to be applied, a schedule for when control measures will be applied and a post-treatment monitoring plan. This weed control plan shall be submitted to the Division as a Technical Revision to the approved plan with the appropriate Technical Revision fee of \$216.00 by the corrective action date.

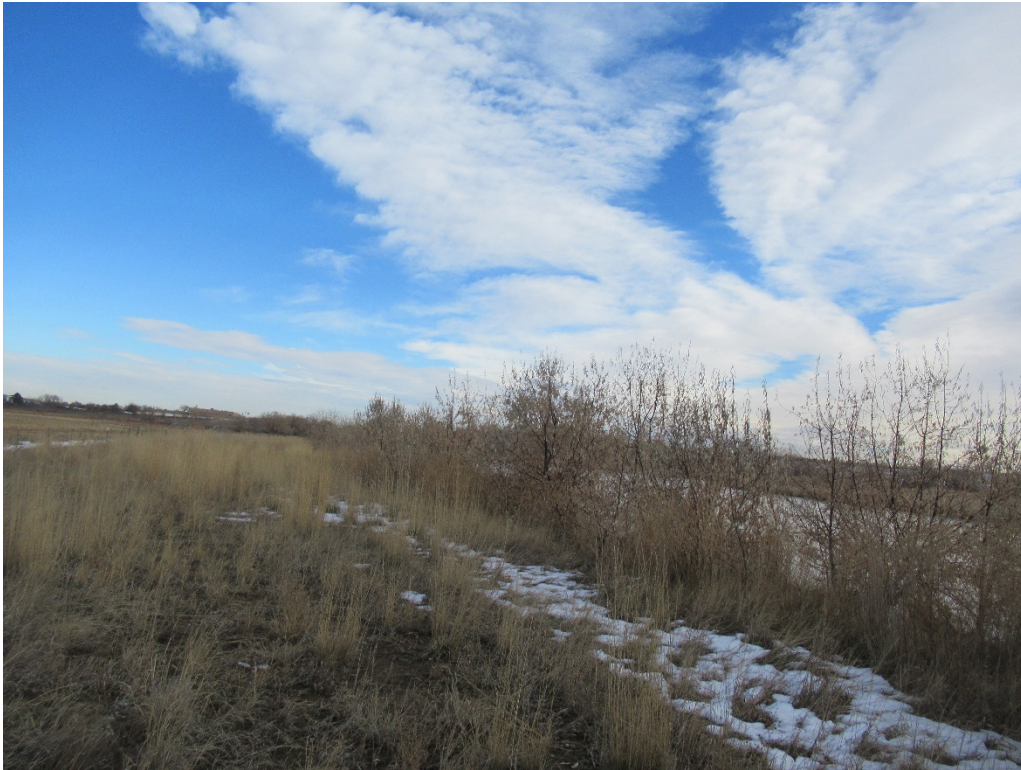
View of vegetation and Russian olive trees along the north shoreline looking east

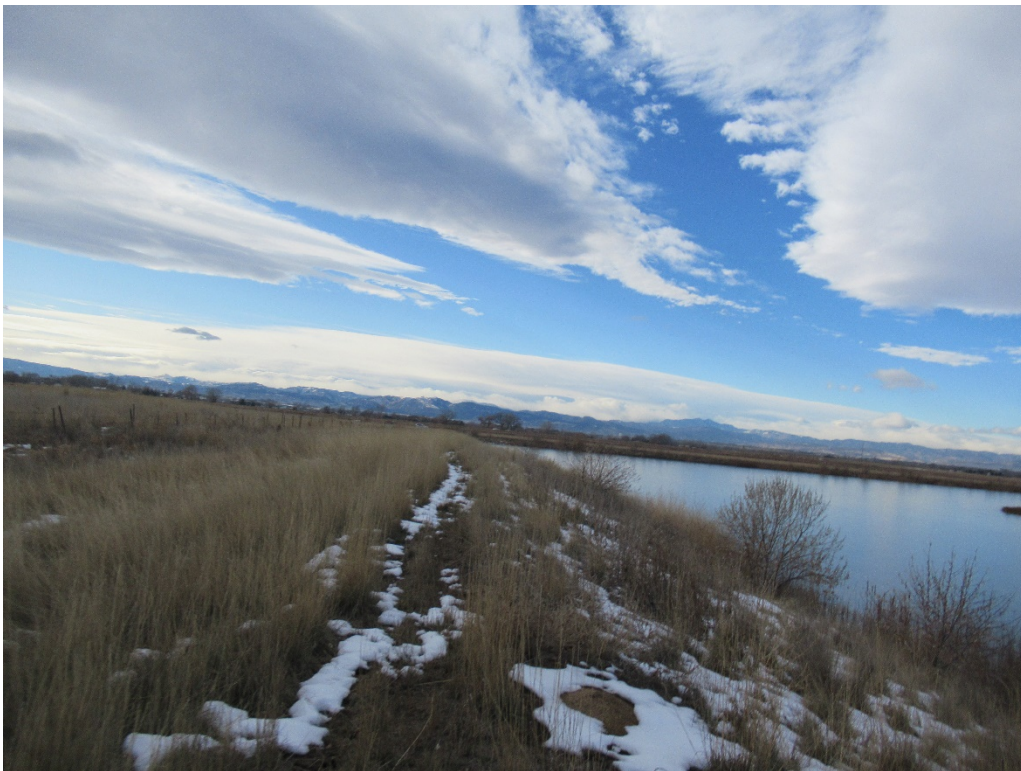
View of vegetation and Russian olive trees along the south shoreline looking west
