MINERALS PROGRAM INSPECTION REPORT

MINE NAME: RBK Pit No. 30	MINE/PROSPECTING ID#: M-1990-106	MINERAL: Gravel	COUNTY: Pueblo
INSPECTION TYPE: Monitoring	INSPECTOR(S): Elliott R. Russell	INSP. DATE: August 15, 2017	INSP. TIME: 11:00
OPERATOR: RBK Construction, Inc.	OPERATOR REPRESENTATIVE: David King	TYPE OF OPERATION: 110c - Construction Limited Impact

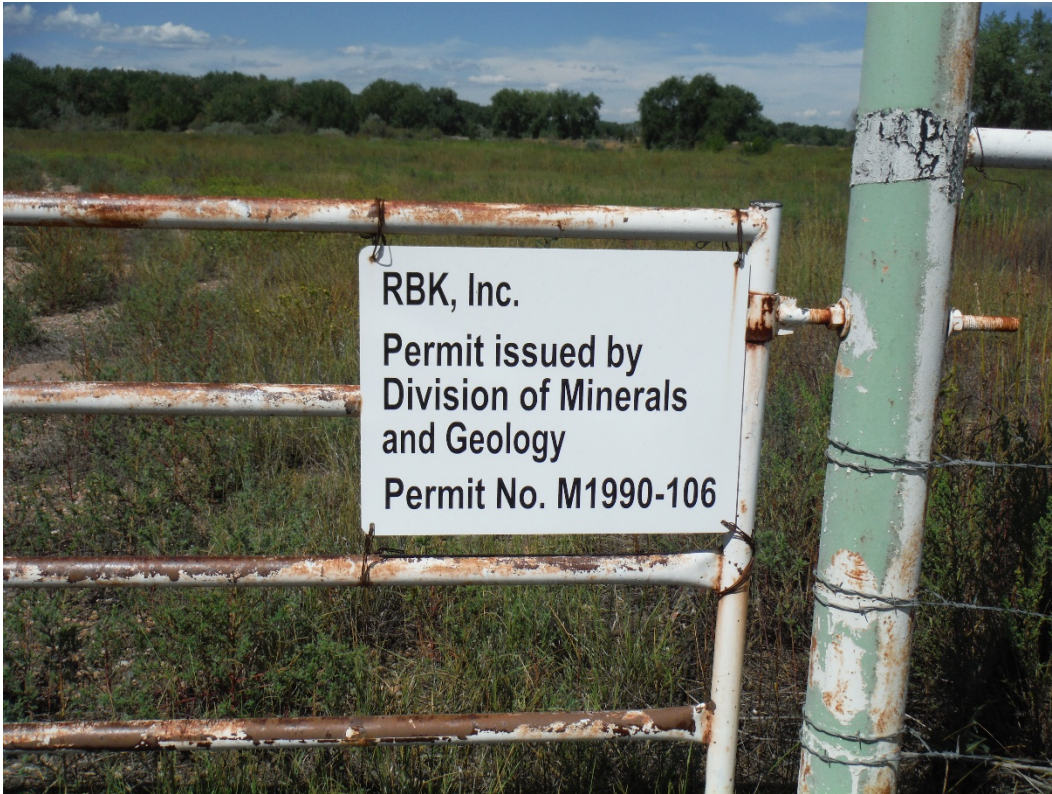
Photo 1. Mine identification sign; looking west.

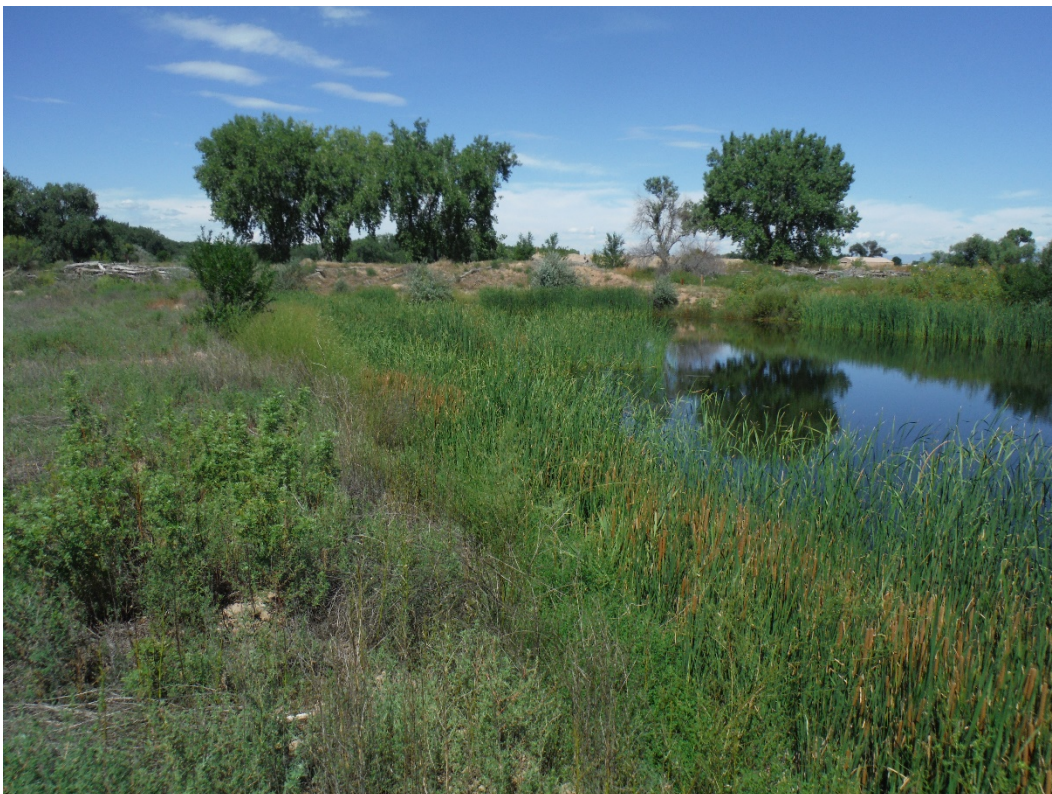
The Operator stated they had been working on backfilling the exposed ground water pond over the last several years. Since the last inspection in 2013, the Operator has backfilled roughly half of the pond with the site's overburden/process fines stockpile. They have used most of the available on-site material and are now planning on importing material from one of the Operator's different local operations to finish the backfilling project. The Division estimates the surface area of the remaining pond is approximately 1.7 acres in size.

Photo 2. Western portion of the pond; looking west.

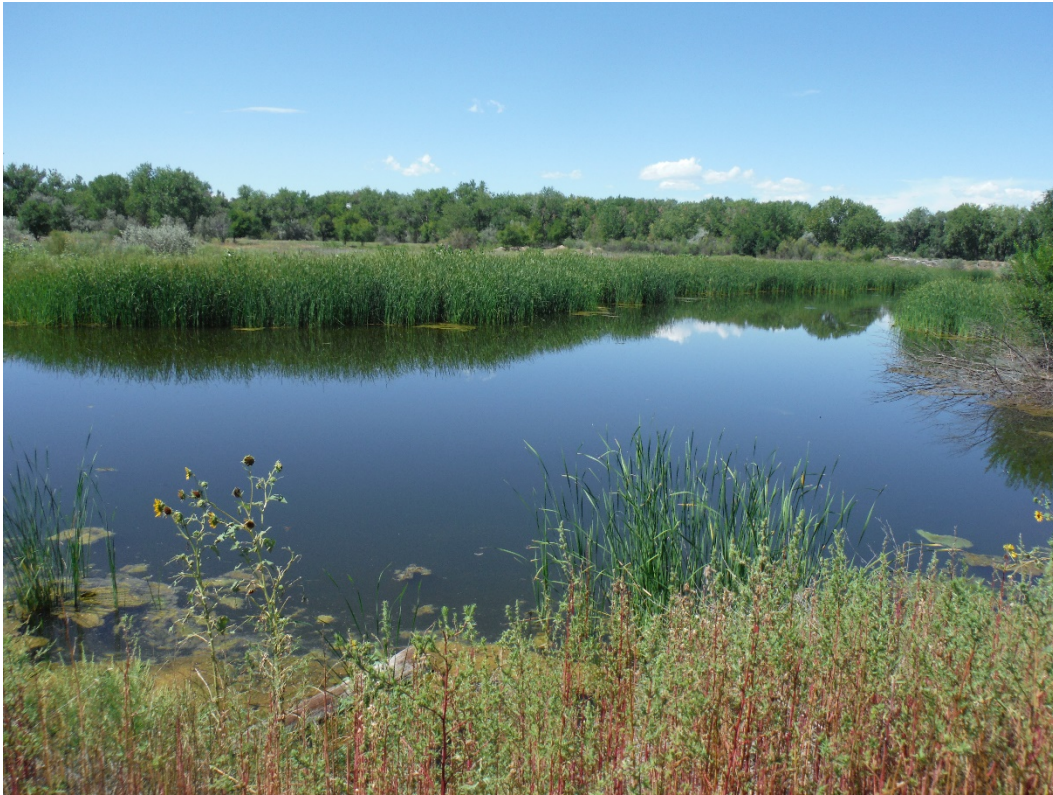
Photo 3. Eastern portion of the pond; looking southwest.

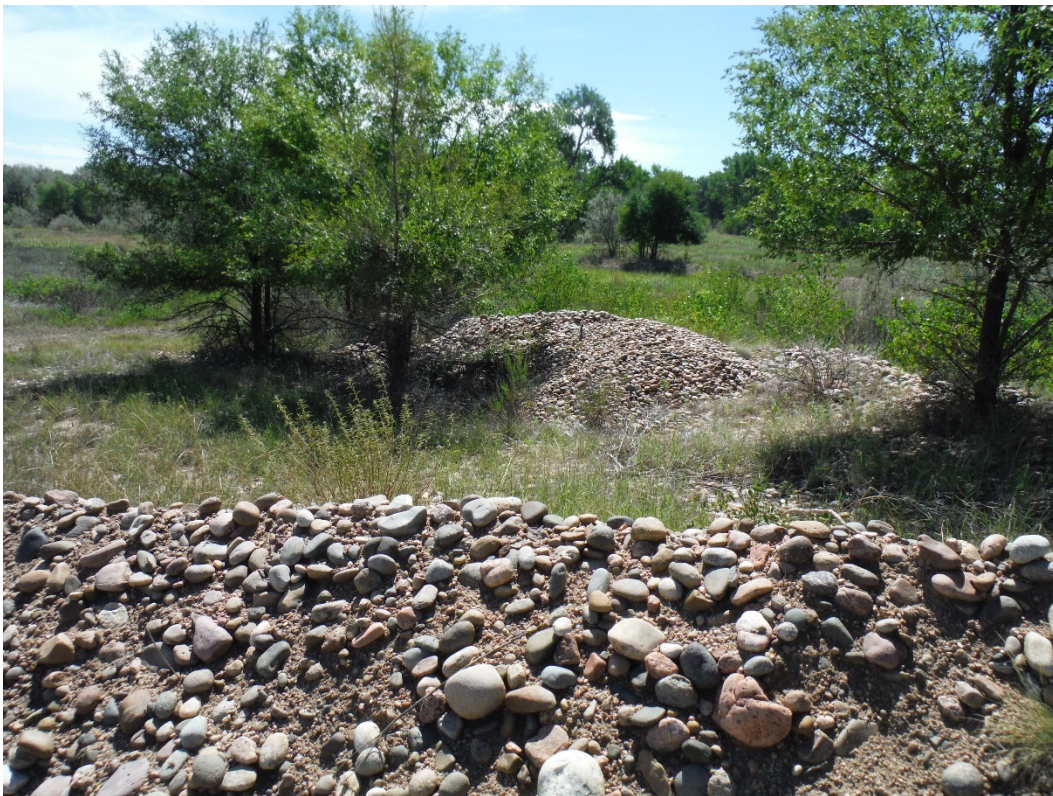
Photo 4. Small stockpiles of rock in the southwest corner of the permit; looking south.

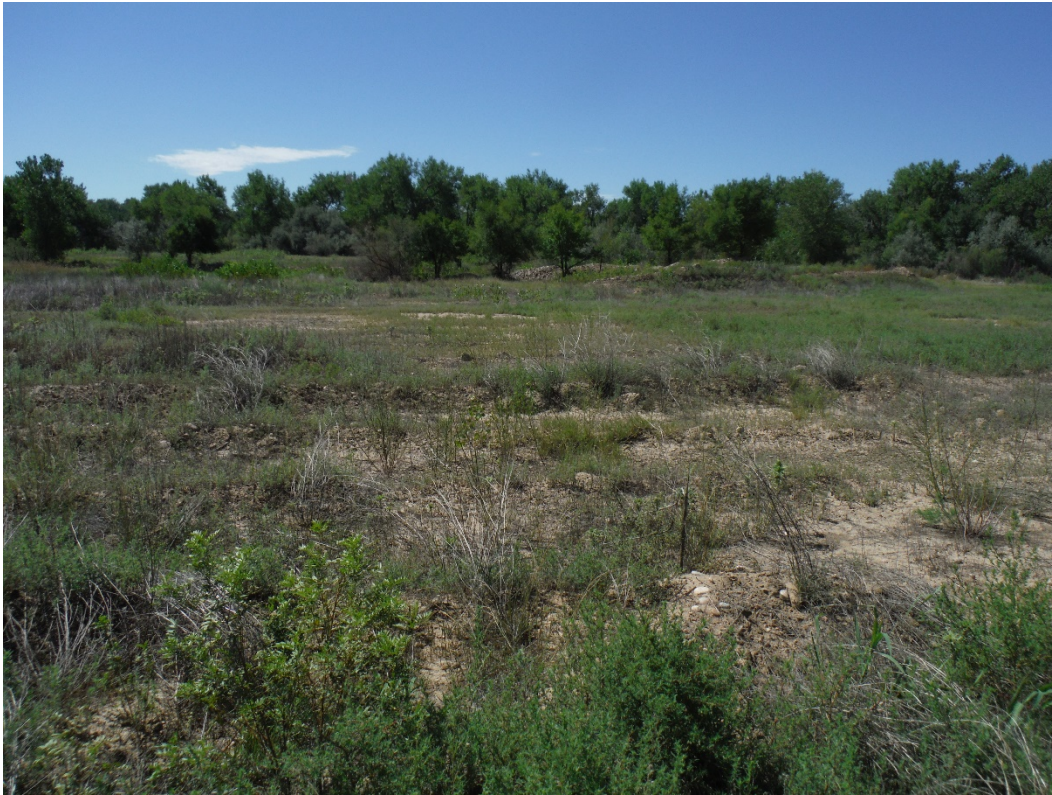
Photo 5. Large flat area south of the pond; looking southwest.
