**MINERALS PROGRAM INSPECTION REPORT**  
**PHONE: (303) 866-3567**

<b>MINE NAME:</b> RBK Pit No. 30	<b>MINE/PROSPECTING ID#:</b> M-1990-106	<b>MINERAL:</b> Gravel	<b>COUNTY:</b> Pueblo
<b>INSPECTION TYPE:</b> Monitoring	<b>INSPECTOR(S):</b> Elliott Russell	<b>INSP. DATE:</b> September 6, 2018	<b>INSP. TIME:</b> 08:30
<b>OPERATOR:</b> RBK Construction, Inc.	<b>OPERATOR REPRESENTATIVE:</b> David King	<b>TYPE OF OPERATION:</b> 110c - Construction Limited Impact	
<b>REASON FOR INSPECTION:</b> Normal I&E Program		<b>BOND CALCULATION TYPE:</b> Partial Bond	
<b>DATE OF COMPLAINT:</b> NA		<b>BOND AMOUNT:</b> \$14,530.00	
<b>POST INSP. CONTACTS:</b> None		<b>JOINT INSP. AGENCY:</b> None	
<b>WEATHER:</b> Cloudy	<b>INSPECTOR'S SIGNATURE:</b>

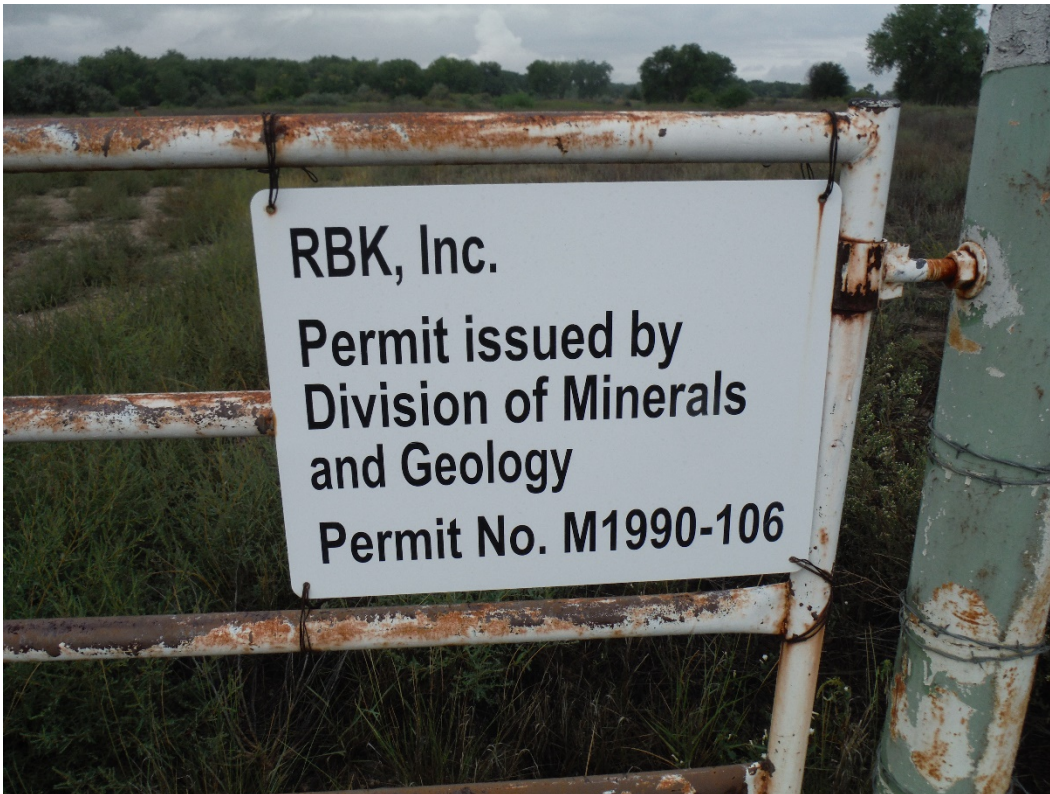
**Signs and Markers:** The permit sign was properly posted and boundary markers were observed to delineate the permit boundary.

**Photo 1.** Mine identification sign; looking west.

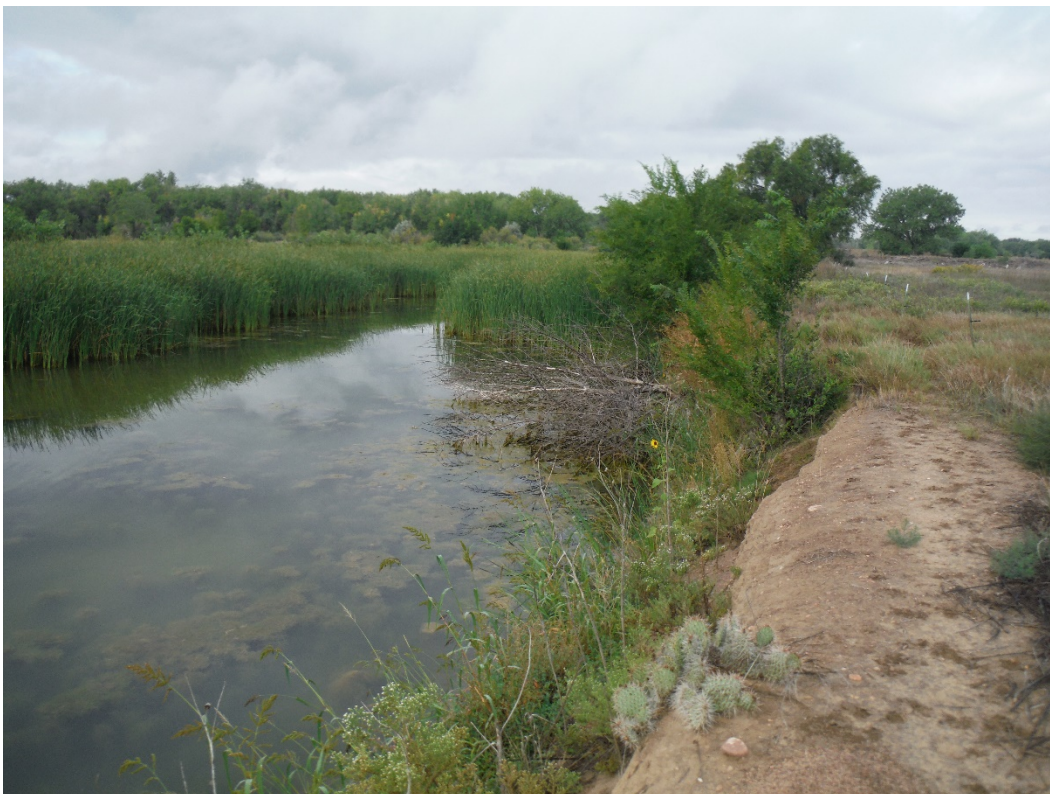
**Photo 2.** Northern bank of the pond; looking west.

**Backfilling and Grading:** The Operator has backfilled and graded a majority of the site with overburden and processing fines. Approximately 1.7 acres of the pond remains to be backfilled. Mr. King indicated they will either import material from off-site to finish backfilling or pursue a permanent augmentation plan to leave the pond as a part of the wildlife habitat. If the later operation is chosen, the northern bank of the pond will need to be graded to 3H:1V or flatter in accordance with Rule 3.1.5(7).

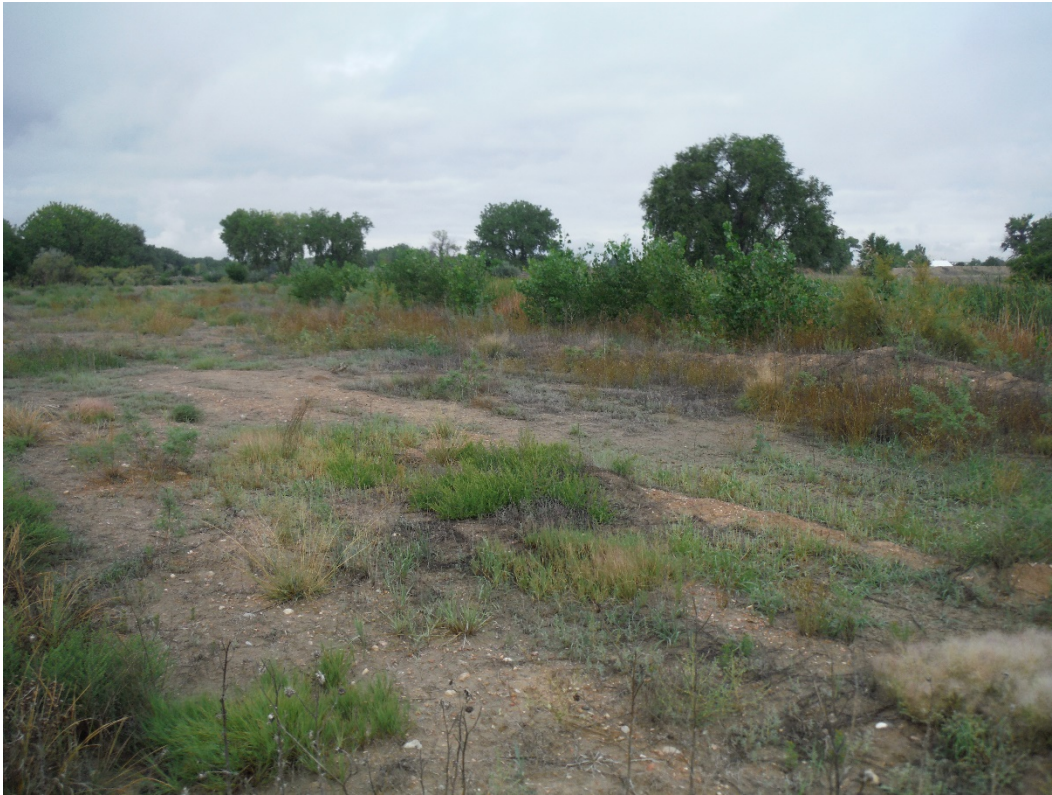
**Photo 3.** Backfilled area south of the remaining pond; looking northwest.
