MINERALS PROGRAM INSPECTION REPORT
PHONE: (303) 866-3567

MINE NAME: Parcel 122 - Resource Development Project	MINE/PROSPECTING ID#: M-2015-033	MINERAL: Gravel and sand	COUNTY: Weld
INSPECTION TYPE: Monitoring	INSPECTOR(S): Peter Hays	INSP. DATE: December 12, 2019	INSP. TIME: 11:30
OPERATOR: Varra Companies, Inc.	OPERATOR REPRESENTATIVE: Brad Janes	TYPE OF OPERATION: 112c - Construction Regular Operation	
REASON FOR INSPECTION: Normal I&E Program		BOND CALCULATION TYPE: Partial Bond	BOND AMOUNT: \$118,575.00
DATE OF COMPLAINT: NA		POST INSP. CONTACTS: None	JOINT INSP. AGENCY: None
WEATHER: Clear	INSPECTOR'S SIGNATURE:

The Parcel 122 – Resource Development Project was inspected by Peter Hays and D.J. Cunningham with the Division of Reclamation, Mining and Safety (Division/DRMS) as part of the Division's monitoring inspection program. The site was previously inspected by the Division on October 22, 2015 for the required pre-operational inspection. Mr. Brad Janes with Varra Companies, Inc. (Varra) was present during the inspection. An inspection map based on the observations from this inspection and the latest available Google Earth image is attached for reference.

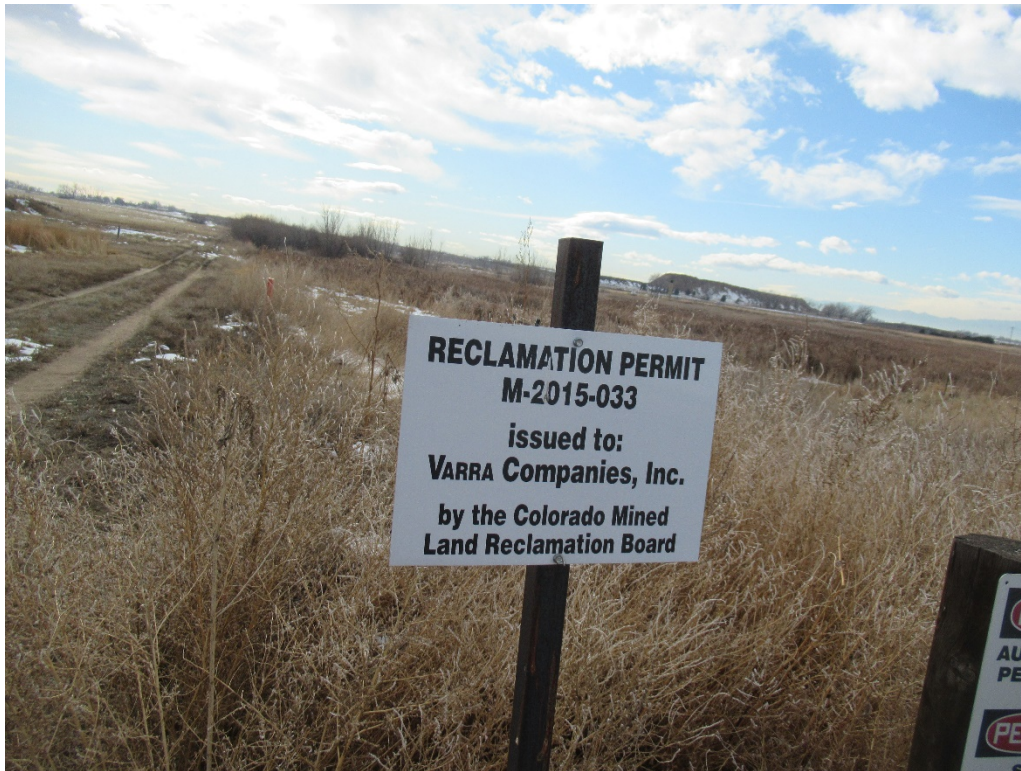
The site is an 112c operation permitted for 156.78 total acres with two extraction areas; Tract A – West Basin and Tract B – East Basin. A total of 101.97 acres of land will be disturbed by the mining excavation operation. The site is located in Firestone, Colorado in Weld County and east of the Heintzelman mine site operated by Varra. The required permit boundaries markers and mine sign were observed as required by Rule 3.1.12.

Parcel 122 mine sign

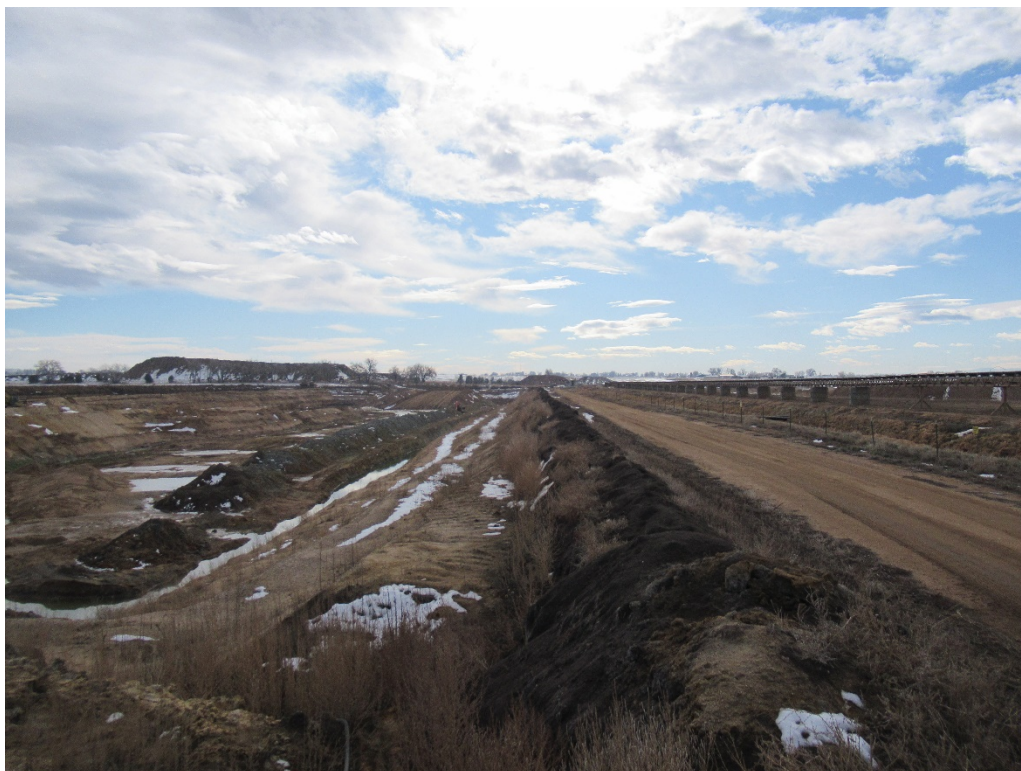
PROBLEM/: The perimeter slopes were benched at an estimated overall 1.5H:1V slope to an estimated depth of 50 feet in Mining Tract A. The approved Geotechnical Stability Exhibit states the lower half of the mine slope (below 20 feet) will be maintained at 3H:1V and the remaining mine slope (from the surface to 20 feet in depth) at 1.25H:1V to allow for maximum material extraction while maintaining an adequate safety factor.

View of Tract A from the northwest corner of the tract looking south

CORRECTIVE ACTIONS: The Operator must demonstrate the perimeter highwall profile is in accordance with the approved Mining Plan and Geotechnical Stability Analysis or submit a technical revision with an updated Stability Analysis to demonstrate a uniform 1.25:1V slope will not pose a hazard to structures 10 feet or greater from the extraction limit boundary. The Operator shall submit a Technical Revision, with the required \$216 revision fee, to update and clarify the current approved mine plan to reflect existing and proposed activities by the corrective action date.

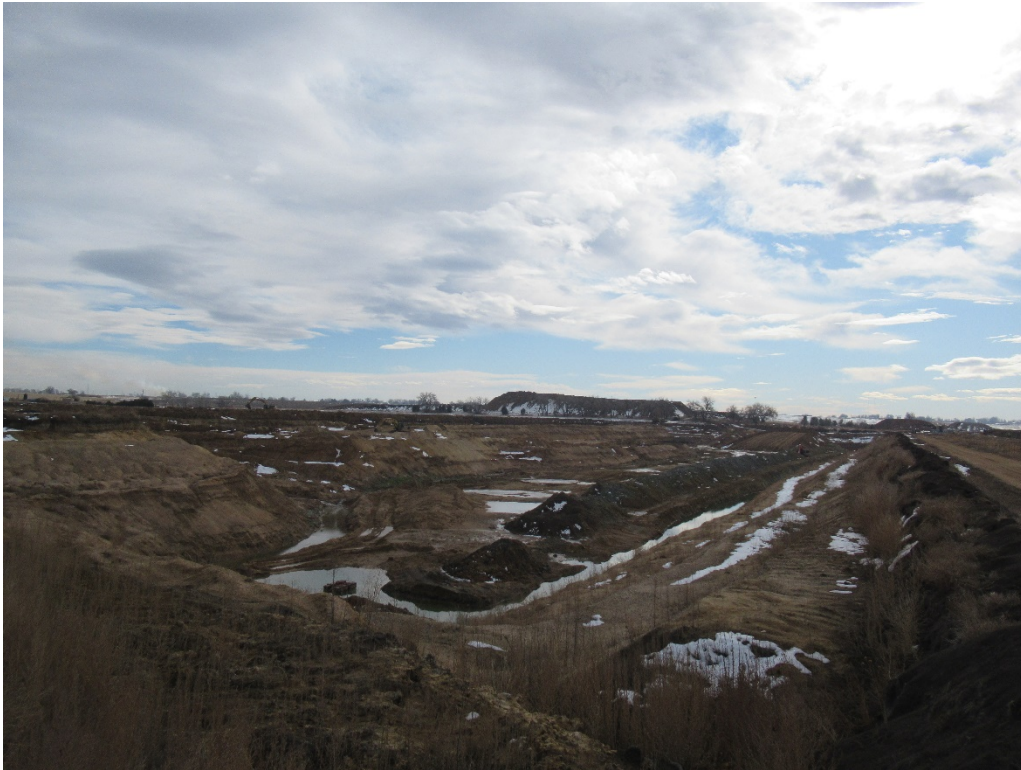
View of Tract A from the northwest corner of the tract looking southeast

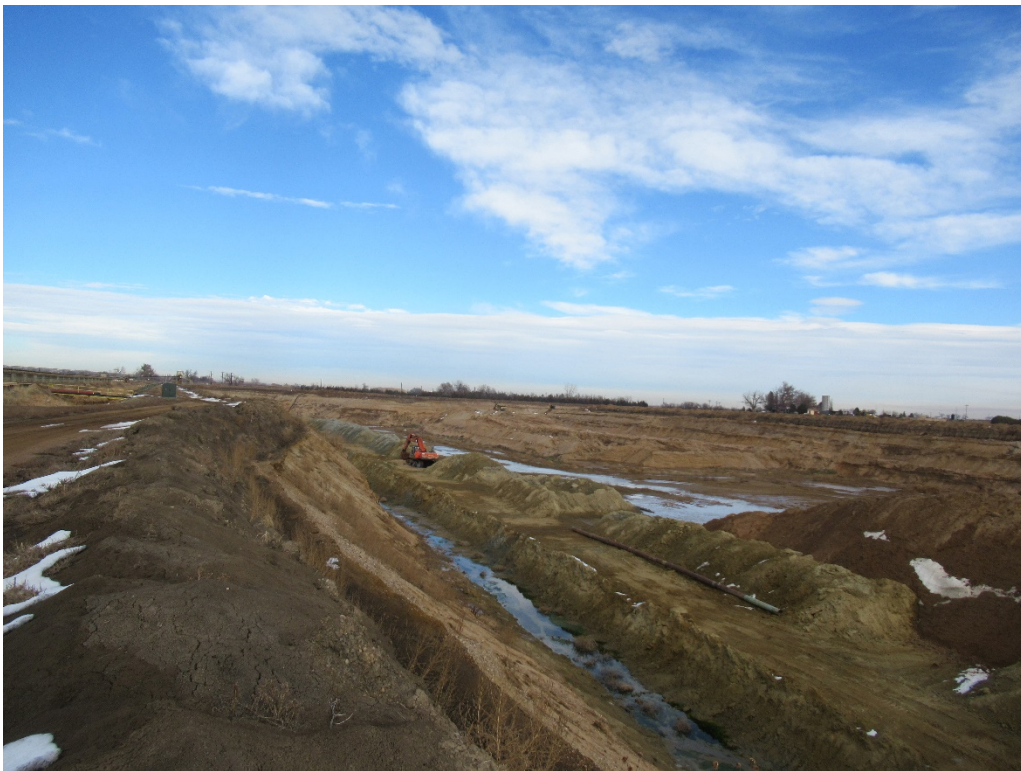
View of Tract A from the southwest corner of the tract looking north

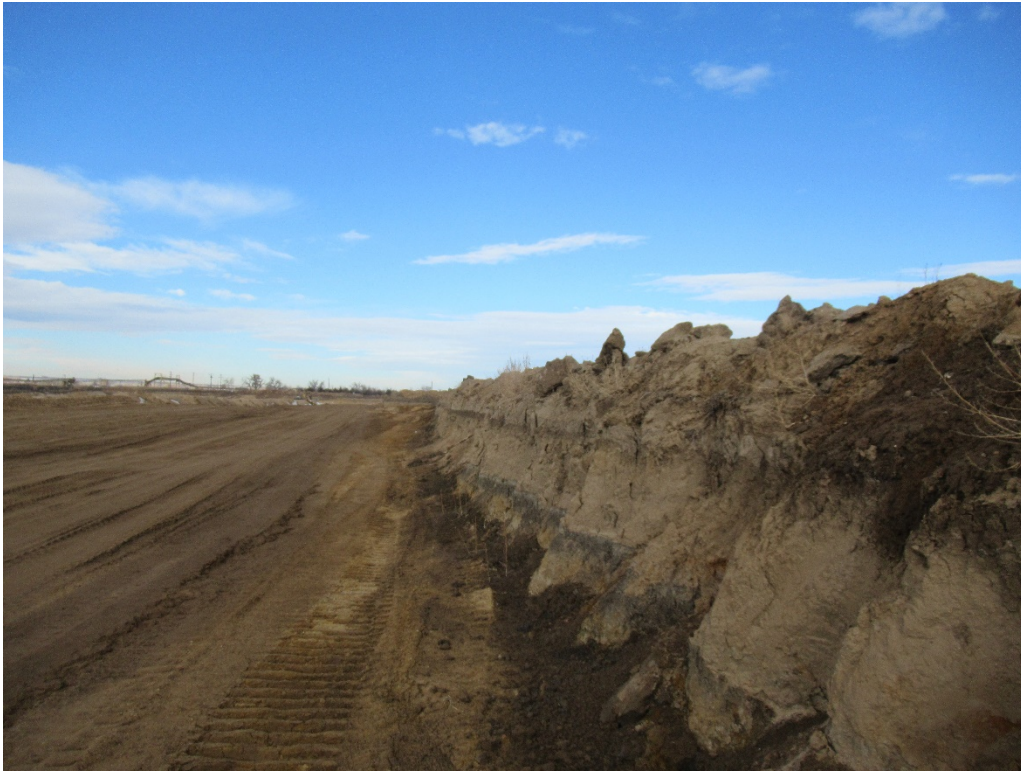
View of topsoil profile being salvaged from the peninsula of Tract A

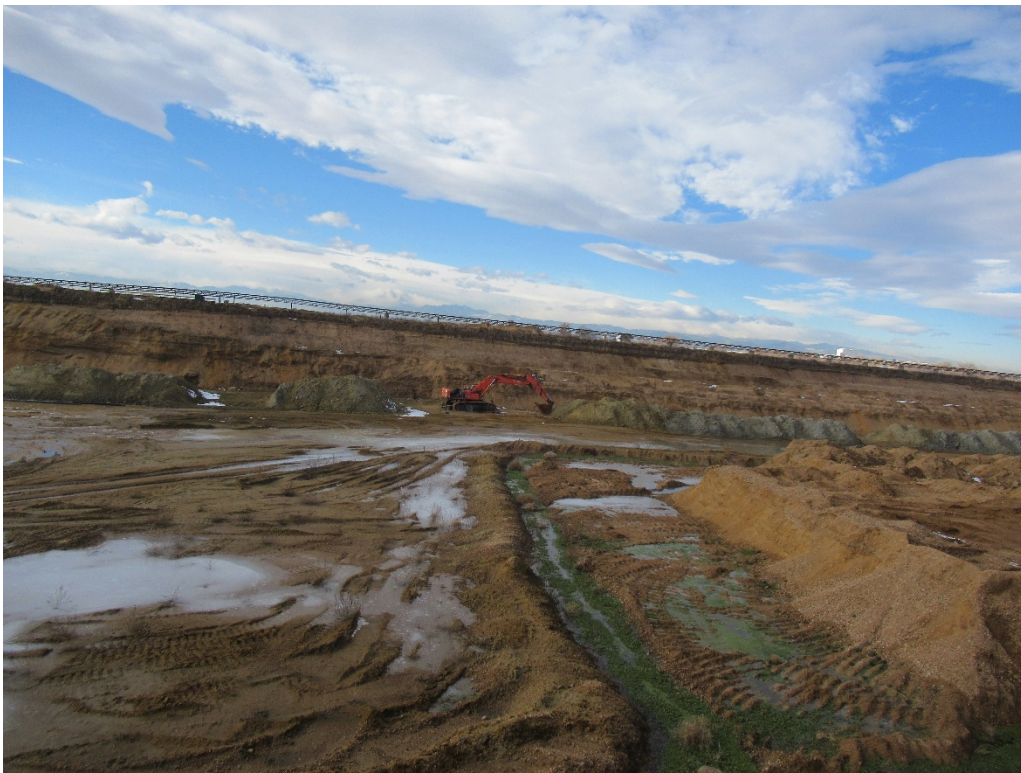
Mining activities have commenced in Tract A. The tract was generally being mined from north to south in accordance with the approved Mining Plan. The perimeter of the tract was excavated to establish dewatering trenches in the underlying bedrock. The mining excavation is progressing to the east from the western boundary. All mined material is conveyed to the Kurtz Resource site for processing. The perimeter slopes were benched at an estimated overall 1.5H:1V slope to an estimated depth of 50 feet. The approved Geotechnical Stability Exhibit states the lower half of the mine slope (below 20 feet) will be maintained at 3H:1V and the remaining mine wall (from the surface to 20 feet in depth) sloped at 1.25H:1V to allow for maximum material extraction while maintaining an adequate safety factor. **As cited as a problem, the Operator must demonstrate the perimeter highwall profile is in accordance with the approved Mining Plan and Geotechnical Stability Analysis or submit a technical revision with an updated Stability Analysis to demonstrate a uniform 1.25:1V slope will not pose a hazard to structures 10 feet or greater from the extraction limit boundary.** A revised Geotechnical Analysis must conform to the requirements of Section 30 or the Policies of The Mined Land Reclamation Board effective May 26, 2018.

View of mining activity in the western portion of Tract A looking west from the center of Tract A

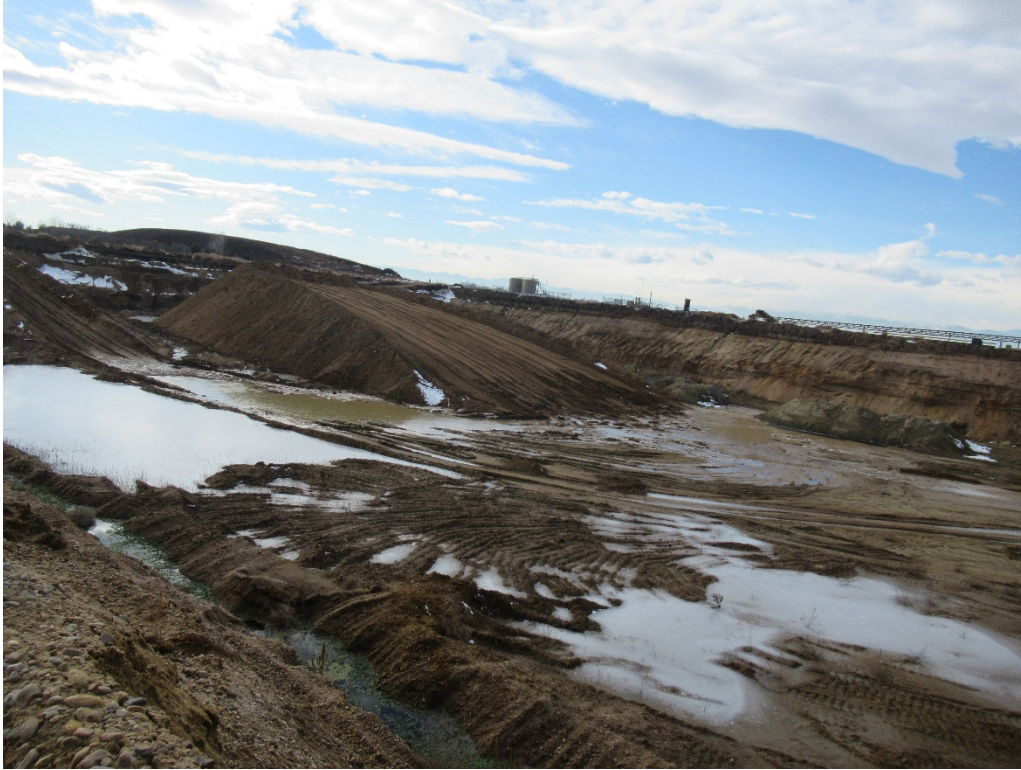
The approved post-mining land use for the site is developed water resource. The site reclamation will create two (2) clay lined reservoirs with 89.37 acres of water surface. No reclamation activity has occurred at the site. No noxious weeds were observed during the inspection. The site appeared stable with no erosion features observed during the inspection. The Operator was reminded of the requirement to stabilize topsoil stockpiles with the approved seed mixture to establish vegetation, once the topsoil salvaging operation concludes for Tract A. A stockpile of overburden was observed in the southwest corner of the pit floor in Tract A.

View of overburden stockpile located on the pit floor in the southwest corner of Tract A

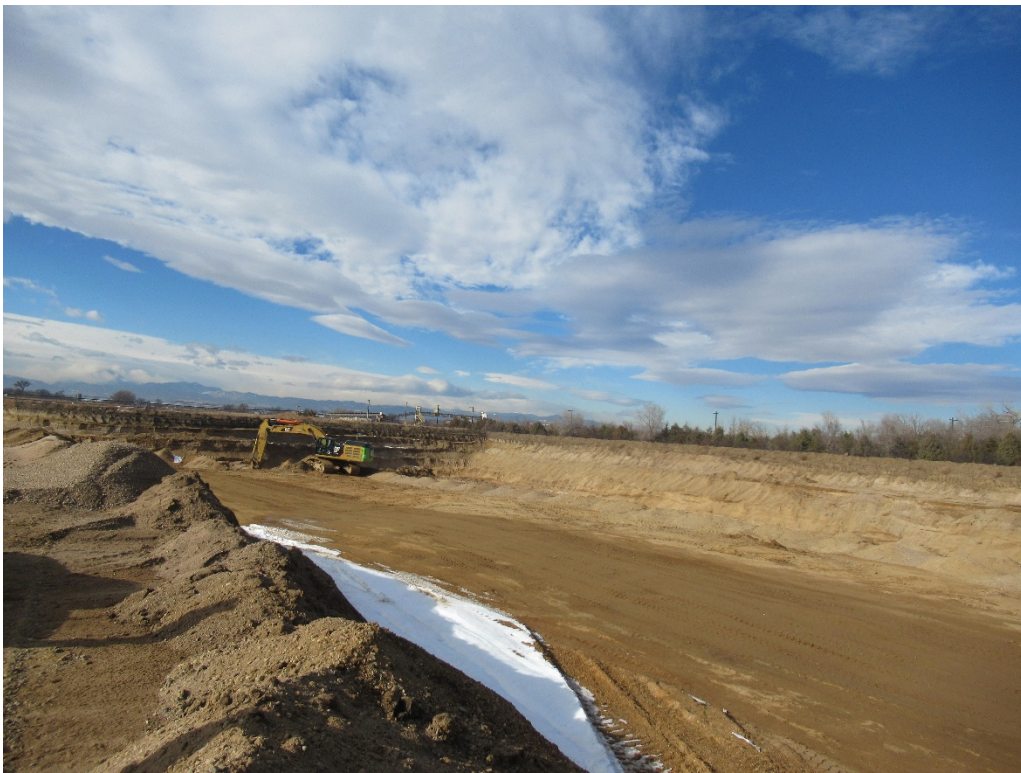
A mining disturbance offset of 125 feet from the residence and 10 feet from all other structures, property boundary, right-of-way or easement without a structure agreement was established by the Operator. A mining offset of 25 feet was established for wellheads and facilities. The wellheads will be backfilled to create a 100+ foot radius around the wellhead. The wellhead offsets were estimated at a minimum 100 foot radius of

undisturbed land from the wellheads located in Tract A during the inspection. The top of the mining excavation appeared greater than the required 10 feet from the permit boundary.

View of the mining activity in the northern portion of Tract A east of the oil well

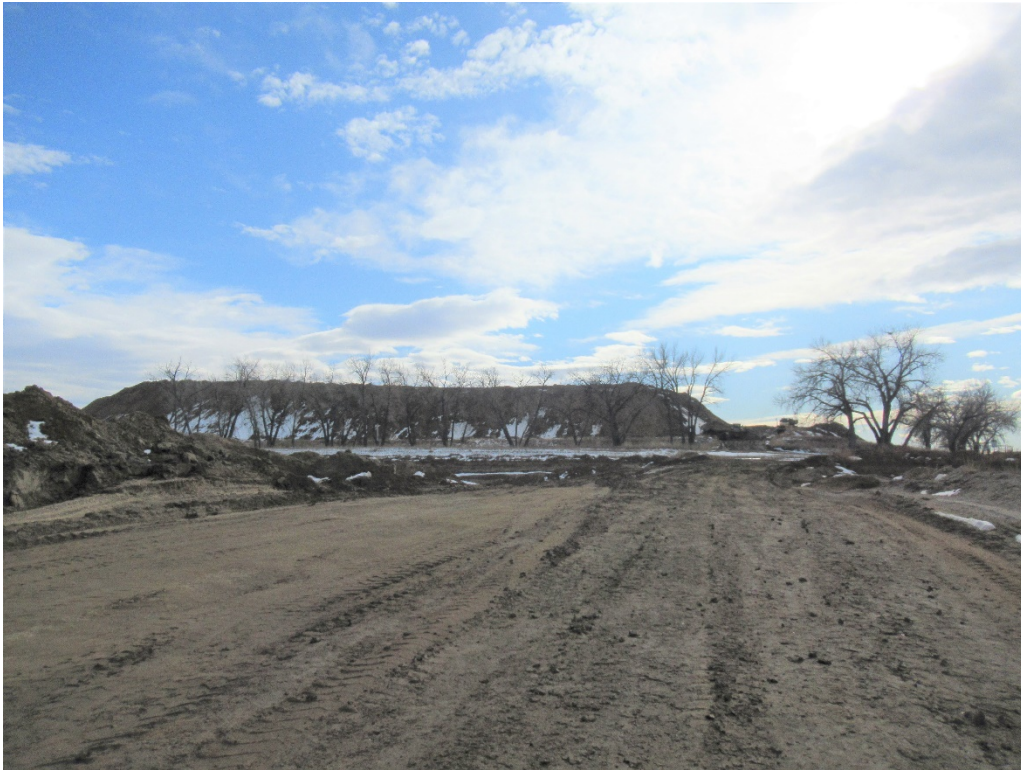
Two mineral reserve areas, a 10 acre area (Area 1) and a 24 acre area (Area 2) are located in the center and along the southern portion of the site, respectively. Mining disturbance will not occur in these areas unless the Mining and Reclamation Plans are revised in the future. No mining activity has occurred in the Mineral Reserve Area 1 and the planned wash pond has not been constructed by the Operator, since all processing is occurring off-site. Mineral Reserve Area 2 is being used for topsoil storage. During the inspection, an excavator was stripping an estimated 10 feet of topsoil from the peninsula area in the center of Tract A. The excavated topsoil was being transported and placed in the Mineral Reserve Area 2 by haul trucks.

View of topsoil stockpile in the Mineral Reserve Area 2 from Tract A looking south

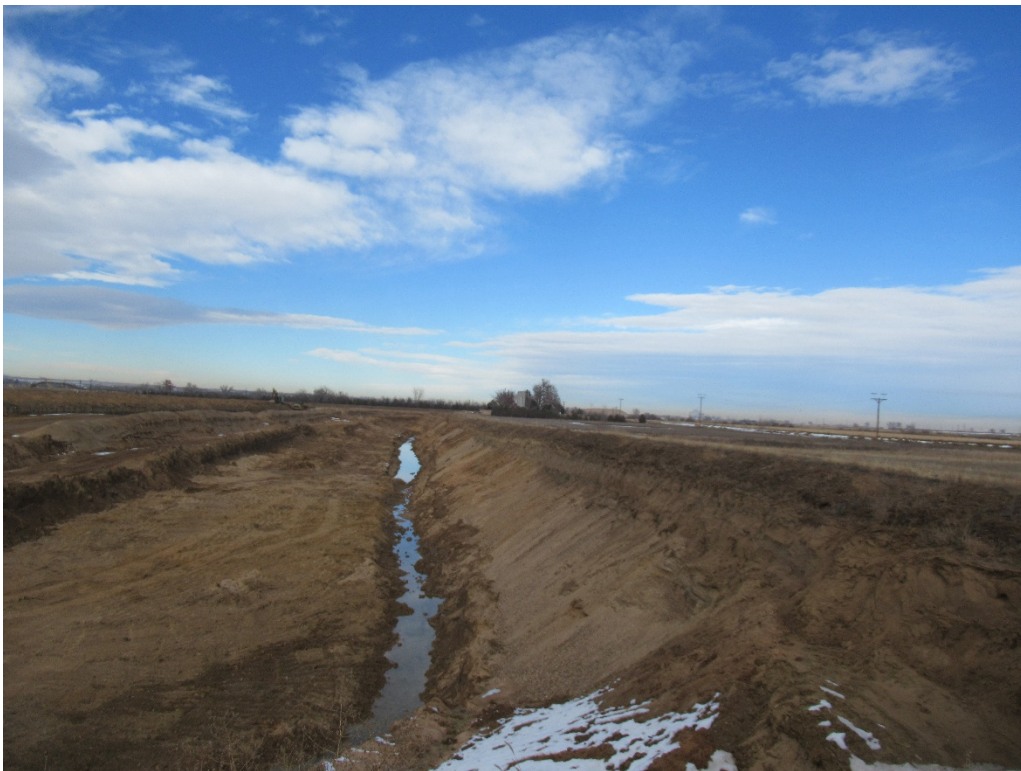
View of Tract A from the southeast corner looking north

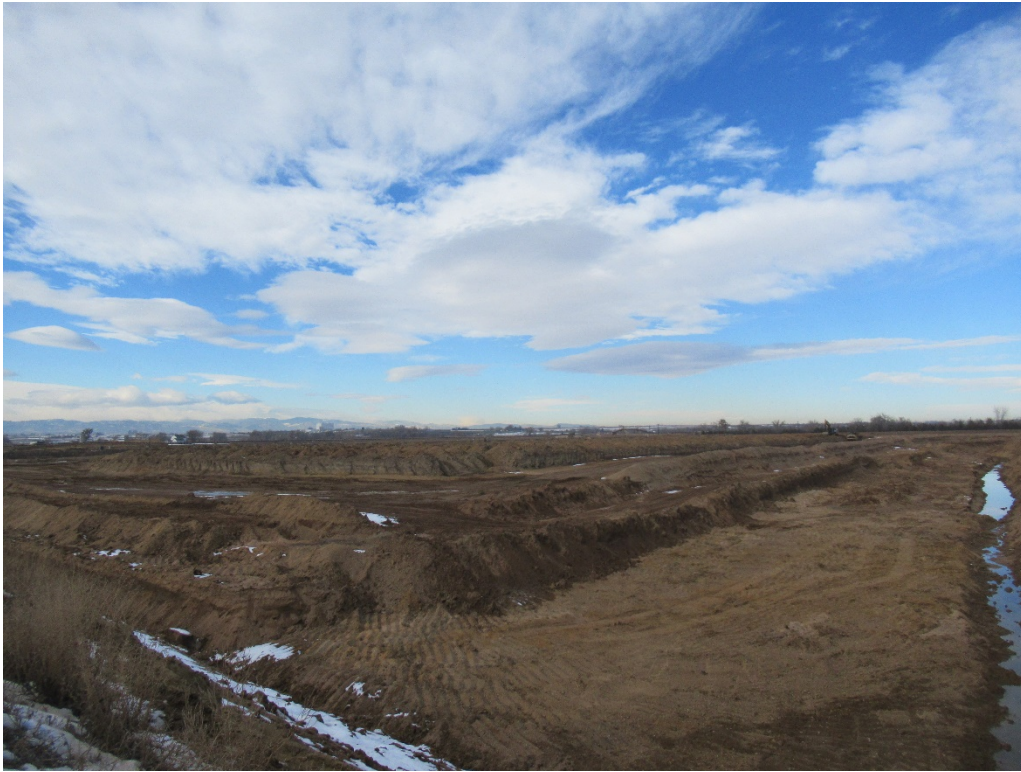
View of Tract A from the southeast corner looking northwest

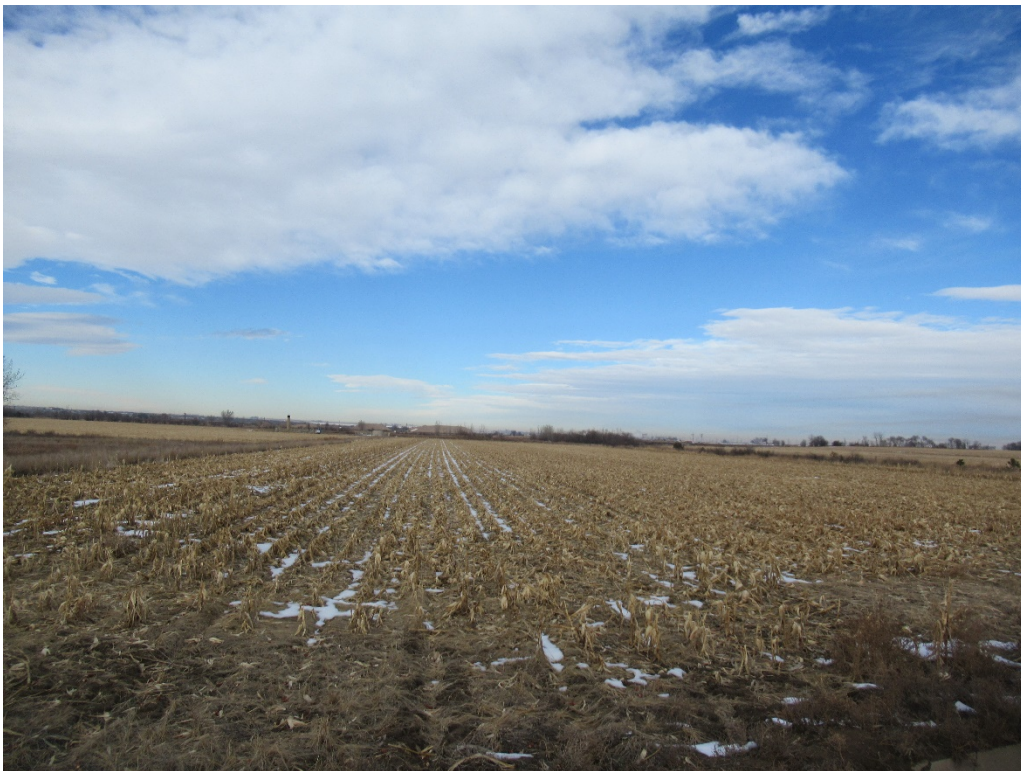
Tract B is undisturbed by mining activities and is used for agricultural purposes.

View of Tract B from the south side looking north
