Geotechnical Addendum

2019 Annual Report

Aggregate Industries Morrison Quarry
Permit M-1973-021
Jefferson County, Colorado

December 2019
Project 1705051

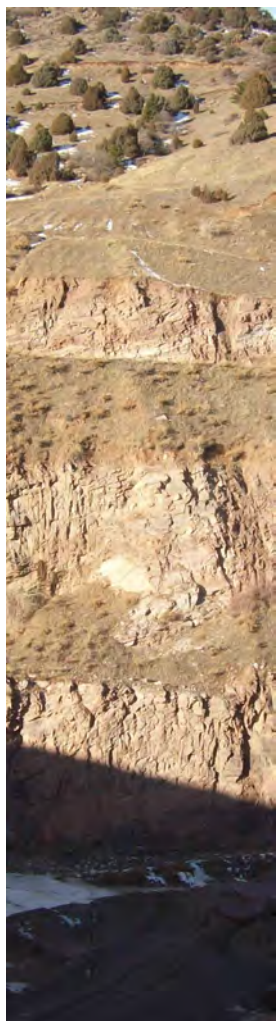
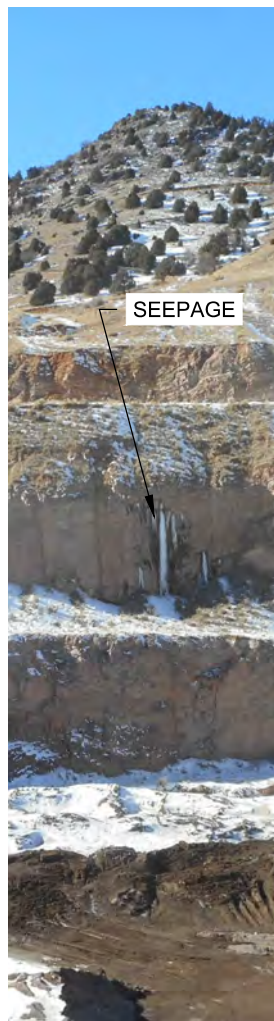
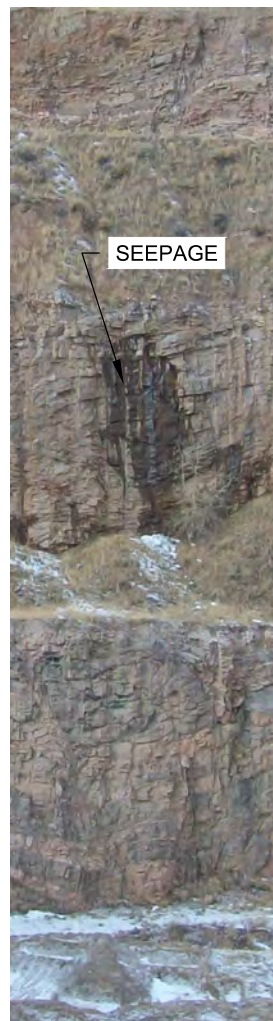
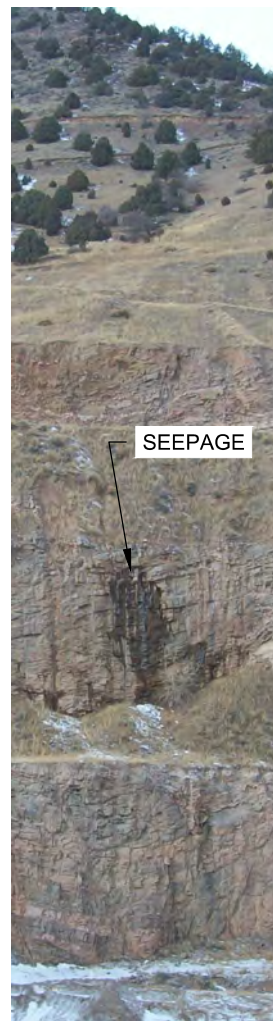
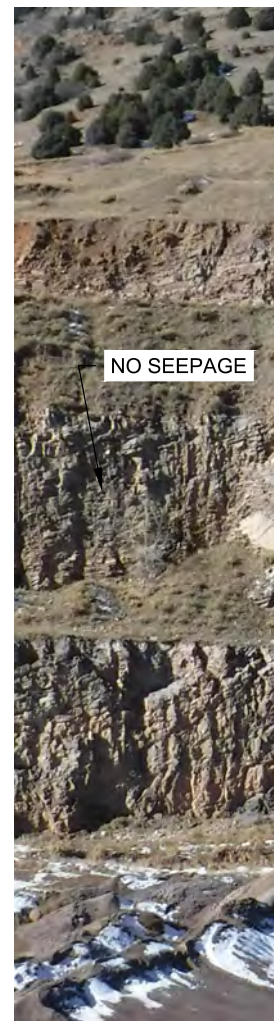
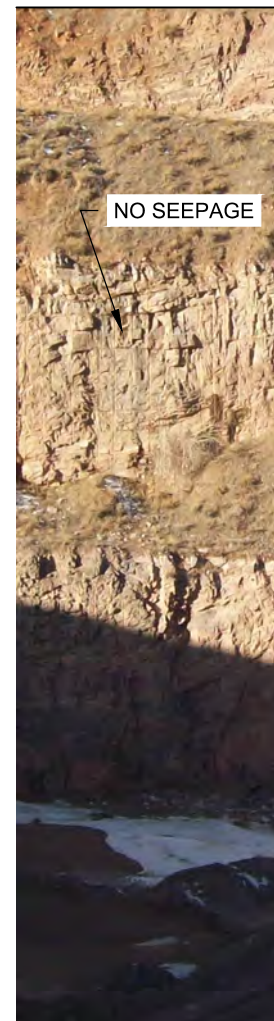
Figure 5

Minor groundwater seepage, visible in the west (east facing) highwall at approximate El. 6600 feet, was noted as a changed condition in the 2013 geotechnical addendum. A year-by-year comparison of the seepage area is shown in Figure 5. The seepage was not observed in 2017, 2018, or 2019.

Based on observations made during the December 2019 field inspection, GEI's familiarity with the site, and review of previous geotechnical addenda, the Central Quarry experienced little change in finished slope characteristics during 2019. Only small-scale, localized rockfall and highwall raveling occurred during the last year, which is considered minor. If the groundwater seepage previously observed at El. 6600 returns, it should be monitored by AI for unusual increases in flow in 2020.

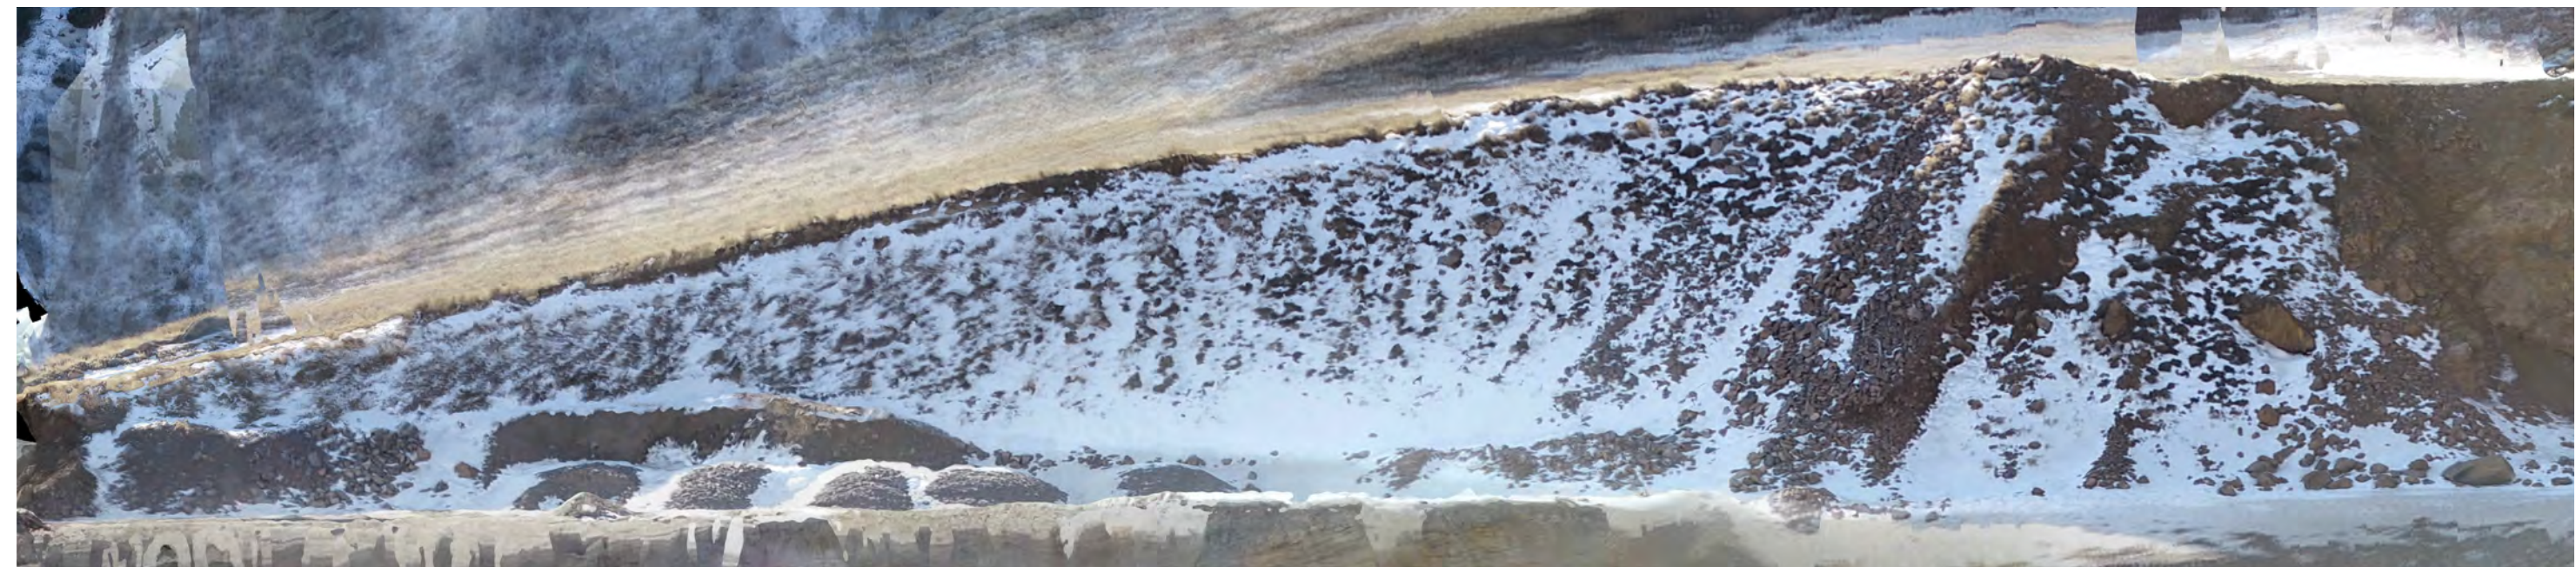
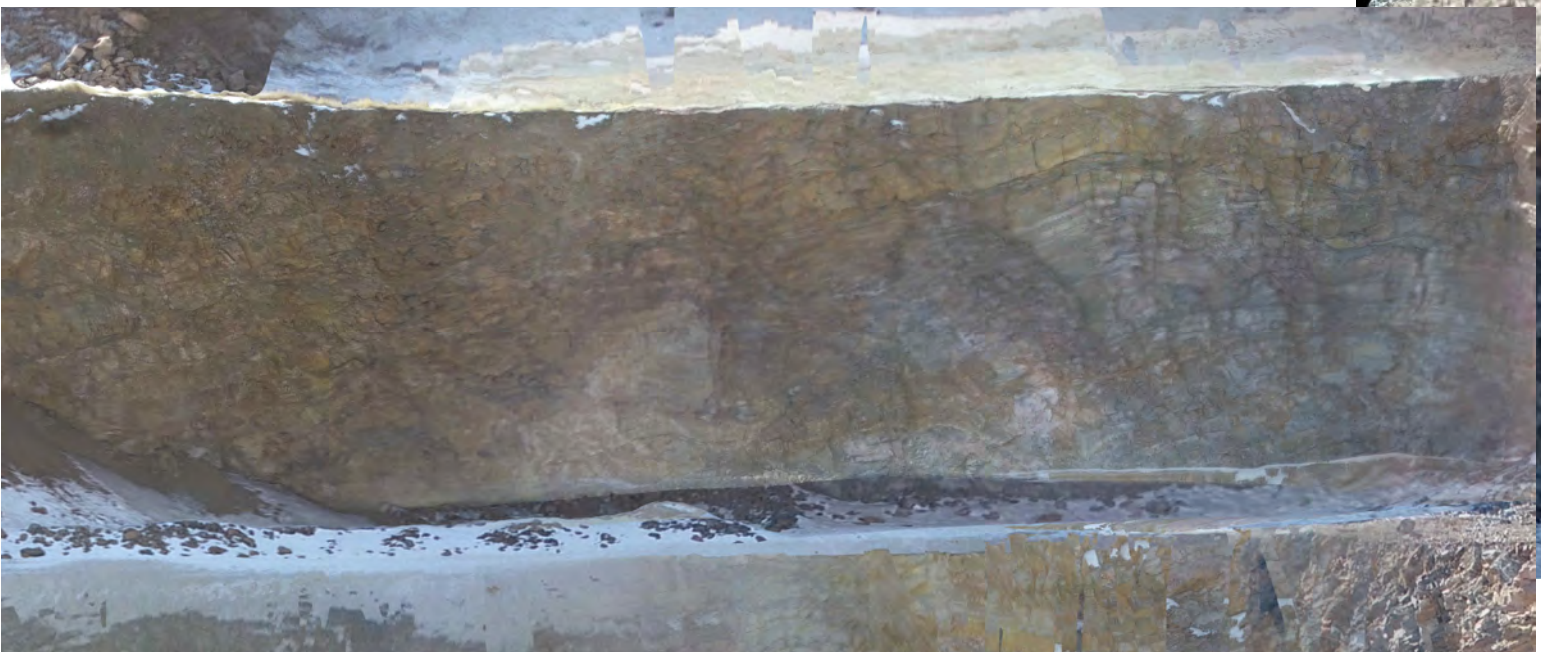
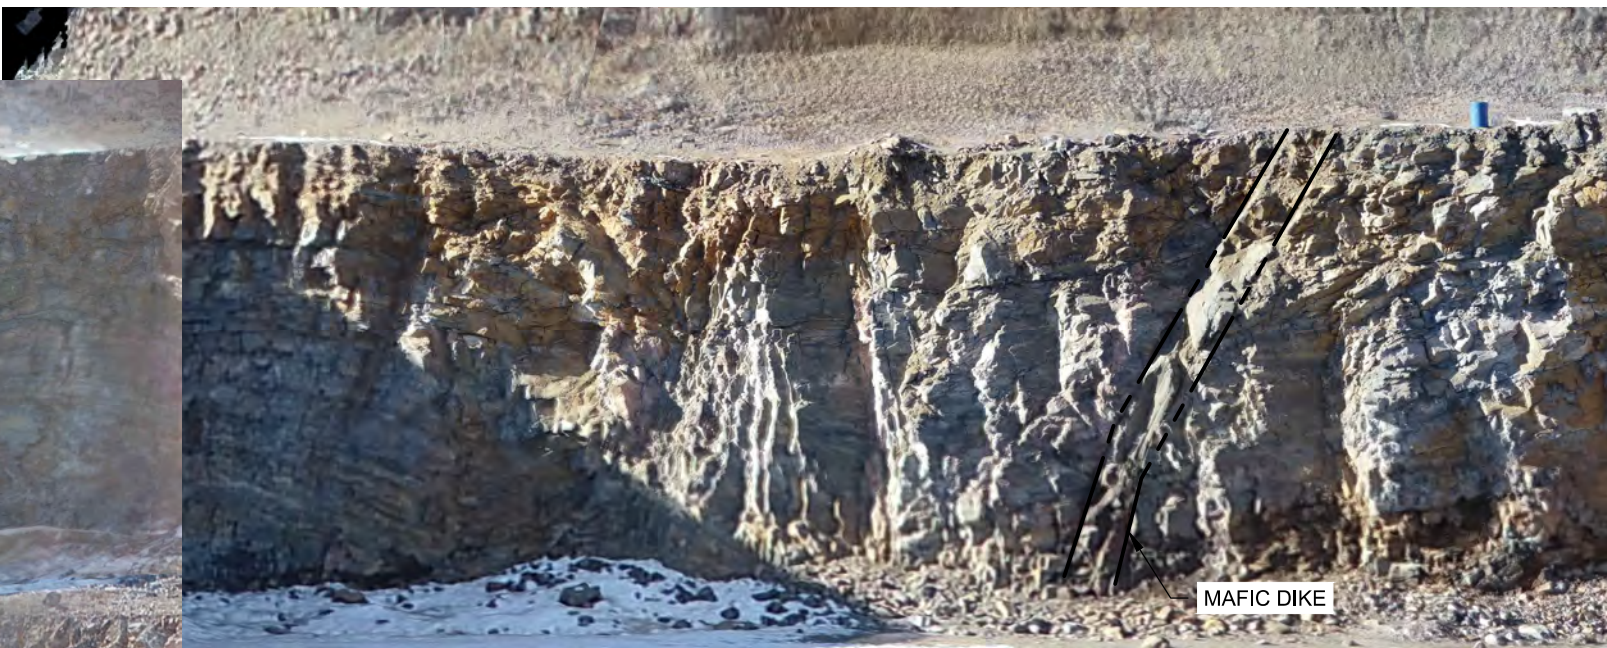
BENCH 6840 (1 OF 3)	
Aggregate Industries		Project 1705051	December 2019 Figure 9

Mining from Bench 6840 was last performed in 2018. During the December 2019 site visit, GEI staff noted rock fall from Bench 6840 and debris that, in some places, extends to the edge of the lower bench (Bench 6800).

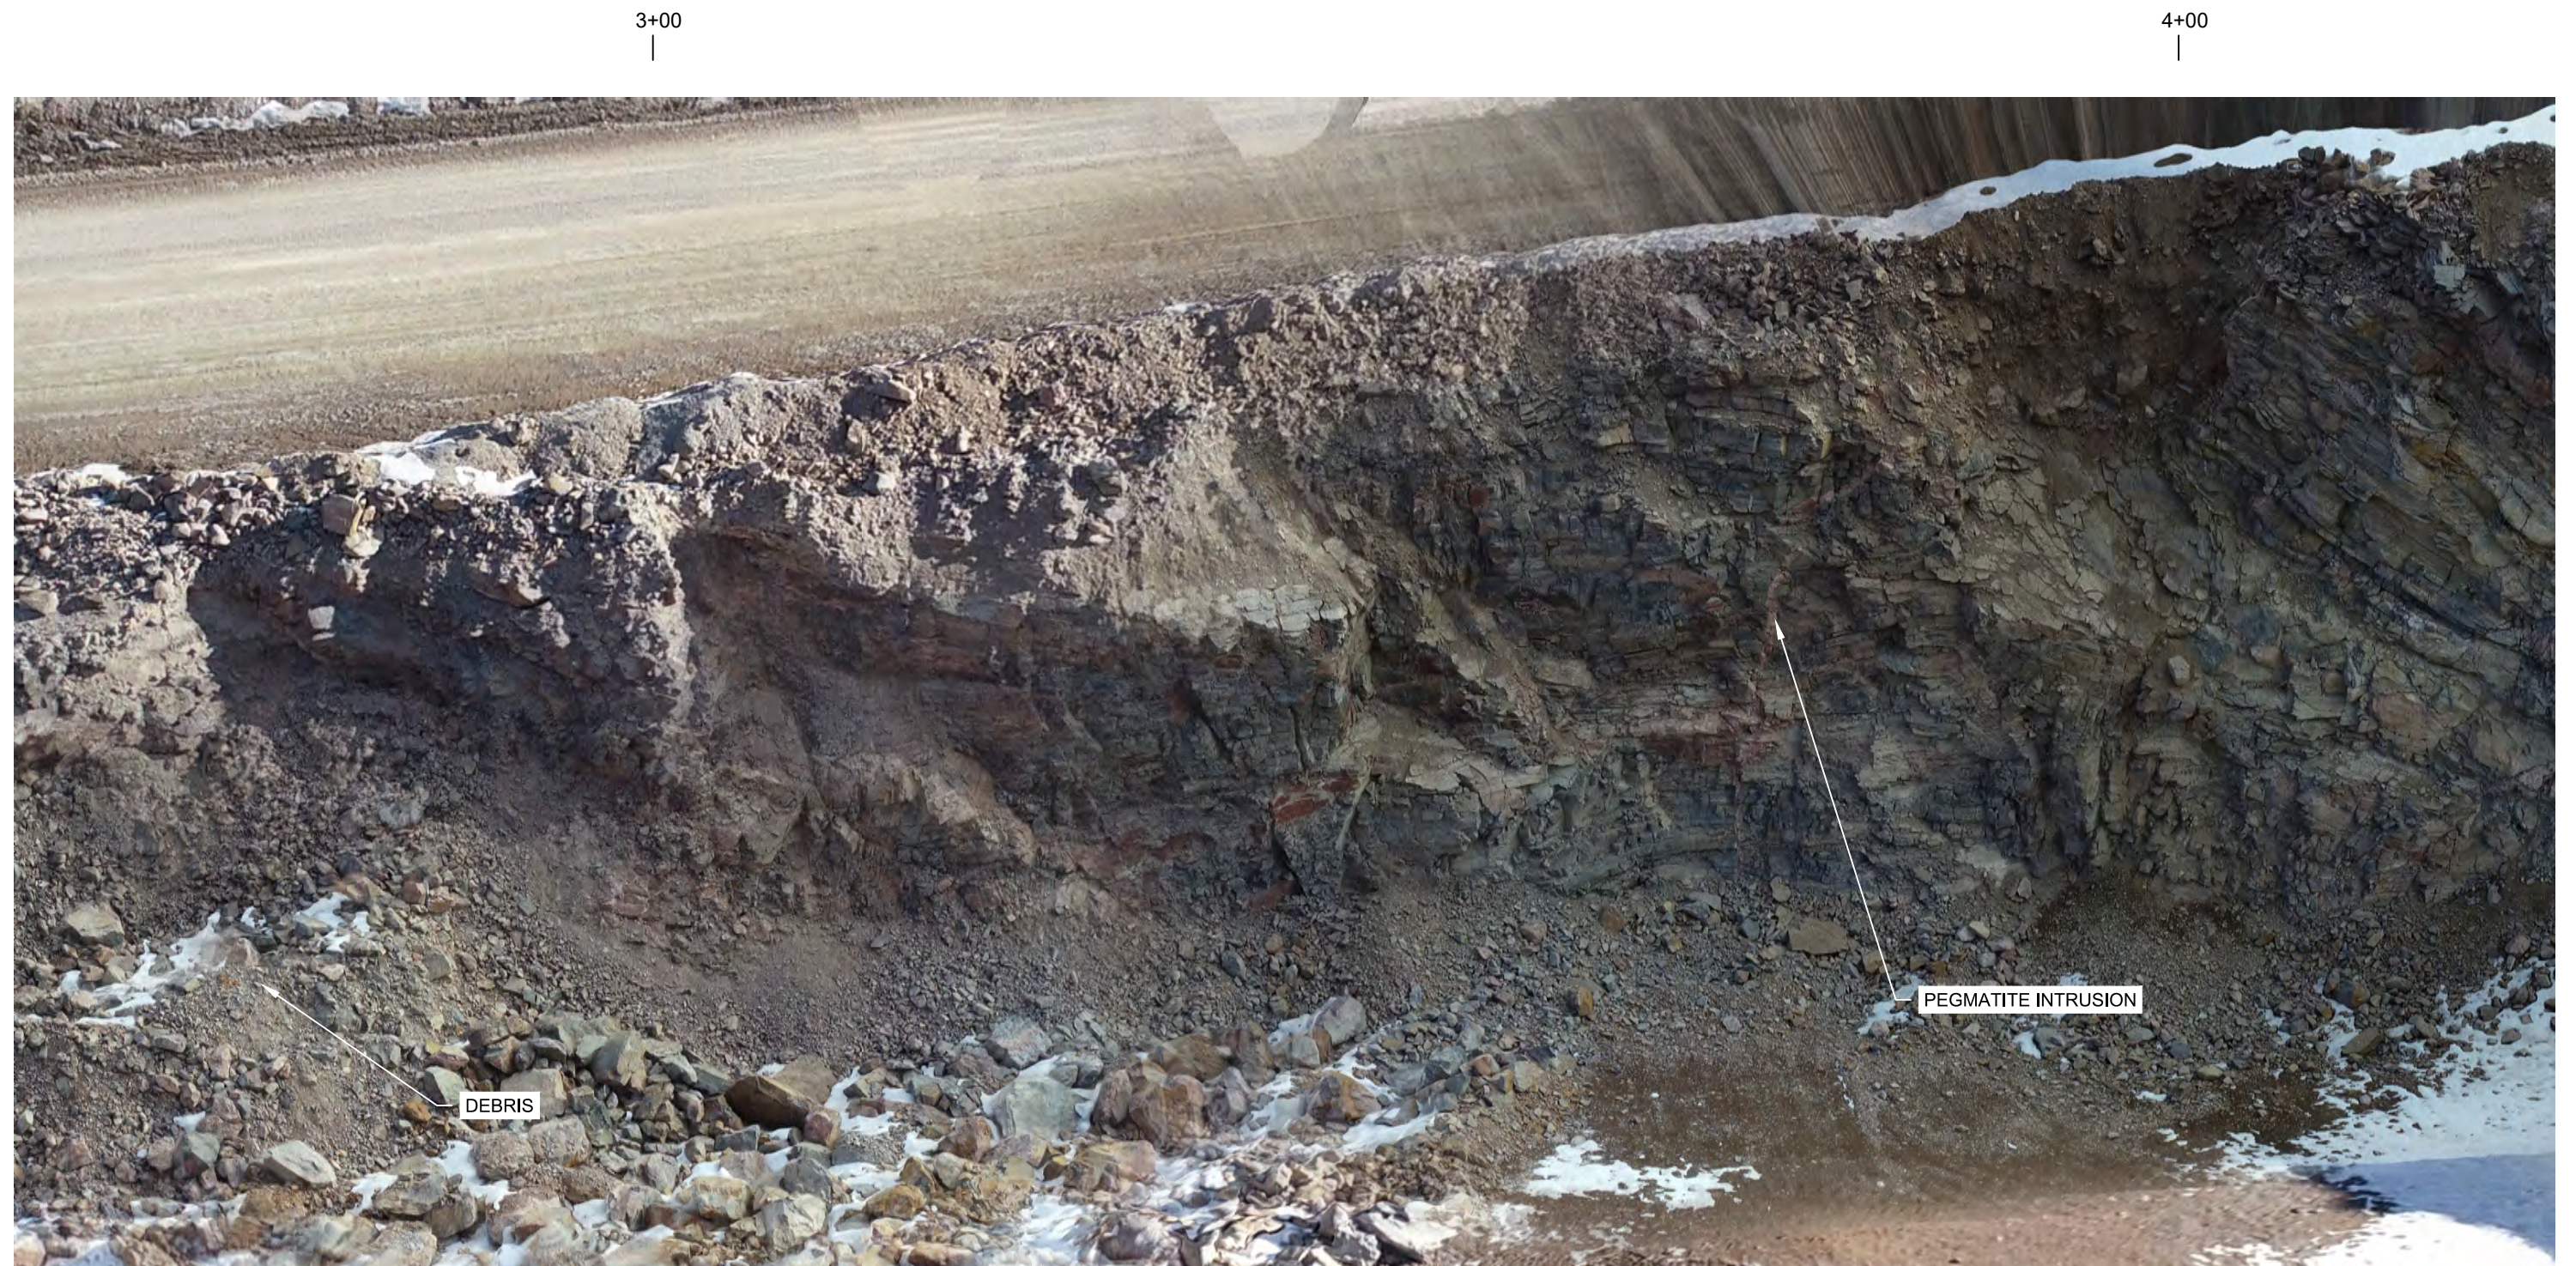
- Scanline B (Sta. 3+00 to Sta. 4+00) trended 7 degrees. Foliations exhibited a strike of about 100 degrees with dips ranging from 12 to 18 degrees. Two primary joint sets were evident. The first primary set exhibited an average strike of 15 degrees and an average dip of 73 degrees. The second set exhibited an average strike of 292 degrees and an average dip of 82 degrees. Very little to no oxide staining was observed in Scanline B. The RMR classification is Poor to Fair. Scanline B is shown in Figure 18.

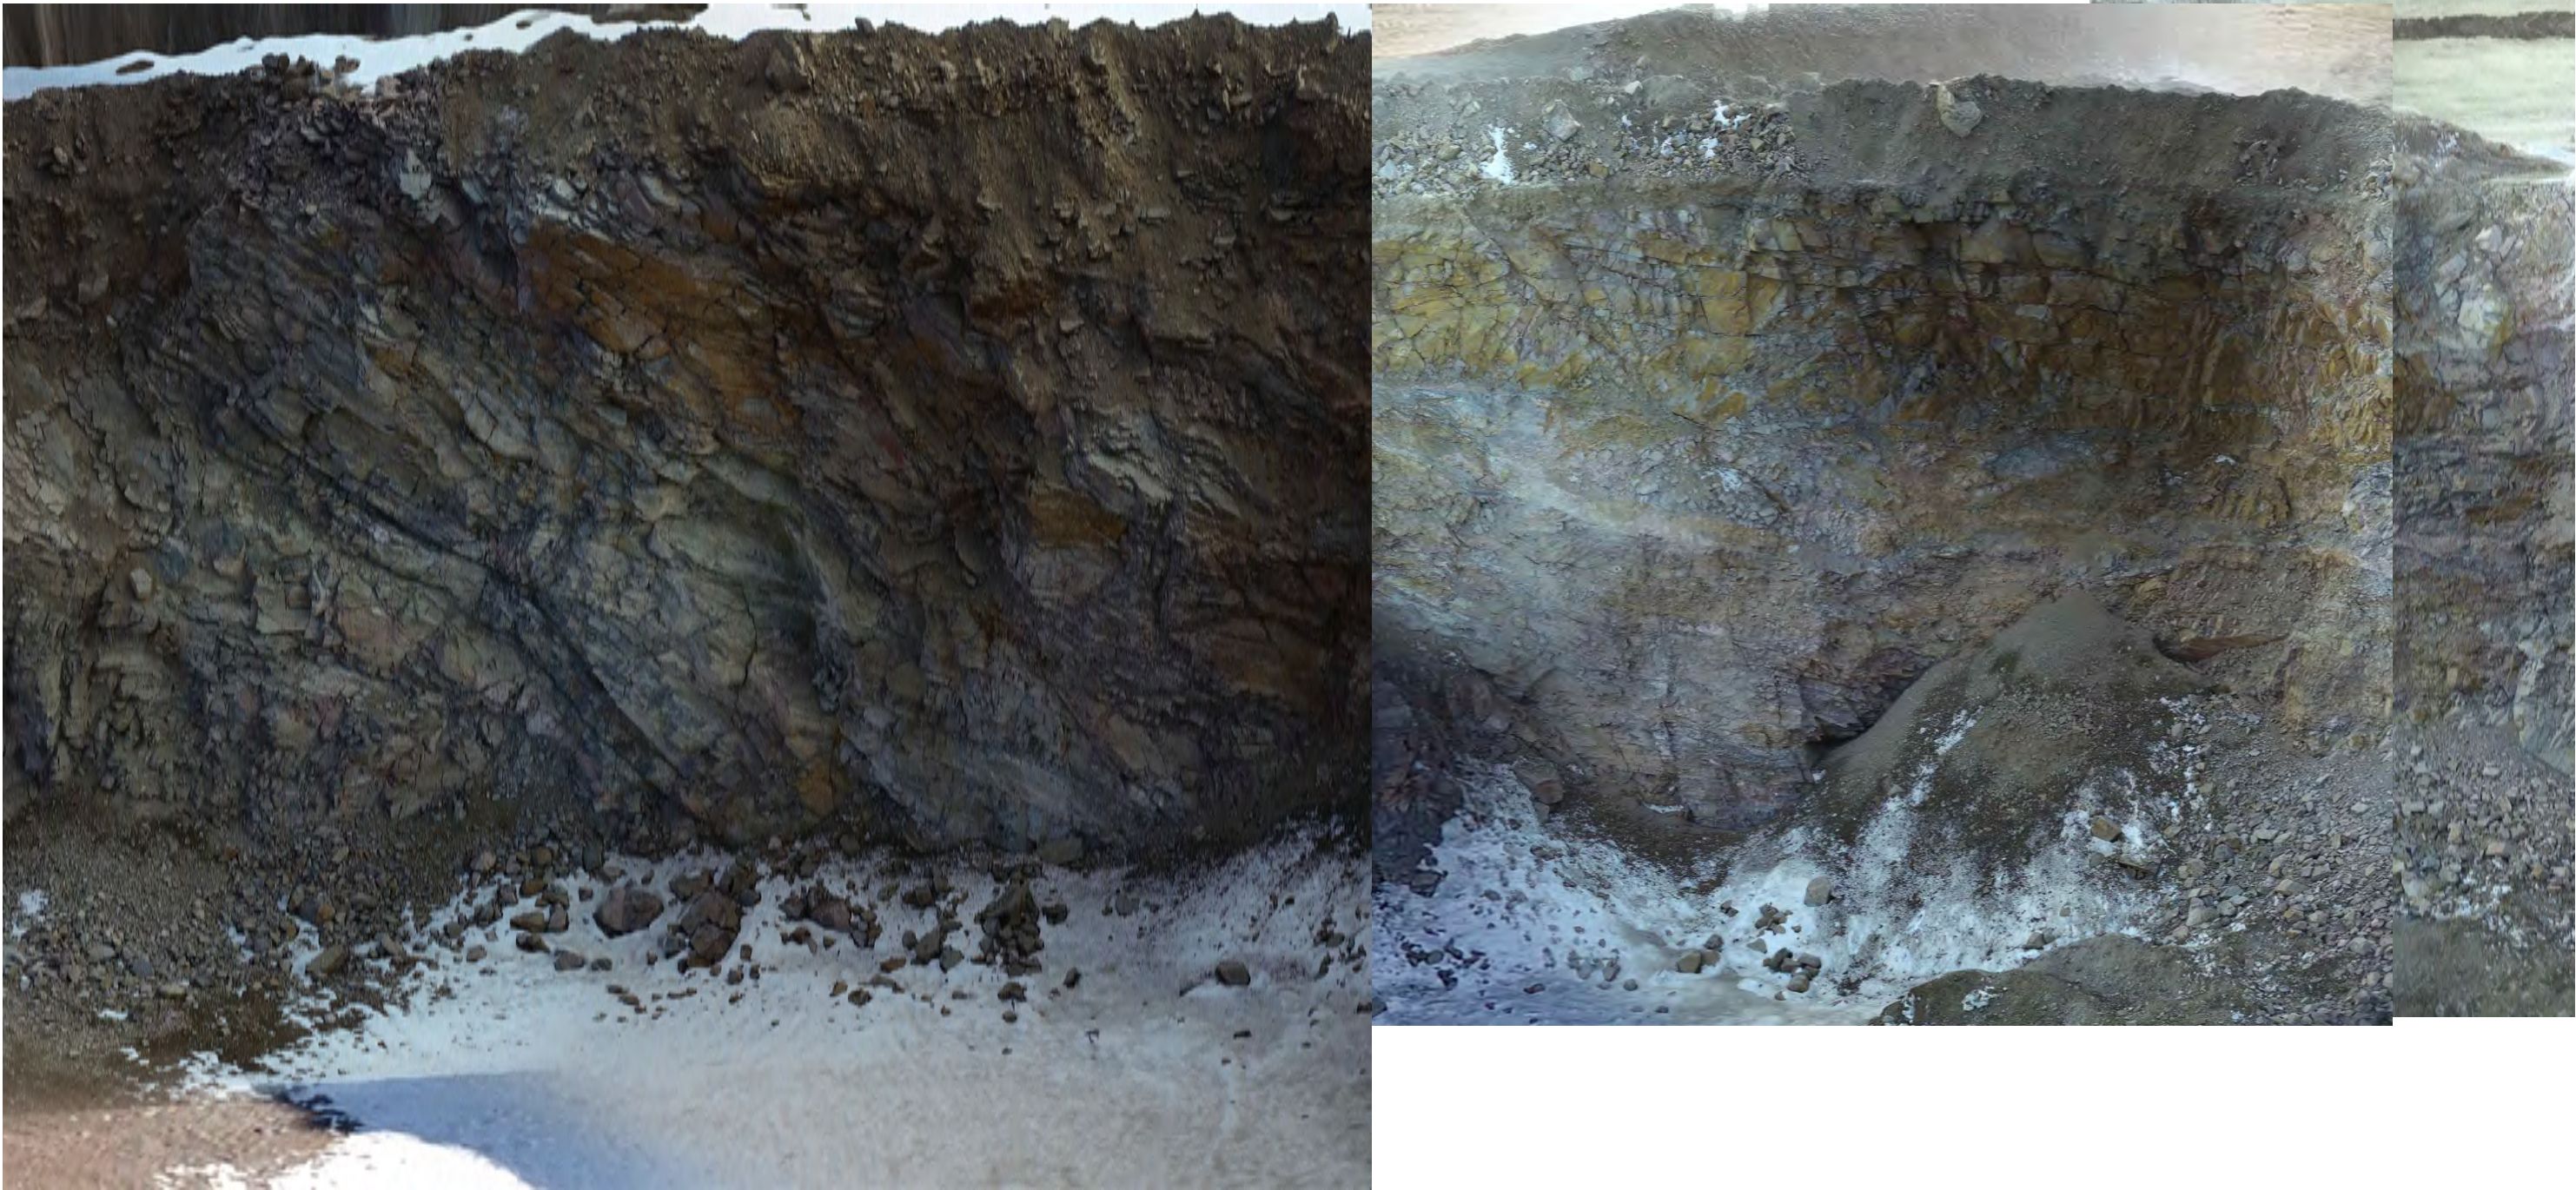
GEI Consultants	BENCH 6740 SCANLINE C	
Aggregate Industries		Project 1705051	December 2019 Figure 19

- Scanline C (Sta. 4+00 to Sta. 4+75) trended 0 degrees. Foliations exhibited a strike ranging from 200 to 320 degrees with dips ranging from 40 to 325 degrees. Two primary joint sets were evident. The first primary joint set exhibited an average strike of 181 degrees and an average dip of 81 degrees. The second primary joint set exhibited an average strike of 101 degrees and an average dip of 76 degrees. A large area of iron oxide staining was present in the top several feet of the highwall. The RMR classification is Poor to Fair. Scanline C is shown in Figure 19.

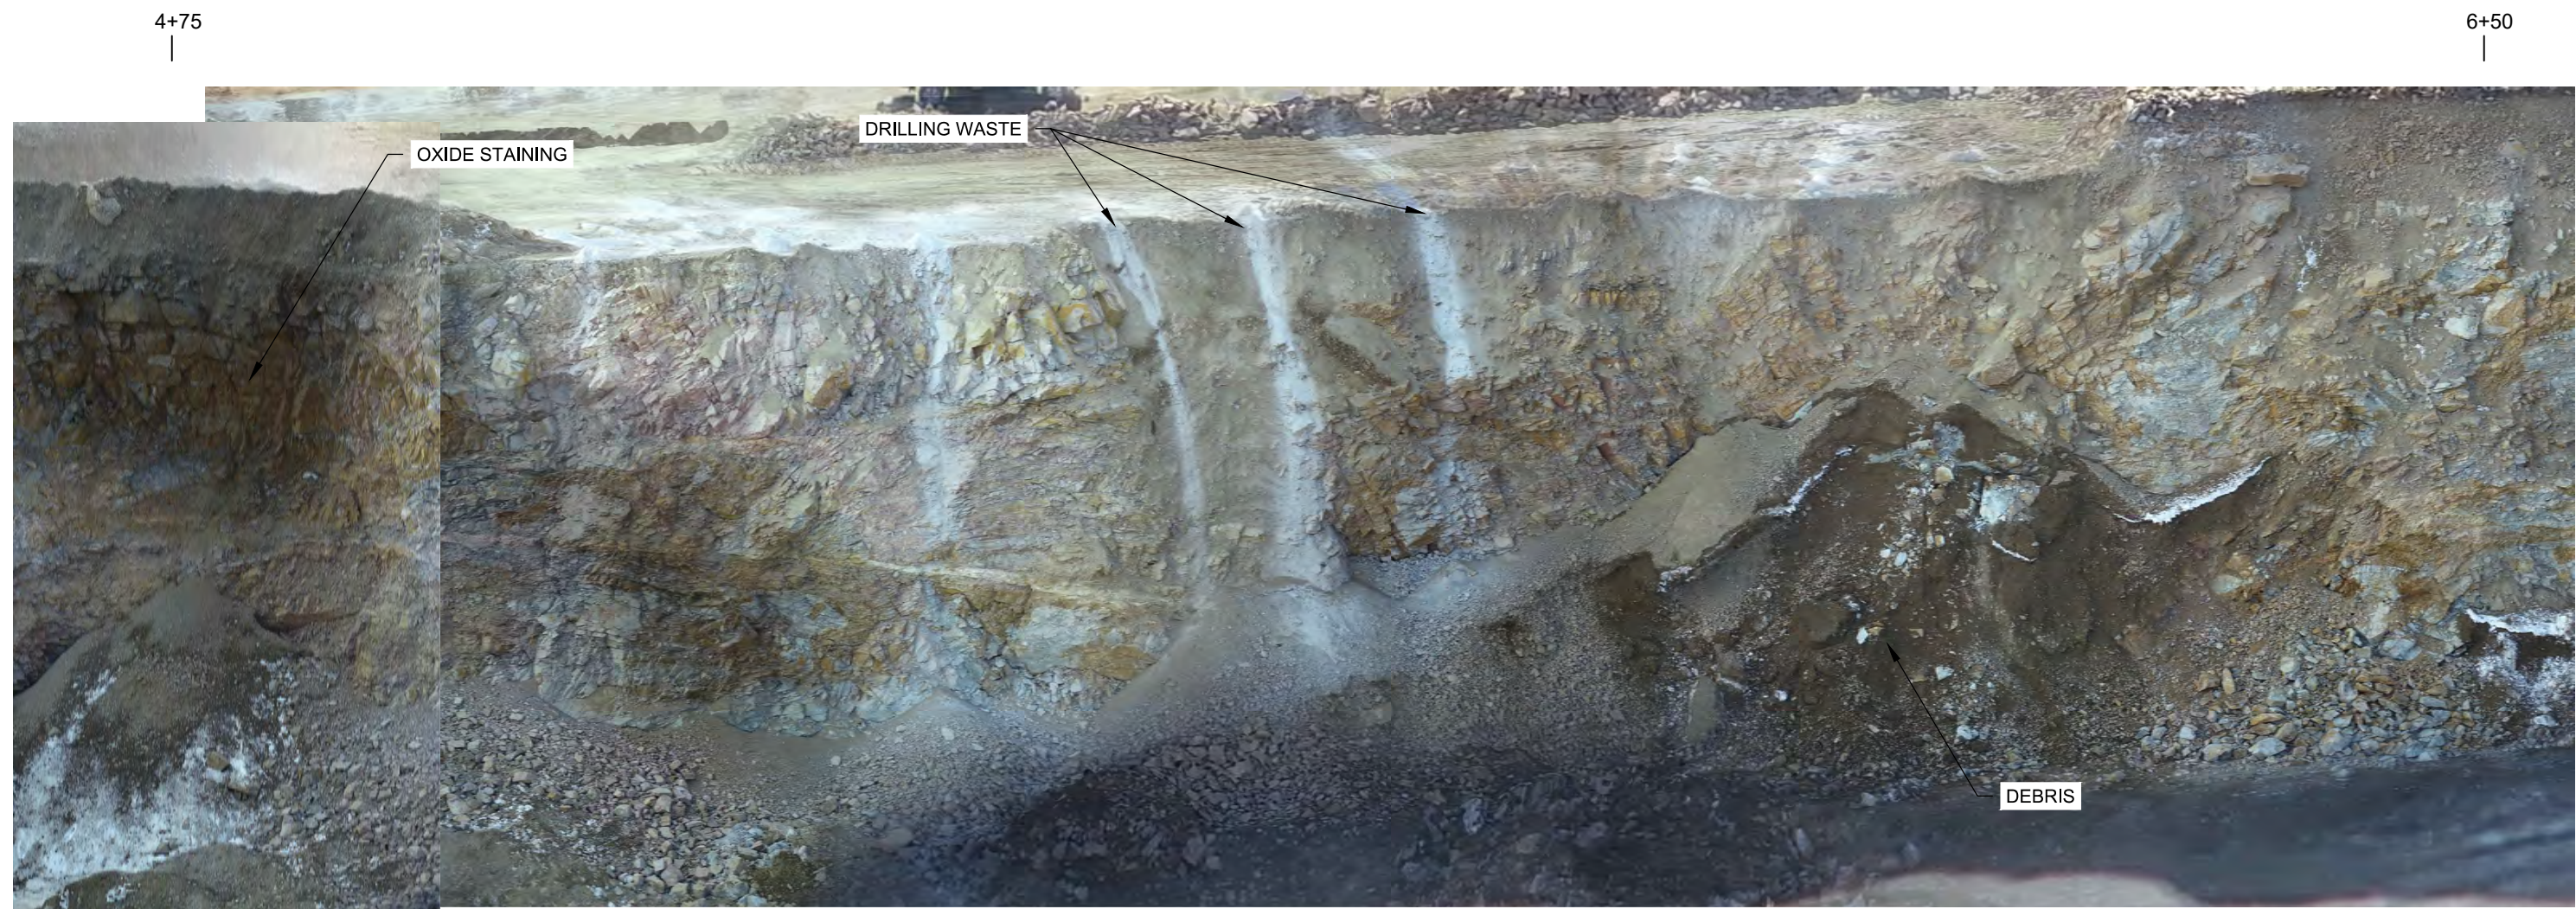
Morrison Quarry 2019 Annual Report DRMS Permit M-1973-021	<div>GEI Consultants</div> <div> </div>	BENCH 6740 SCANLINE D	
Aggregate Industries		Project 1705051	December 2019

- Scanline D (Sta. 4+75 to Sta. 6+50) trended 260 degrees. Foliations exhibited a strike ranging from 80 to 124 degrees with dips ranging from 8 to 35 degrees. Two primary joint sets were evident. The first primary joint set exhibited an average strike of 340 degrees and an average dip of 80 degrees. The second primary joint set exhibited an average strike of 255 degrees and an average dip of 83 degrees. Widespread iron oxide staining was present in the upper portions of the highwall. Minor, localized areas of adversely dipping foliation were present. The RMR classification is Very Poor to Fair. Scanline D is shown in Figure 20.

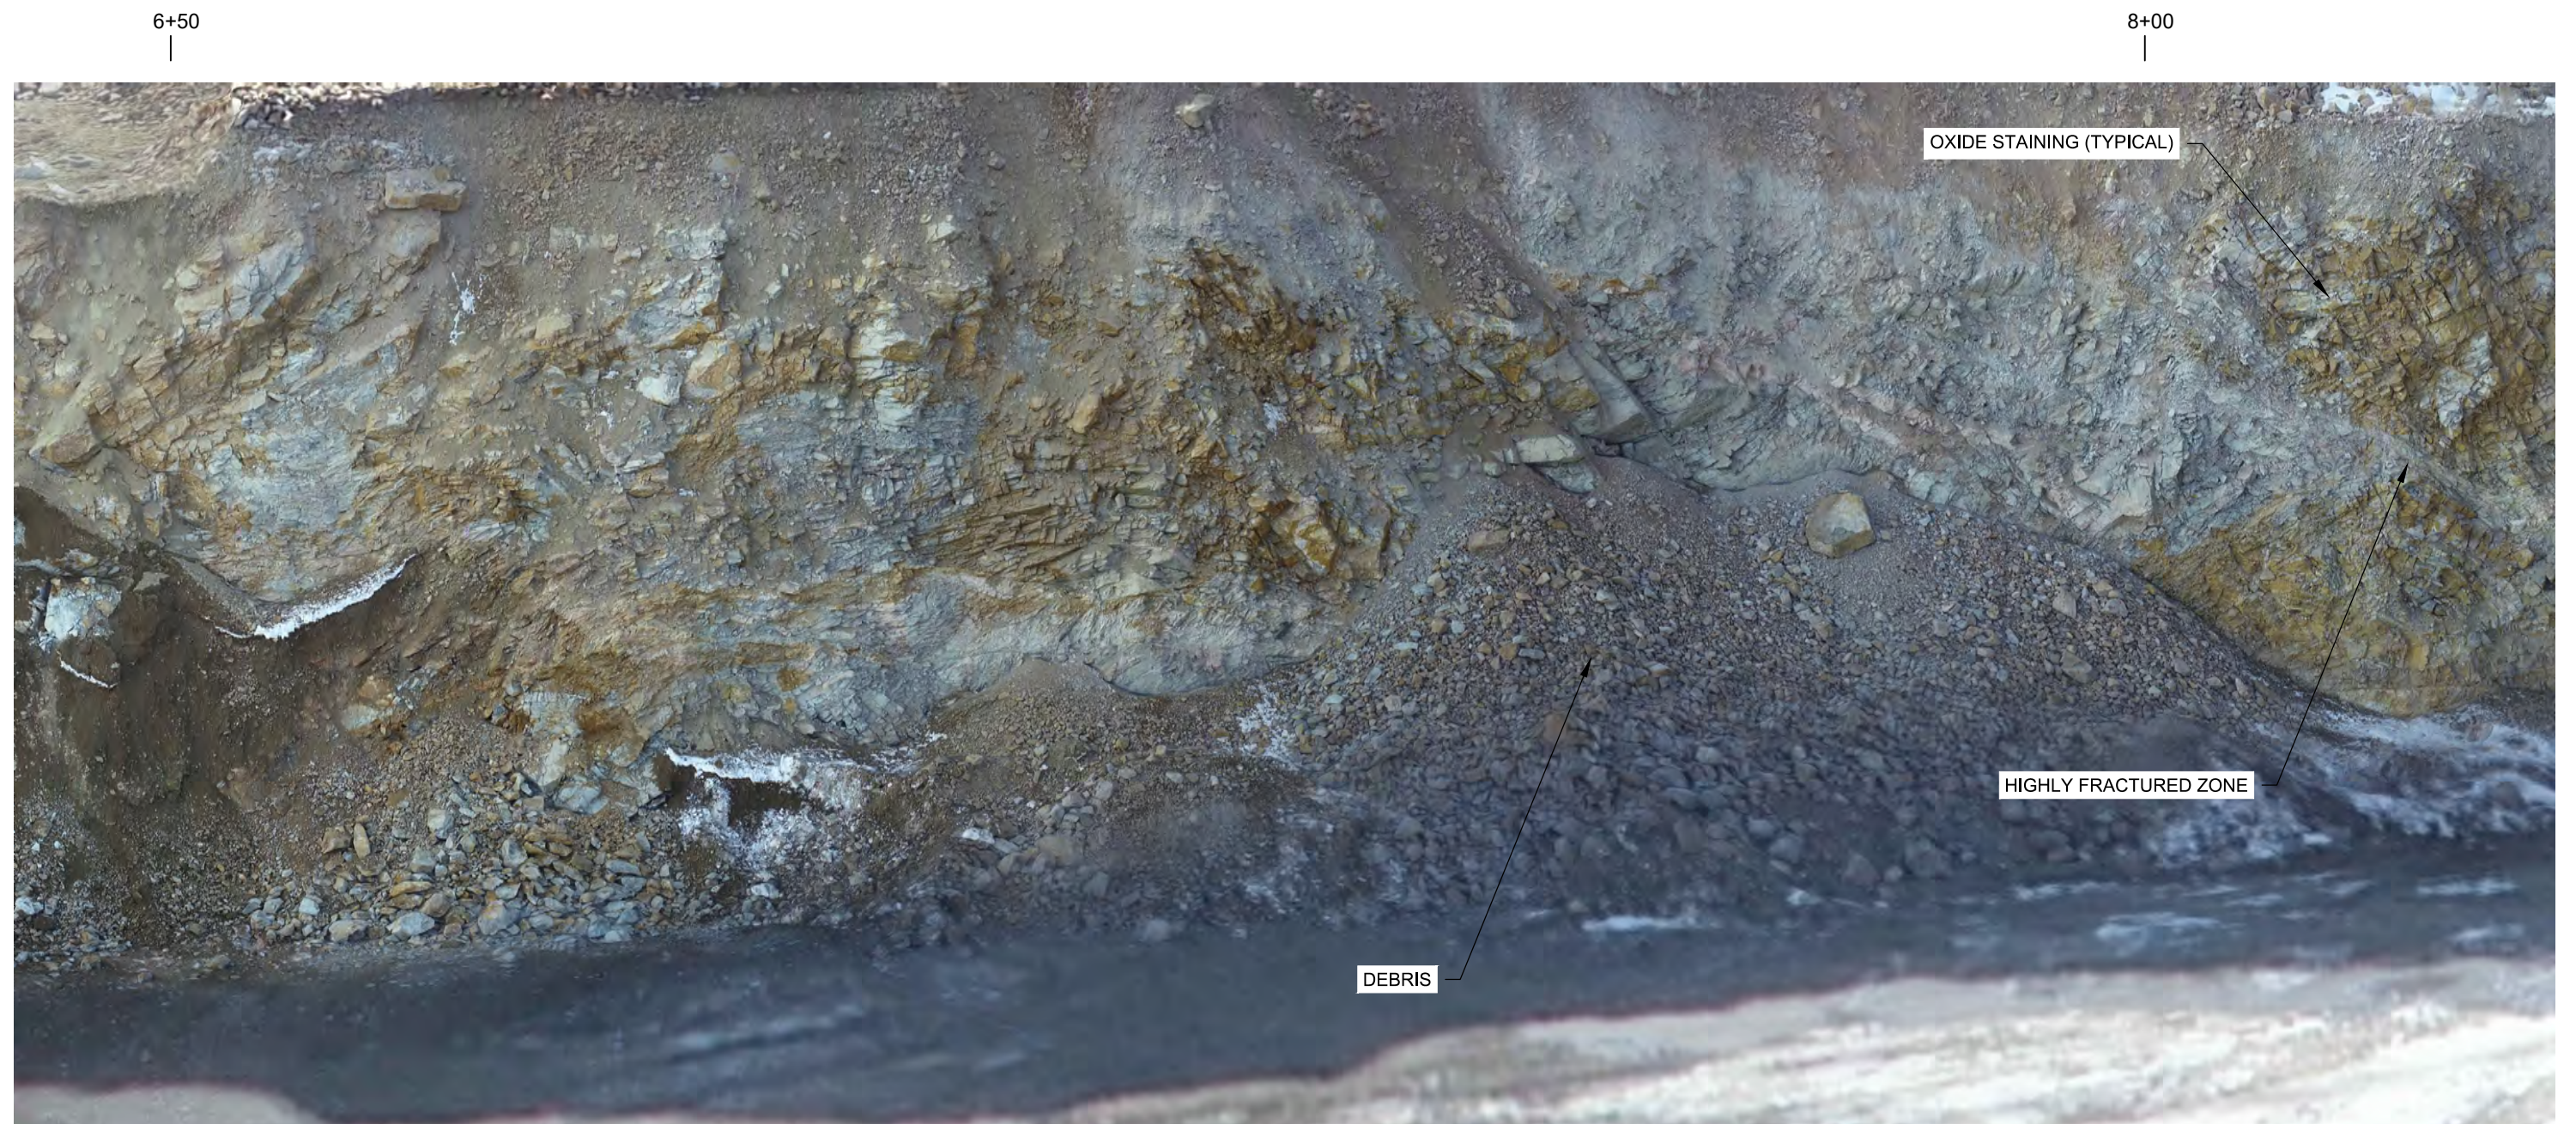
Figure 21

- Scanline E (Sta. 6+50 to Sta. 8+00) trended 240 degrees. The scanline was unmappable from about Sta. 7+00 to 8+00 on the bottom half of the highwall due to a debris pile resulting from uncontrolled blasting. Foliations exhibited a strike ranging from 102 to 125 degrees with dips ranging from 17 to 30 degrees. Two primary joint sets were evident. The first primary joint set exhibited an average strike of 196 degrees and an average dip of 64 degrees. The second primary joint set exhibited an average strike of 259 degrees and an average dip of 53 degrees. Widespread iron oxide staining was present throughout the entire scanline. The RMR classification is Poor to Fair. Scanline E is shown in Figure 21.

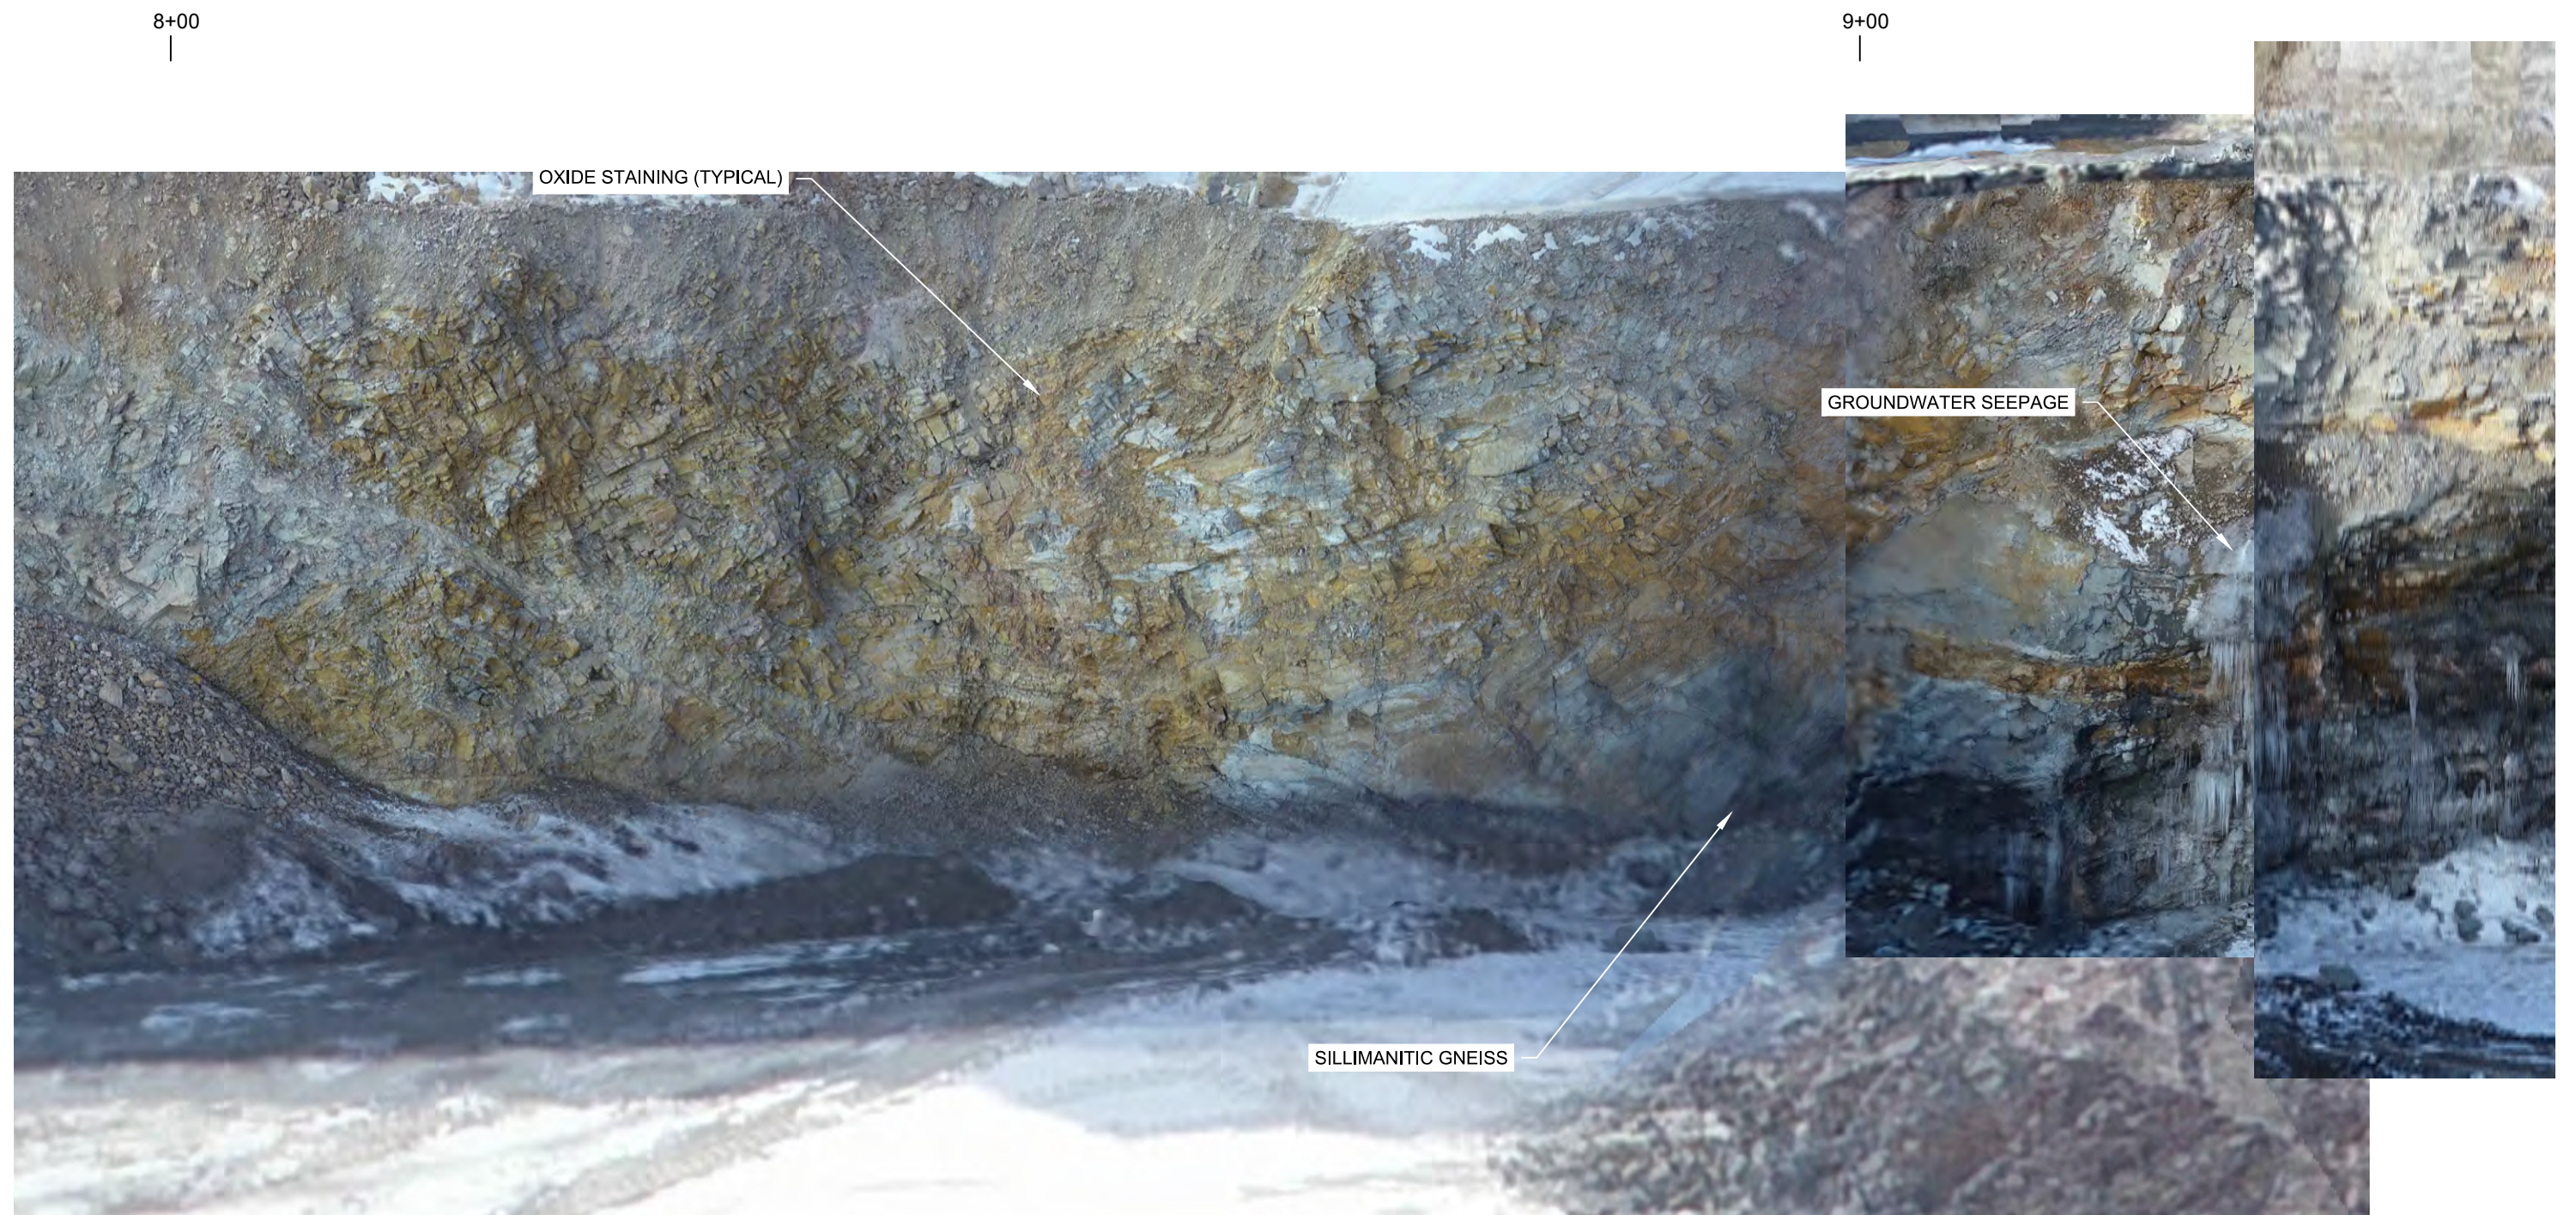
Figure 22

exhibited an average strike of 296 degrees and an average dip of 76 degrees. Widespread iron oxide staining was present. A localized area of sillimanitic gneiss was visible near the base of the highwall, at approximately Sta. 9+00, near the corner of the highwall. The RMR classification is Poor to Fair. Scanline F is shown in Figure 22.
