Geotechnical Addendum

2019 Annual Report

Aggregate Industries Morrison Quarry
Permit M-1973-021
Jefferson County, Colorado

December 2019
Project 1705051

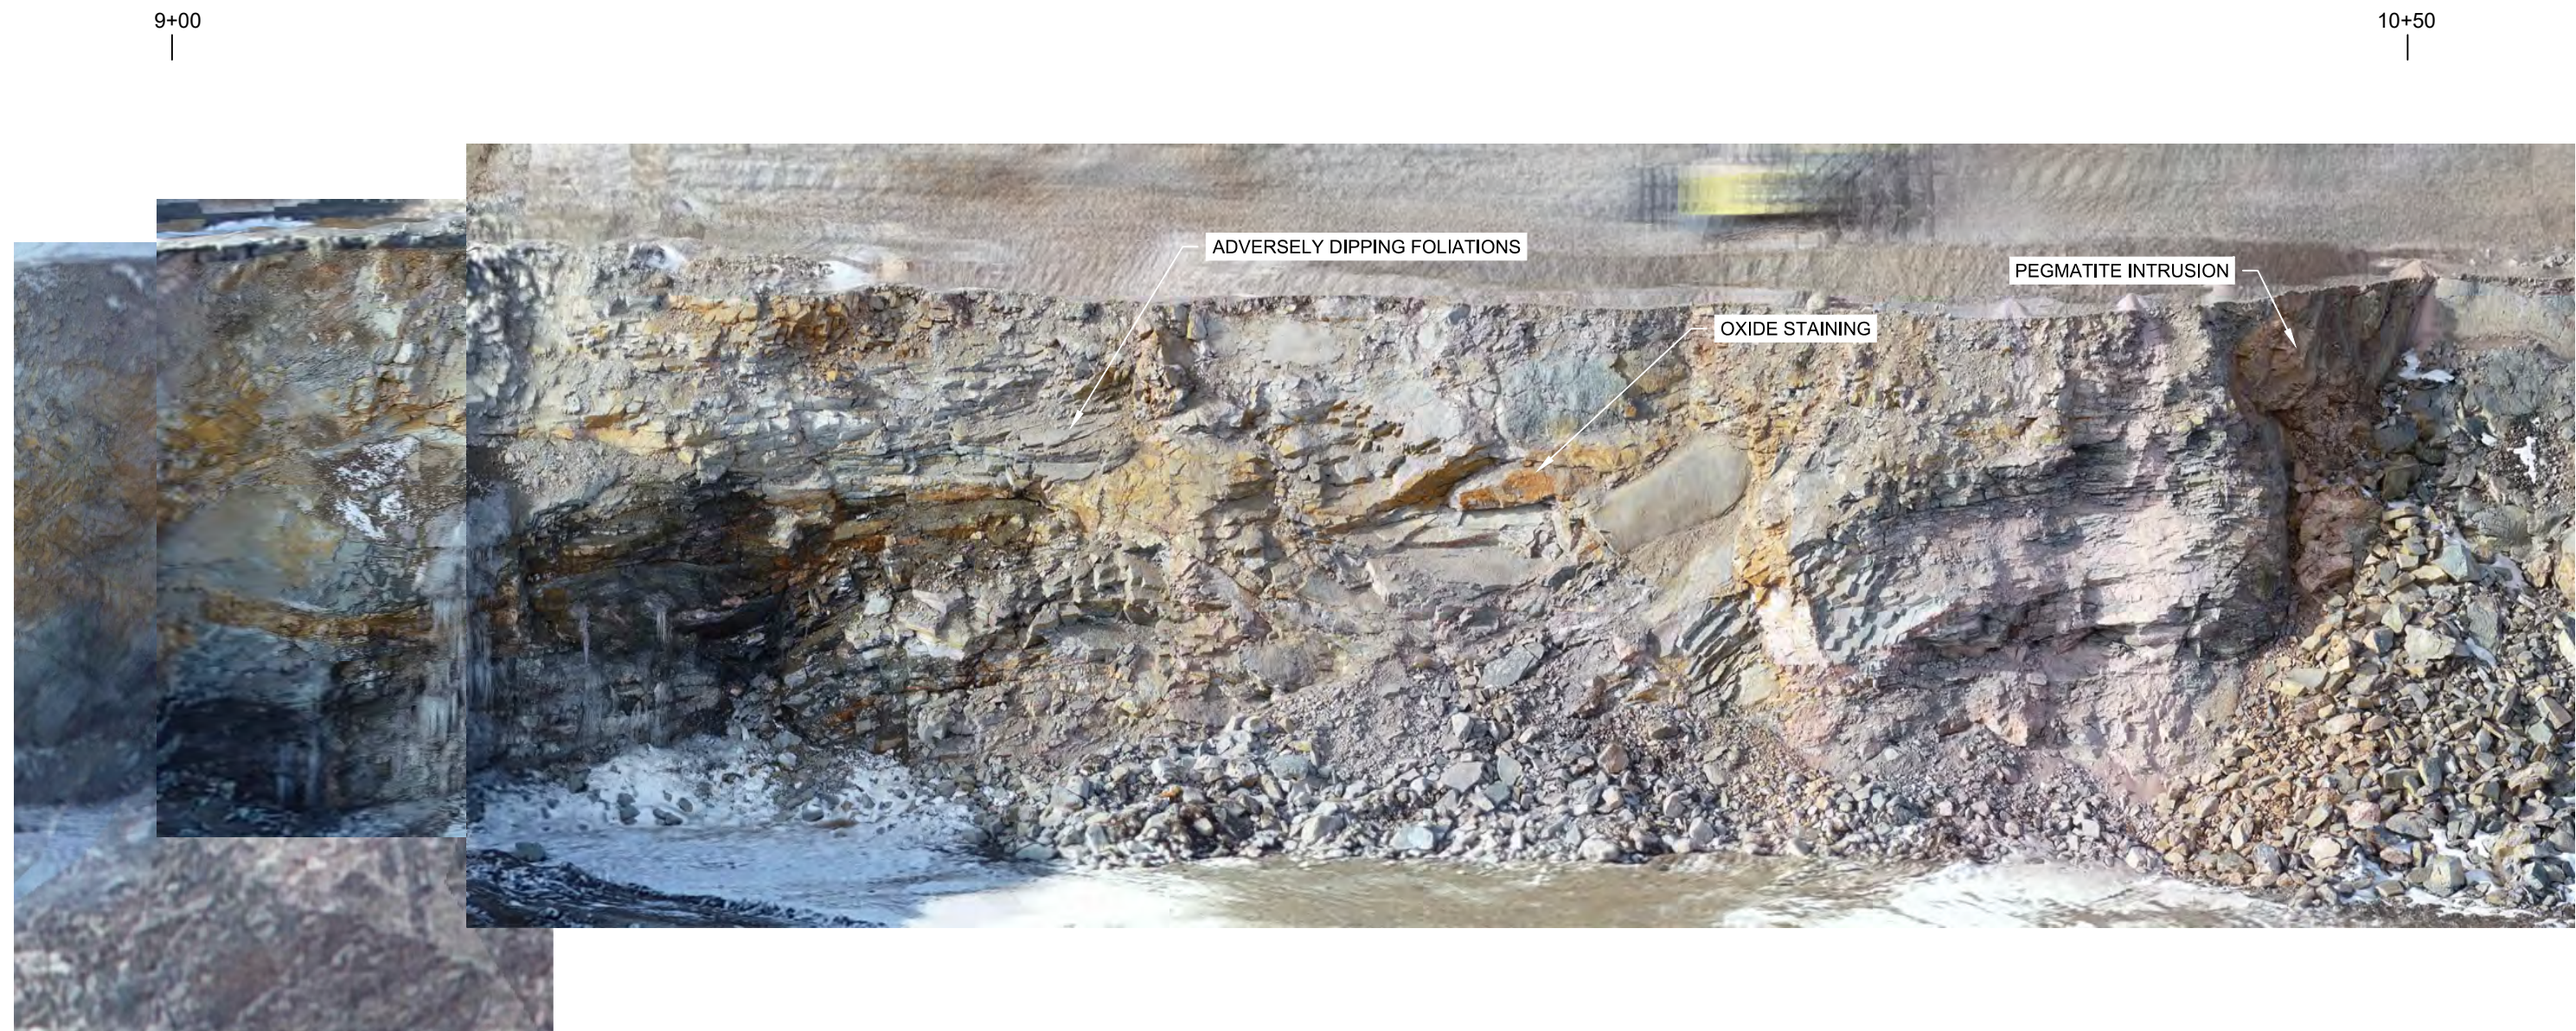
Morrison Quarry 2019 Annual Report DRMS Permit M-1973-021	<div data-bbox="2371 1755 2588 1858">   </div>	BENCH 6740 SCANLINE G
Aggregate Industries		
	Project 1705051	December 2019 Figure 23

- Scanline G (Sta. 9+00 to Sta. 10+50) trended 5 degrees. Foliations exhibited a strike ranging from 0 to 347 degrees with dips ranging from 4 to 90 degrees. Two primary joint sets were evident. The first set exhibited an average strike of 99 degrees and an average dip of 58 degrees. The second primary set exhibited an average strike of 226 degrees and an average dip of 76 degrees. Localized iron oxide staining was present in the middle to lower sections of the scanline. Groundwater seepage was present from the base of the wall to a height of about two-thirds up the highwall, from approximately Sta. 9+00 to 9+25. The RMR classification is Poor to Fair. Scanline G is shown in Figure 23.

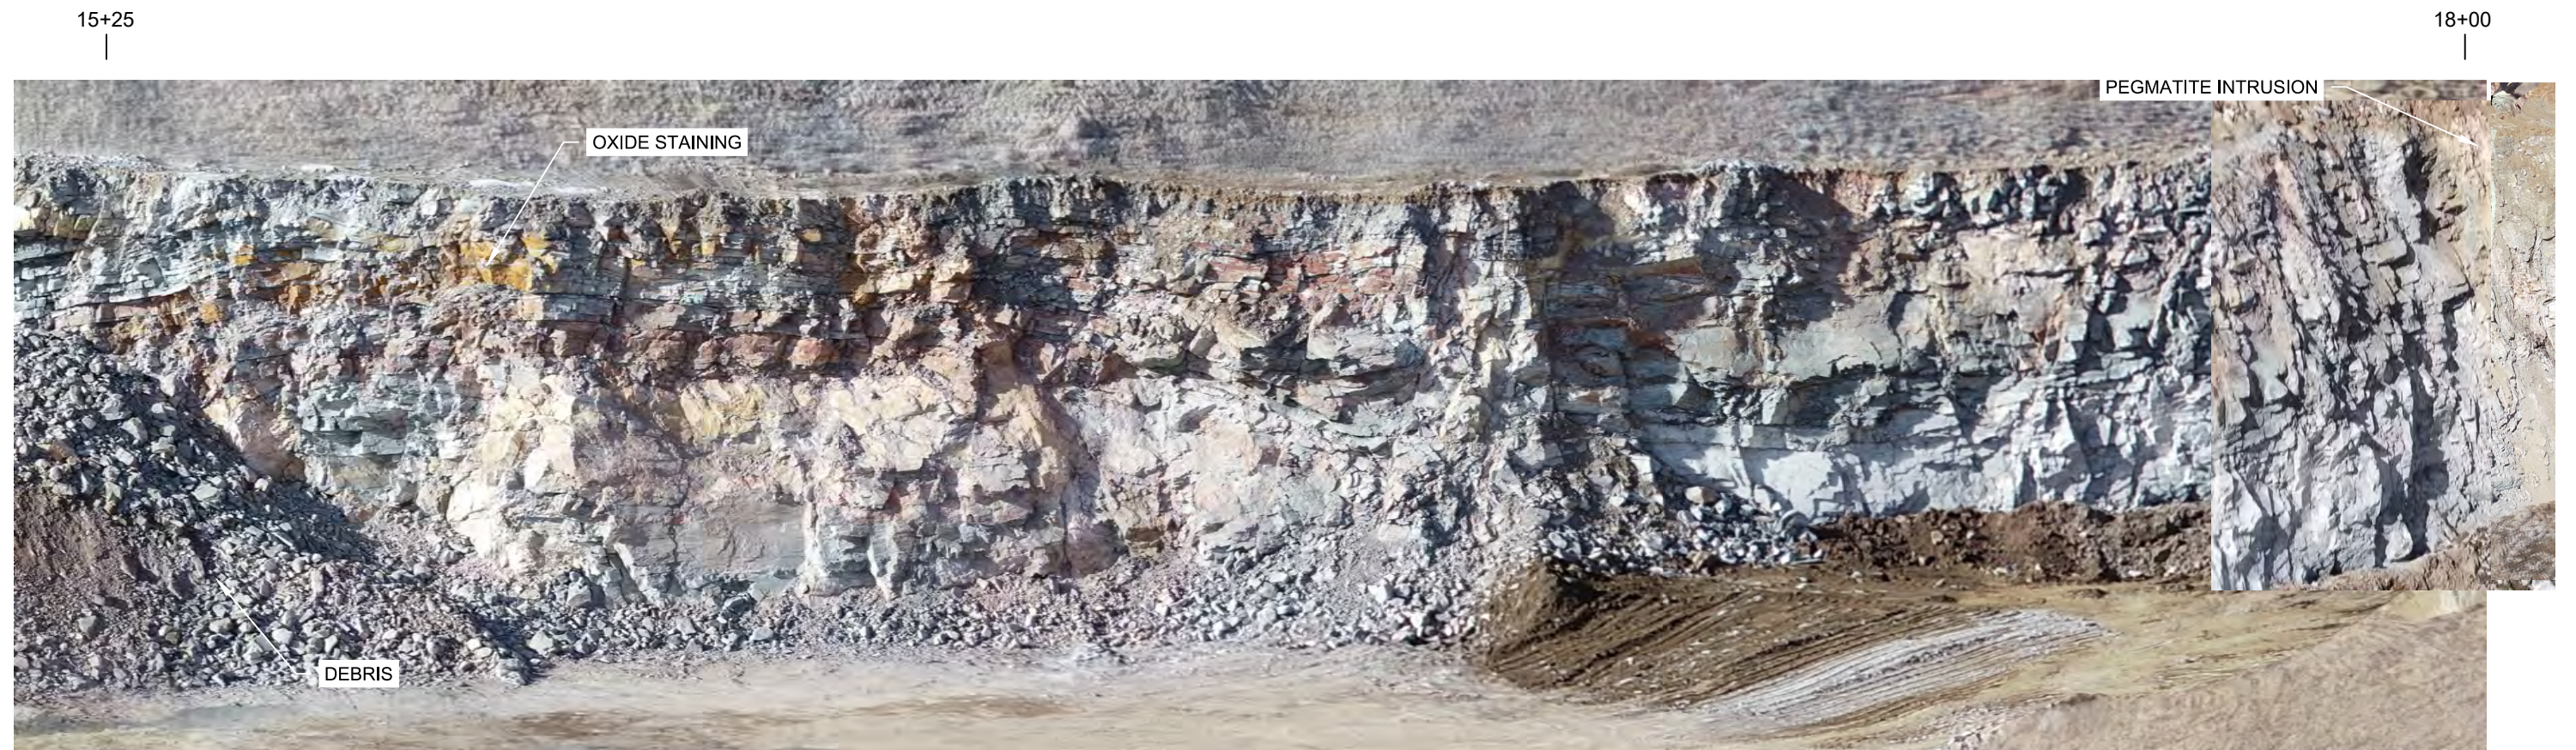
Figure 25

- Scanline I (Sta. 15+25 to Sta. 18+00) trended 10 degrees. Foliations exhibited a strike ranging from 153 to 182 degrees with dips ranging from 12 to 24 degrees. Two primary joint sets and a secondary joint set were evident. The first primary set exhibited an average strike of 250 degrees and an average dip of 69 degrees. The second primary set exhibited an average strike of 202 degrees and an average dip of 75 degrees. The secondary joint set exhibited an average strike of 229 degrees and an average dip of 83 degrees. Localized iron oxide staining was present near the top of the highwall. The RMR classification is Poor to Good. Scanline I is shown in Figure 25.

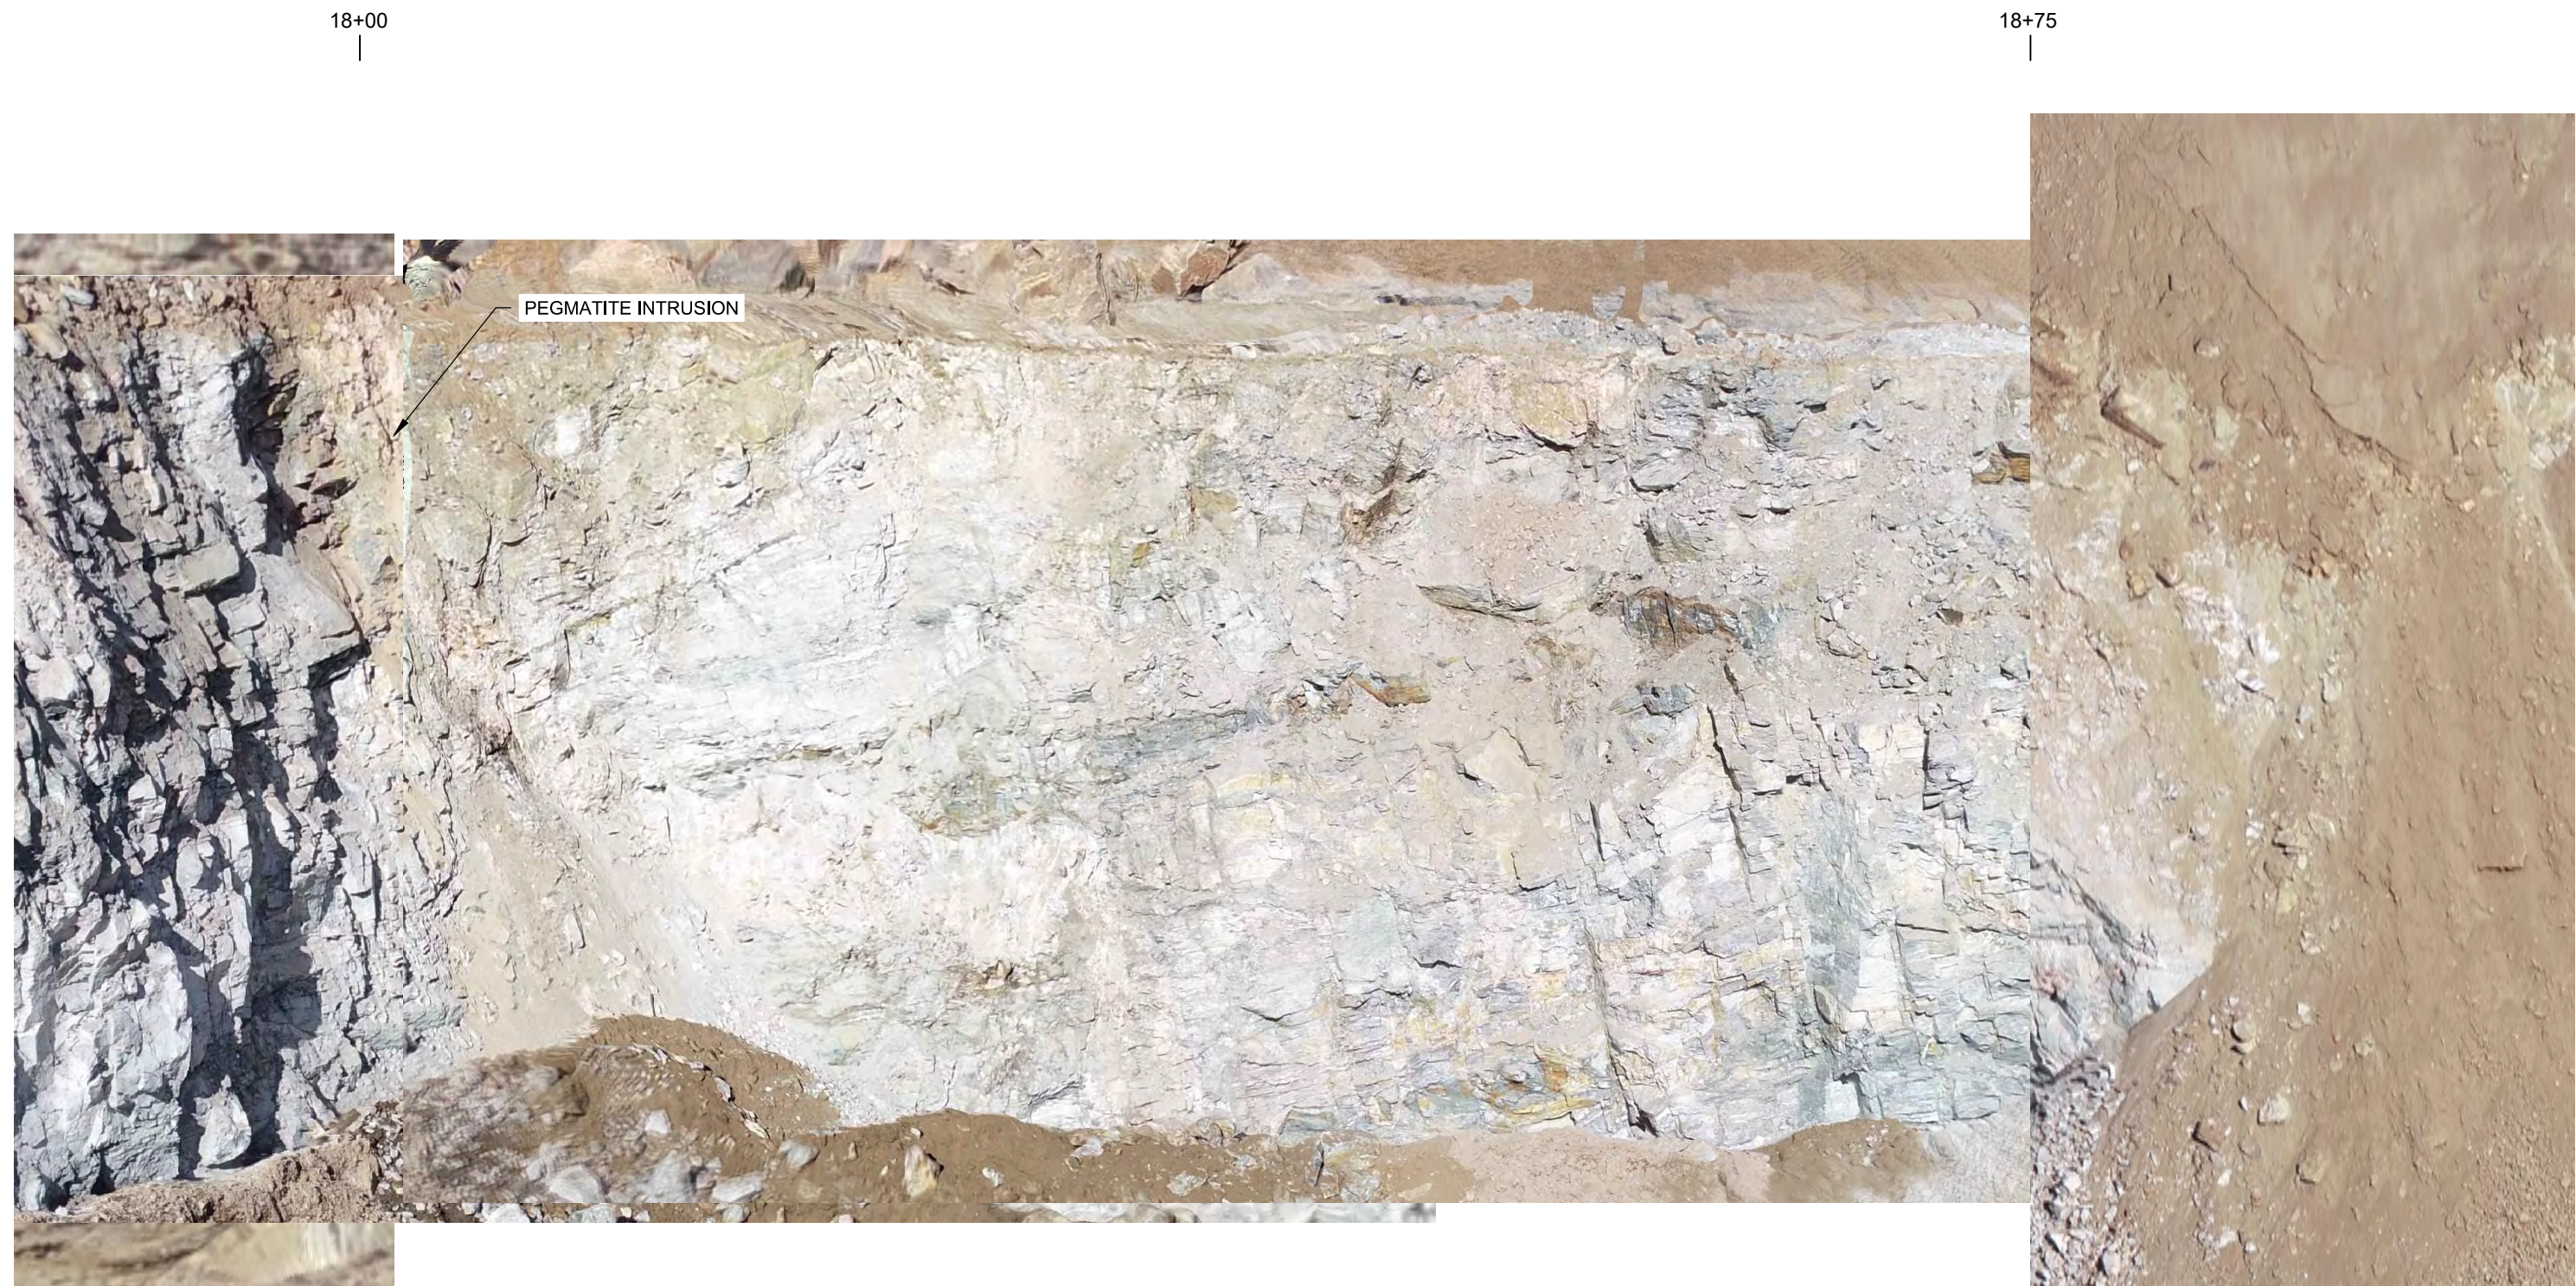
- Scanline J (Sta. 18+00 to Sta. 18+75) trended 75 degrees. Foliations exhibited a strike ranging from 102 to 242 degrees with dips ranging from 20 to 41 degrees. Two primary joint sets were evident. The first primary set exhibited an average strike of 338 degrees and an average dip of 74 degrees. The second set exhibited an average strike of 95 degrees and an average dip of 81 degrees. Little to no iron oxide staining was present. A pegmatite intrusion was visible in the highwall at approximately Sta. 18+00, near the corner of the highwall. In general, the pegmatite intrusion separated more fractured rock on the south from more massive

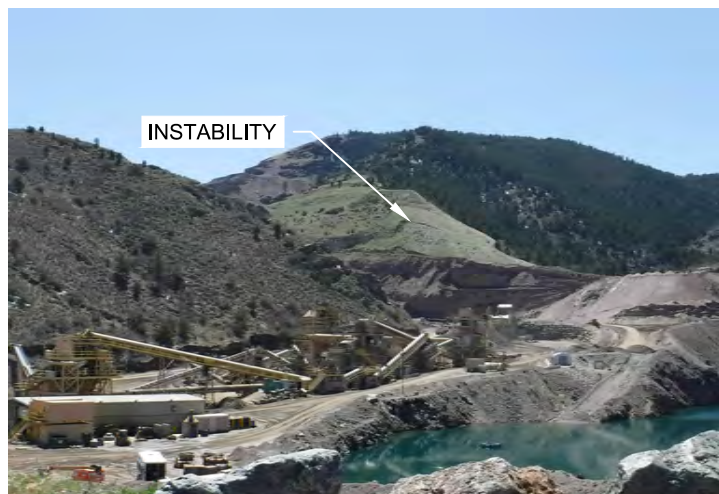
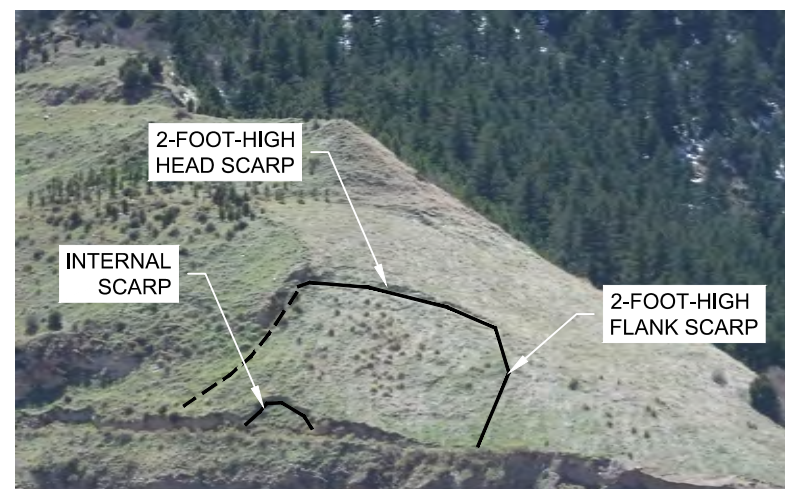
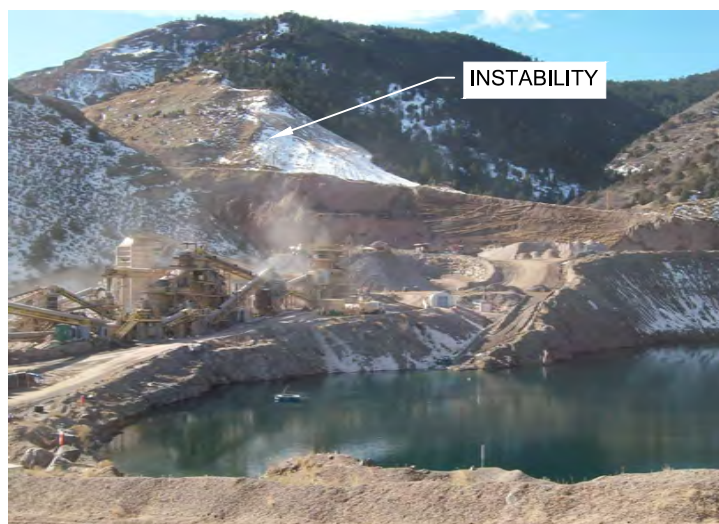
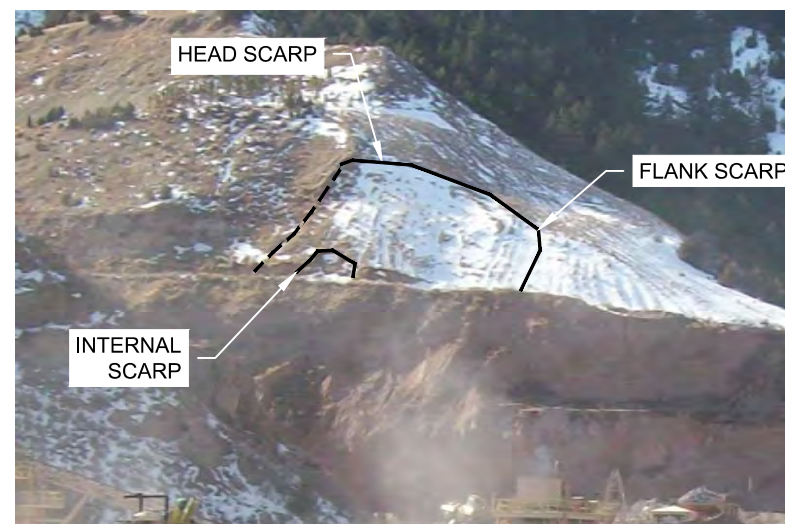
During a site visit in June 2018, GEI noted a scarp on a reclaimed slope above the access road west of the Central Quarry. The scarp is visible from the mine office (Figure 29). When the area was originally inspected in June 2018, a 2-foot-high head scarp and flank scarp were observed, which indicated movement of a section of slope approximately 150 feet wide between approximate El. 6675 and 6725. It is not known when the initial movement occurred. The reclaimed slope was covered in snow during the 2019 Annual Report inspection, and the scarp was not observed.

The instability previously observed in the Central Quarry on the reclaimed slope was covered with snow during the December 2020 inspection and not visible. The unstable slope is limited to surficial deposits and is not considered to present a long-term stability risk to the Central Quarry. Infiltration caused by heavy precipitation or snowmelt could be sufficient to mobilize the slide in the future. AI mine staff should monitor the slope for changing conditions, especially after heavy precipitation. GEI recommends performing a detailed slope stability evaluation and ongoing monitoring of groundwater levels in the area near the slide.
