MINERALS PROGRAM INSPECTION REPORT
PHONE: (303) 866-3567

MINE NAME: Climax Mine	MINE/PROSPECTING ID#: M-1977-493	MINERAL: Molybdenum	COUNTY: Summit
INSPECTION TYPE: Monitoring	INSPECTOR(S): Lucas West	INSP. DATE: December 18, 2019	INSP. TIME: 10:00
OPERATOR: Climax Molybdenum Company	OPERATOR REPRESENTATIVE: Diana Kelts, Alex Ungers	TYPE OF OPERATION: 112d-3 - Designated Mining Operation	
REASON FOR INSPECTION: Normal I&E Program	BOND CALCULATION TYPE: Complete Bond	BOND AMOUNT: \$91,011,850.00	
DATE OF COMPLAINT: NA	POST INSP. CONTACTS: None	JOINT INSP. AGENCY: None	
WEATHER: Clear	INSPECTOR'S SIGNATURE:

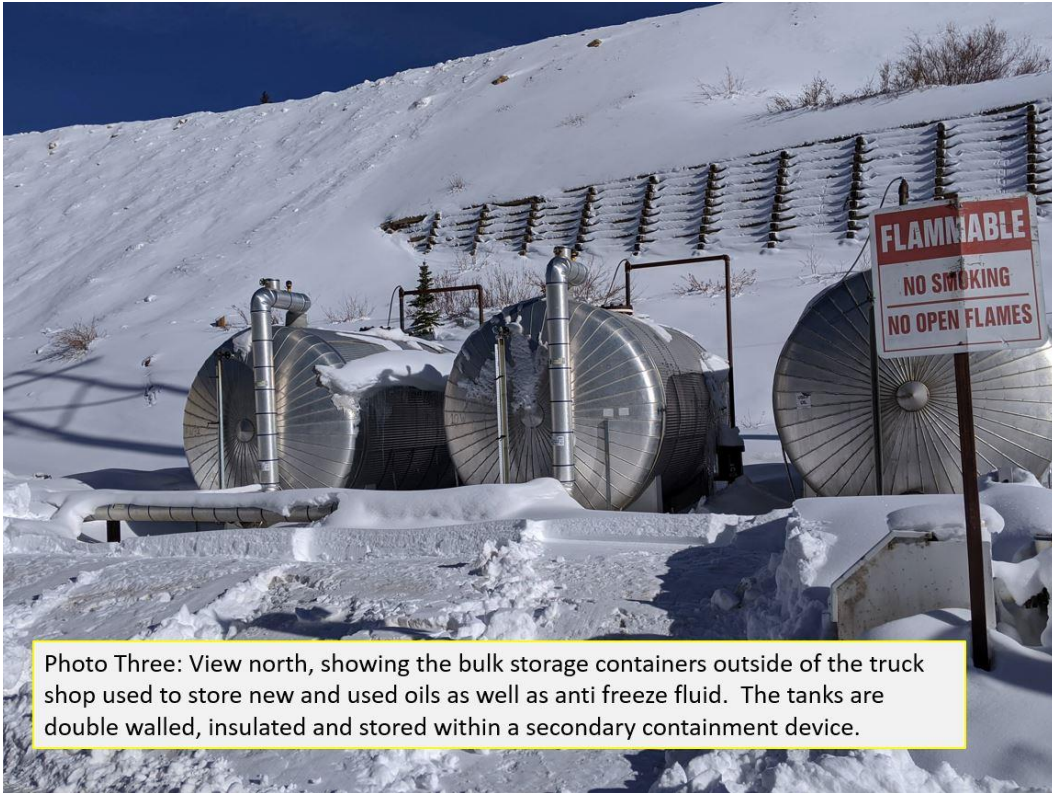
Photo Three: View north, showing the bulk storage containers outside of the truck shop used to store new and used oils as well as anti freeze fluid. The tanks are double walled, insulated and stored within a secondary containment device.

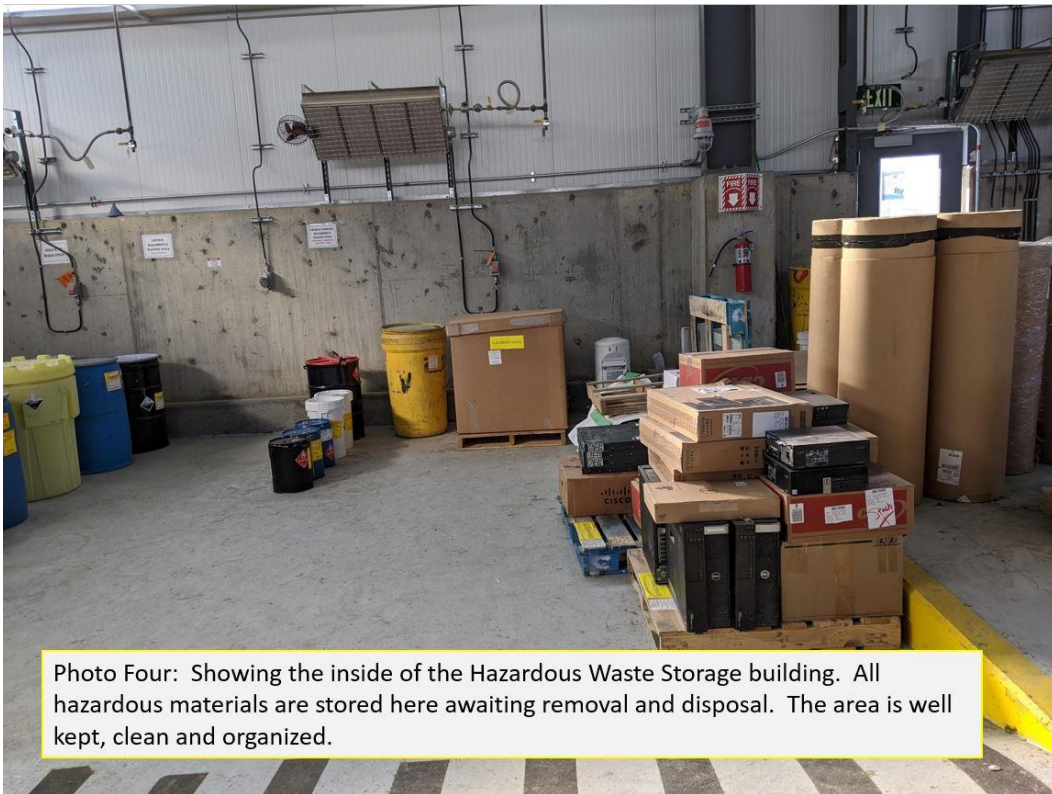
Hazardous Waste Storage Building: The Climax Mine facility is registered as a small quantity generator in compliance with all rules and regulations under the Resource Conservations and Recovery Act (RCRA). All hazardous waste that is generated by the site is stored in the Hazardous Waste Storage Building. The Hazardous Waste Storage Facility is a small building located near the Main Building on site that includes an internal secondary containment system. All manner of hazardous materials are stored there for disposal including used oils, oily rags, various electronics and other materials that are regulated as hazardous materials. The building was constructed in a way that the storage area acts as secondary containment for any and all items stored there. The storage area can be seen in Photo Four. All materials being stored in the facility are well kept and organized. No problems or possible violations were observed in this area.

Photo Four: Showing the inside of the Hazardous Waste Storage building. All hazardous materials are stored here awaiting removal and disposal. The area is well kept, clean and organized.

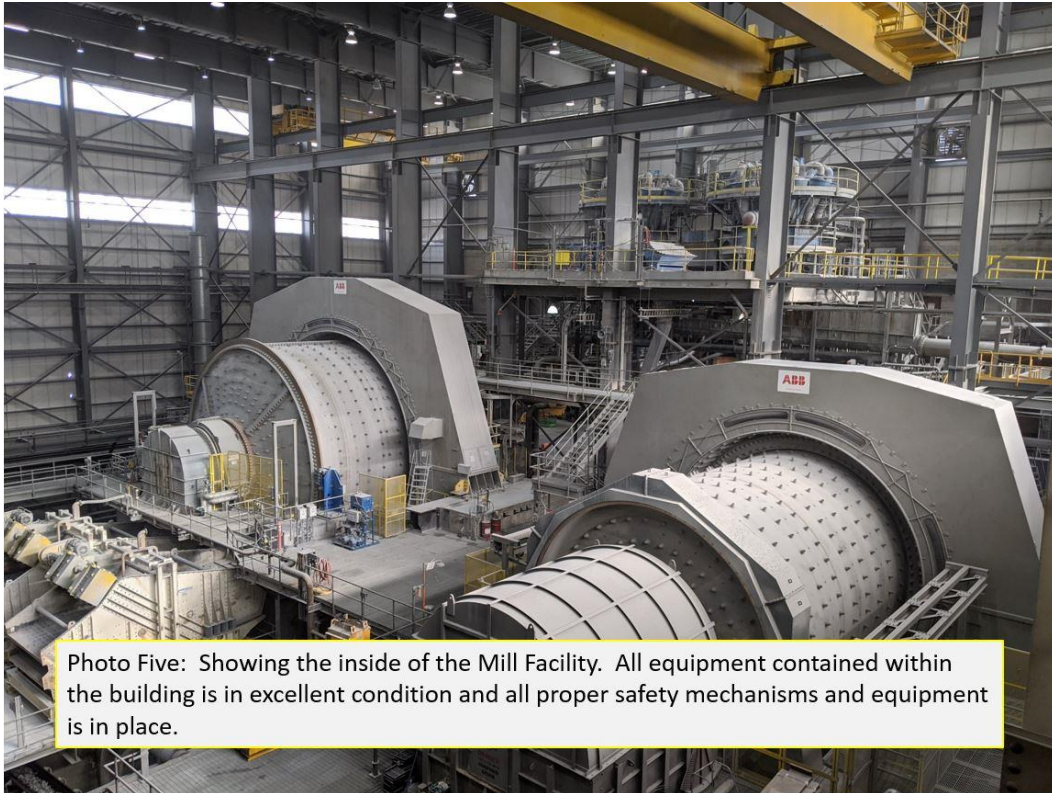
Mill Facility: The Mill Facility, including the Mill Lube Room was inspected. The flow of material was followed through the Mill Facility from the Sag Mill through the Flotation Circuits and to packaging and storage areas of the concentrate. All conveyors and equipment observed in operation during the inspection were in good condition and appeared to be functioning as designed. No signs of leakage of hazardous materials or spills were observed within the facility. Safety equipment as well as first aid and spill kits was observed at several locations throughout the facility and appeared to be in good condition. The Mill Facility as a whole is in excellent condition and in good working order and can be seen in Photo Five. The Mill Lube Room is a small room located within the Mill Facility that houses the lubricant pumps for the Sag Mill, Ball Mill and other heavy equipment used in the milling process and can be seen in Photo Six. Also stored in the Mill Lube Room are various other lubricants and oils used throughout the milling process. All materials stored in the room are stored with proper secondary containment. The room is well organized and is in good condition.

Photo Five: Showing the inside of the Mill Facility. All equipment contained within the building is in excellent condition and all proper safety mechanisms and equipment is in place.

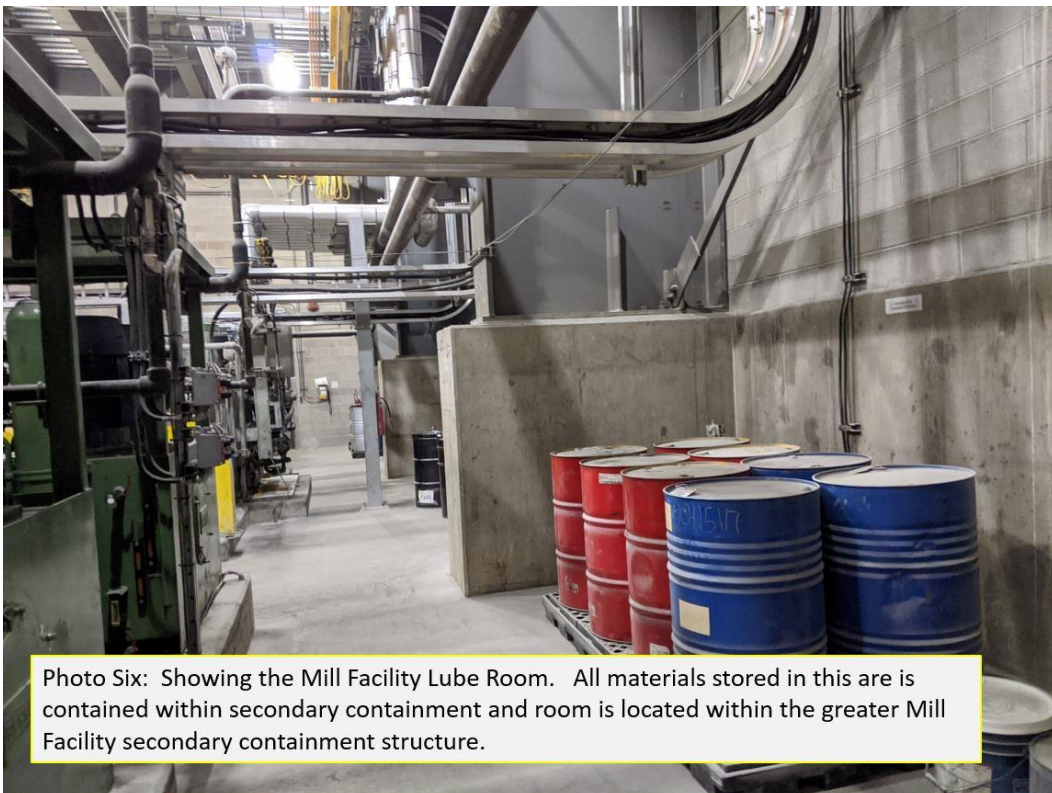
Photo Six: Showing the Mill Facility Lube Room. All materials stored in this are is contained within secondary containment and room is located within the greater Mill Facility secondary containment structure.
