**MINERALS PROGRAM INSPECTION REPORT**  
**PHONE: (303) 866-3567**

<b>MINE NAME:</b> Western Sugar Project	<b>MINE/PROSPECTING ID#:</b> M-2010-049	<b>MINERAL:</b> Gravel and sand	<b>COUNTY:</b> Weld
<b>INSPECTION TYPE:</b> Monitoring	<b>INSPECTOR(S):</b> Peter Hays	<b>INSP. DATE:</b> December 12, 2019	<b>INSP. TIME:</b> 10:00
<b>OPERATOR:</b> Varra Companies, Inc.	<b>OPERATOR REPRESENTATIVE:</b> Brad Janes	<b>TYPE OF OPERATION:</b> 112c - Construction Regular Operation	
<b>REASON FOR INSPECTION:</b> Normal I&E Program	<b>BOND CALCULATION TYPE:</b> Partial Bond	<b>BOND AMOUNT:</b> \$309,000.00	
<b>DATE OF COMPLAINT:</b> NA	<b>POST INSP. CONTACTS:</b> None	<b>JOINT INSP. AGENCY:</b> None	
<b>WEATHER:</b> Clear	<b>INSPECTOR'S SIGNATURE:</b>

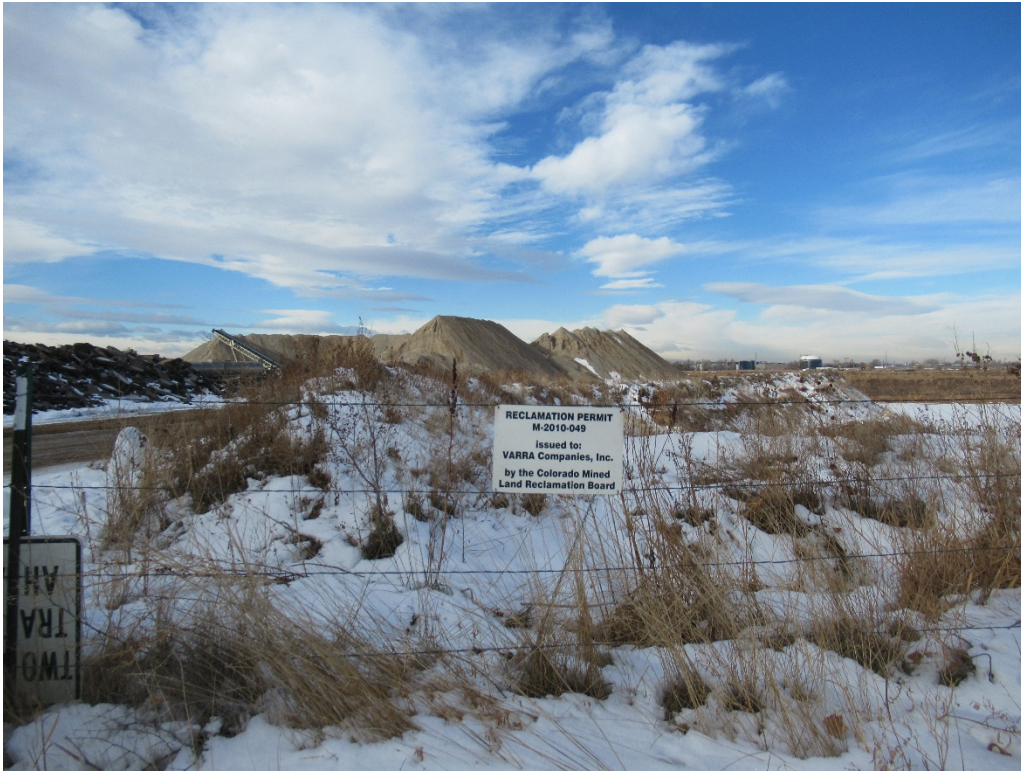
The required permit boundaries markers and mine sign were observed as required by Rule 3.1.12. Photographs taken during the inspection are attached.

Western Sugar mine sign

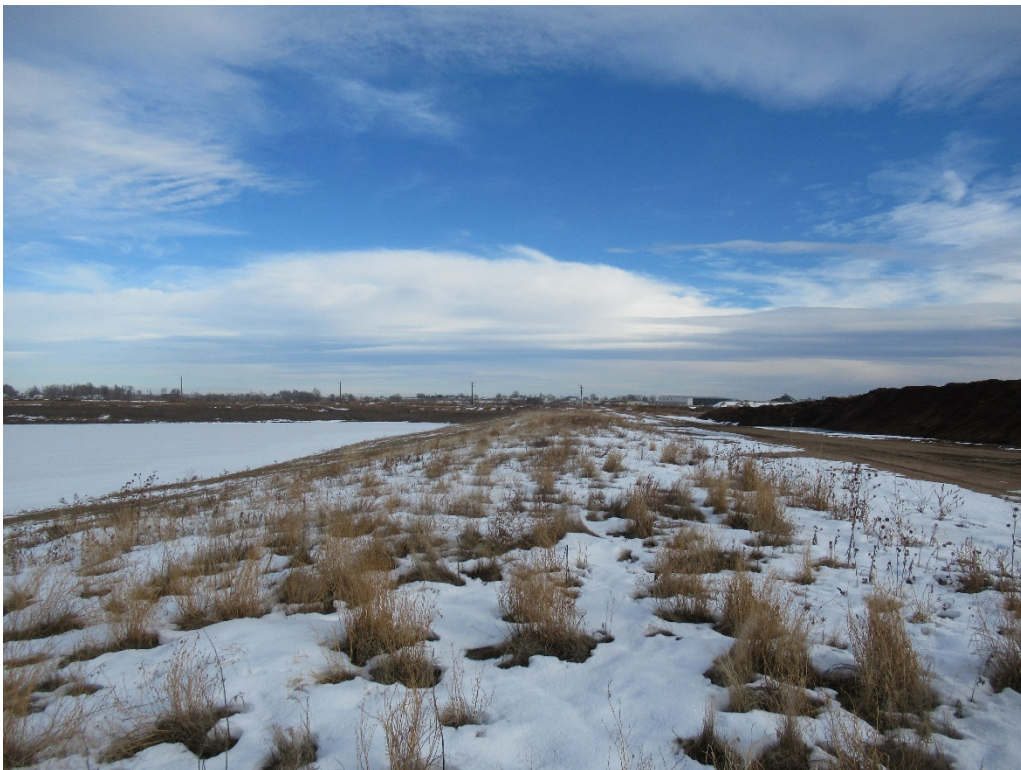
View of the east shoreline of Tract A from the south end of Tract A looking north

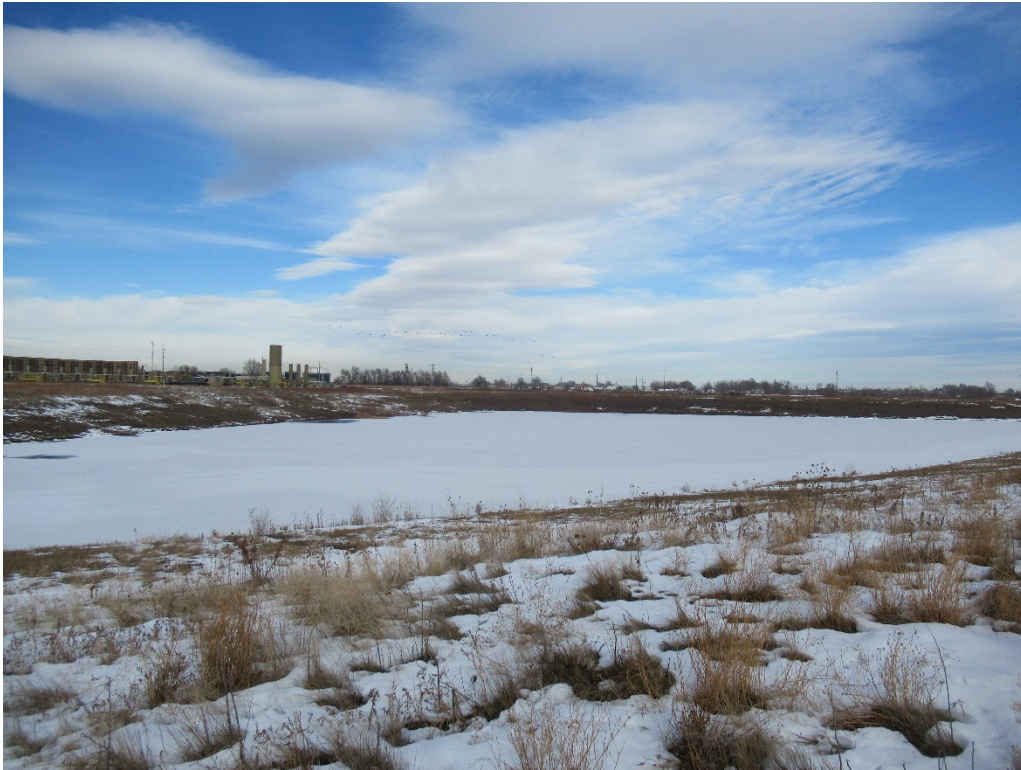
A processing plant and product stockpiles were observed in the tract during the inspection. The concrete batch plant remains in the southwest corner of the tract. Mining excavation has begun along the eastern portion of the tract and will progress towards the west. The upland area located east of the tract was being used for concrete and asphalt recycling. Stockpiles of concrete and asphalt were observed during the inspection. A large stockpile of topsoil was located along the western boundary of the tract adjacent to Tract B. Stockpiles of imported rip rap were located along the southern boundary of the tract. The rip rap will be used to construct the required spillways located in the northwest corner of Tract C and between Tracts C and D during final reclamation.

View of Tract A from the south end of Tract A looking northwest

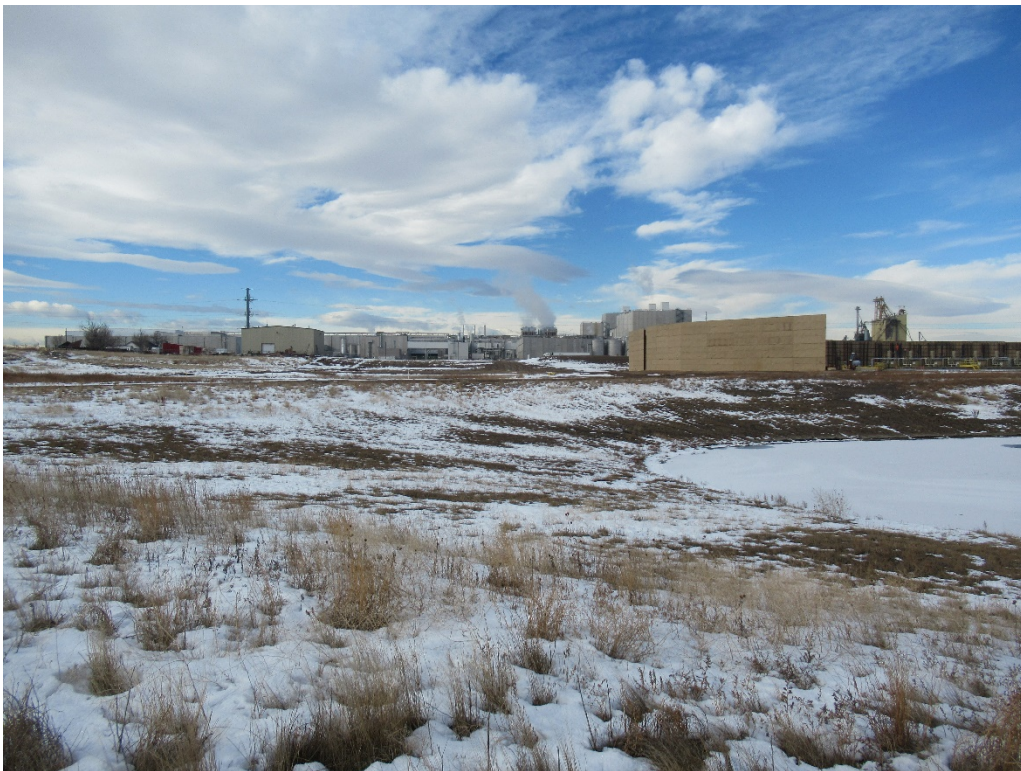
View of the south shoreline of Tract A from the south end of Tract A looking west

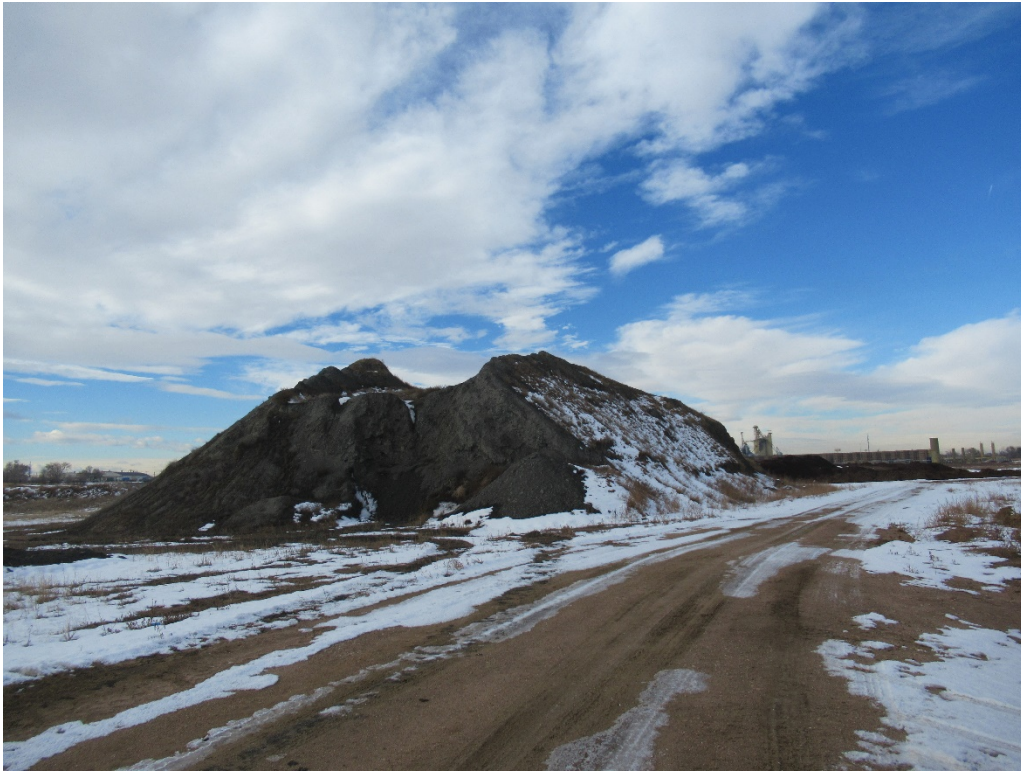
Topsoil stockpile located in Tract A adjacent to Tract B

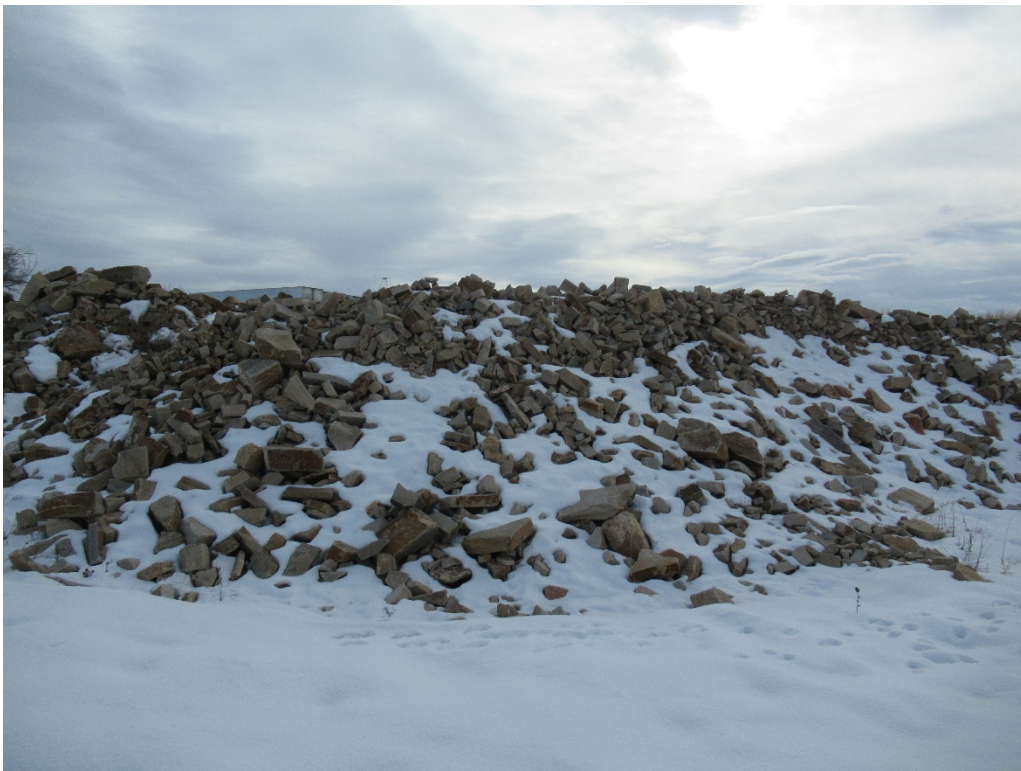
Rip Rap stockpile located along the south boundary of Tract A

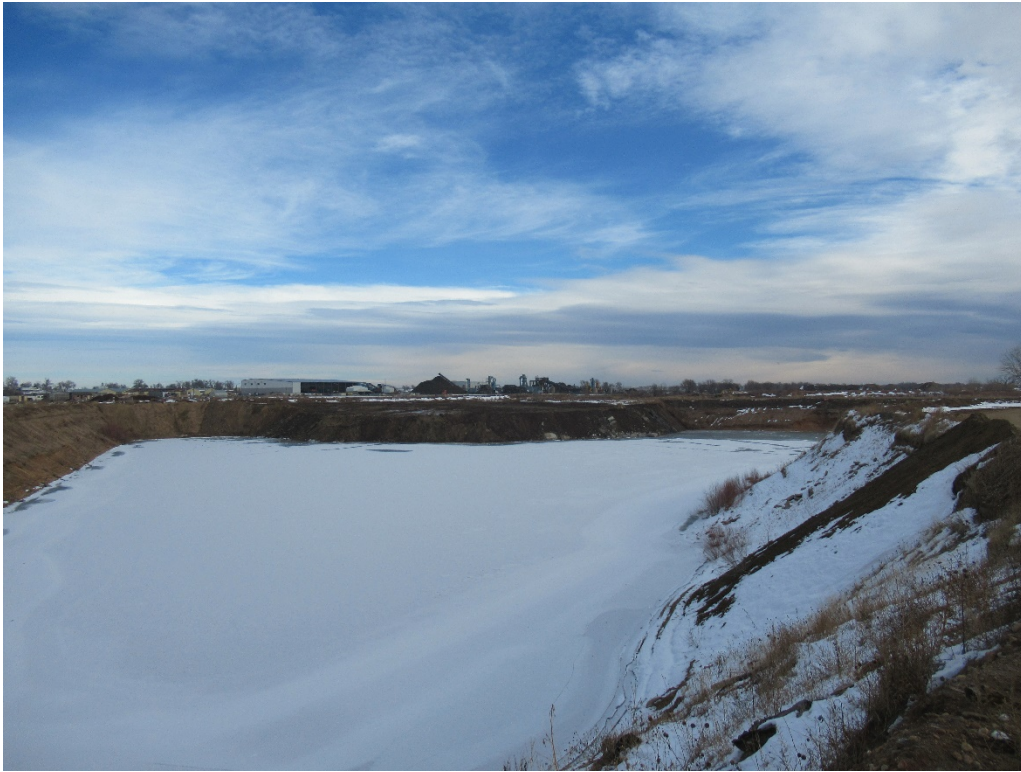
Mining excavation in Tract D is complete. The north side of the tract was backfilled with imported material. The Operator submitted a technical revision (TR-05) on November 27, 2018 to backfill the mined 1.5H:1V slope in the upper 32 feet of the perimeter highwall of the tract to 3H:1V. The Operator submitted an inert fill notice in accordance with Rule 3.1.5(9) as part of the original and amendment (AM-01) permit applications. The tract was approximately half full of water at the time of the inspection.

View of Tact D and north shoreline backfill operation from the southwest corner of Tract D looking north

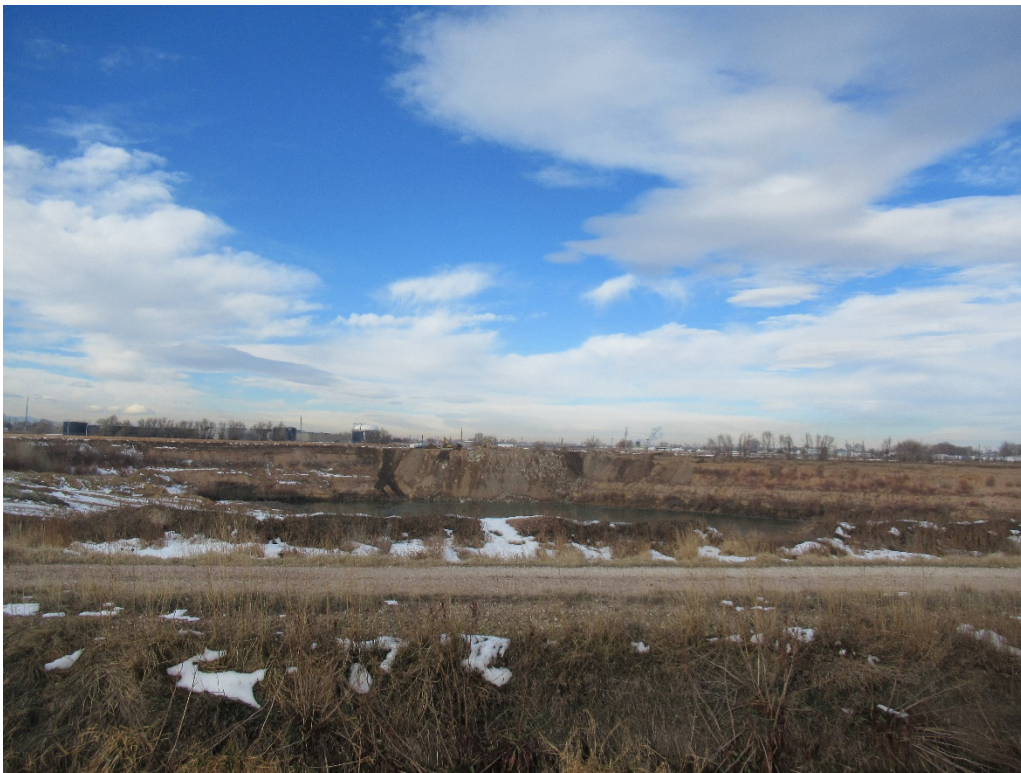
Mining excavation in Tract C is complete. The northwest corner of the tract was actively being backfilled with imported material. The Operator submitted a technical revision (TR-05) on November 27, 2018 to backfill the mined 1.75H:1V slope in the upper 35.5 feet of the perimeter highwall along the north and east sides of the tract to 3H:1V. The Operator submitted an inert fill notice in accordance with Rule 3.1.5(9) as part of the original and amendment (AM-01) permit applications. The depth of the mining excavation was estimated at 50 feet.

View of Tact C and northwest shoreline backfill operation from the south side of Tract C looking northwest

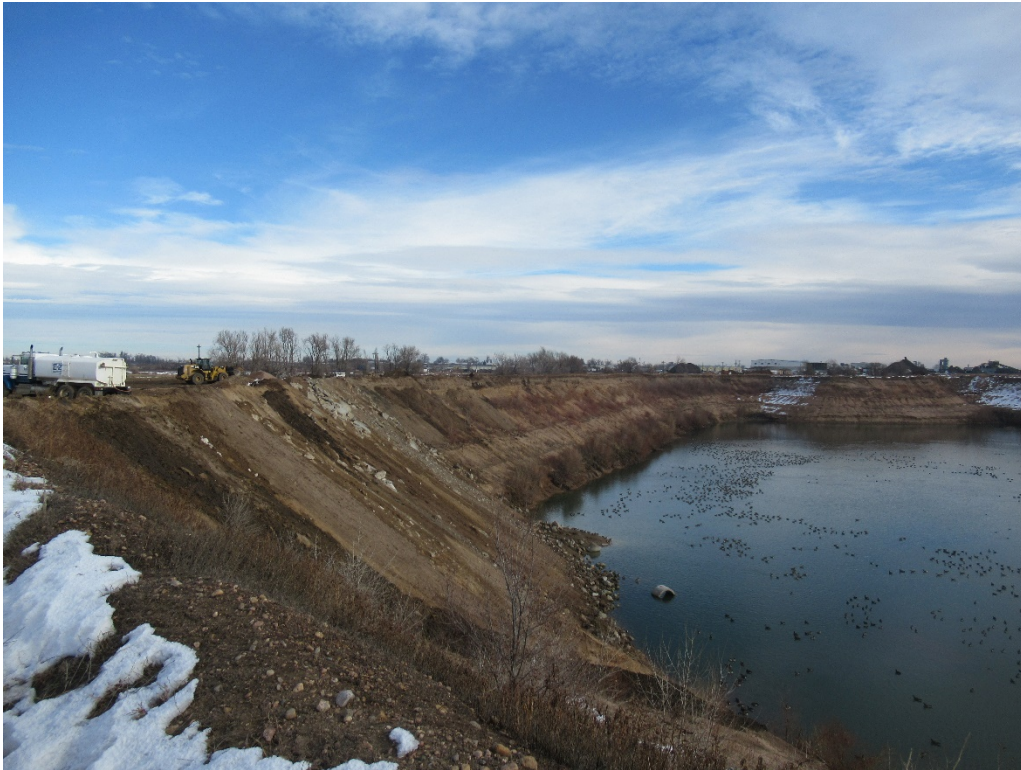
View of the backfill operation in Tract C from the northwest corner of Tract C looking east

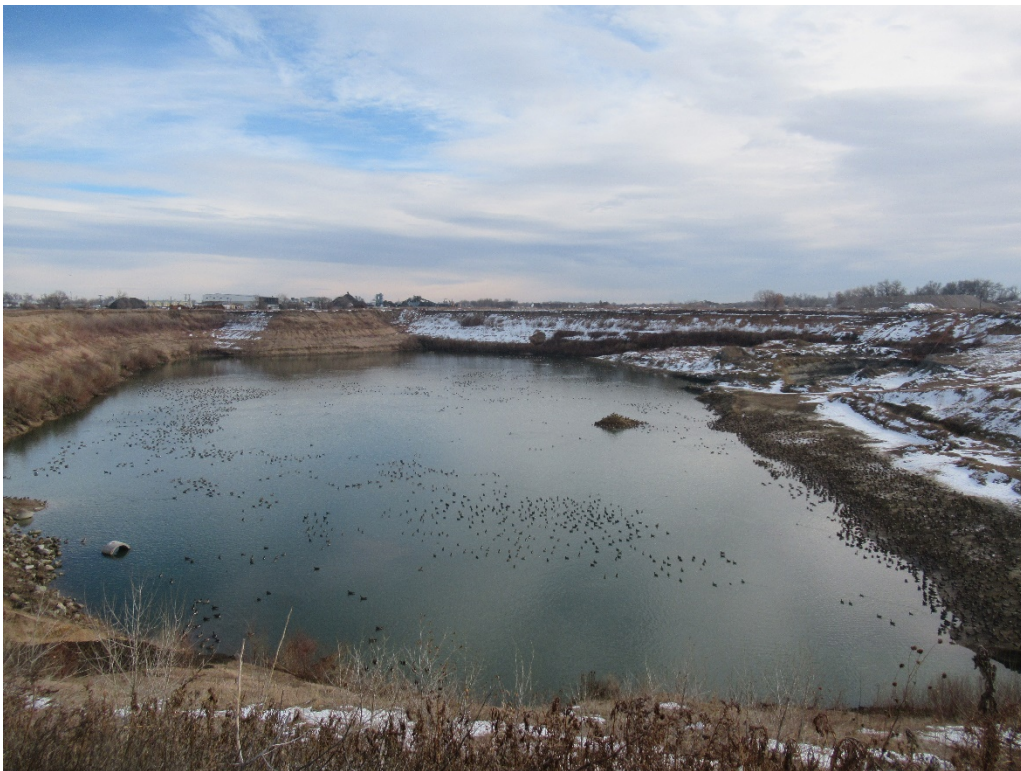
View of Tract C from the west shoreline looking east

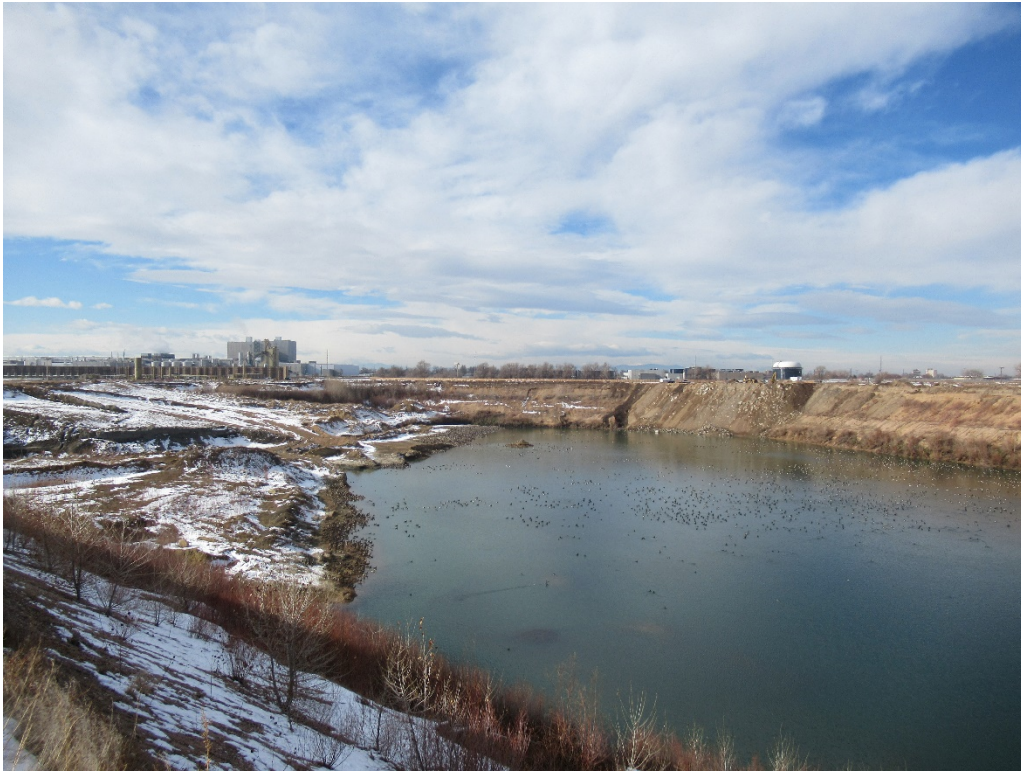
View of Tract C from the east shoreline looking west

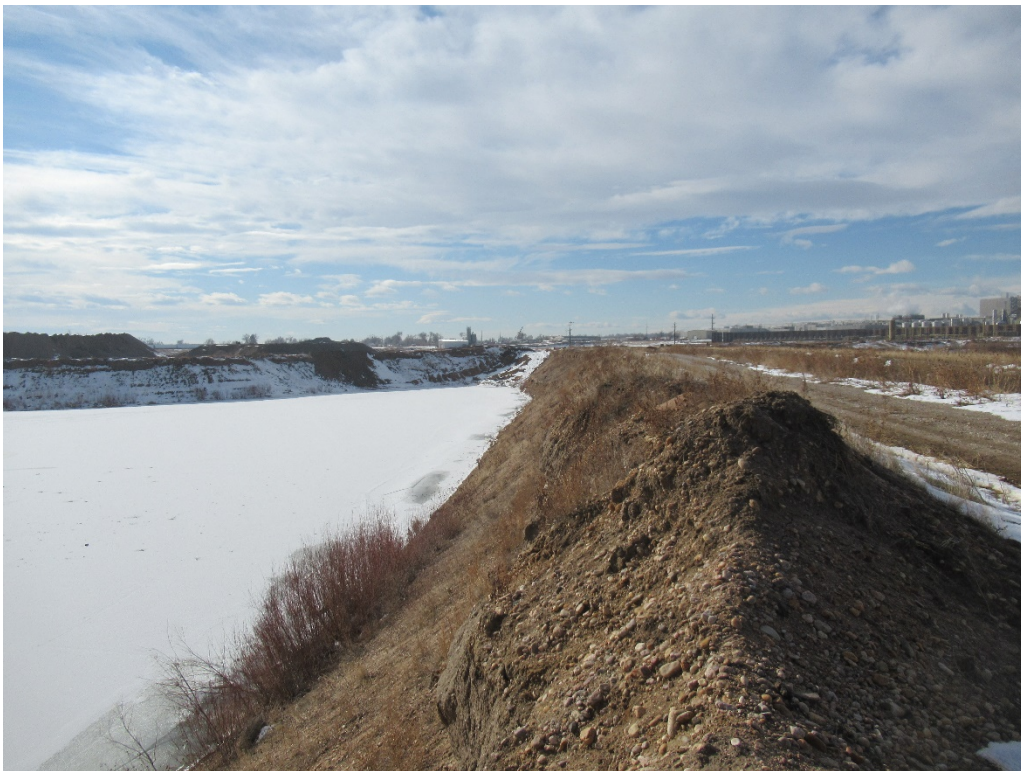
View of Tract D from the northwest corner of Tract D looking south

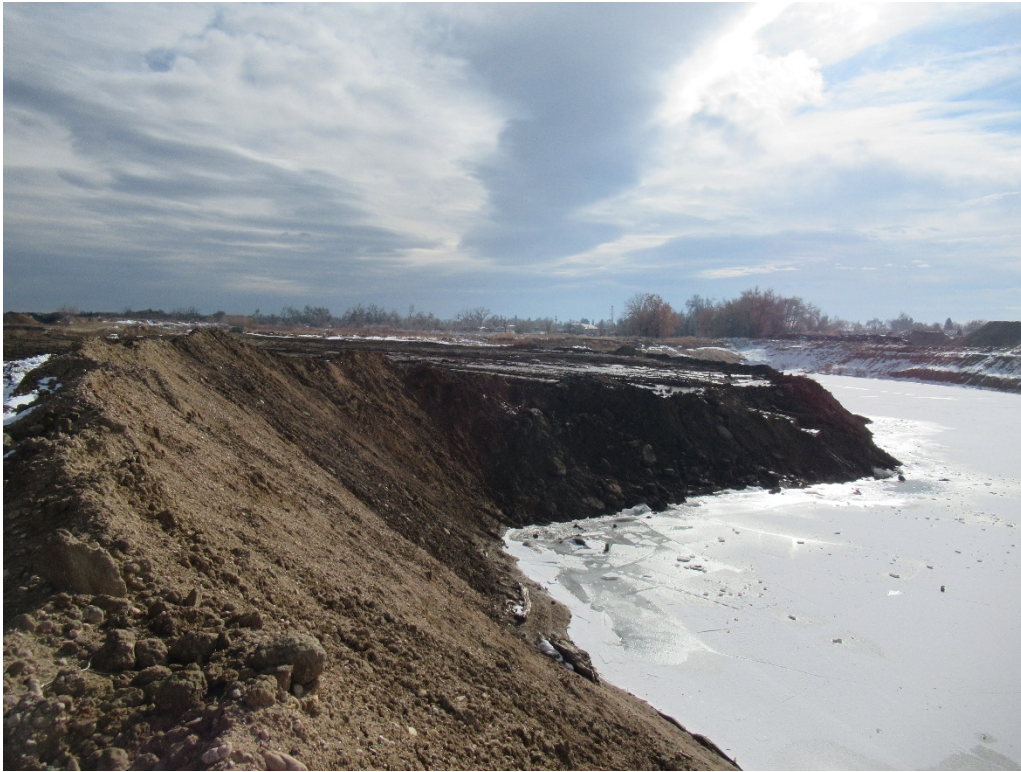
View of Tract D from the northwest corner of Tract D looking east at the backfill operation along the north shoreline
